**FY 2014 Annual Report for the  
Quarterly Land Use Control Inspections,  
RVAAP-05 Winklepeck Burning Grounds**

**Camp Ravenna Joint Military Training Center  
Former Ravenna Army Ammunition Plant  
Portage and Trumbull Counties, Ohio**

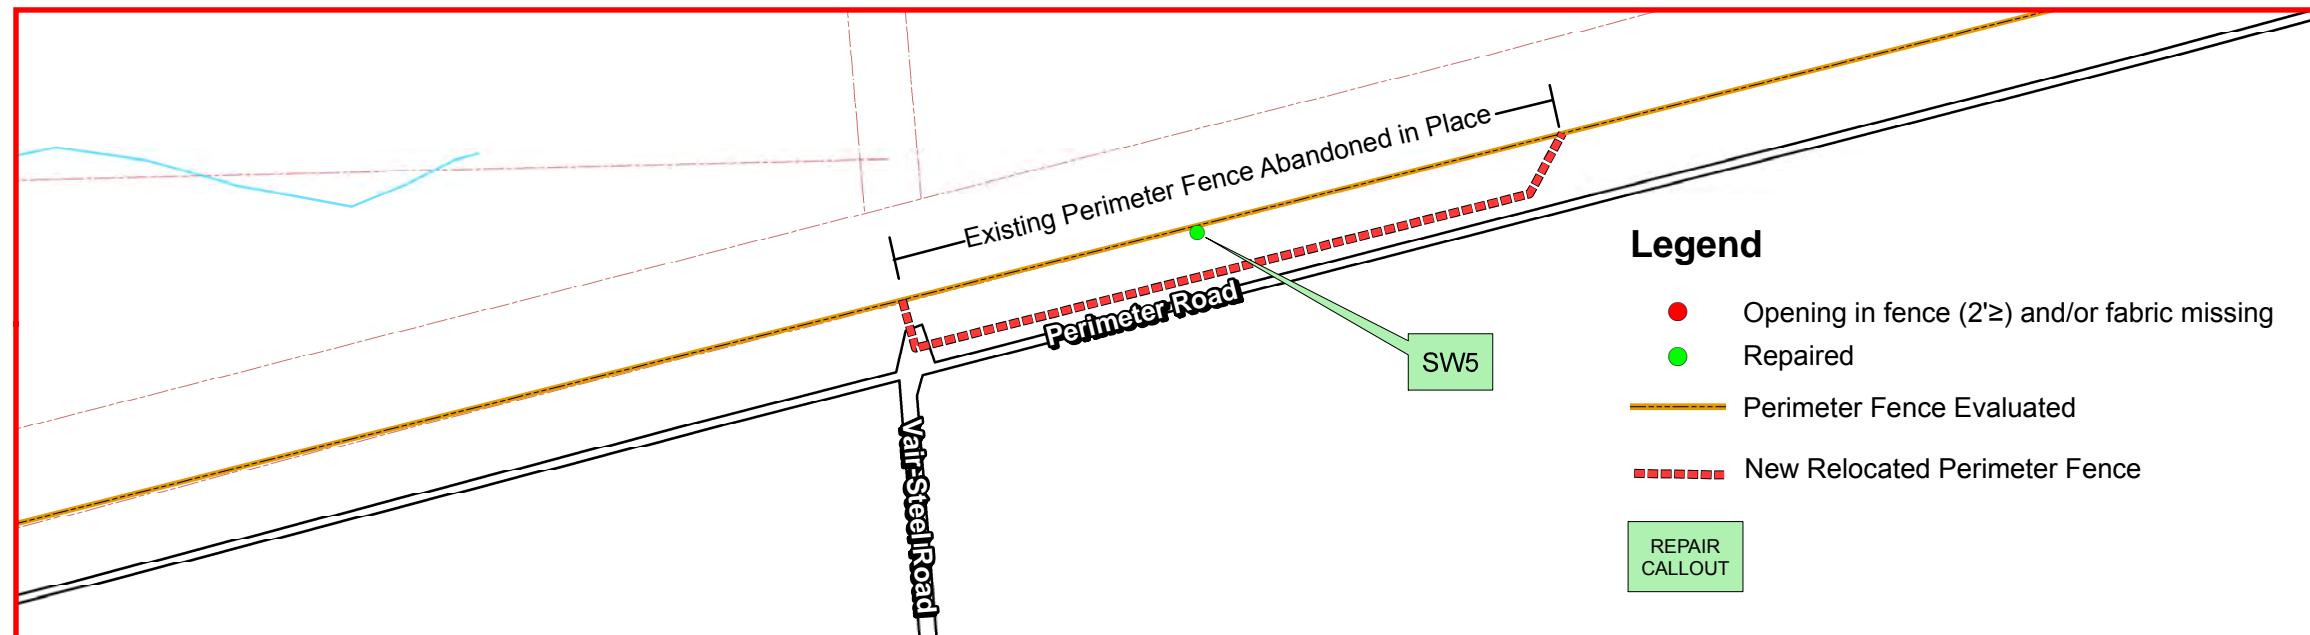
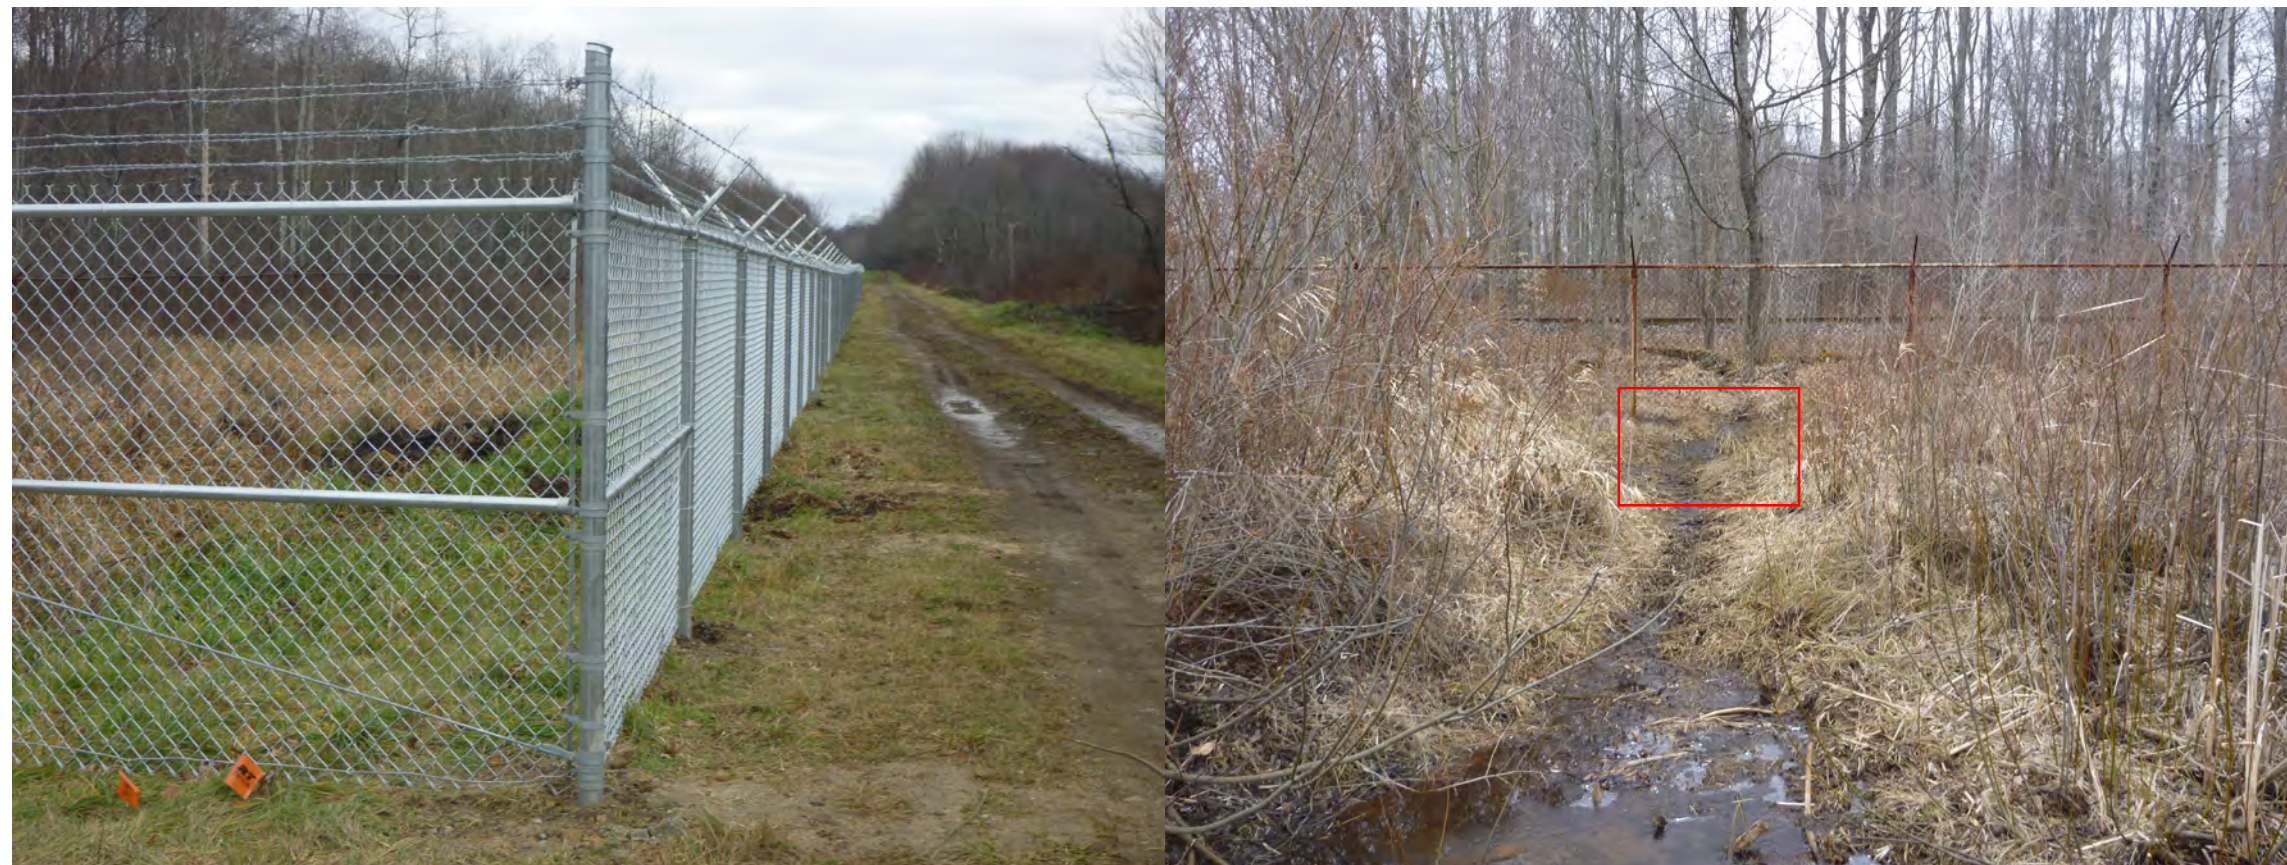
## DETAIL SHEET FOR SW5

PHOTO SW5 discovered 02/12/2013

REPAIR PHOTO SW5 DEPICTING NEW RELOCATED FENCE  
photo dated 11/19/2013

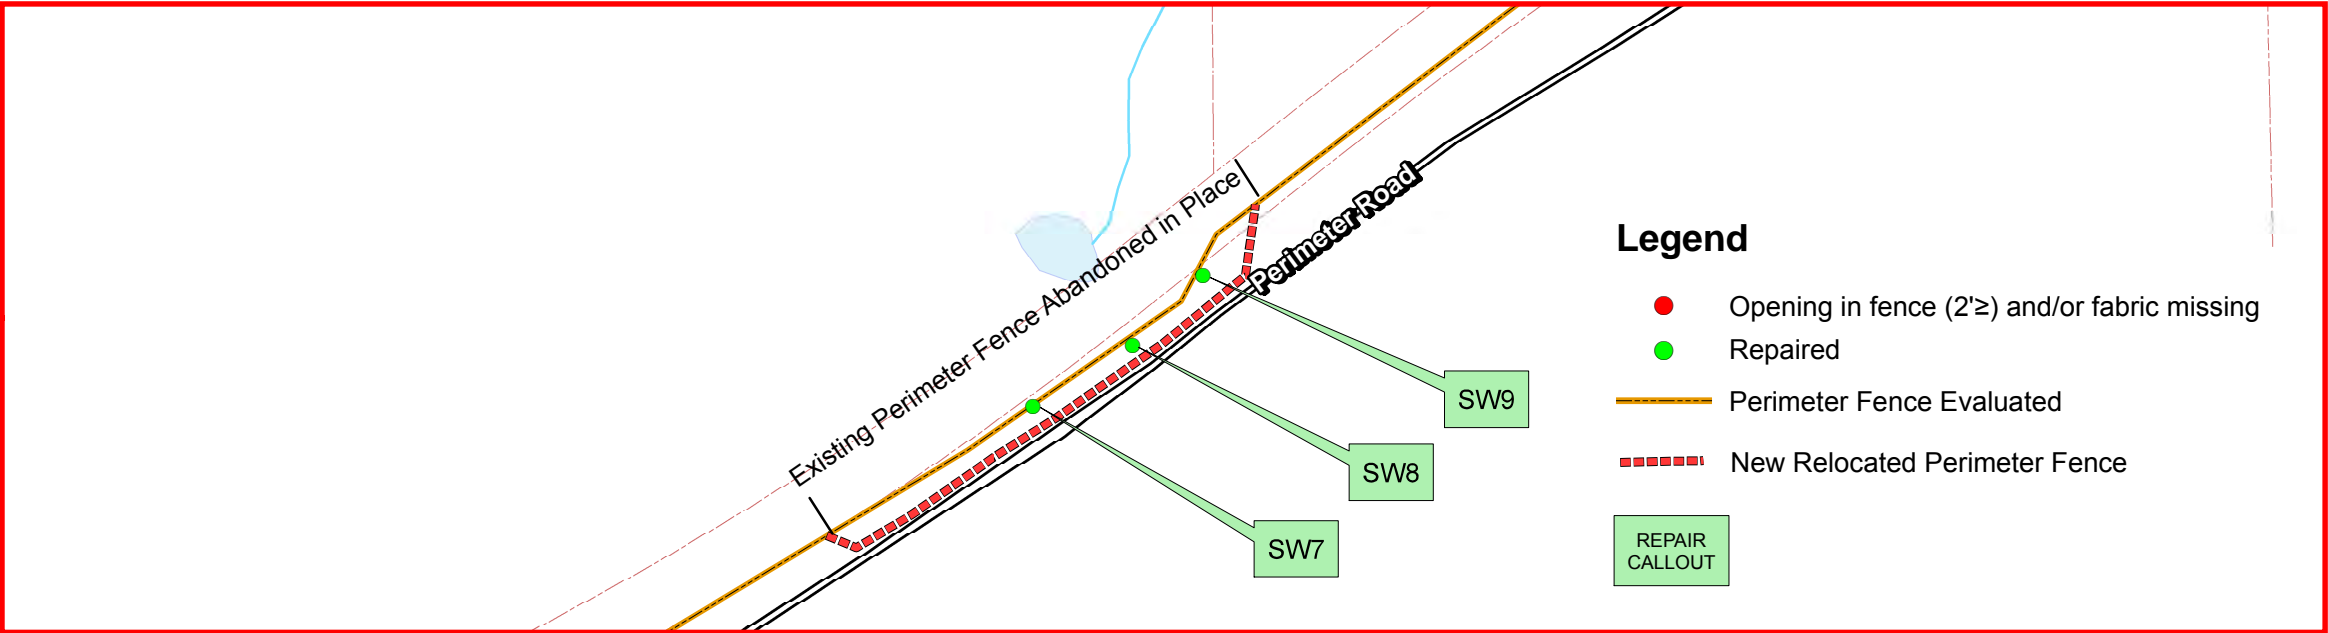
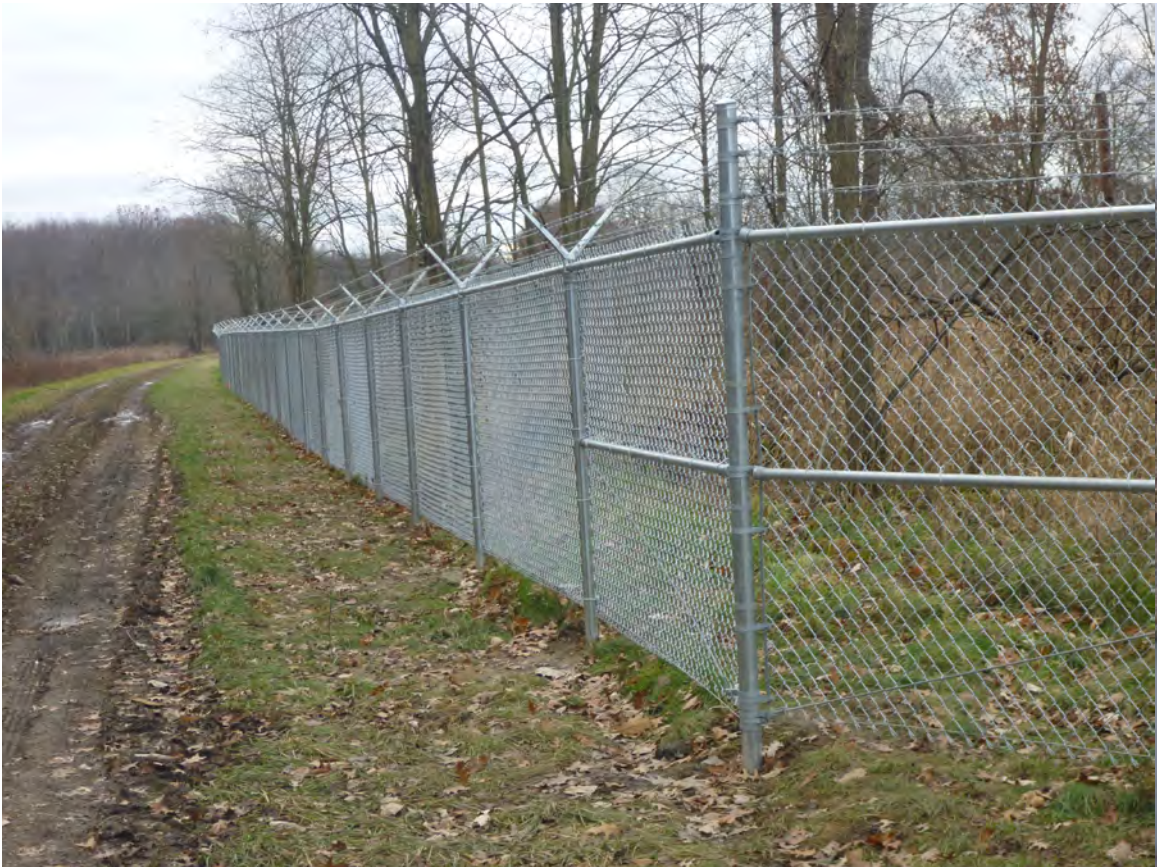
DETAIL SHEET FOR SW7, SW8 and SW9

PHOTO SW7 discovered 02/12/2013

REPAIR PHOTO SW7 DEPICTING NEW RELOCATED FENCE  
photo taken 11/19/2013

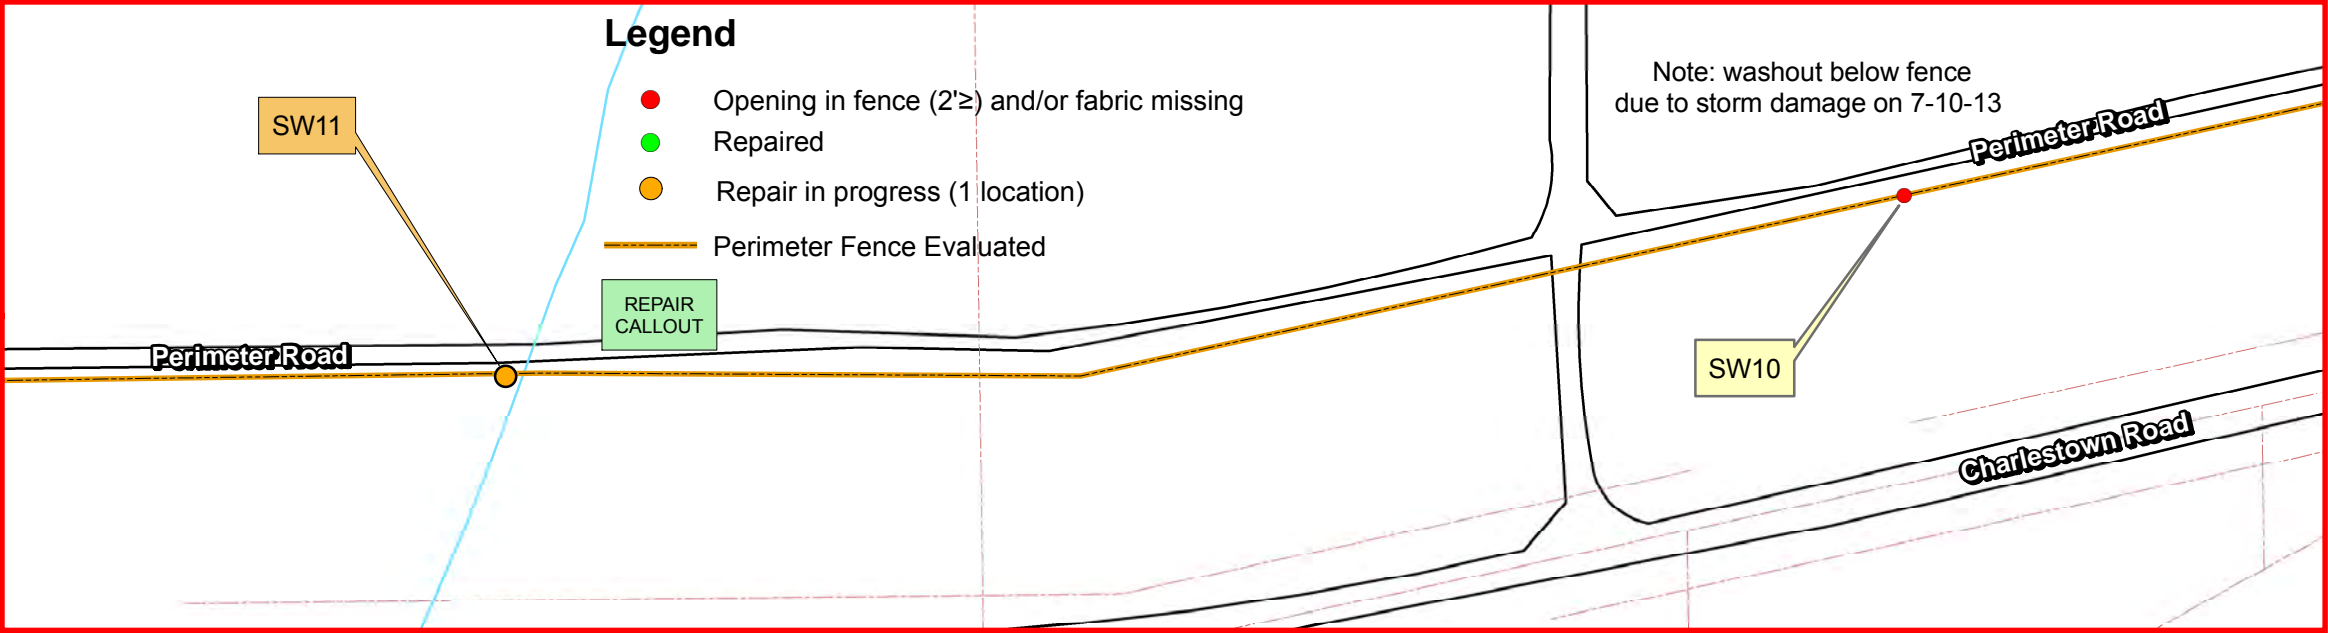
# DETAIL SHEET FOR SW11

PHOTO SW11 DEPICTING REPAIRS IN PROGRESS  
photo taken 11/18/2013

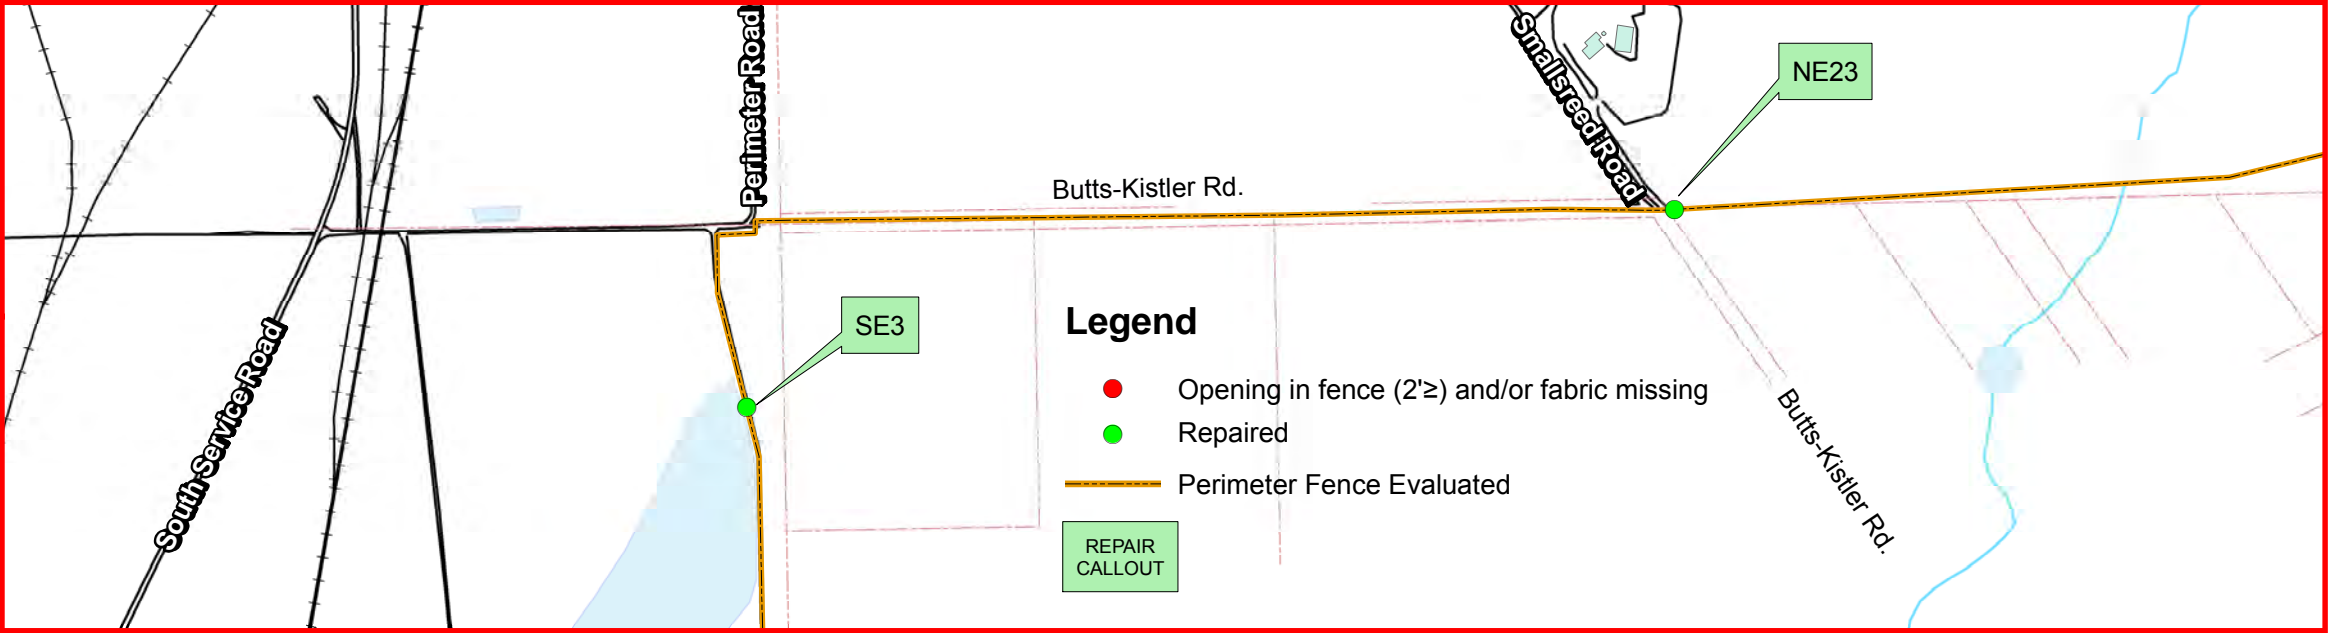
DETAIL SHEET FOR NE23

| Camp Ravenna Joint Military Training Center 2nd Qtr FY2014 LUC Inspection Summary Table | | | | | US Survey Ft | | Path to Repair Photo | |
|---|---|--|---|--|---|---|--|---|
| NE23 | 11/25/2013 | c:\My Documents\My ArcPad\P1010269.JPG | 3 sections badly damaged | | 563209 | 2383312 | c:\My Documents\My ArcPad\P1010375.JPG | NE23 |

PHOTO NE23 repair 03/05/2014

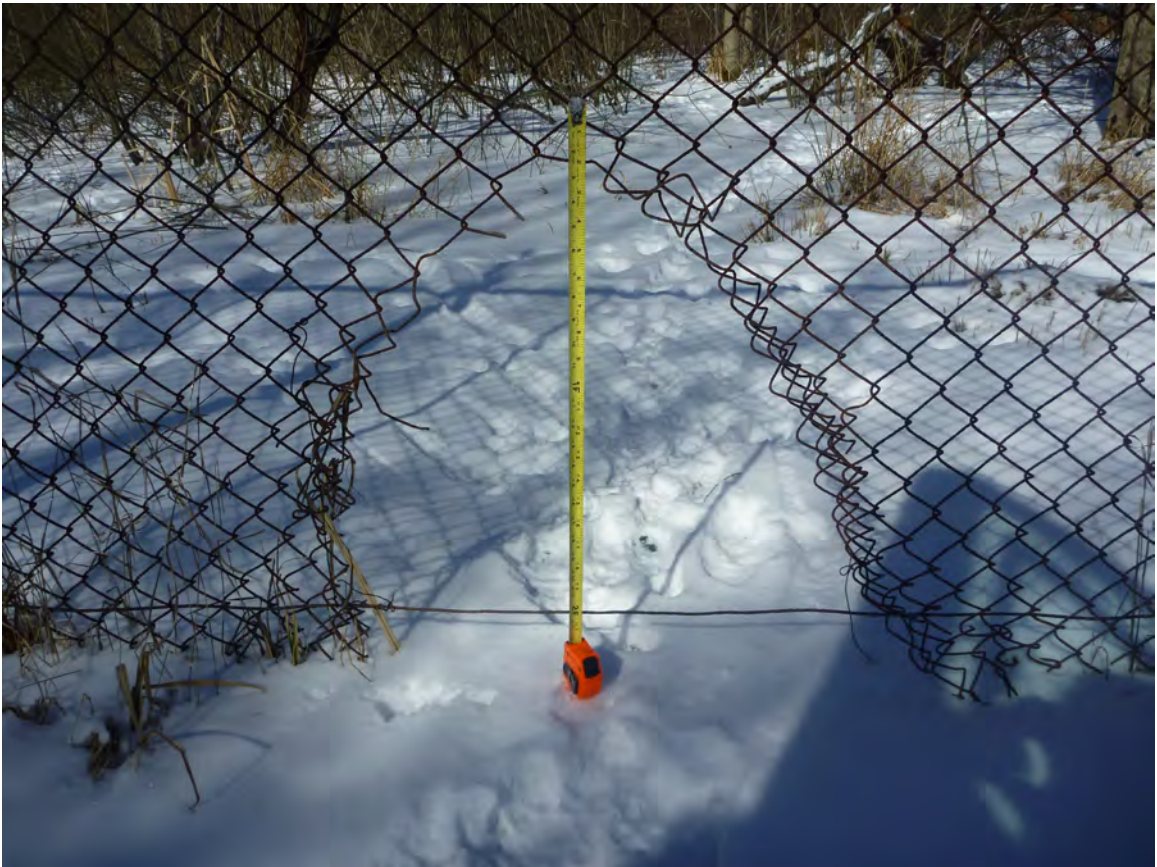
PHOTO NE24 discovered 03/03/2014

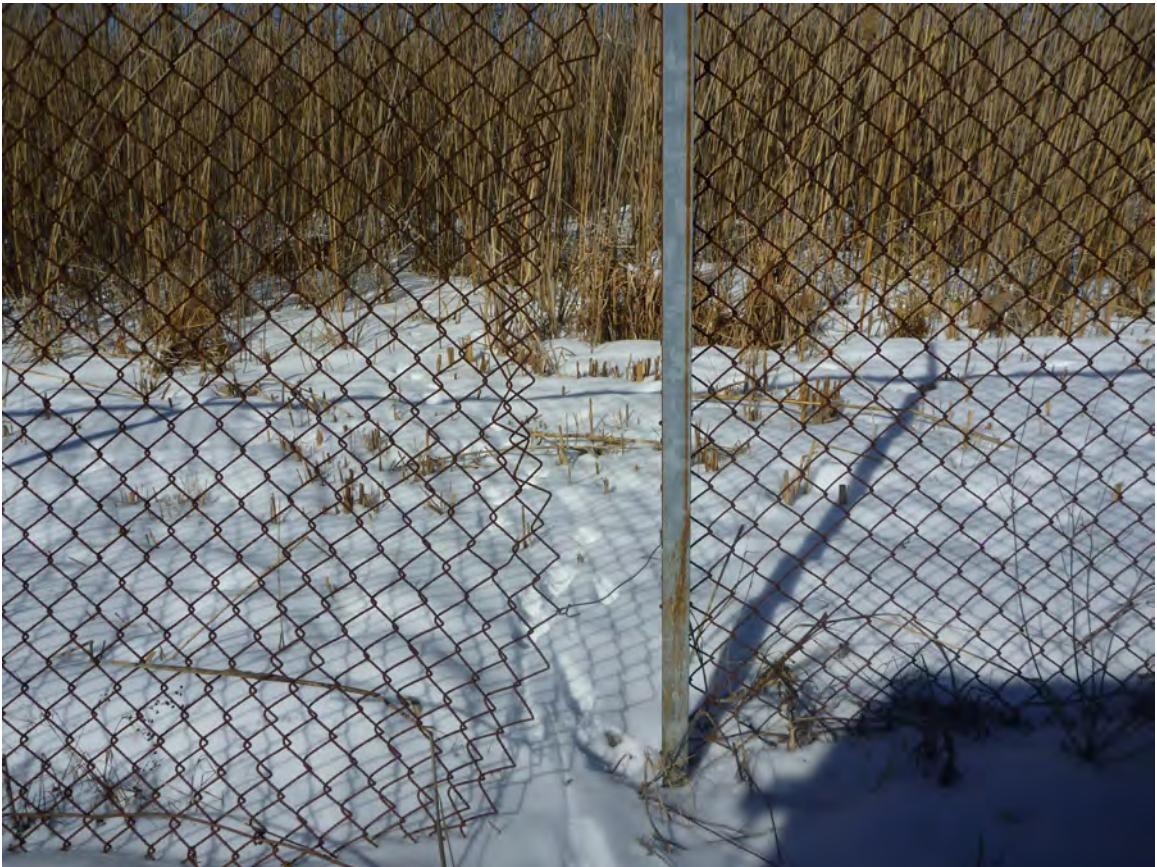
PHOTO NE25 discovered 03/03/2014

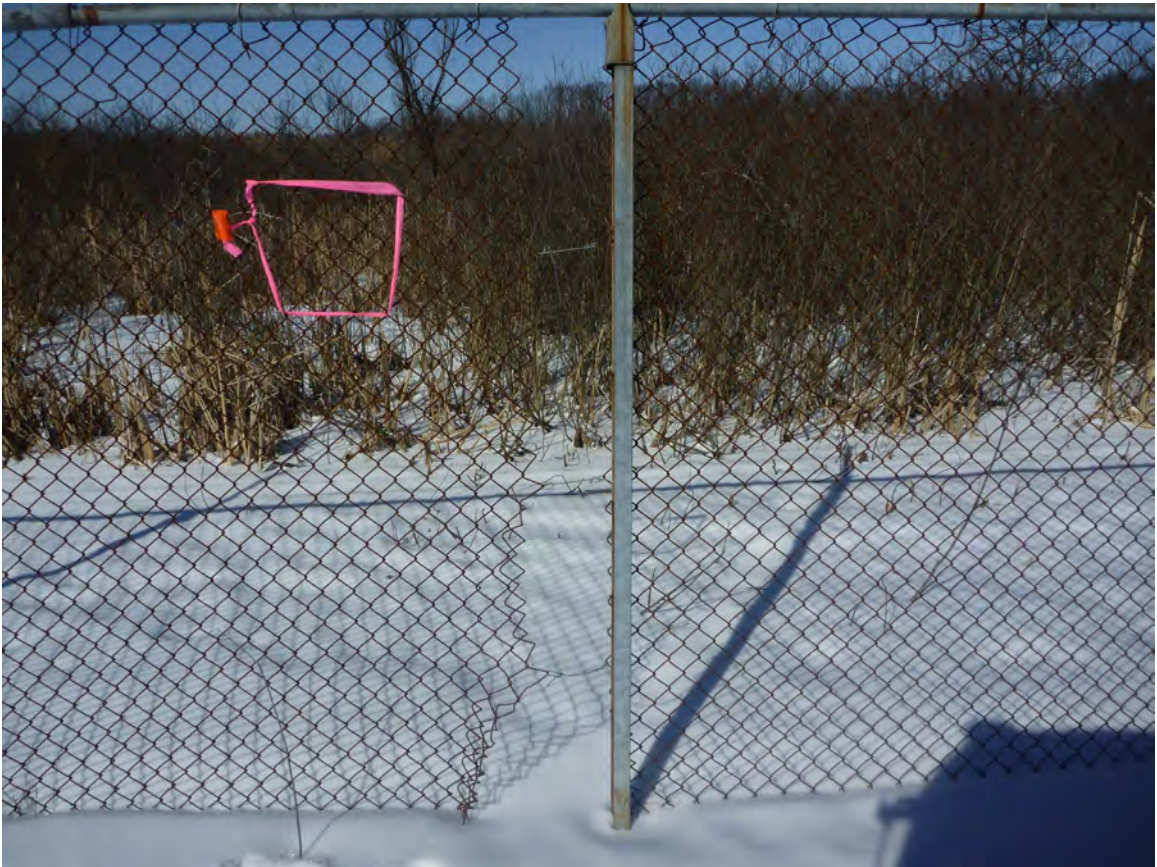
PHOTO NE26 discovered 03/03/2014

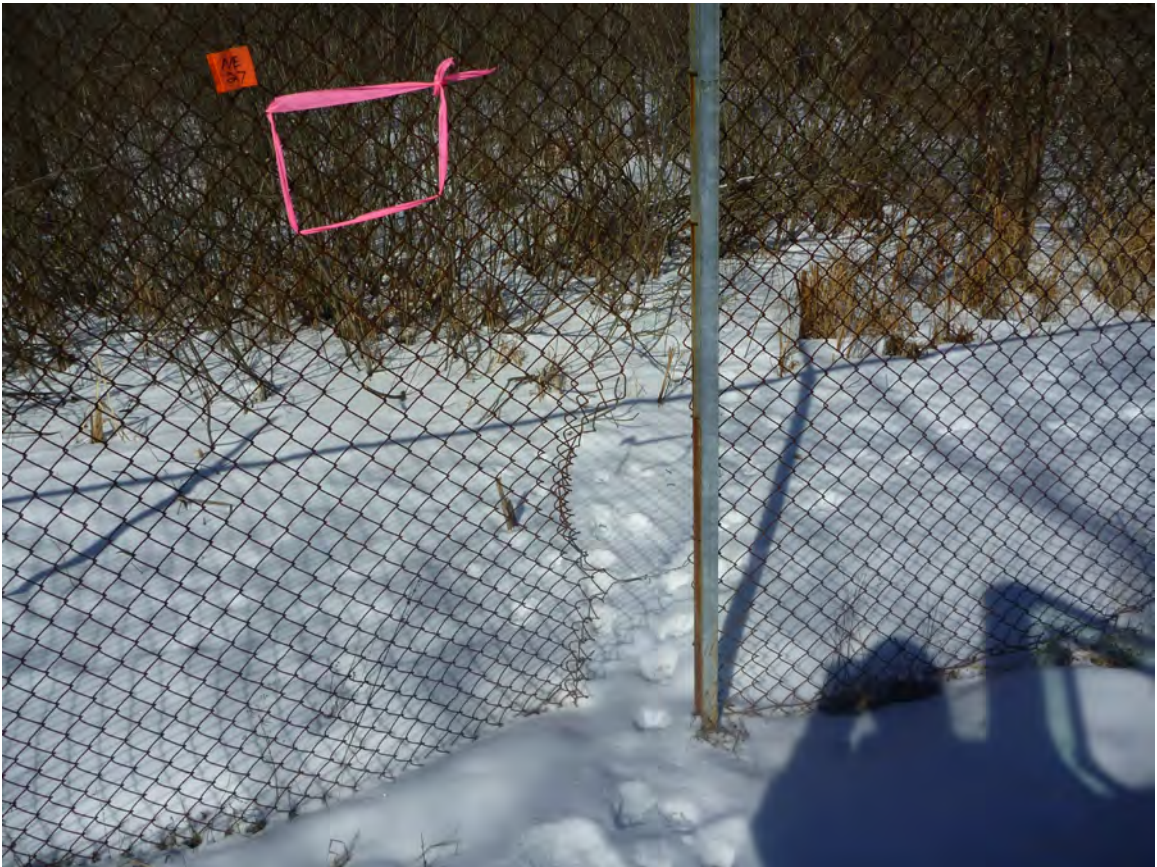
PHOTO NE27 discovered 03/03/2014

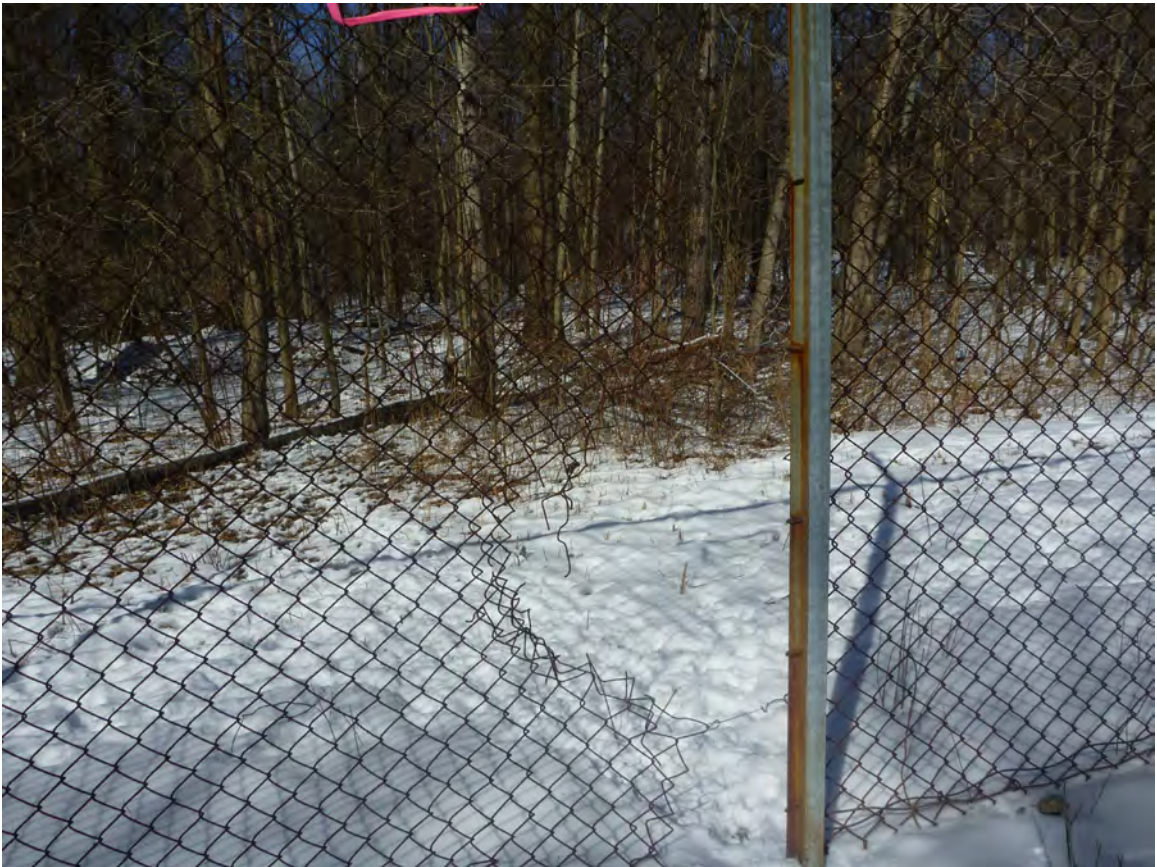
PHOTO NE28 discovered 03/03/2014

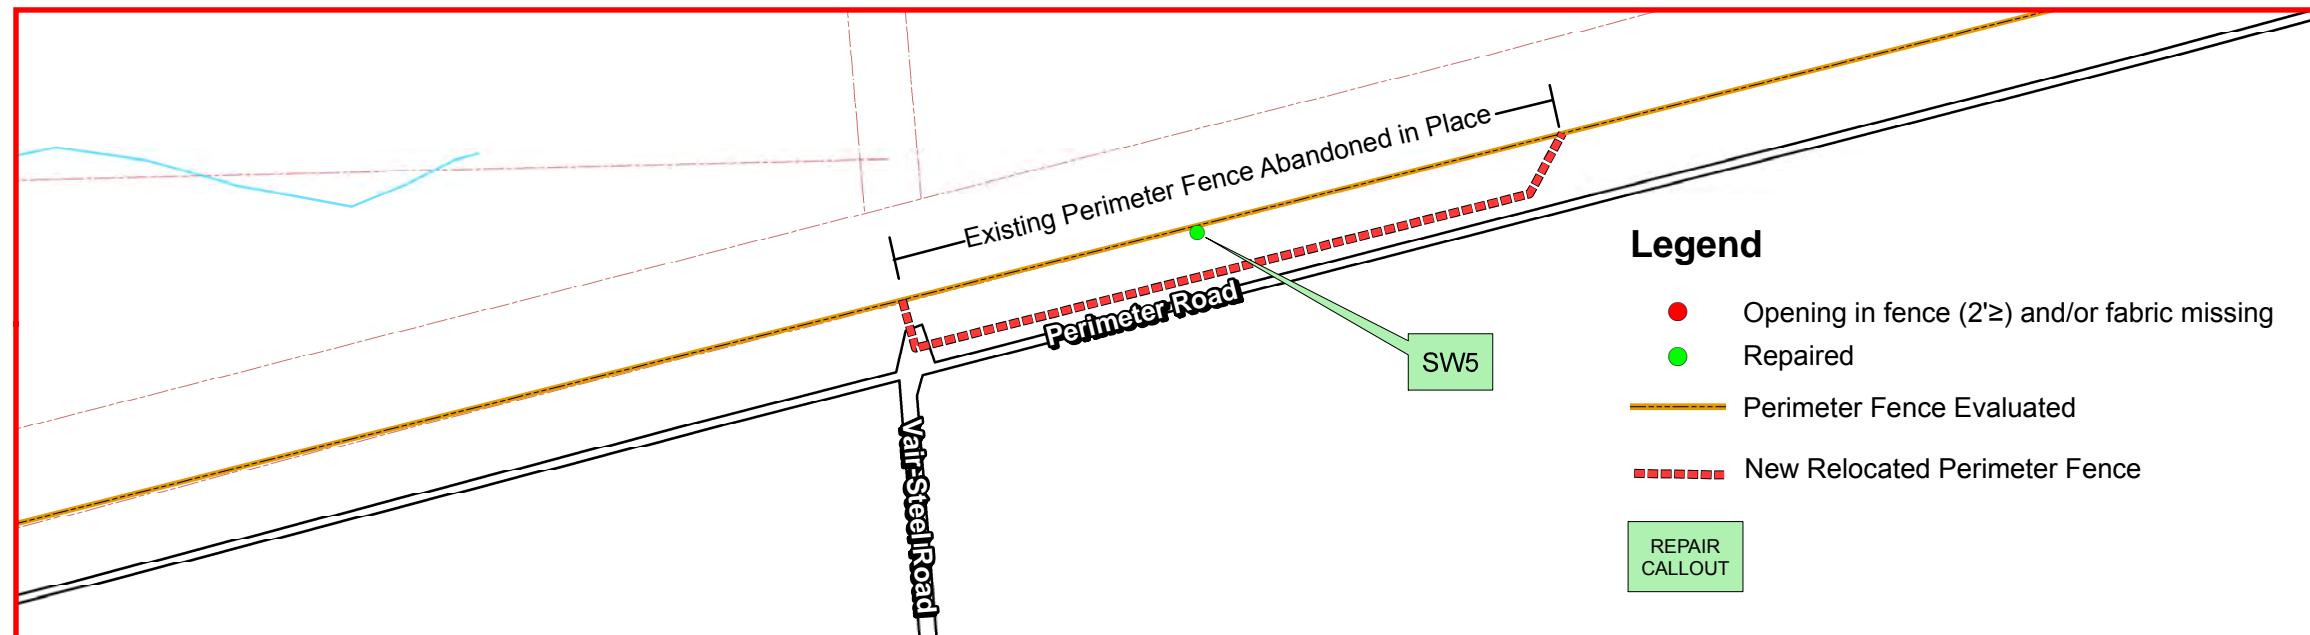
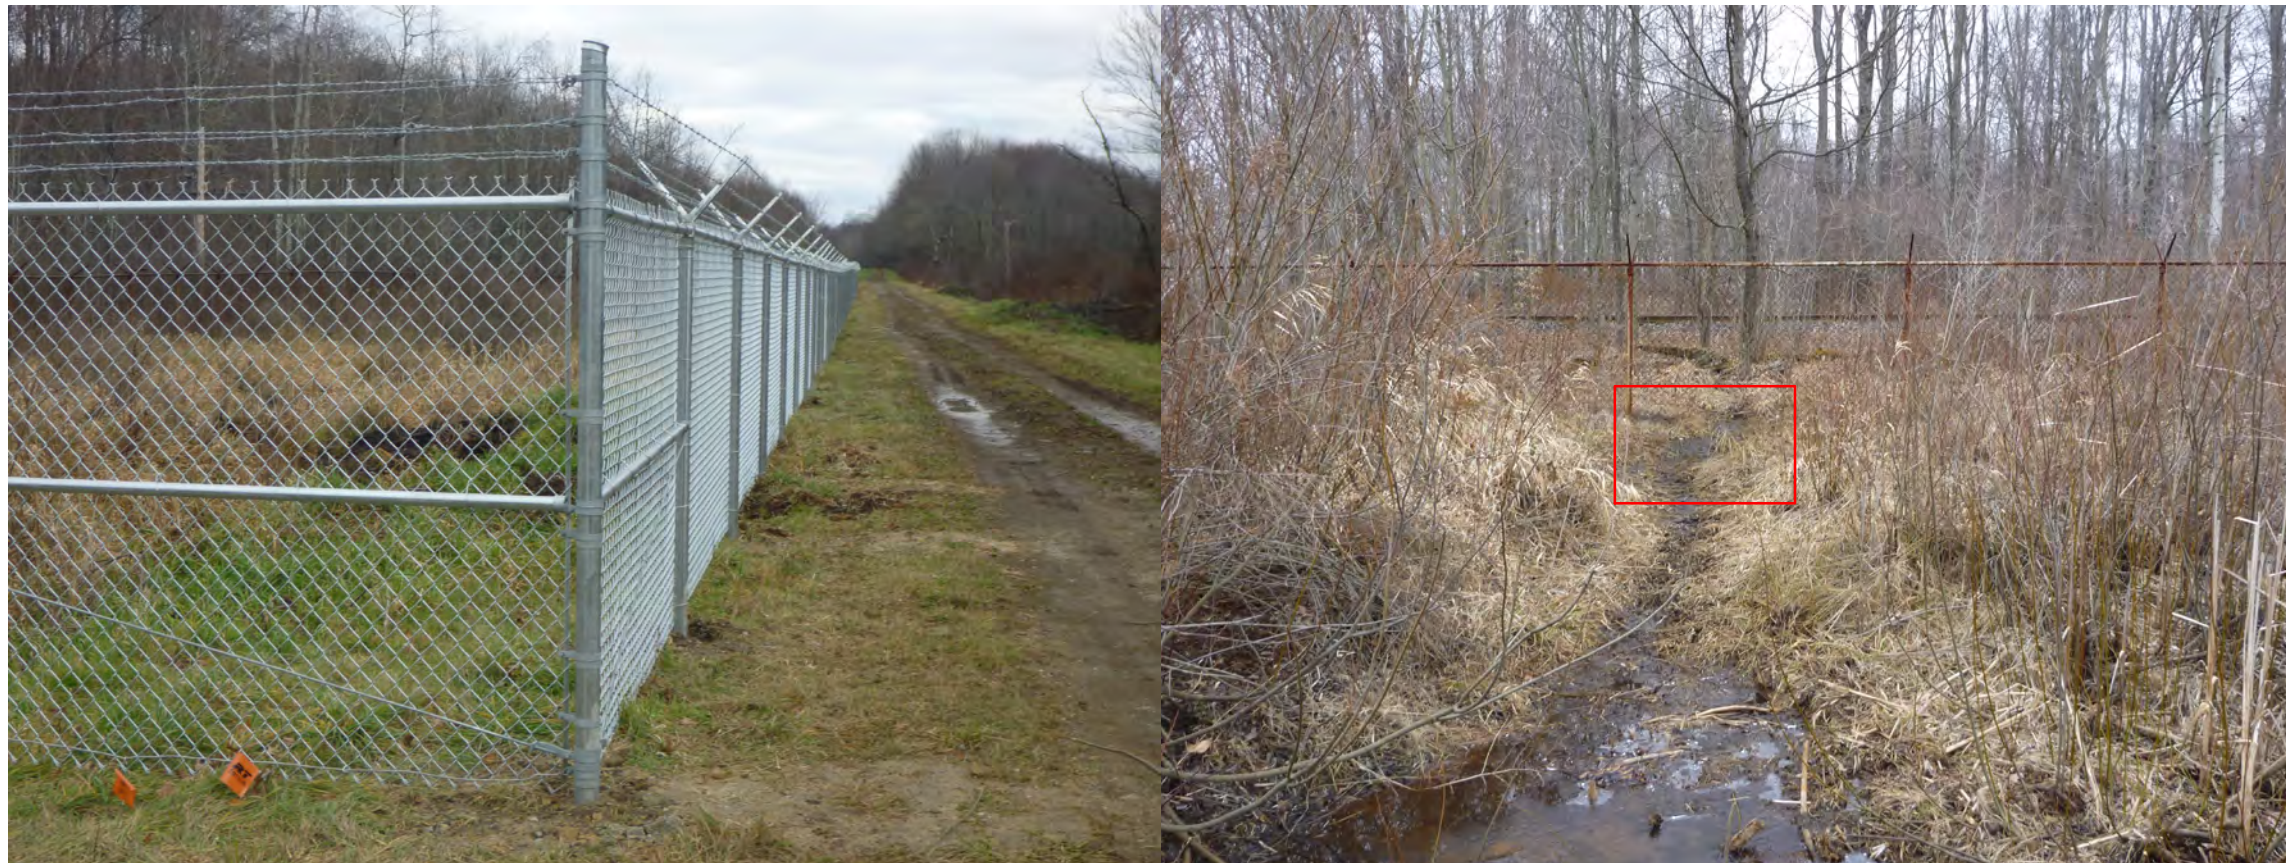
## DETAIL SHEET FOR SW5

PHOTO SW5 discovered 02/12/2013

REPAIR PHOTO SW5 DEPICTING NEW RELOCATED FENCE  
dated 11/19/2013

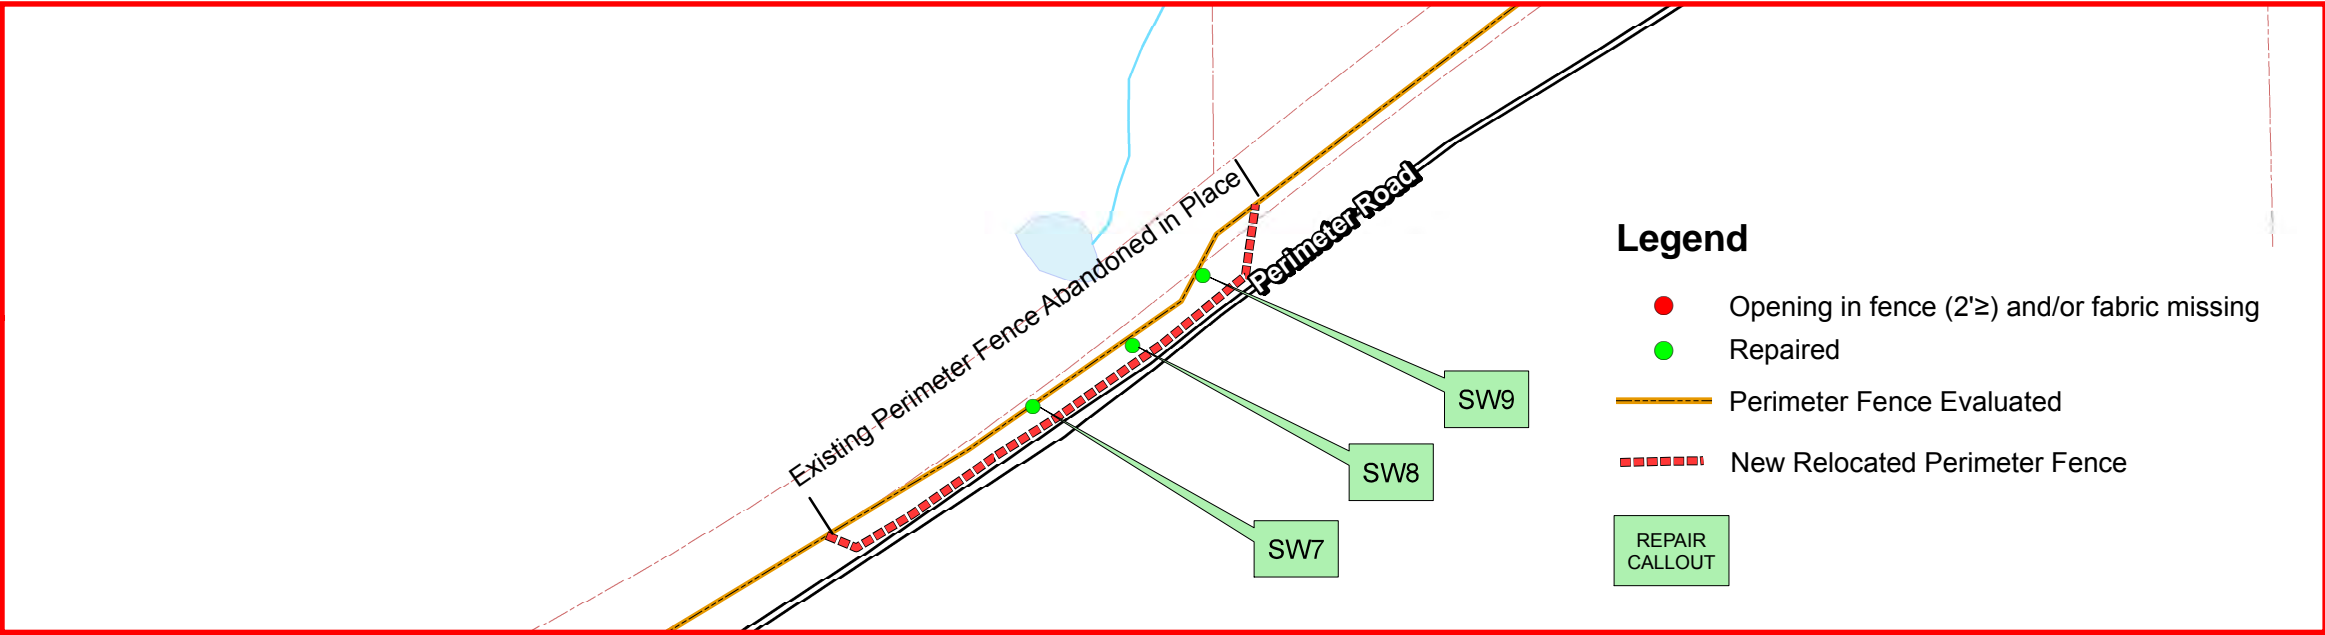
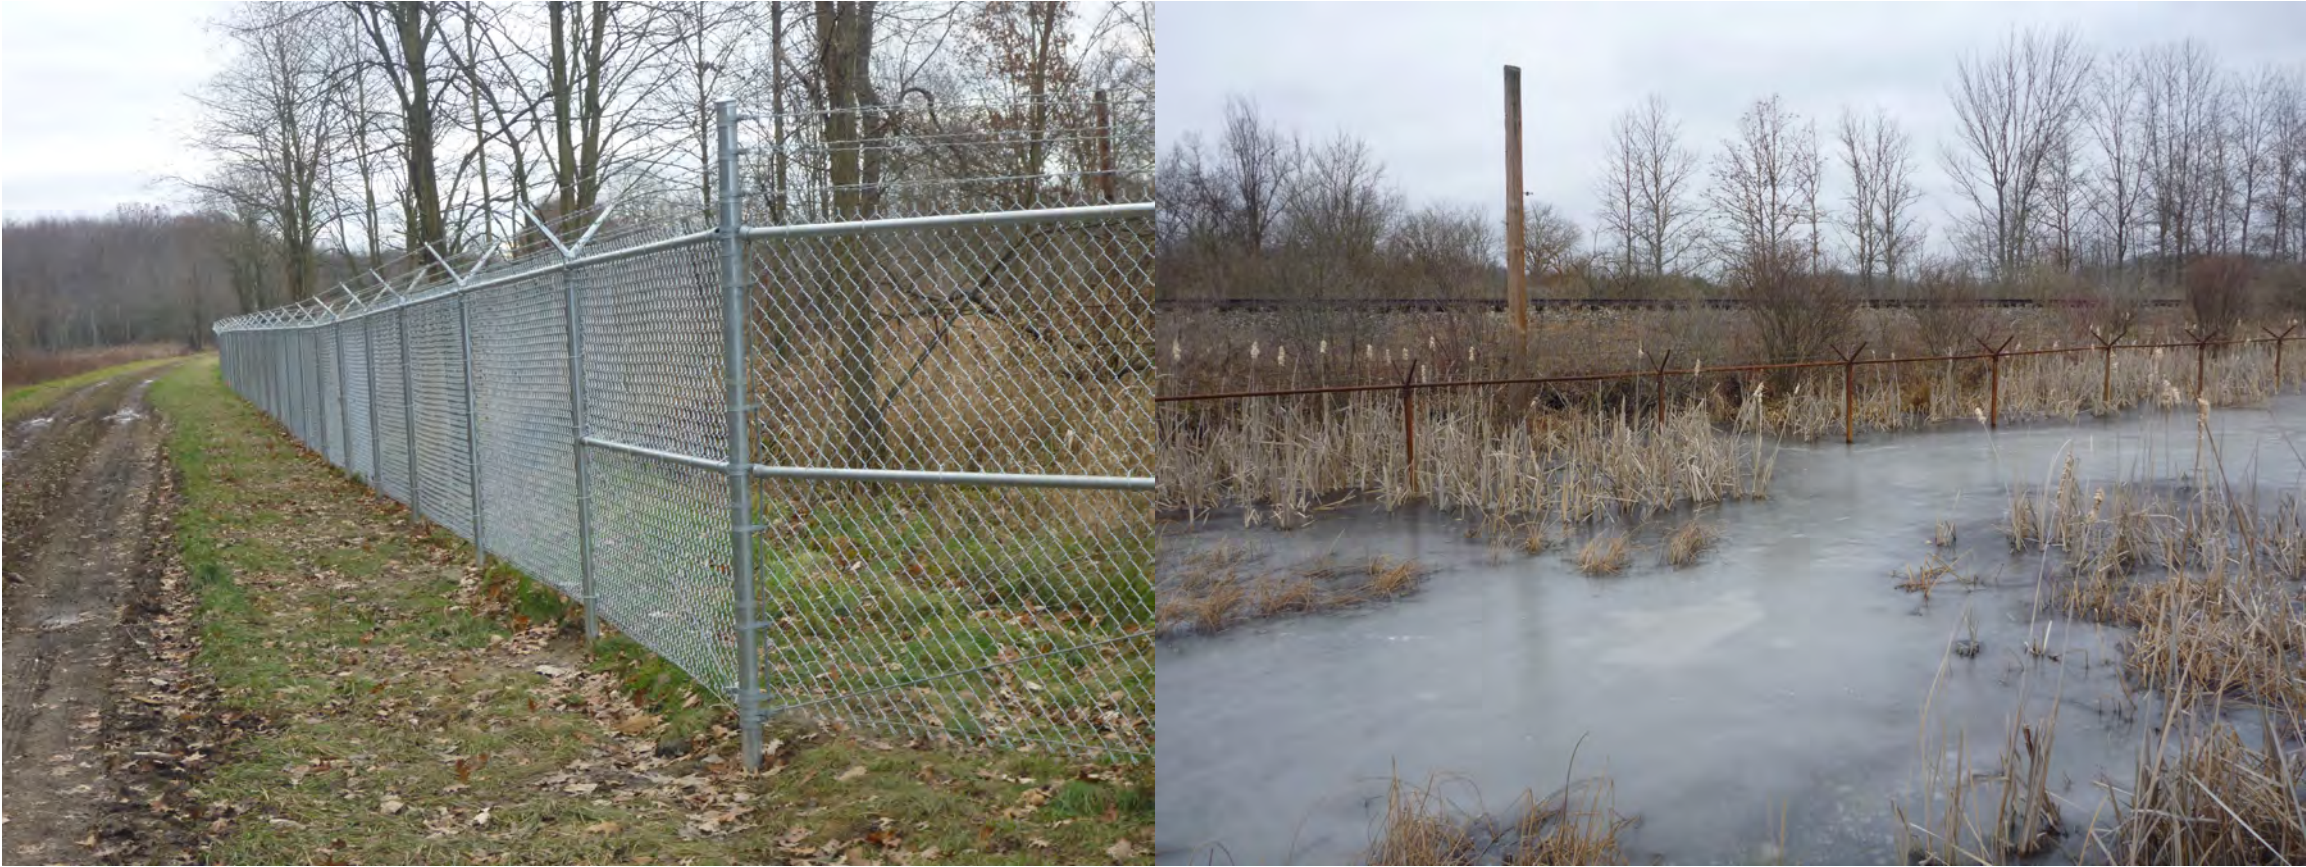
DETAIL SHEET FOR SW7, SW8 and SW9

| Camp Ravenna Joint Military Training Center 2nd Qtr FY2014 LUC Inspection Summary Table | | | | | US Survey Ft | | Path to Repair Photo | |
|---|---|--|---|--|---|---|--|---|
| SW07 | 02/12/2013 | c:\My Documents\My ArcPad\P1010076.JPG | apx. 100 ft of fabric missing | | 561189 | 2336373 | c:\My Documents\My ArcPad\P1010257.JPG | SW07 |

PHOTO SW7 discovered 02/12/2013

REPAIR PHOTO SW7 DEPICTING NEW RELOCATED FENCE  
dated 11/19/2013
