**FY 2014 Annual Report for the  
Quarterly Land Use Control Inspections,  
RVAAP-05 Winklepeck Burning Grounds**

**Camp Ravenna Joint Military Training Center  
Former Ravenna Army Ammunition Plant  
Portage and Trumbull Counties, Ohio**

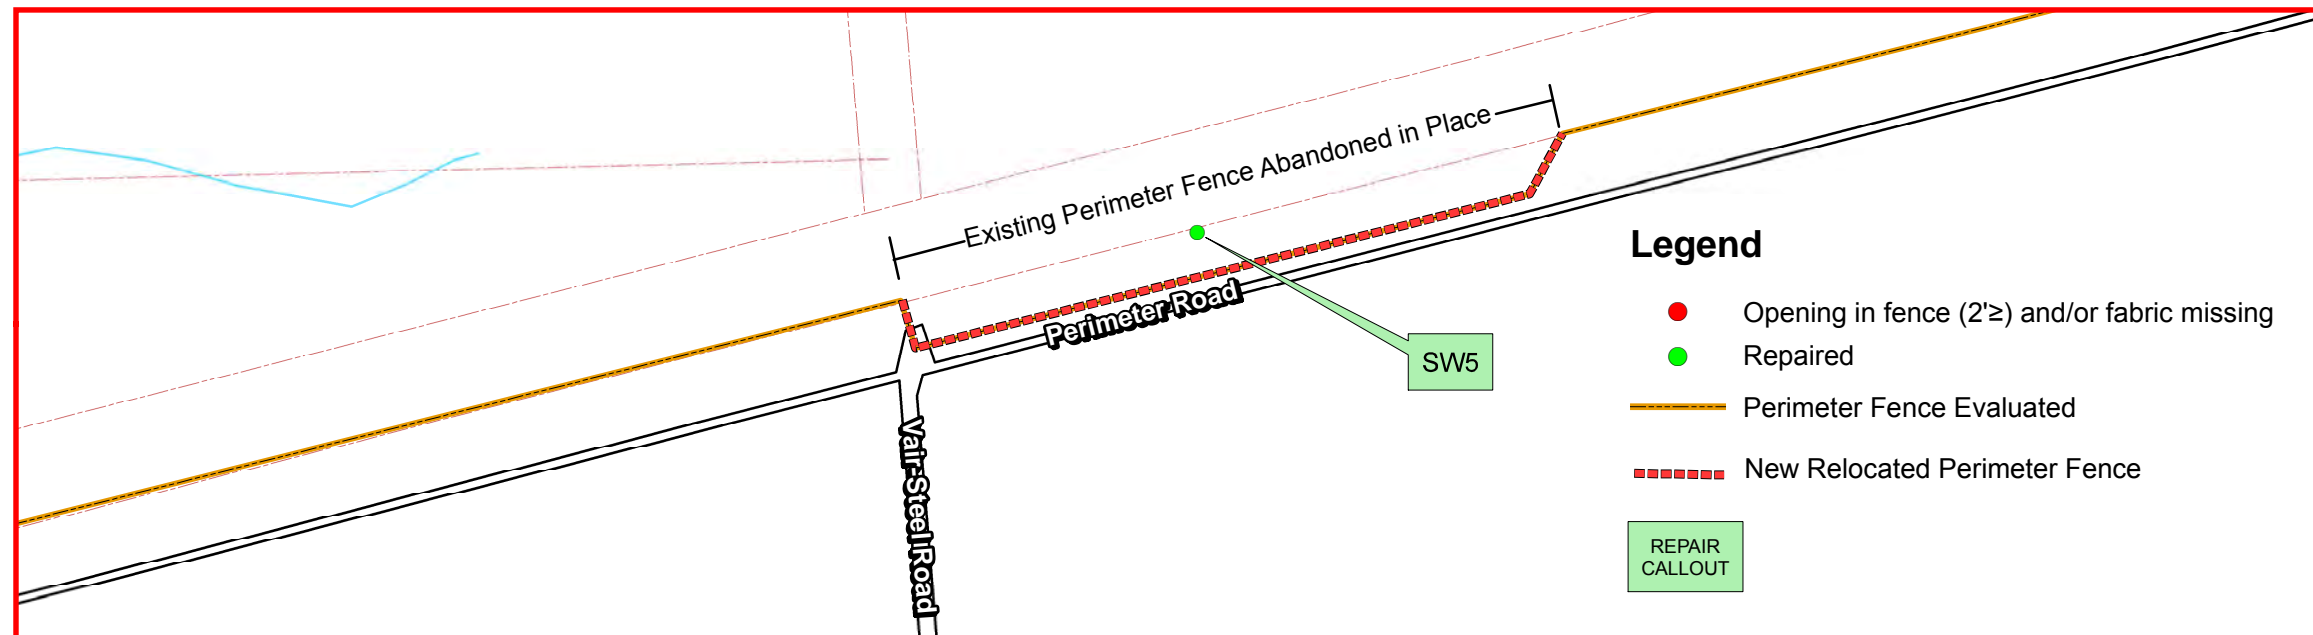
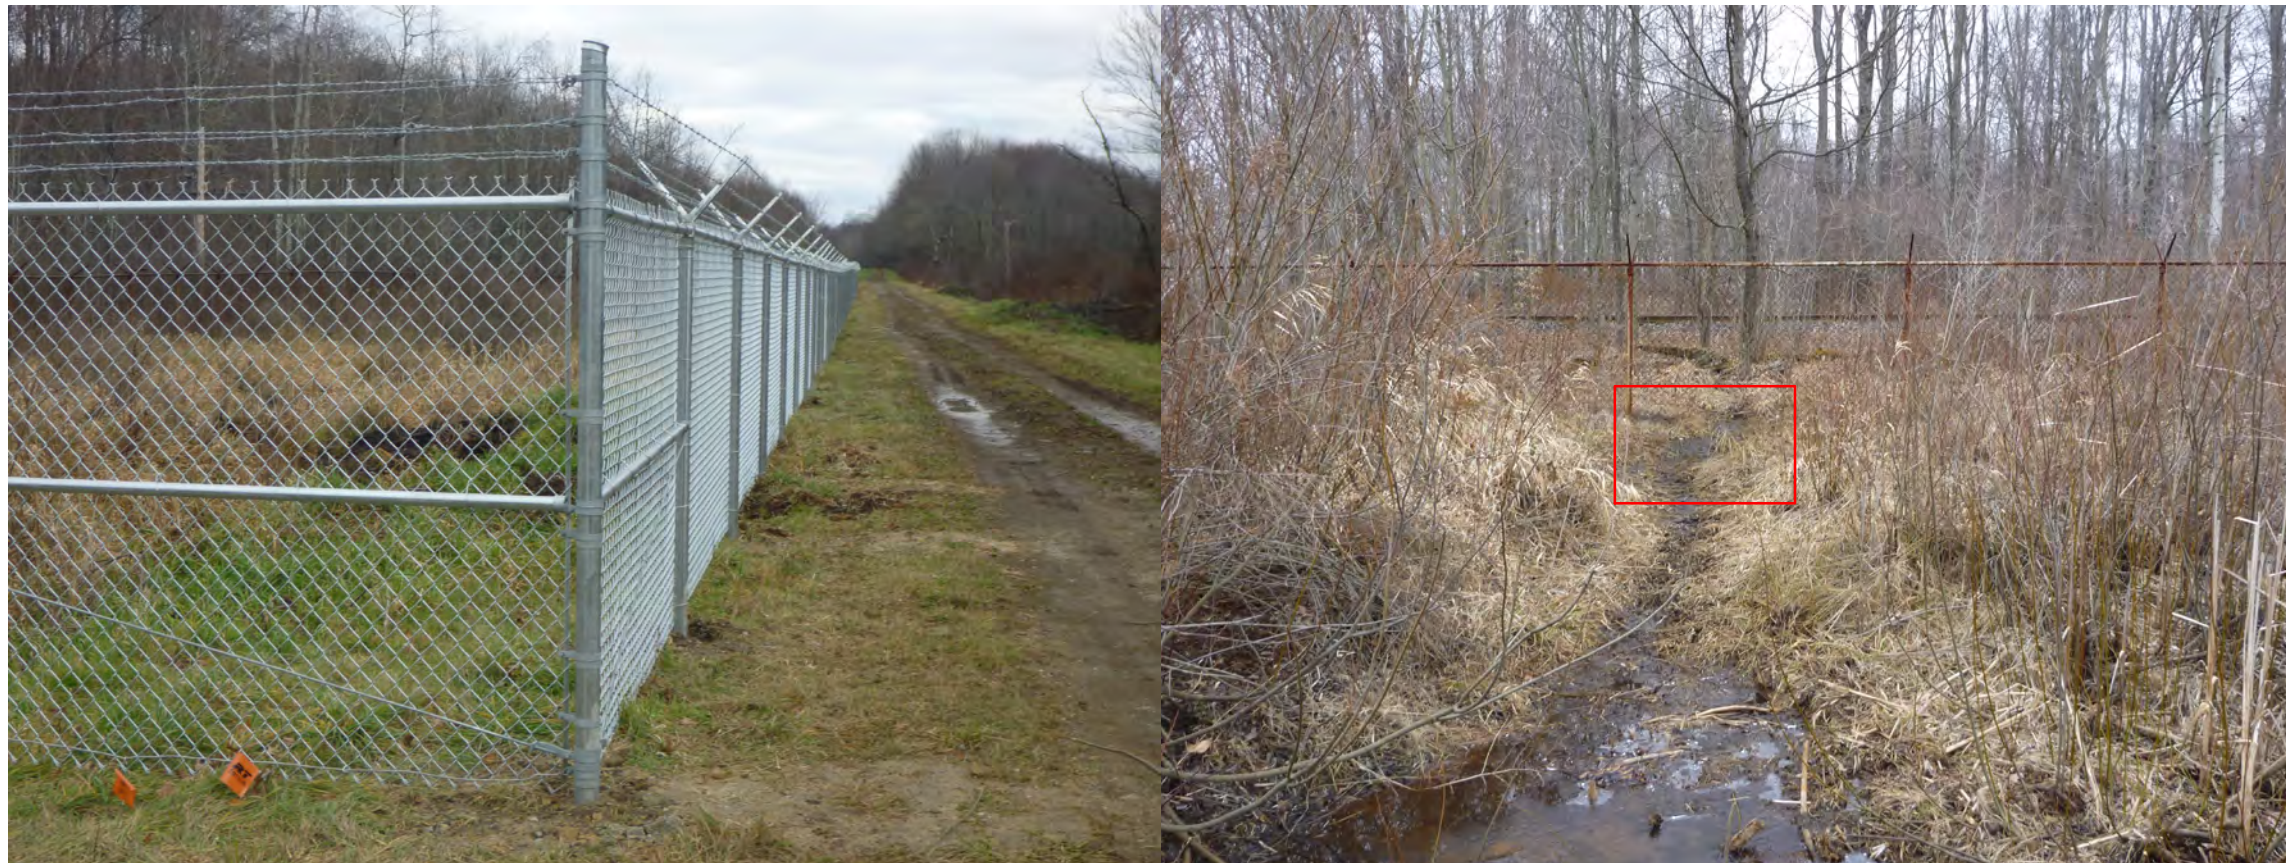
## DETAIL SHEET FOR SW5

PHOTO SW5 discovered 02/12/2013

REPAIR PHOTO SW5 DEPICTING NEW RELOCATED FENCE  
dated 11/19/2013
