**Final**  
**2020 Annual Land Use Control Monitoring Report,**  
**RVAAP-01 Ramsdell Quarry Landfill,**  
**RVAAP-05 Winklepeck Burning Grounds,**  
**RVAAP-08 through RVAAP-11 (Load Lines 1 through 4),**  
**RVAAP-12 (Load Line 12) and RVAAP-51 (Dump Along Paris-Windham**  
**Road)**

**Camp James A. Garfield Joint Military Training Center**  
**Former Ravenna Army Ammunition Plant**  
**Portage and Trumbull Counties, Ohio**

**May 24, 2021**

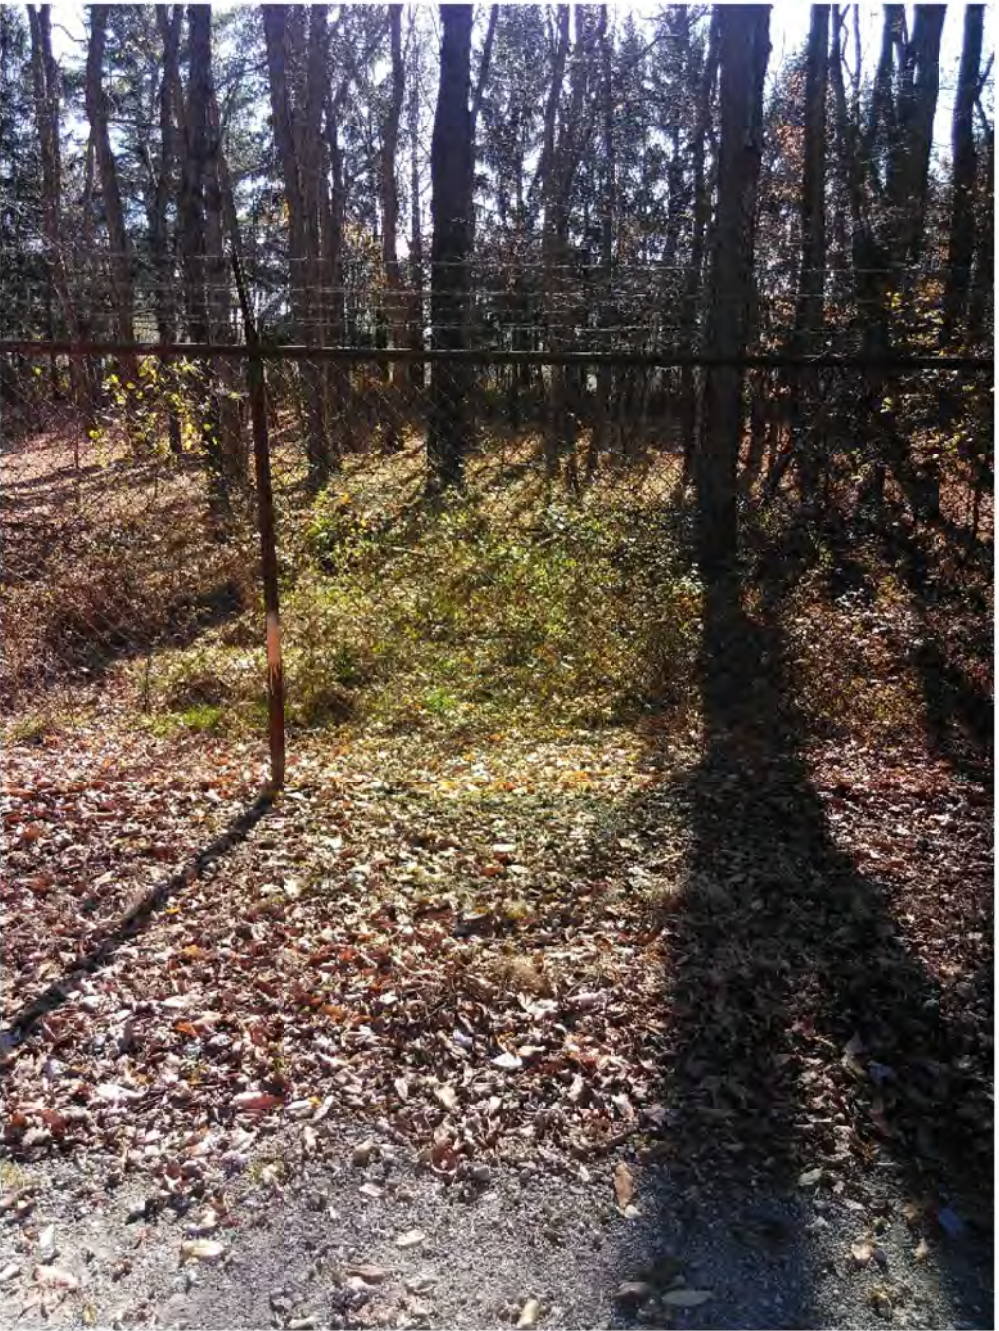
Discovered November 10, 2020

Repaired. New fencing, posts and post foundations were installed between December 2020 and January 2021 between mile markers 0.9 and 5.0. Photo not available.

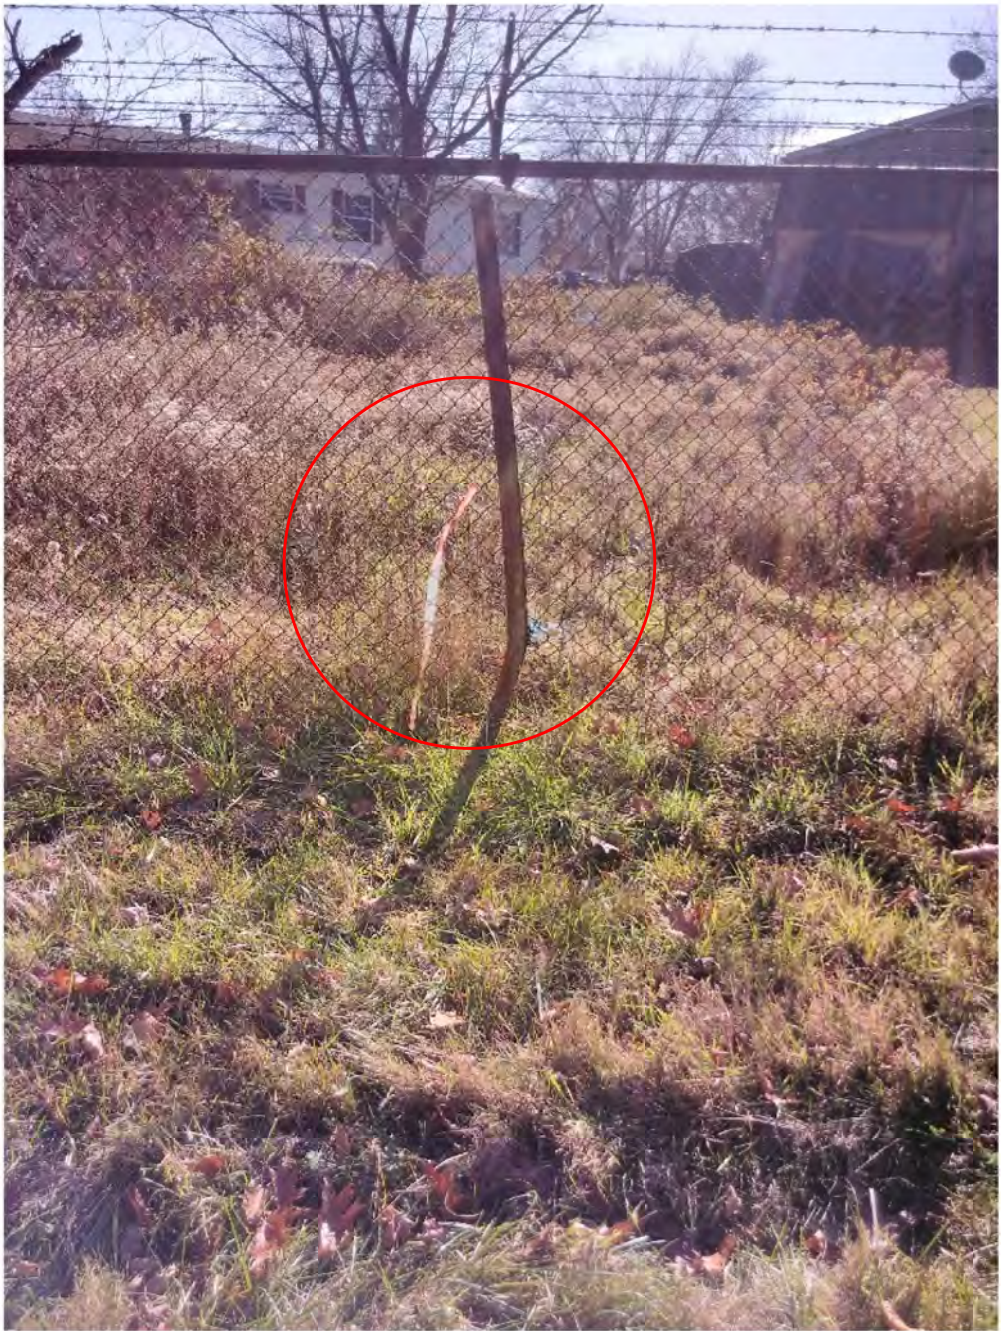
# DETAIL SHEET FOR SW66

Fence Damage/Poacher Hole at Mile 4.33

Discovered November 11, 2020

Repaired. New fencing, posts and post foundations were installed between December 2020 and January 2021 between mile markers 0.9 and 5.0.  
Photo not available.

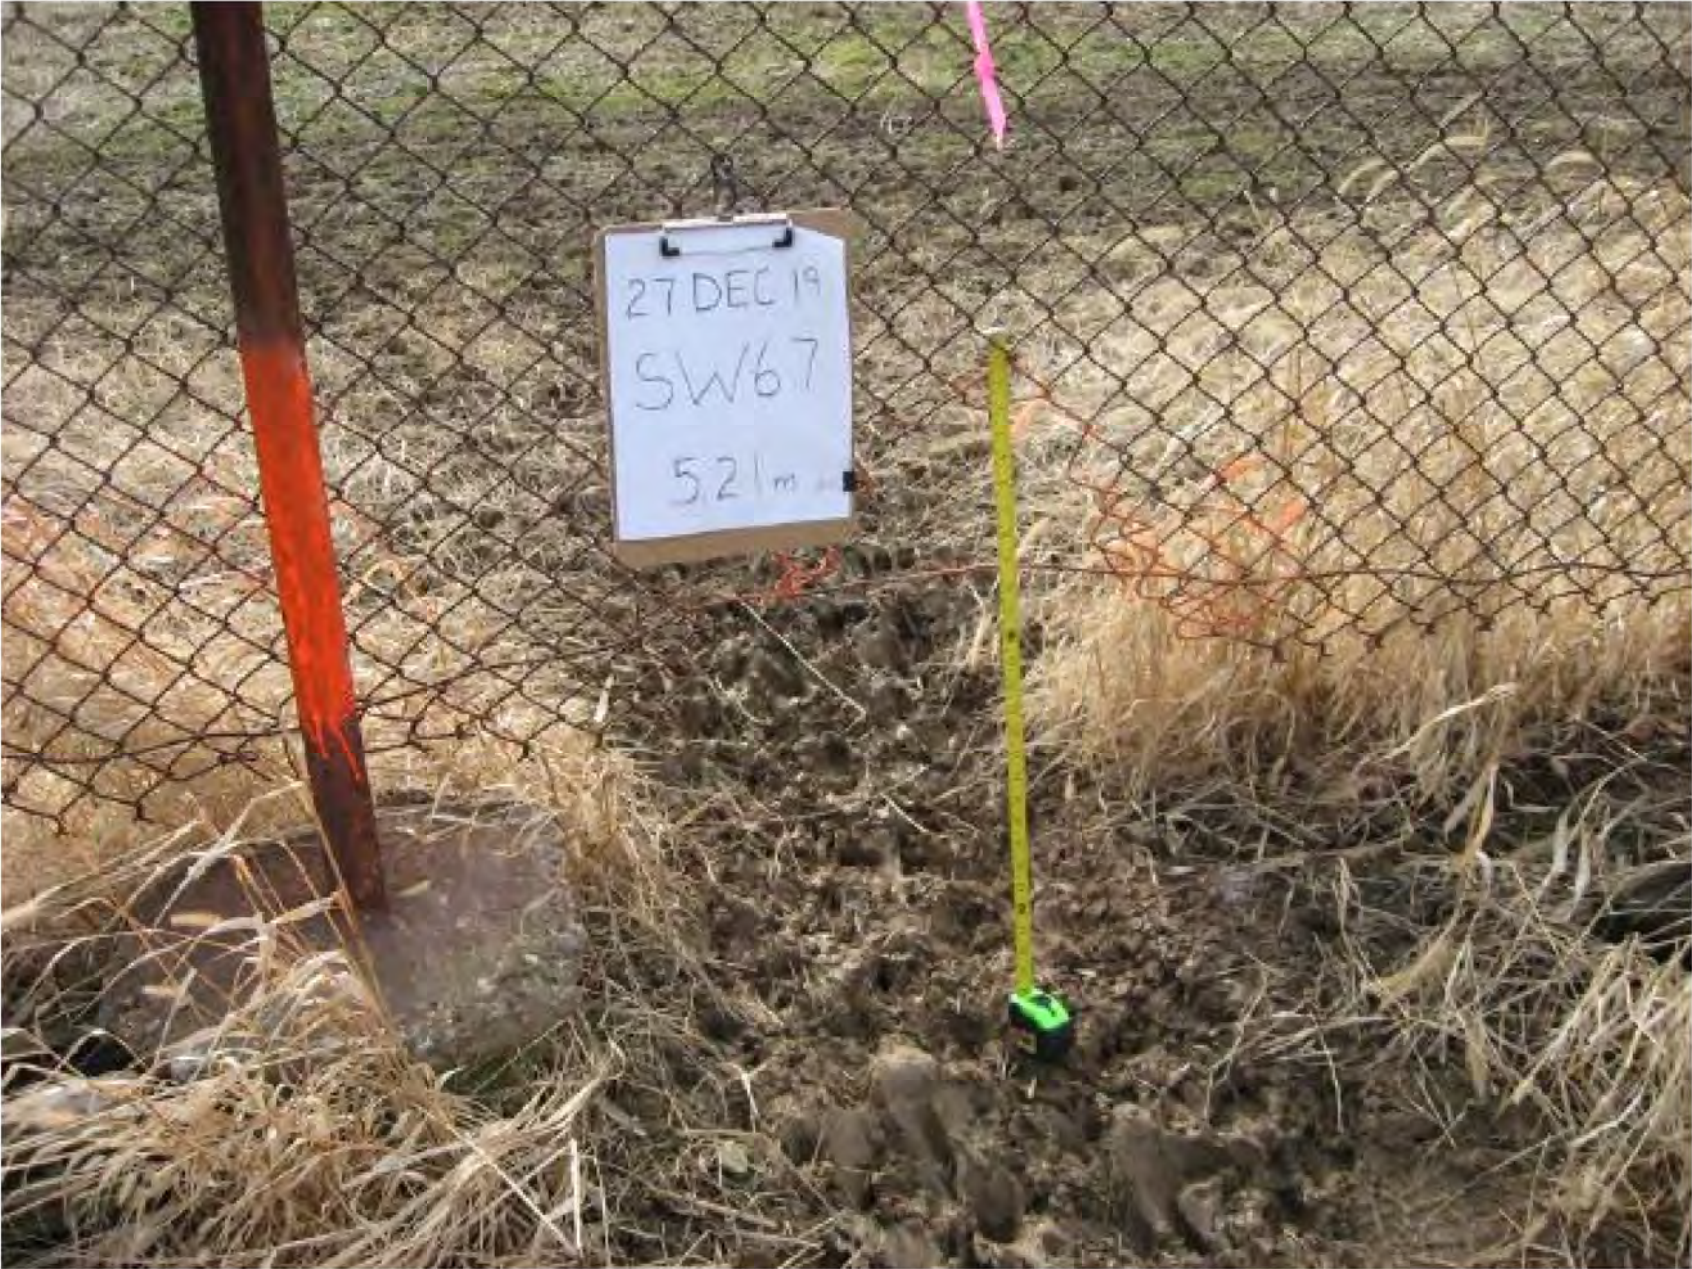
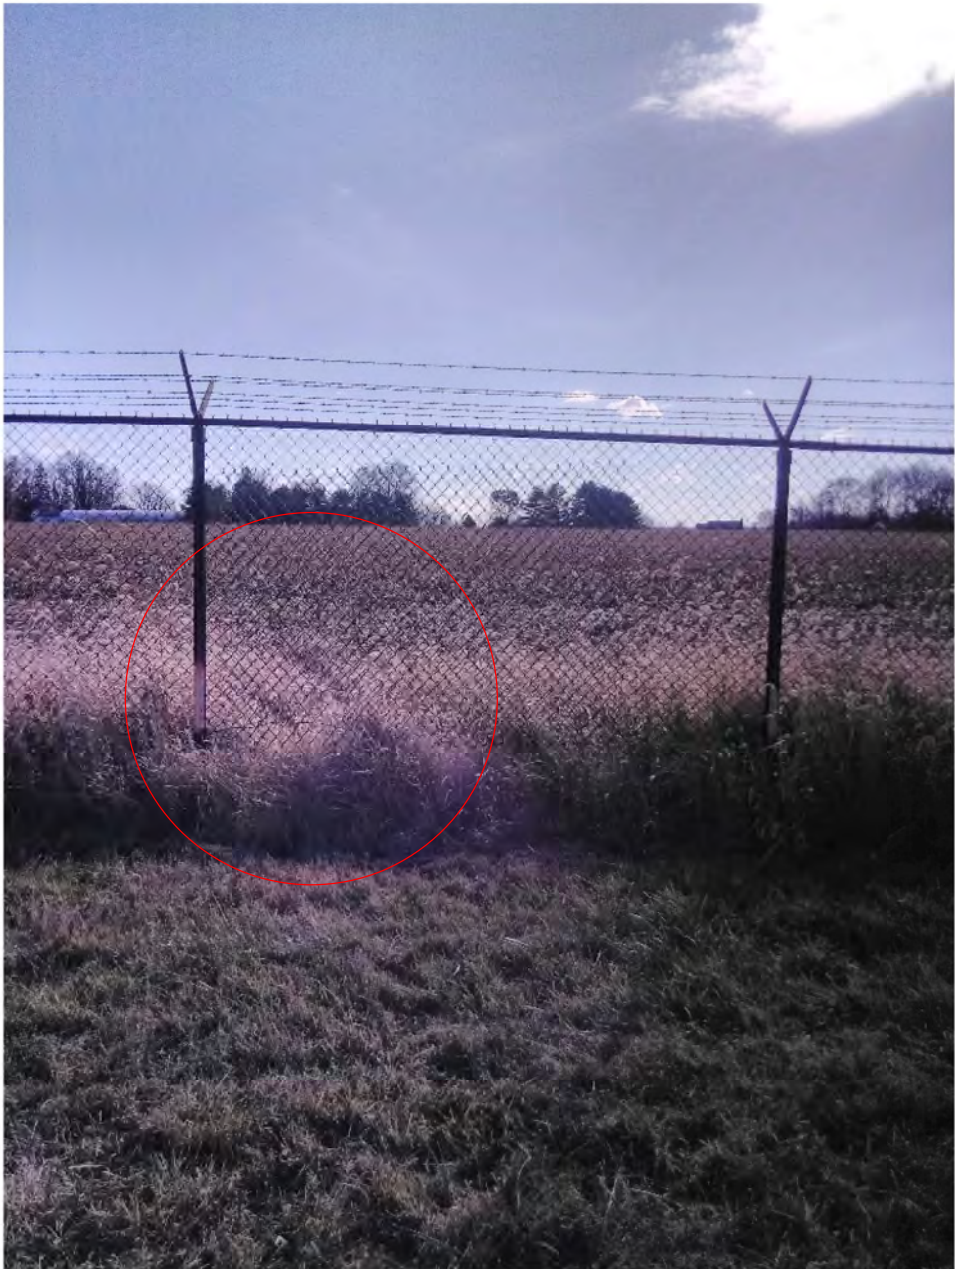
DETAIL SHEET FOR SW67a

FENCE DAMAGE / POACHER HOLE MILE 5.99

DISCOVERED 12/27/2019

REPAIR VERIFIED 11/10/2020

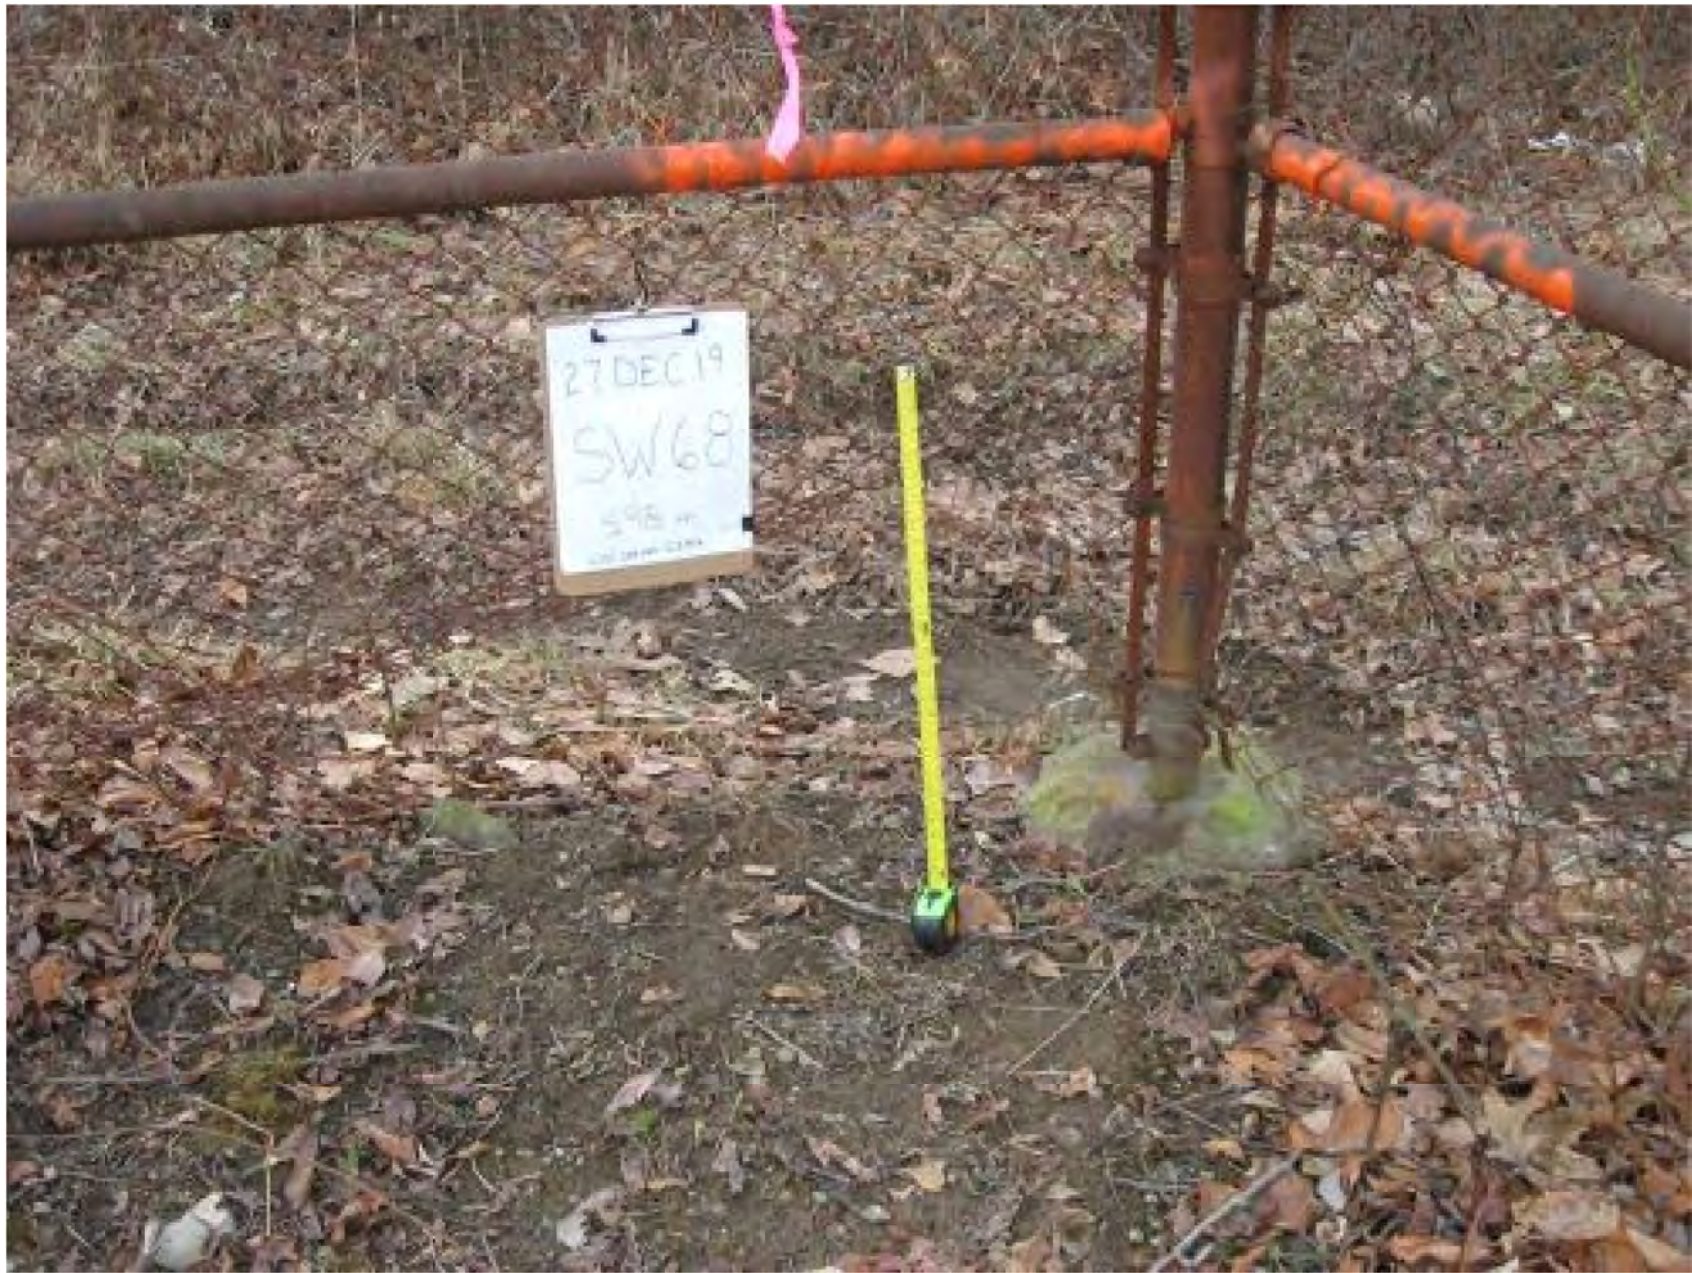
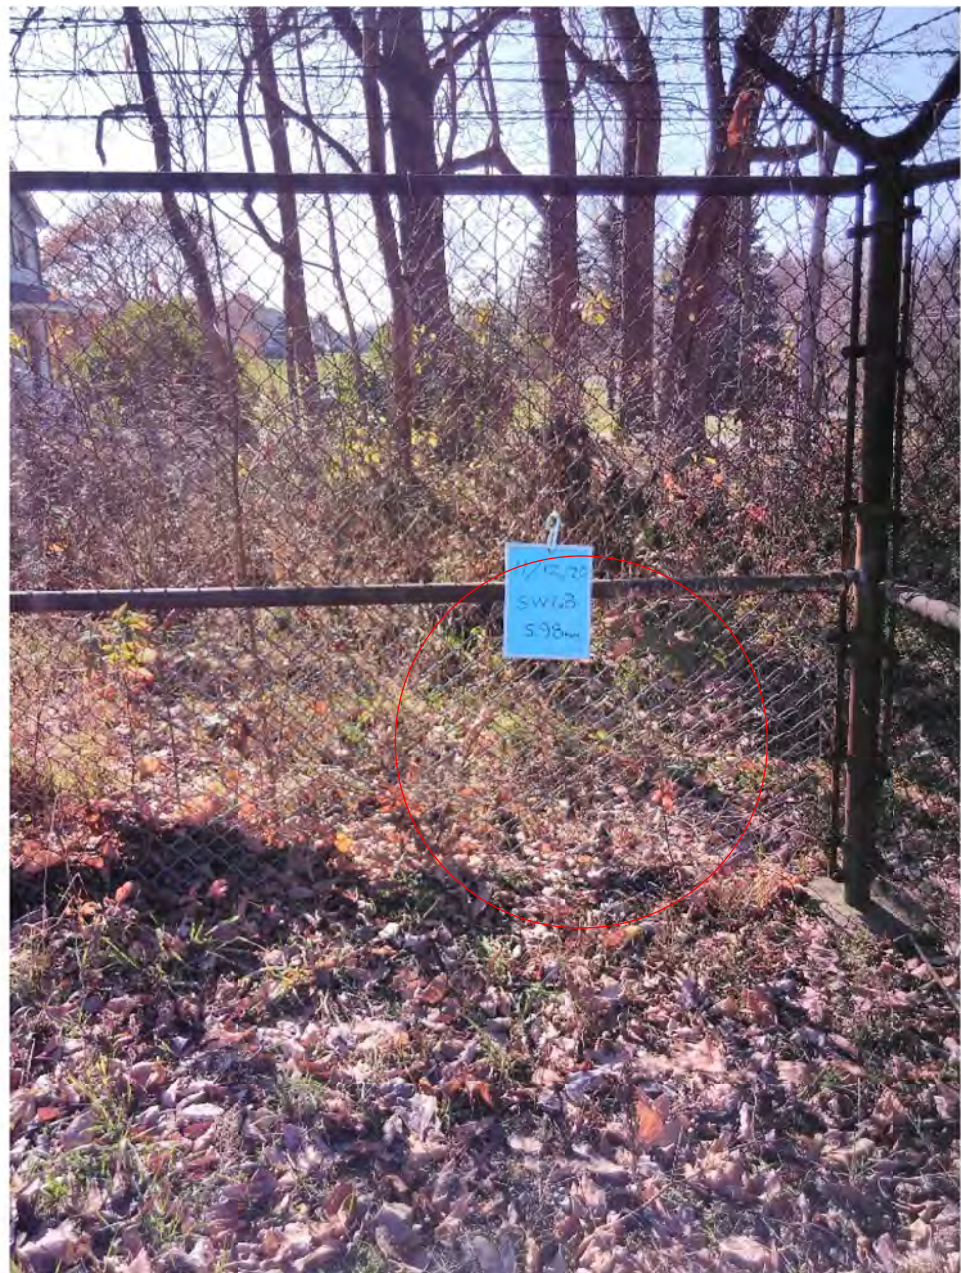
DETAIL SHEET FOR SW68

FENCE DAMAGE / POACHER HOLE MILE 5.99

DISCOVERED 12/27/2019

REPAIR VERIFIED 11/10/2020

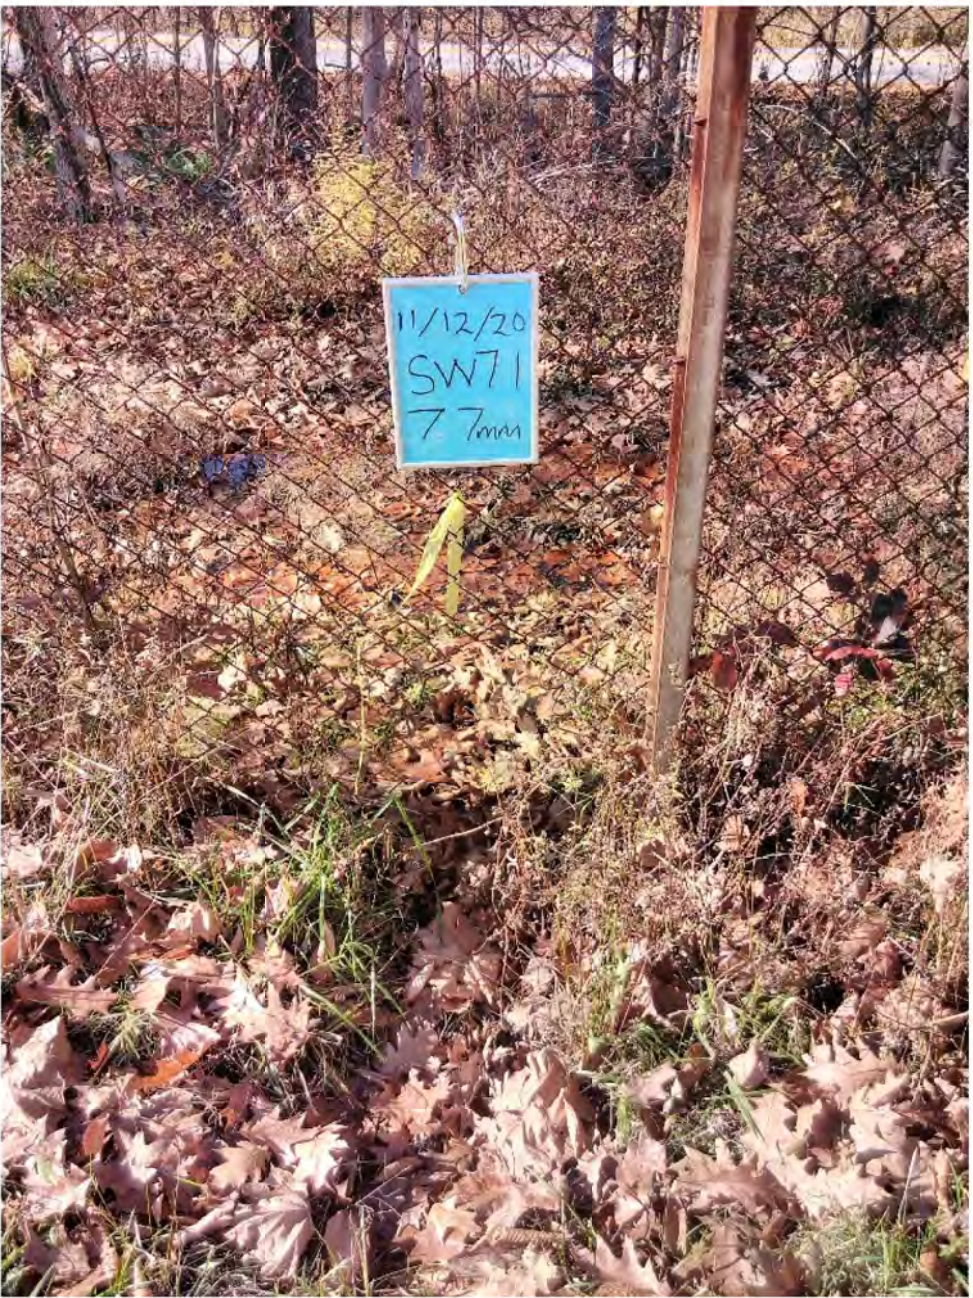
# DETAIL SHEET FOR SW71

Fence Damage/Poacher Hole at Mile 7.66

Discovered November 12, 2020

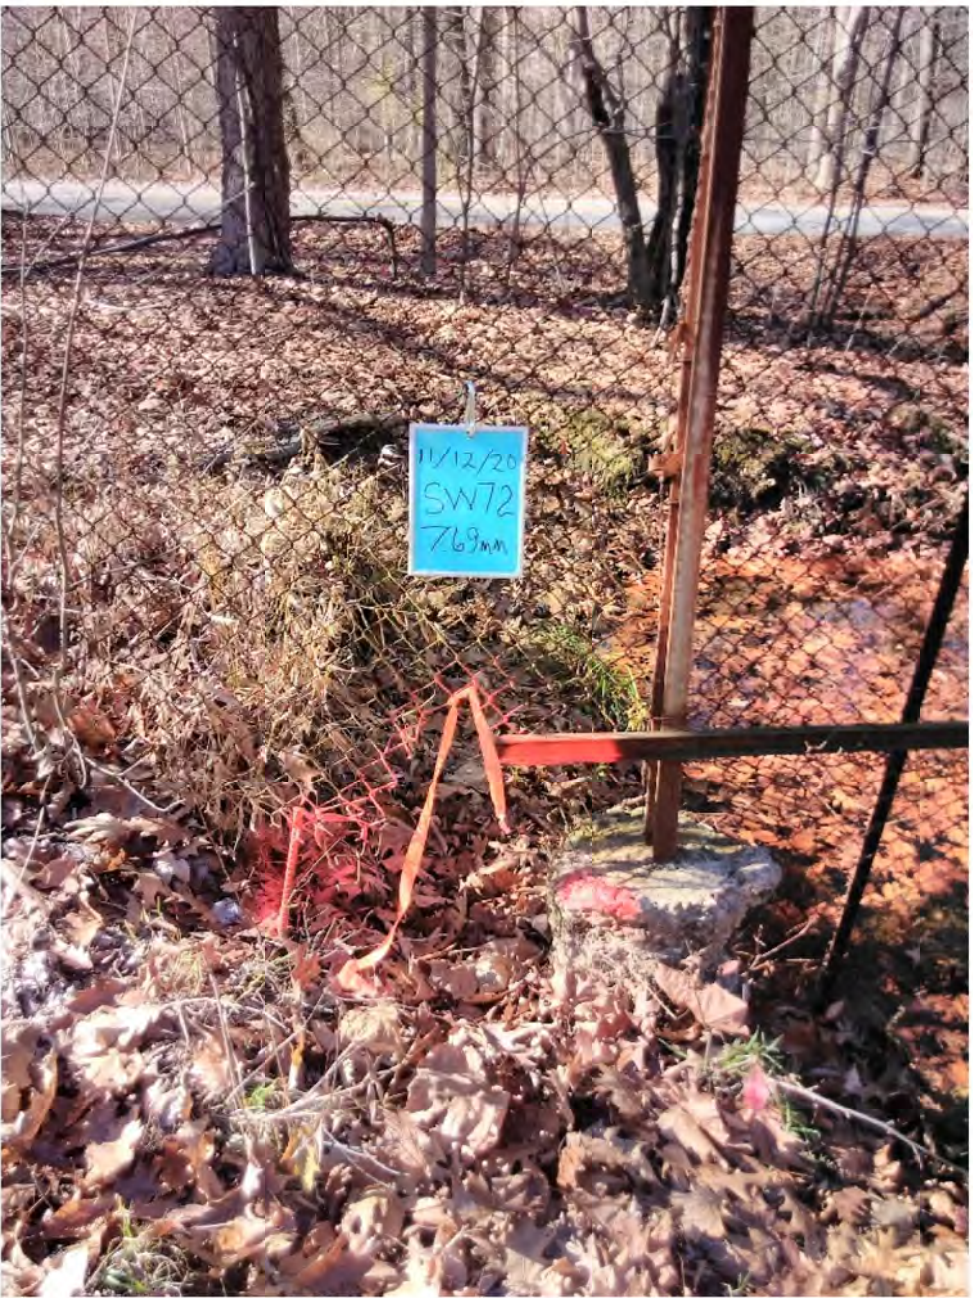
# DETAIL SHEET FOR SW72

Fence Damage/Poacher Hole at Mile 7.69

Discovered November 12, 2020

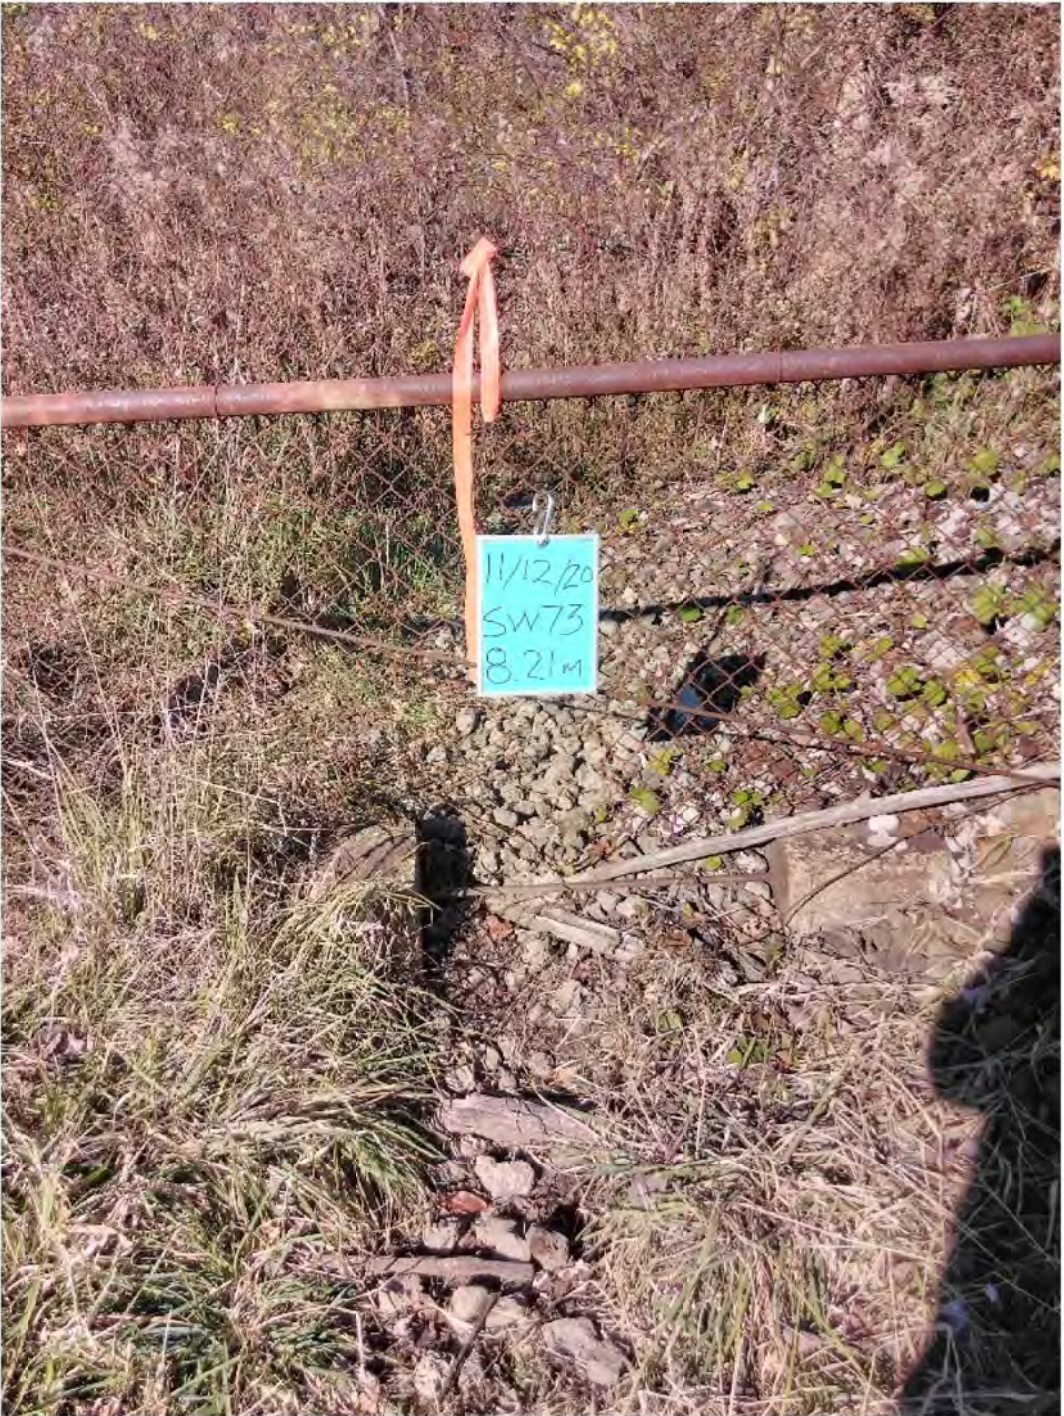
# DETAIL SHEET FOR SW73

Fence Damage/Poacher Hole at Mile 8.21

Discovered November 12, 2020

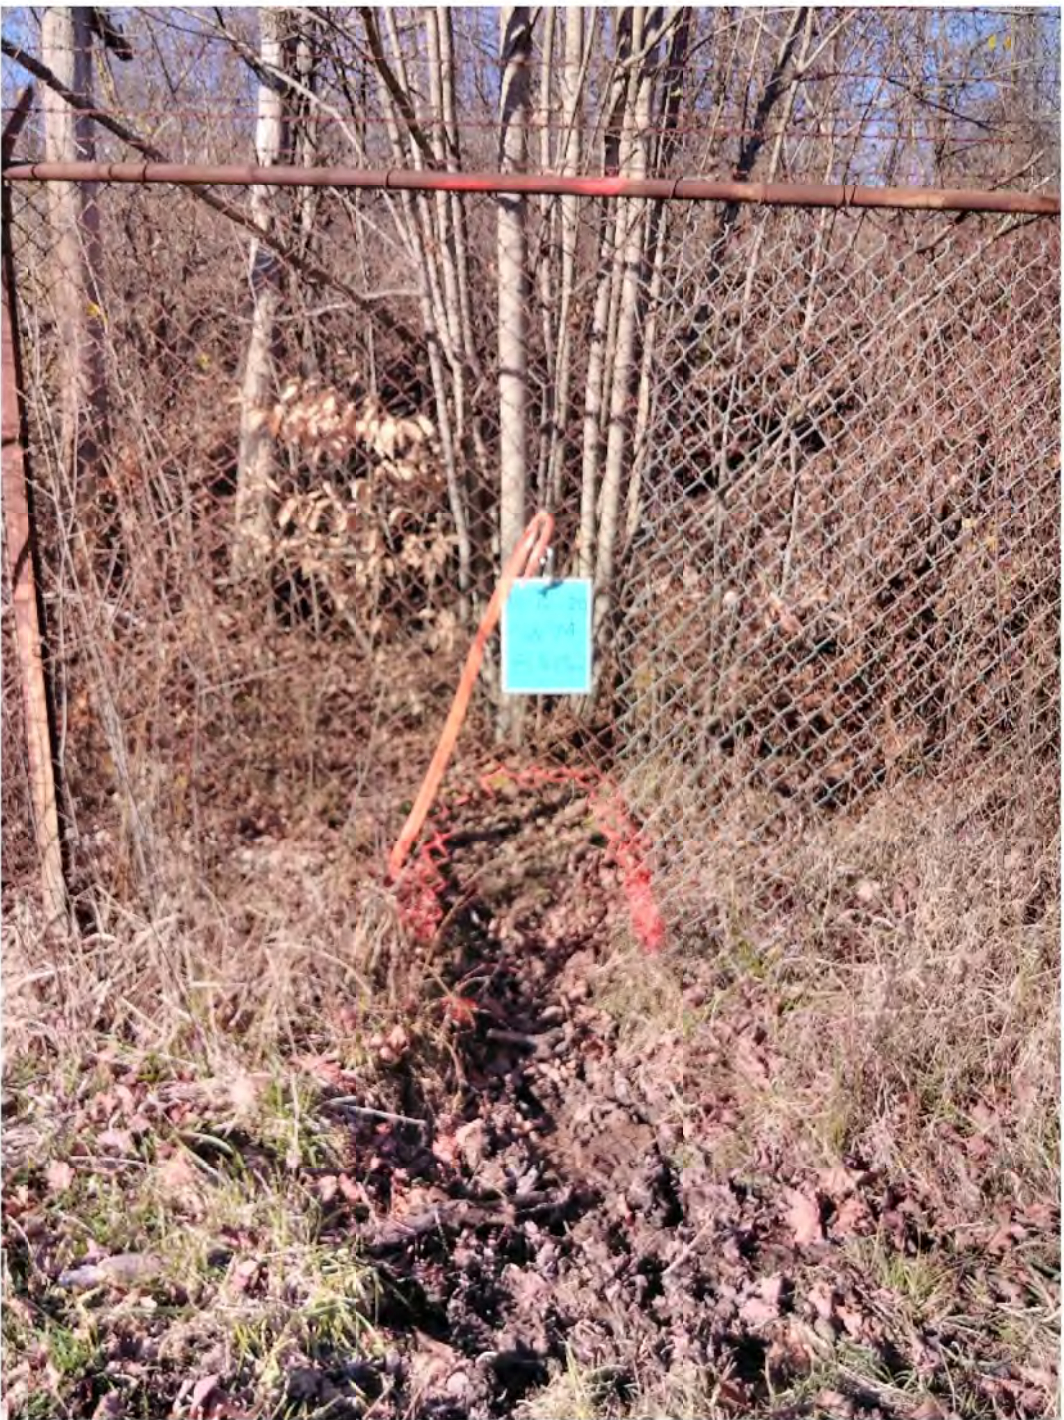
# DETAIL SHEET FOR SW74

Fence Damage/Poacher Hole at Mile 8.49

Discovered November 12, 2020

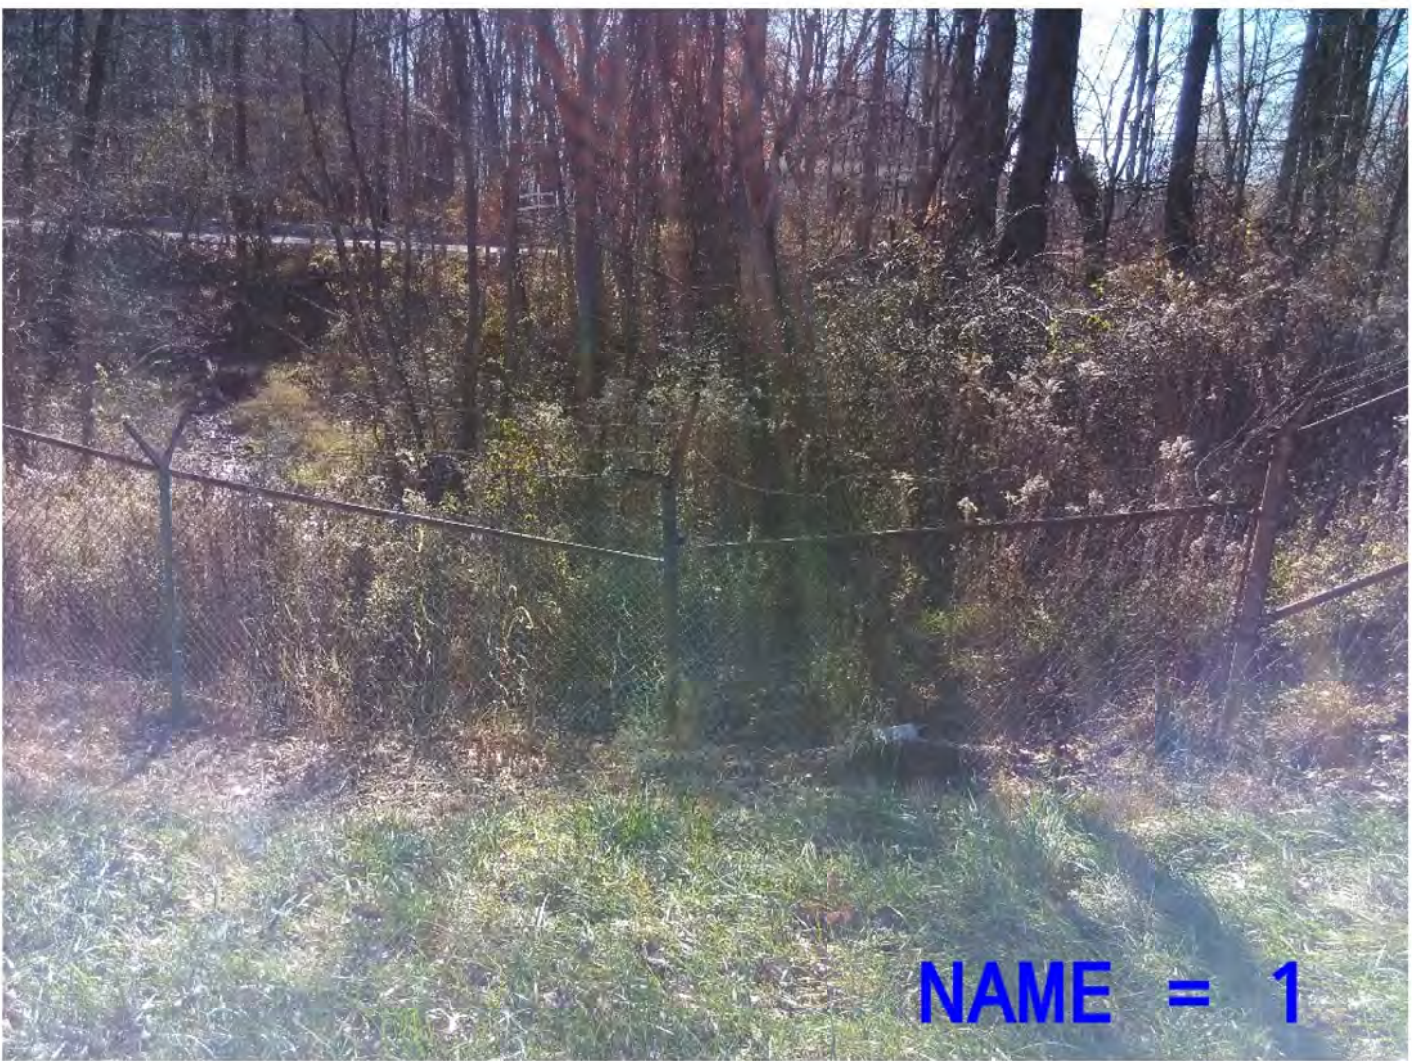
DETAIL SHEET FOR SW75

Fence Damage at Mile 1.53

Discovered November 10, 2020

Repaired. New fencing, posts and post foundations were installed between December 2020 and January 2021 between mile markers 0.9 and 5.0.  
Photo not available.

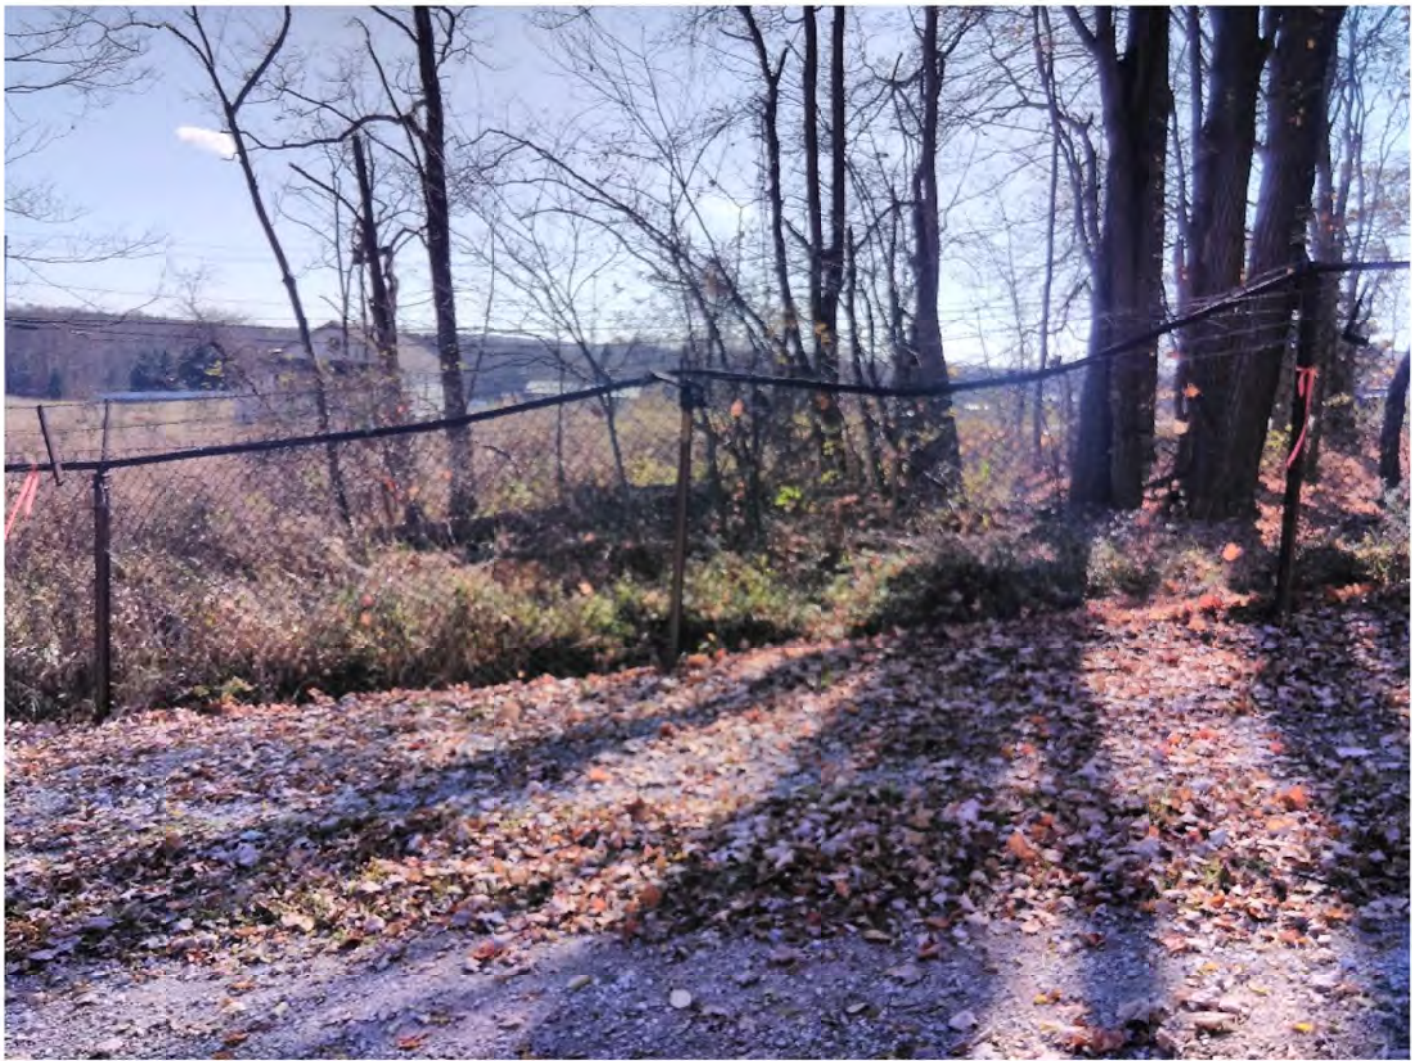
# DETAIL SHEET FOR SW79

Fence Damage at Mile 3.49

Discovered November 10, 2020

Repaired. New fencing, posts and post foundations were installed between December 2020 and January 2021 between mile markers 0.9 and 5.0. Photo not available.

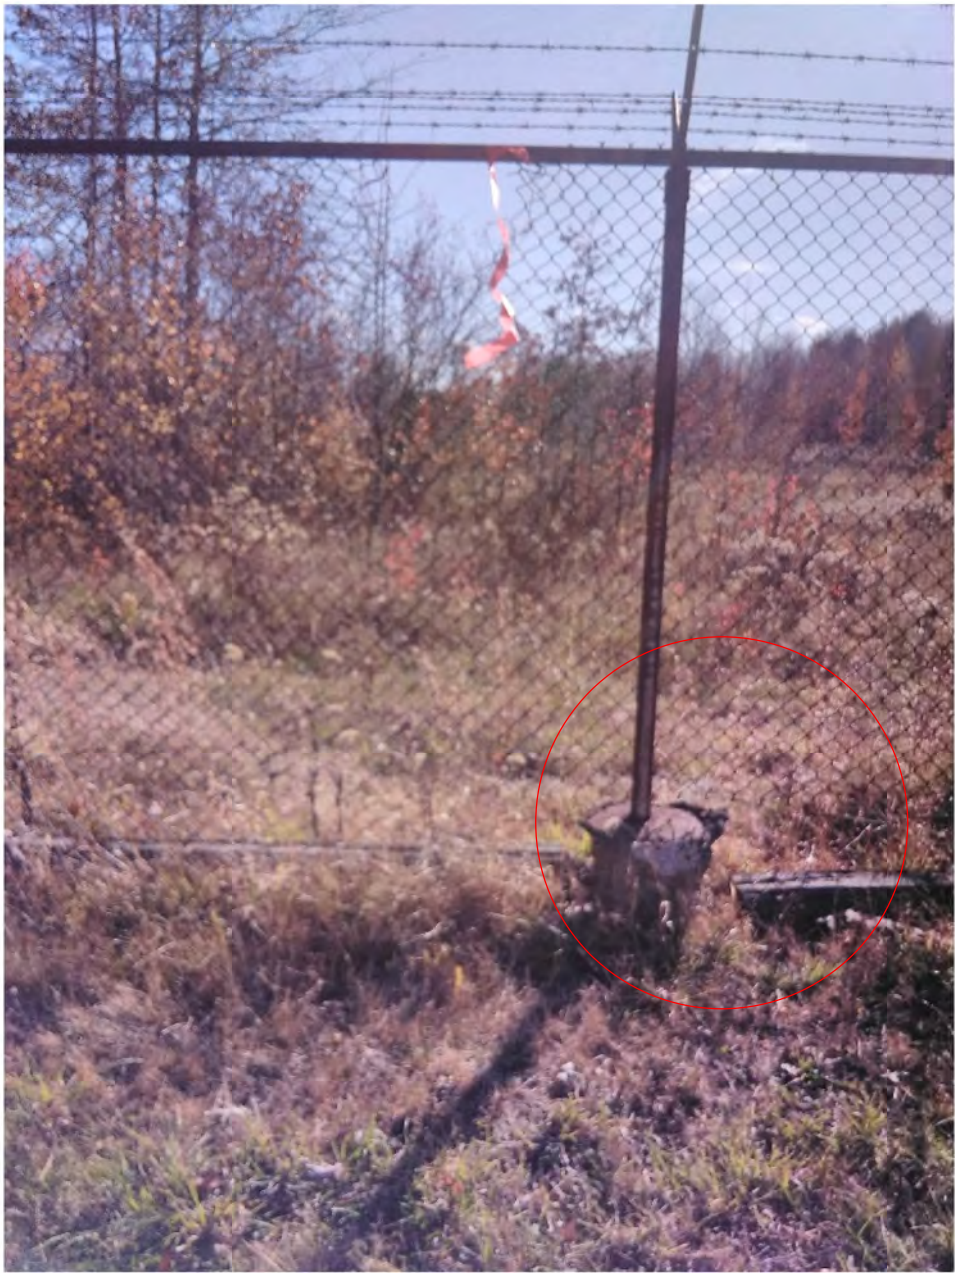
# DETAIL SHEET FOR SW80

FENCE DAMAGE / POACHER HOLE MILE 5.08

DISCOVERED 11/10/2020

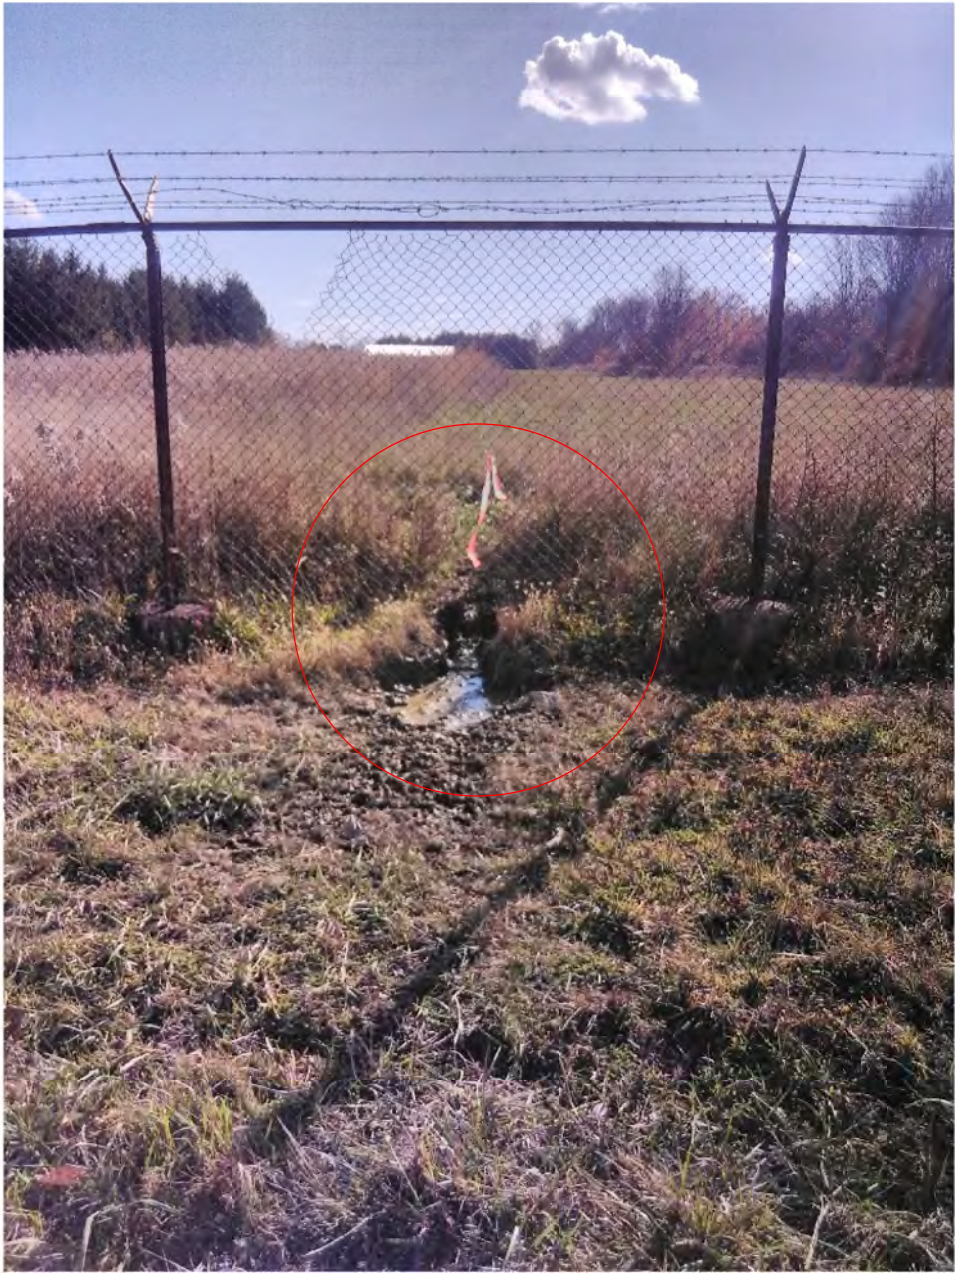
DETAIL SHEET FOR SW81

FENCE DAMAGE / POACHER HOLE MILE 5.14

DISCOVERED 11/10/2020

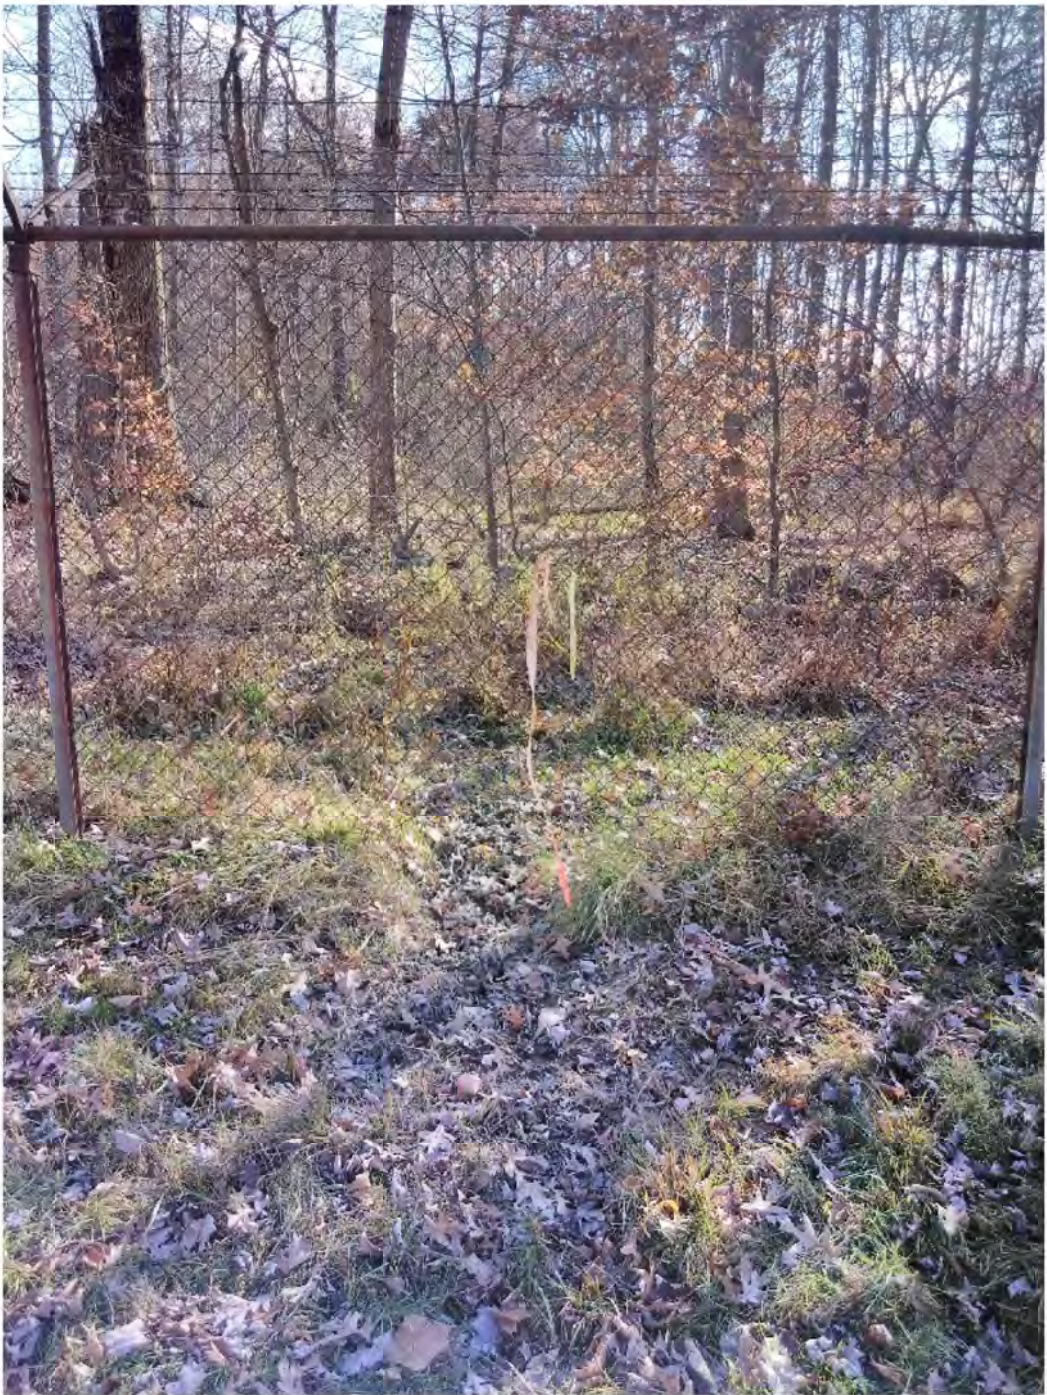
# DETAIL SHEET FOR SW82

Fence Damage / Pocaher Hole at Mile 5.46

Discovered November 10, 2020
