**Final**  
**2020 Annual Land Use Control Monitoring Report,**  
**RVAAP-01 Ramsdell Quarry Landfill,**  
**RVAAP-05 Winklepeck Burning Grounds,**  
**RVAAP-08 through RVAAP-11 (Load Lines 1 through 4),**  
**RVAAP-12 (Load Line 12) and RVAAP-51 (Dump Along Paris-Windham**  
**Road)**

**Camp James A. Garfield Joint Military Training Center**  
**Former Ravenna Army Ammunition Plant**  
**Portage and Trumbull Counties, Ohio**

**May 24, 2021**

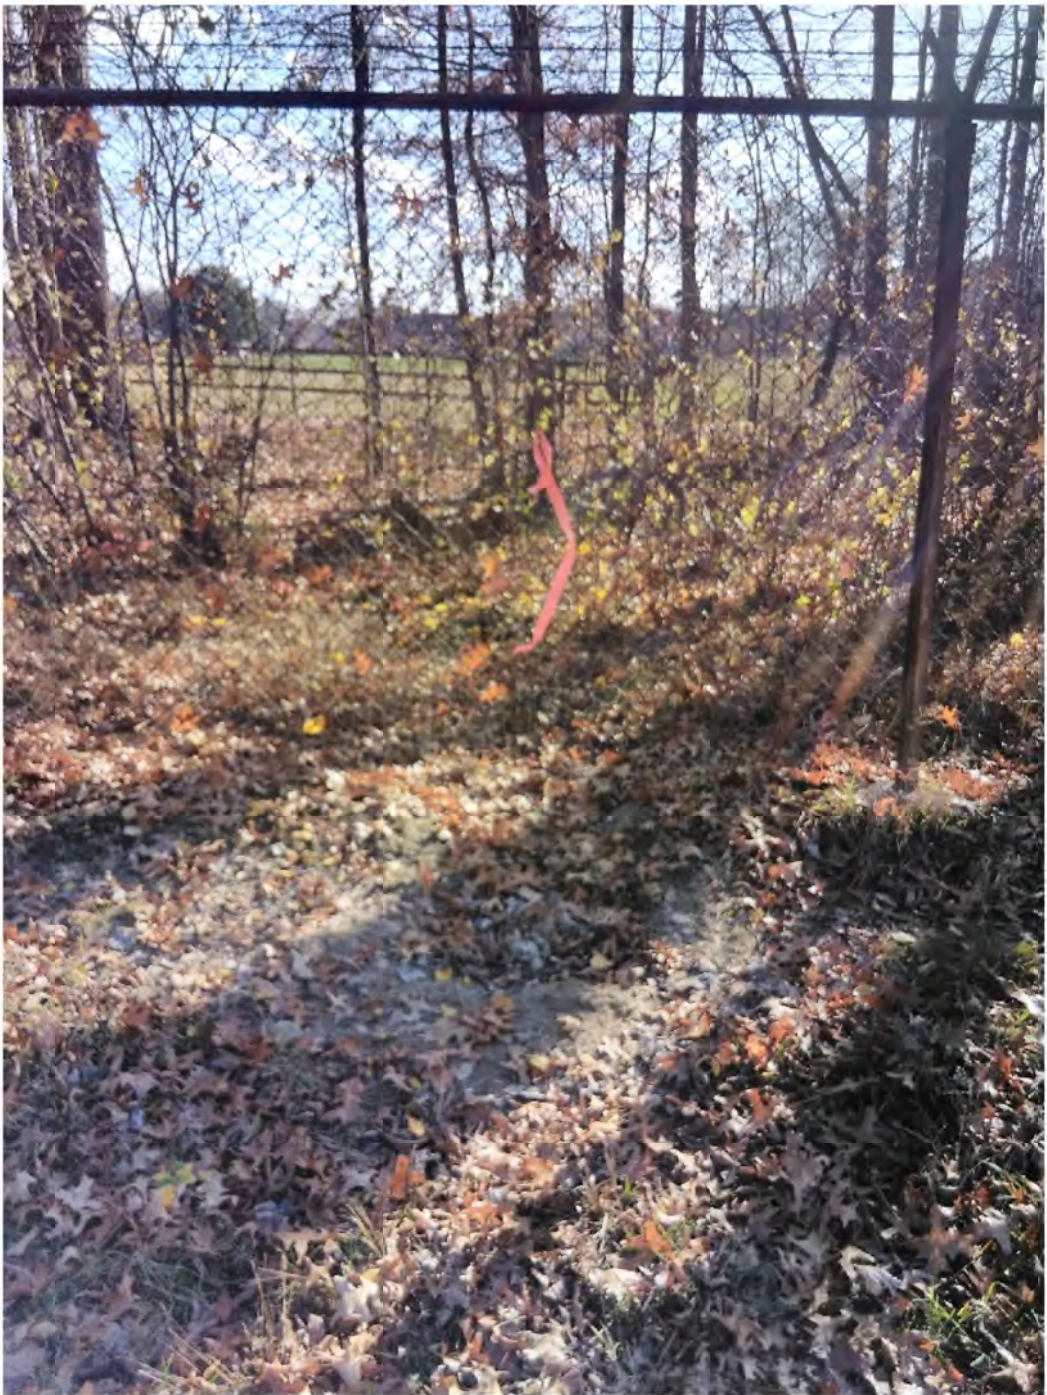
# DETAIL SHEET FOR SW83

Fence Damage / Pocaher Hole at Mile 5.75

Discovered November 10, 2020

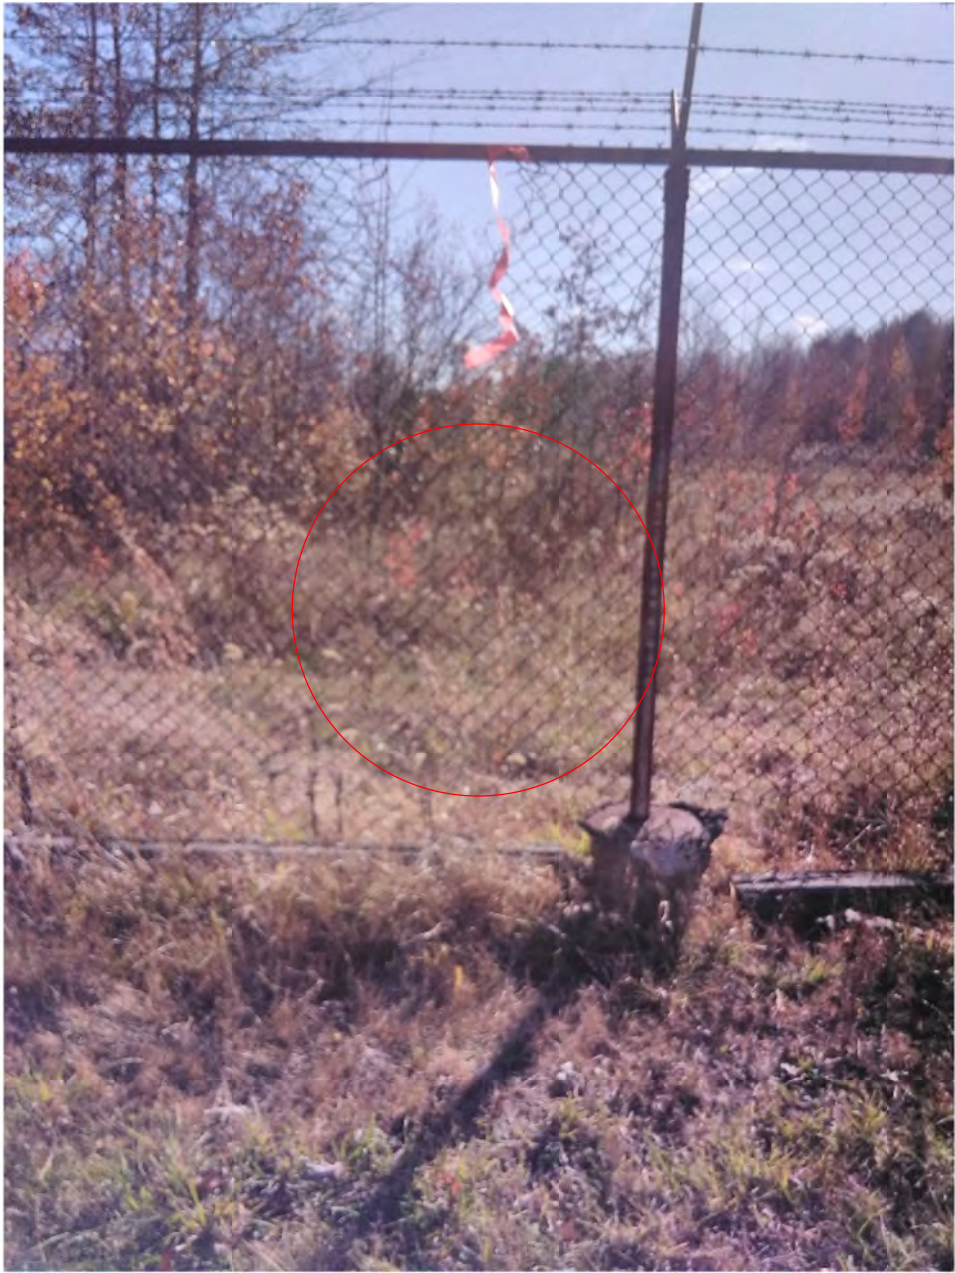
DETAIL SHEET FOR SW84

FENCE DAMAGE / POACHER HOLE MILE 5.08

DISCOVERED 11/10/2020

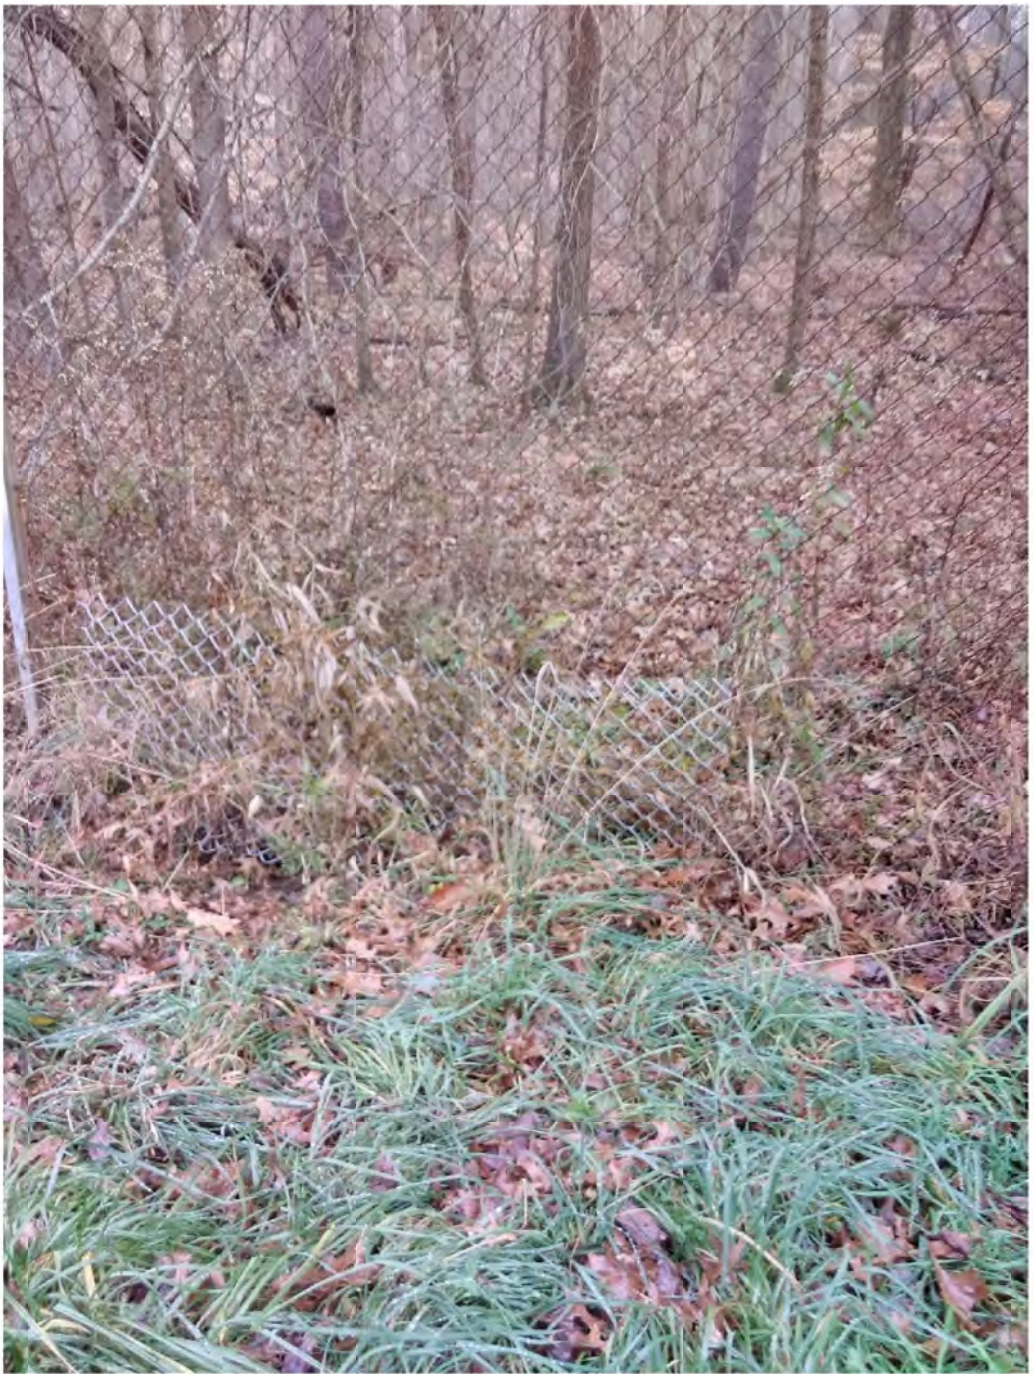
DETAIL SHEET FOR NE58

Poacher Hole Repair at Mile 19.57

Observed November 17, 2020

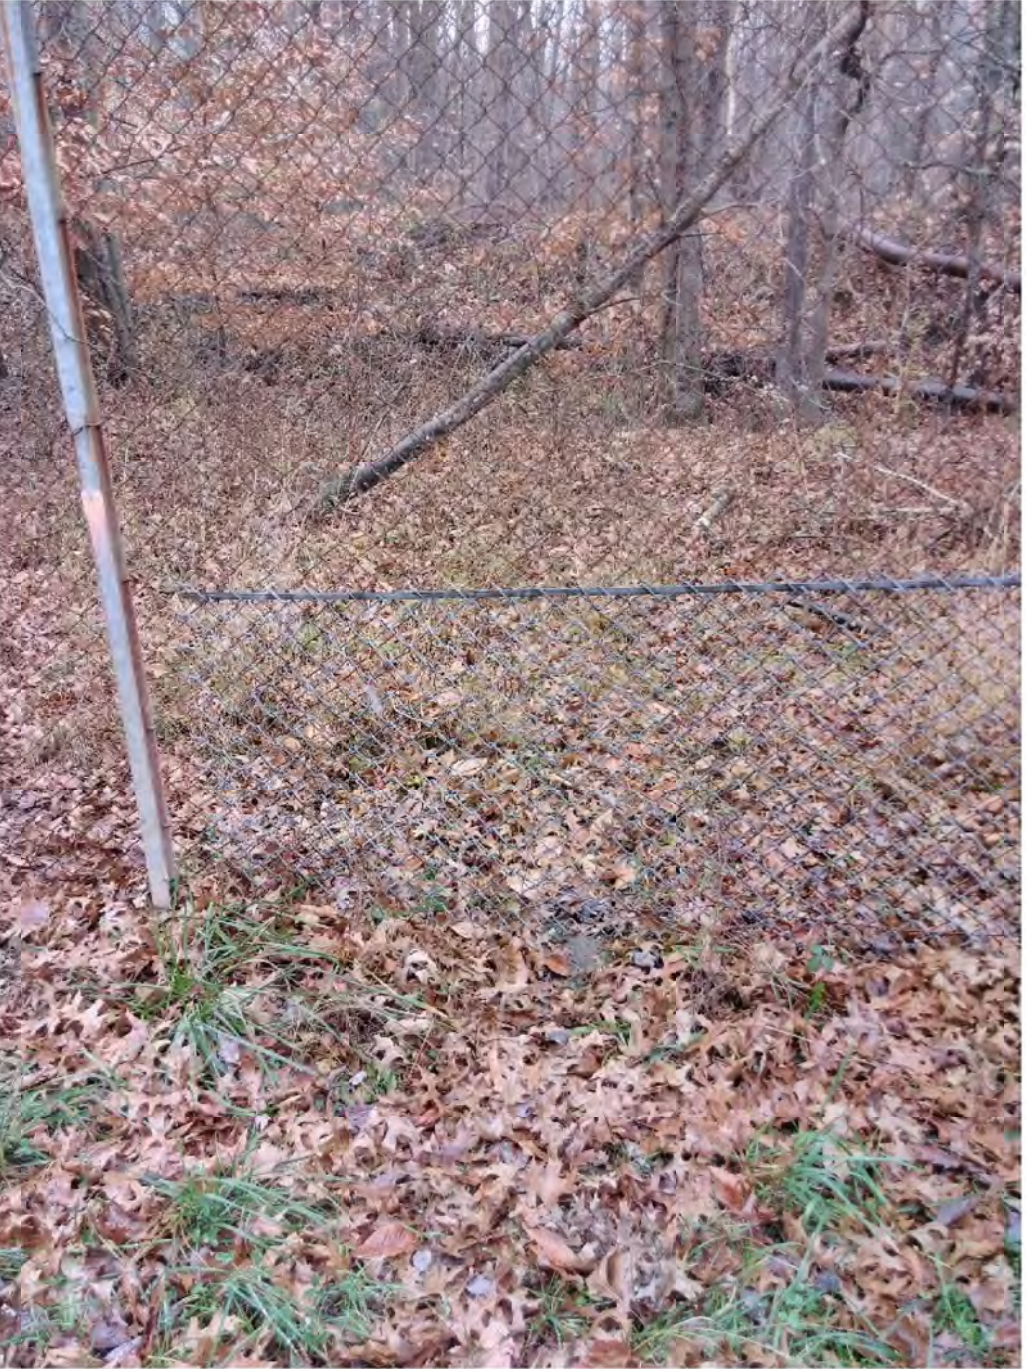
DETAIL SHEET FOR NE59

Poacher Hole Repair at 19.71

Observed November 17, 2020

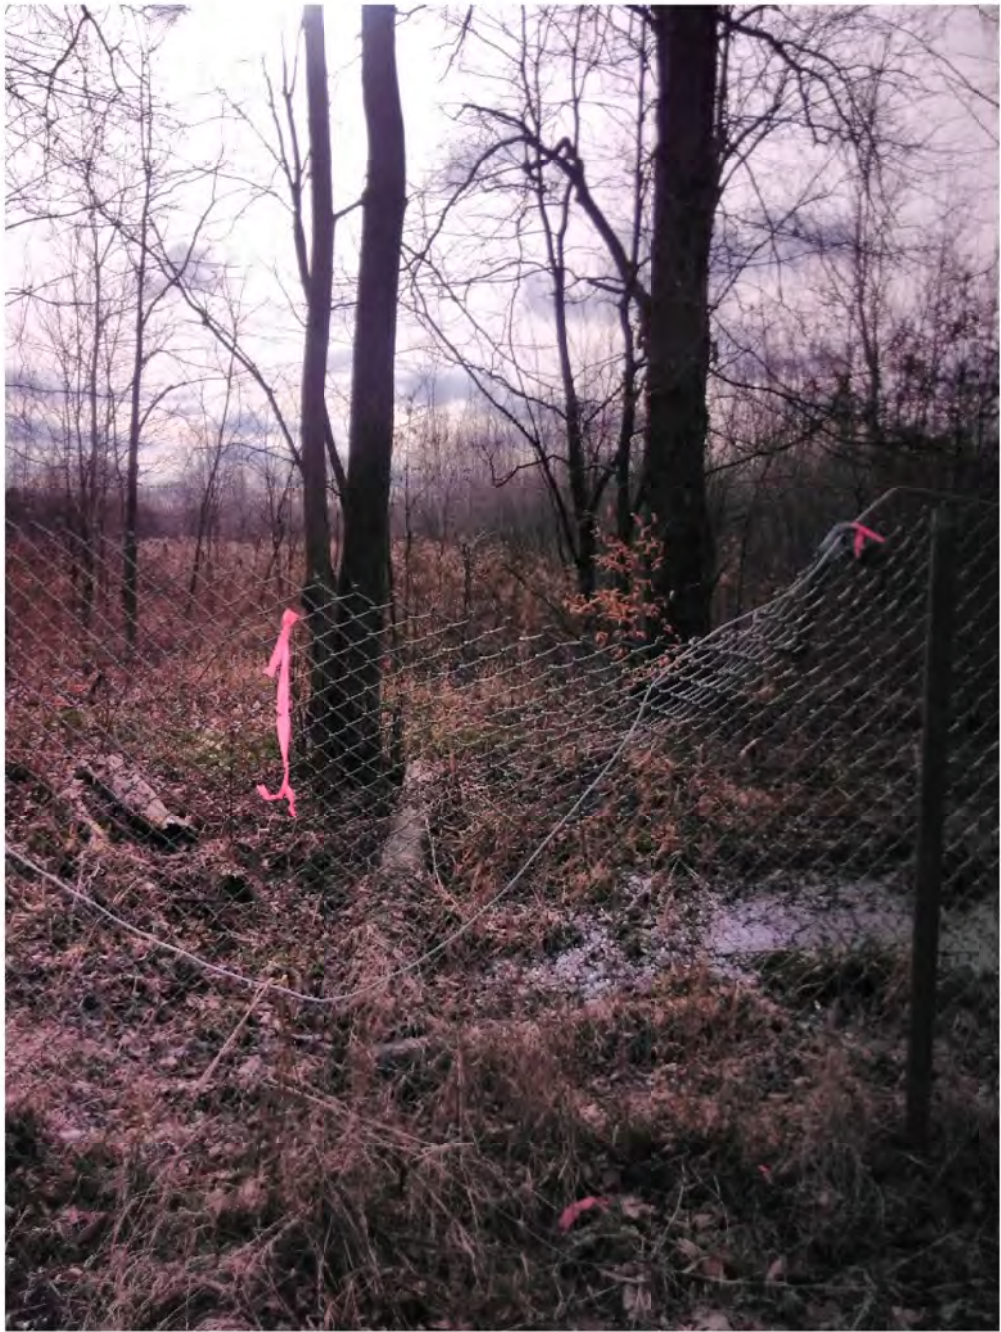
DETAIL SHEET FOR NE75/NE55

Fence Damage at Mile 23.04

Discovered December 15, 2020
