Appendix M
Property Visit Photographs

CC-RVAAP-68
Electric Substations (East, West, and No. 3)

**COMPLIANCE RESTORATION SITES
RAVENNA ARMY ANNUNITION
PLANT - RAVENNA, OHIO**

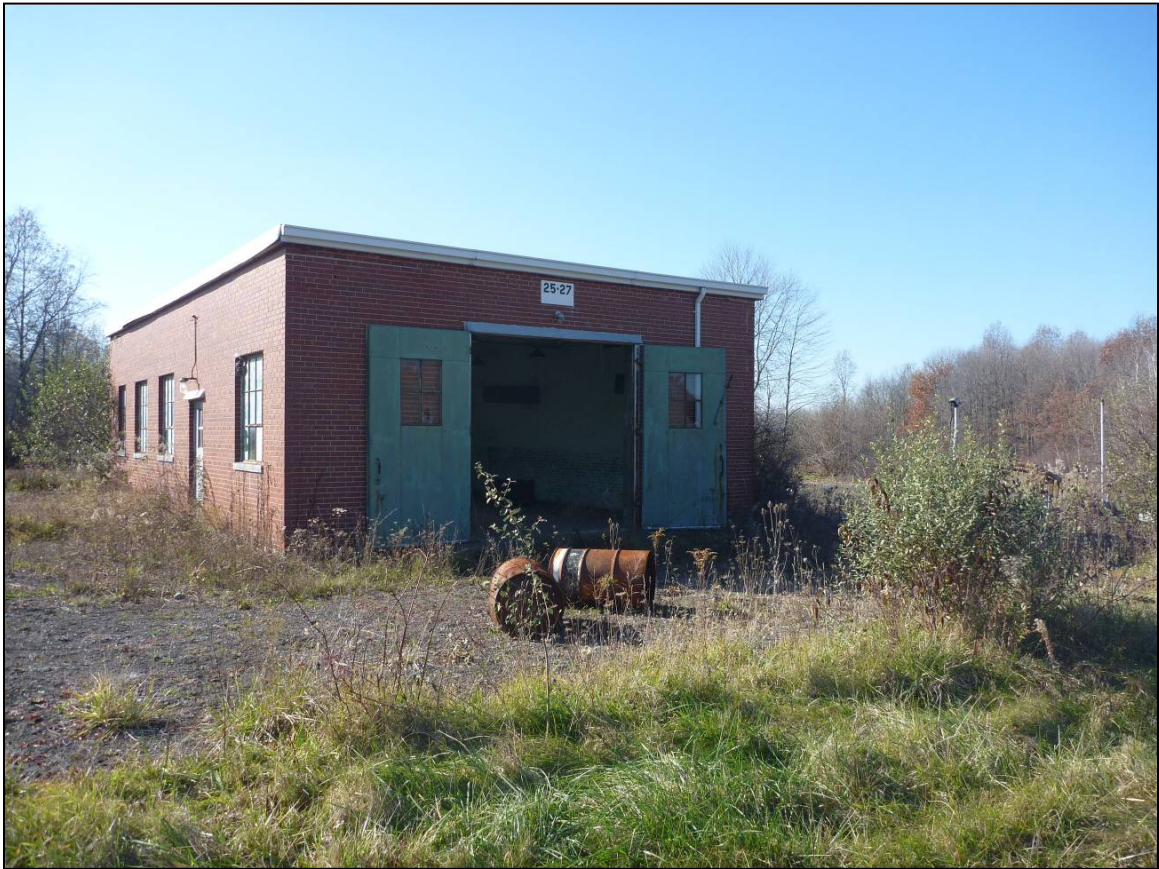
CC-RVAAP-68	East Substation	Photograph Number: 001
Date: 11/09/2010	Direction of View: Southwest	Photographer: Corey Pacer (SAIC)
Description: Photograph taken to document the East Substation building (25-27) and surroundings. Area around the building is gravelly with little vegetation. Two rusted, empty, 55-gal drums lay outside of the main building. Building is in fair to good condition.

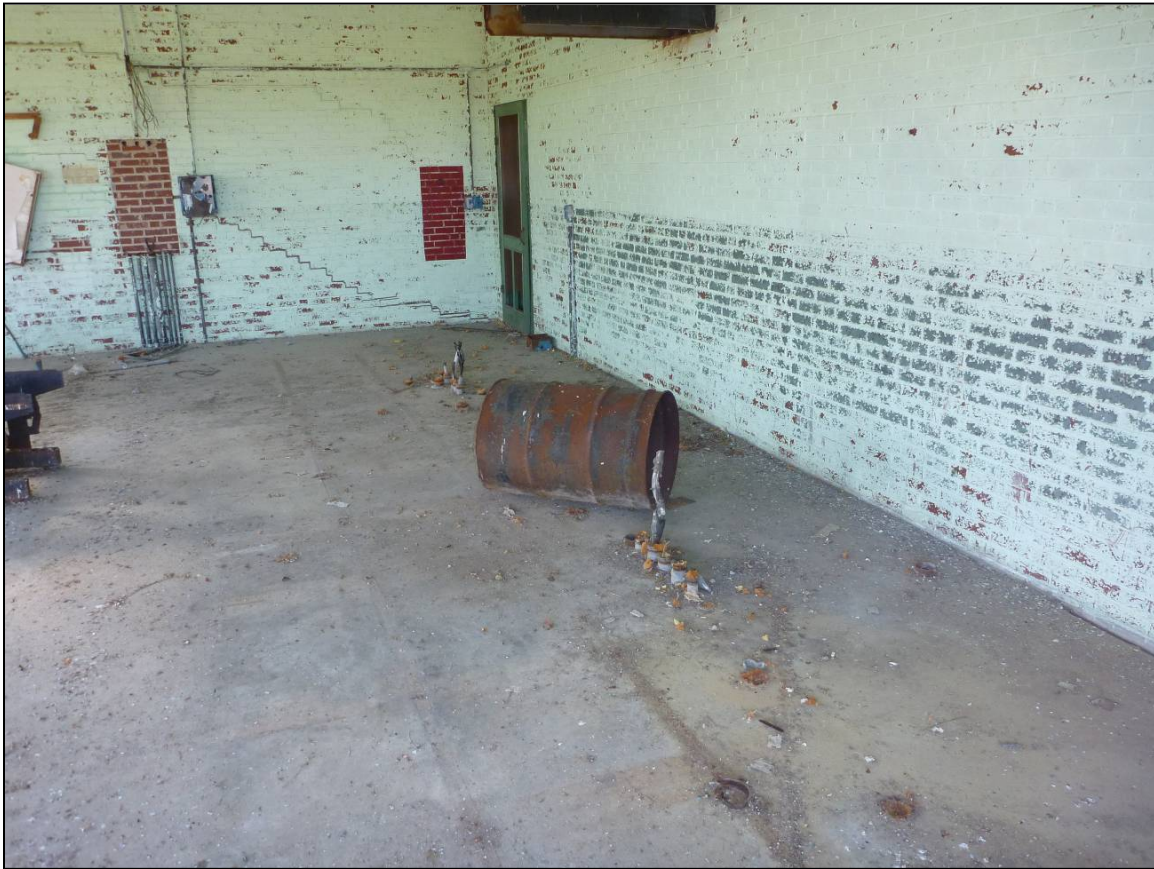
CC-RVAAP-68	East Substation	Photograph Number: 002
Date: 11/09/2010	Direction of View: Northwest	Photographer: Corey Pacer (SAIC)
Description: Photograph taken to document interior of the East Substation building (25-27). A rusted, empty, 55-gal drum is observed as well as paint flaking from the brick walls. Some concrete staining was noted across the entirety of the interior concrete floor.

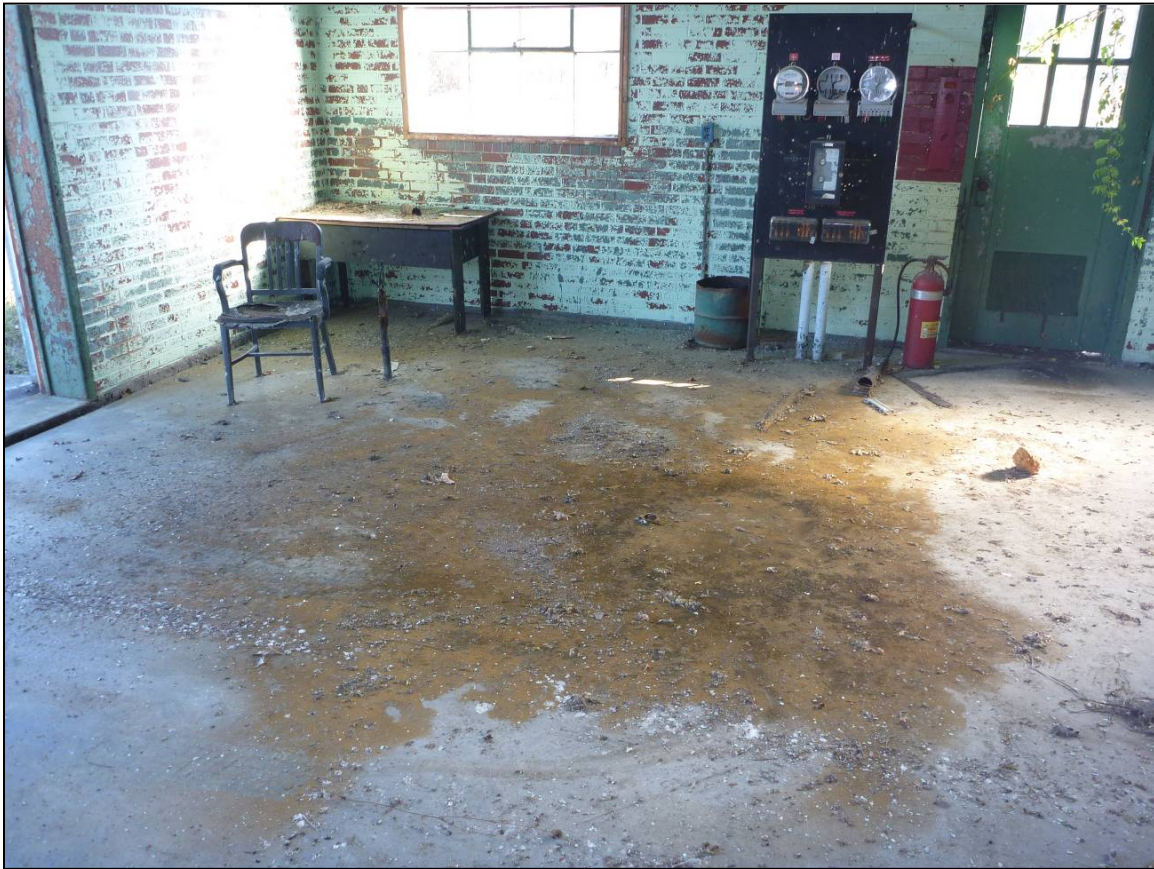
CC-RVAAP-68	East Substation	Photograph Number: 003
Date: 11/09/2010	Direction of View: Southeast	Photographer: Corey Pacer (SAIC)
Description: Photograph taken to document interior of the East Substation building (25-27). Main door is barely visible on the left side of the photograph. Unused equipment remains within the building. Some visible staining across the entirety of the interior concrete floor.

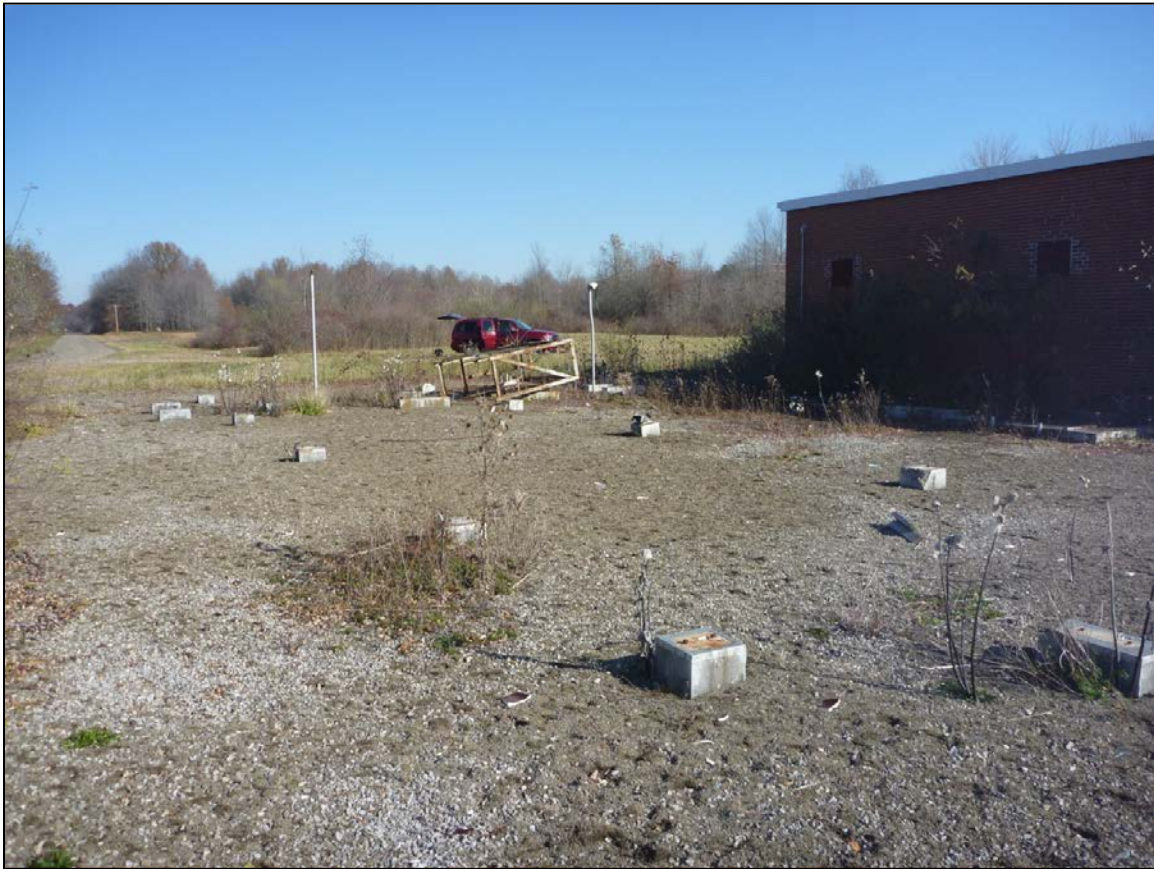
CC-RVAAP-68	East Substation	Photograph Number: 004
Date: 11/09/2010	Direction of View: Southeast	Photographer: Corey Pacer (SAIC)
Description: Photograph taken to document former transformer area at the East Substation. The north side of the main building (25-27) is present in the right side of the photo. The former transformer area is primarily gravel with some debris and remnant concrete pads.

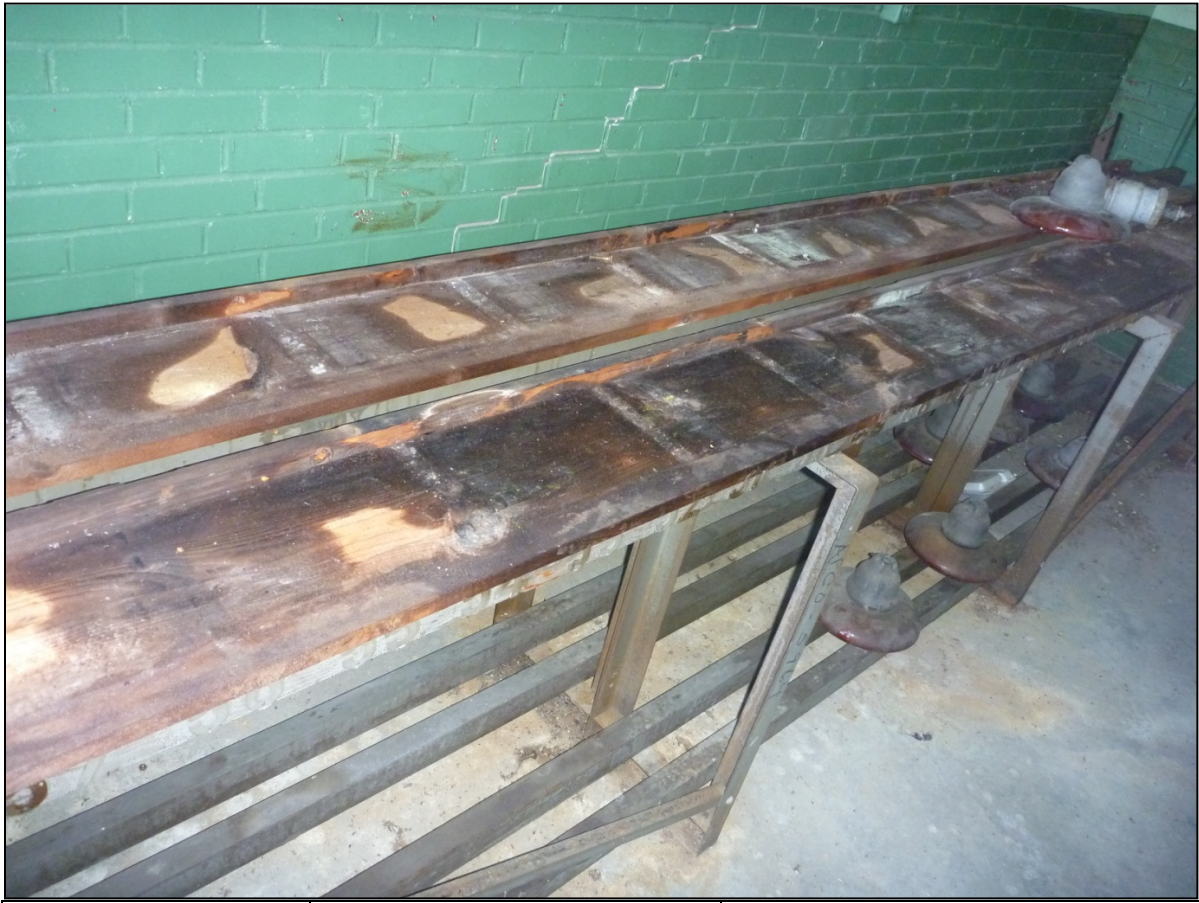
CC-RVAAP-68	East Substation	Photograph Number: 005
Date: 11/09/2010	Direction of View: South	Photographer: Corey Pacer (SAIC)
Description: Photograph taken to document condition of former battery room. Note staining on wood where batteries were stored. Historical photo of this area is provided in Appendix H.

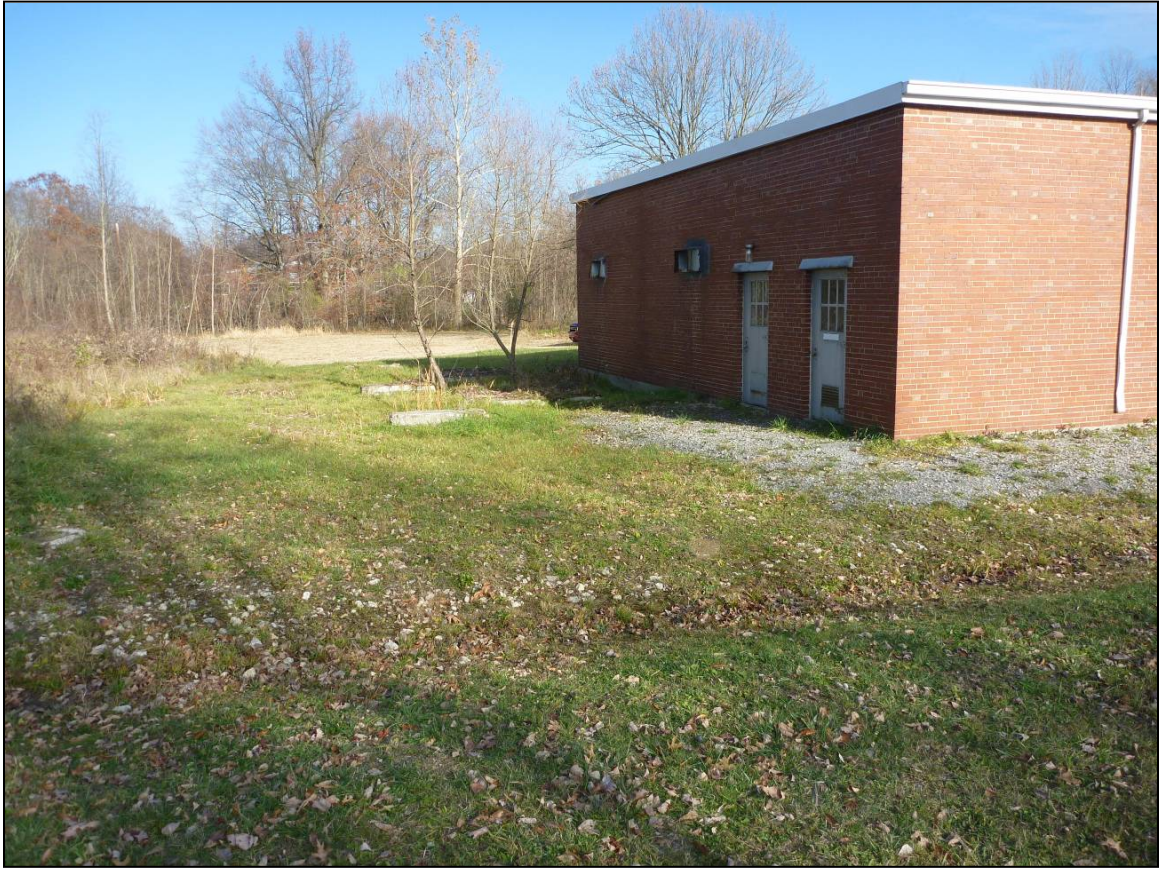
CC-RVAAP-68	West Substation	Photograph Number: 001
Date: 11/09/2010	Direction of View: East	Photographer: Corey Pacer (SAIC)
Description: Photograph taken to document the West Substation (28-28). North and west sides of the building are visible as well as concrete pads north of the building. The transformer and ancillary equipment have been removed from the site. A small ditch runs parallel to the west side of the building, as documented in this photo.

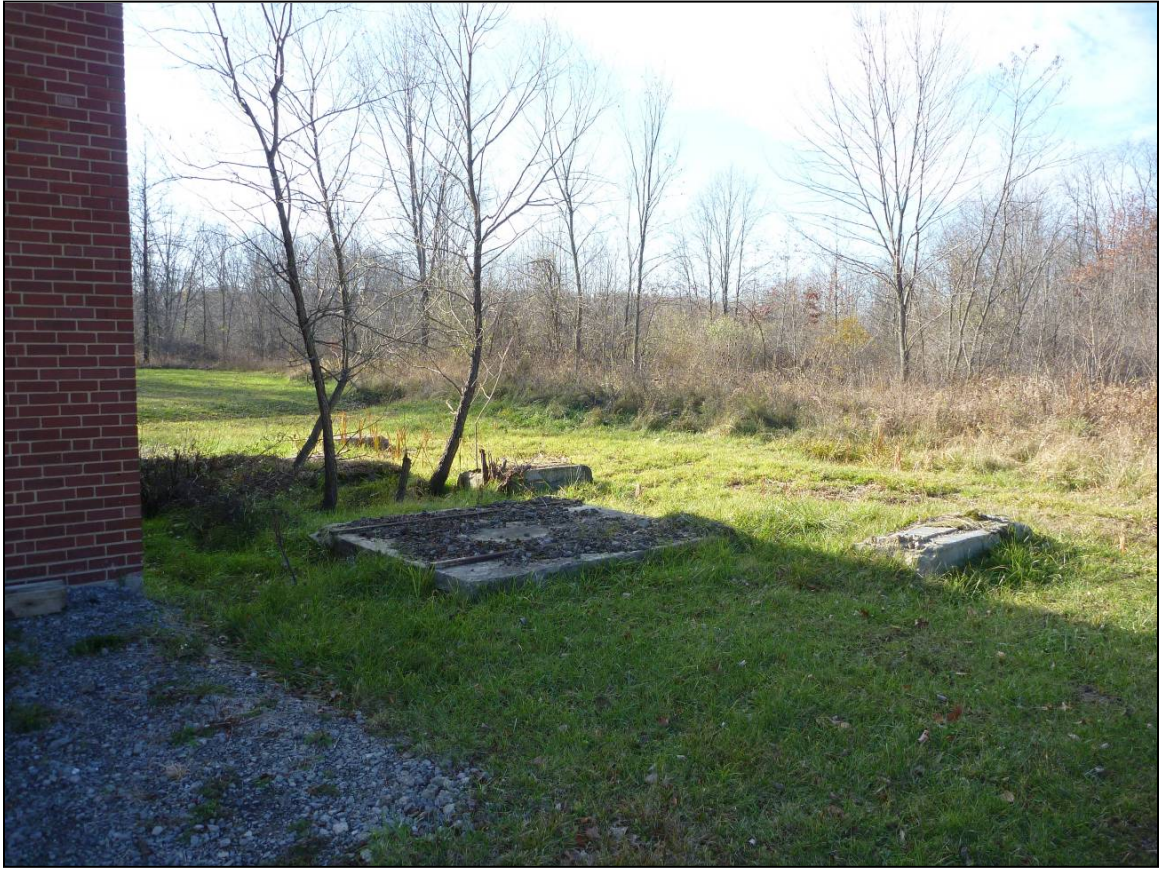
CC-RVAAP-68	West Substation	Photograph Number: 002
Date: 11/09/2010	Direction of View: Northwest	Photographer: Corey Pacer (SAIC)
Description: Photograph of concrete slabs at the former location of the substation transformers.

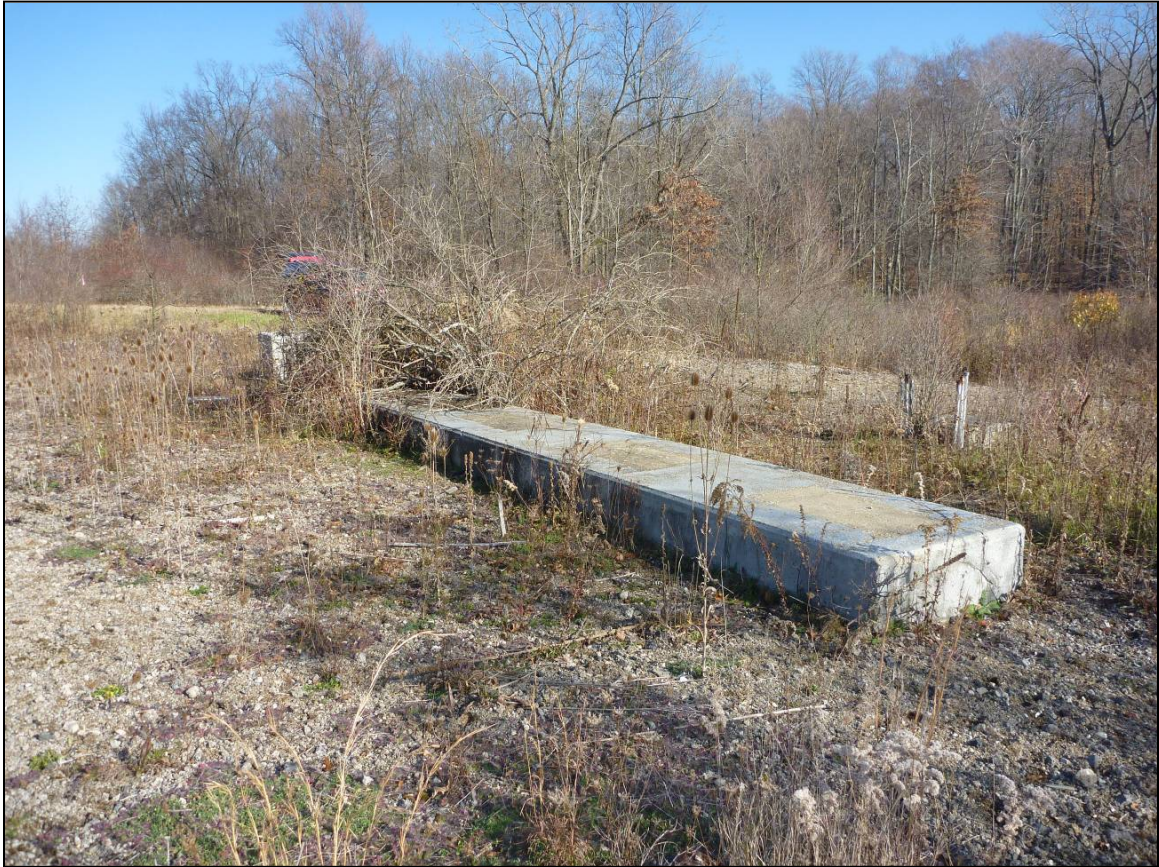
CC-RVAAP-68	Substation No. 3	Photograph Number: 001
Date: 11/09/2010	Direction of View: Northeast	Photographer: Corey Pacer (SAIC)
Description: Photograph of concrete slabs at the former location of the substation transformers.

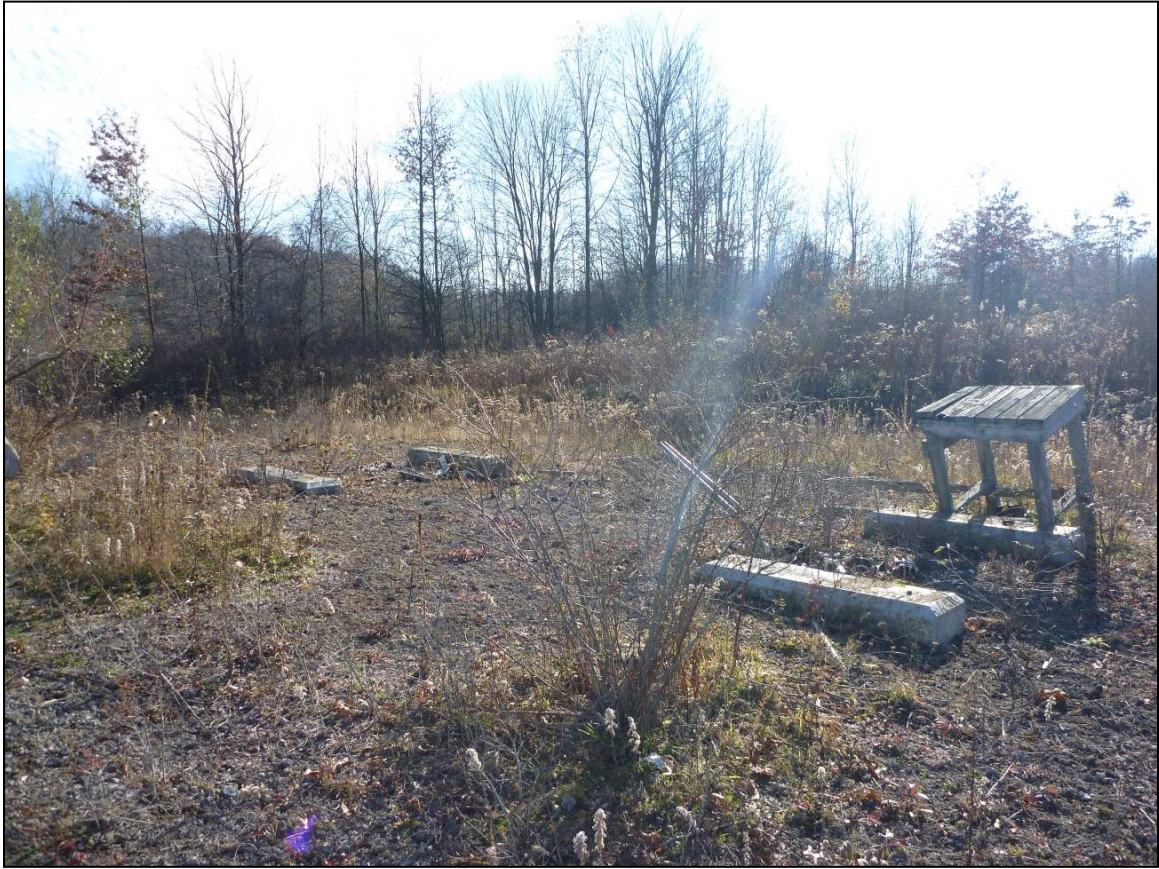
CC-RVAAP-68	Substation No. 3	Photograph Number: 002
Date: 11/09/2010	Direction of View: Southwest	Photographer: Corey Pacer (SAIC)
Description: Photograph of concrete slabs and debris at the former location of the substation. Majority of substation is gravelly, with some debris and little vegetation in the substation footprint.

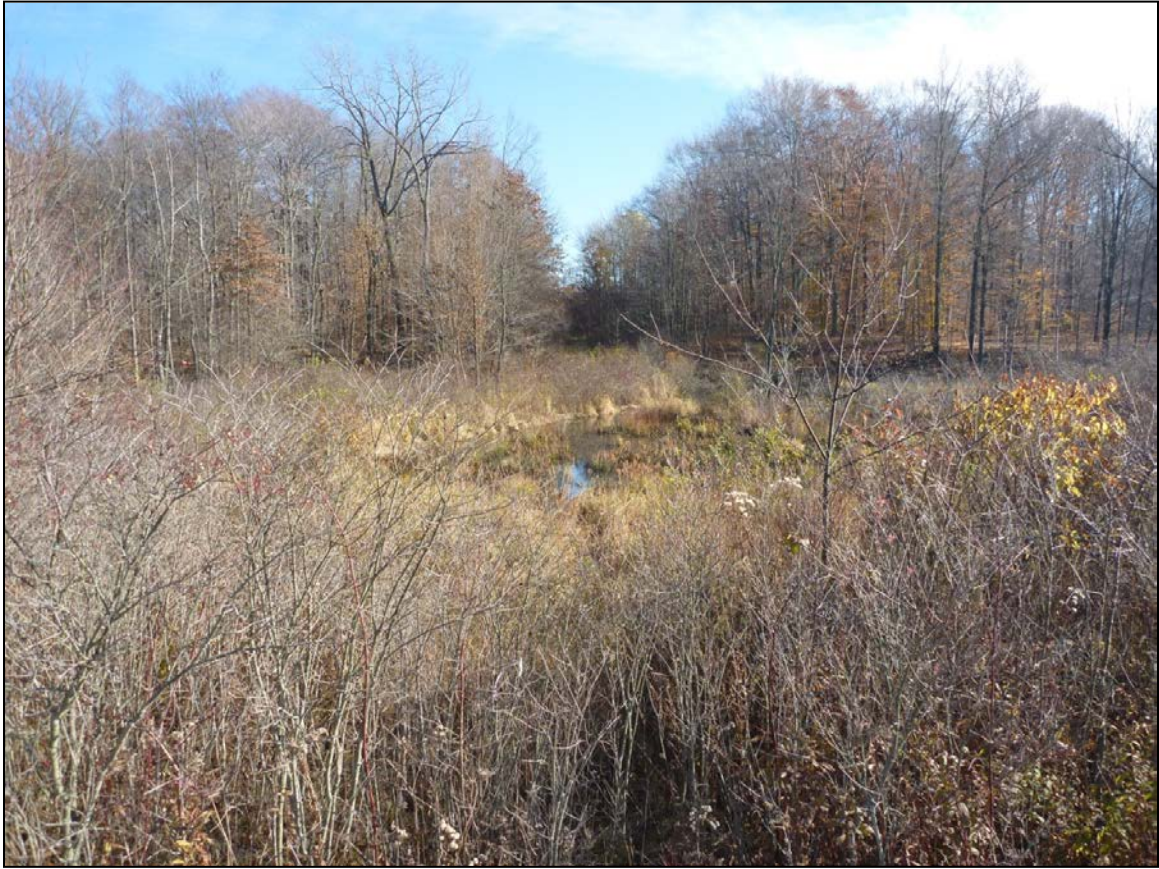
CC-RVAAP-68	Substation No. 3	Photograph Number: 003
Date: 11/09/2010	Direction of View: Southeast	Photographer: Corey Pacer (SAIC)
Description: Wetland and tributary to Sand Creek east of the former substation.

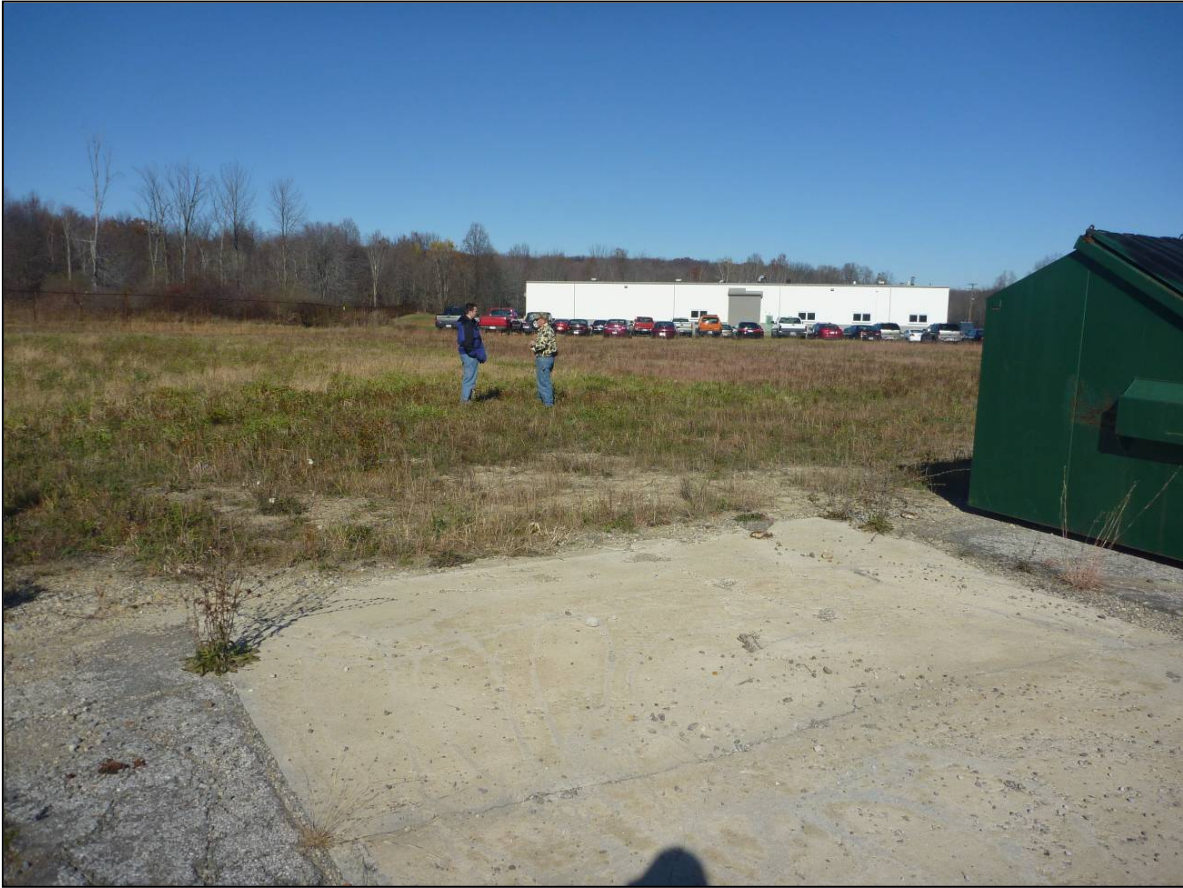
CC-RVAAP-69	Building 1048 - Fire Station	Photograph Number: 001
Date: 11/10/2010	Direction of View: Northwest	Photographer: Amanda Trenton (SAIC)
Description: No structures remain at the site. Concrete slab in front of photo is from former truck bay of building.

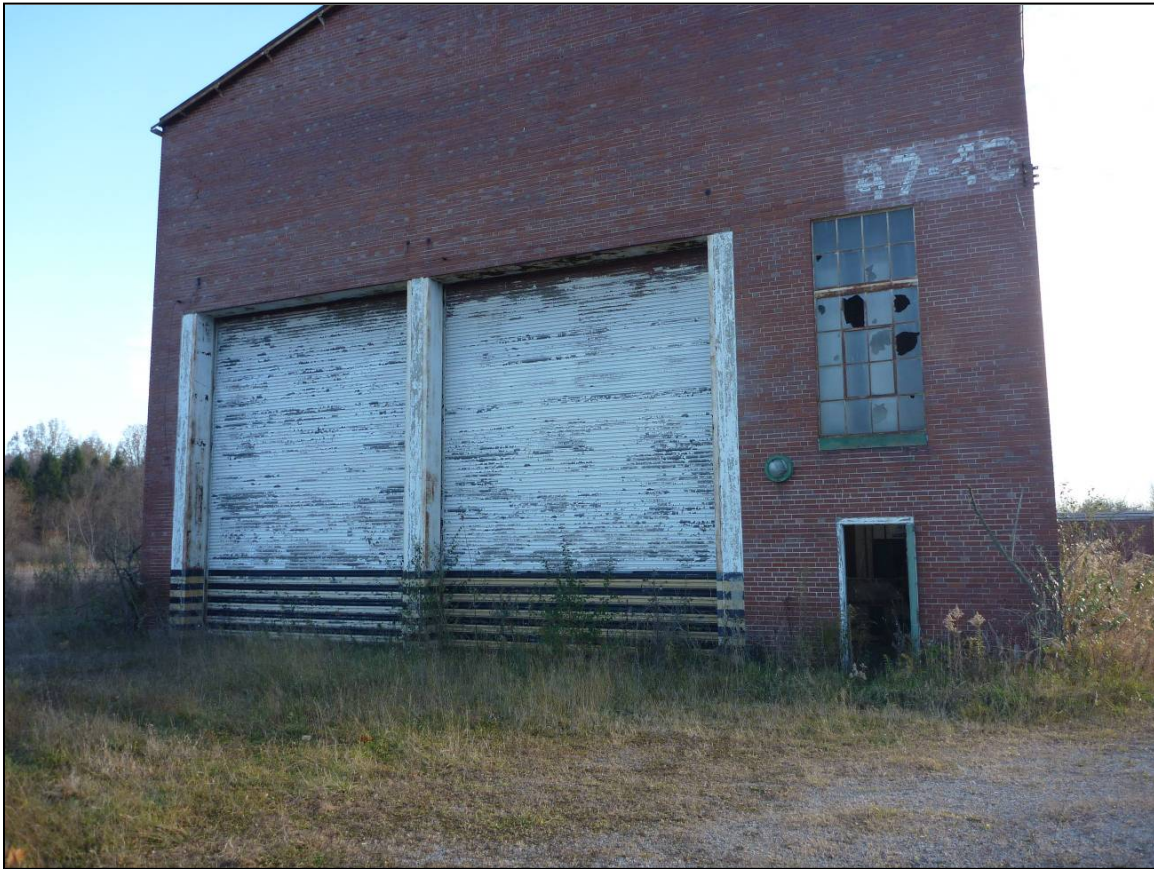
CC-RVAAP-70	East Classification Yard	Photograph Number: 001
Date: 11/09/2010	Direction of View: South	Photographer: Corey Pacer (SAIC)
Description: Photograph to document the exterior of Building 47-40, the only building remaining at the East Classification Yard. This photo documents the north side of the building and the bays for train tracks 47 and 48.

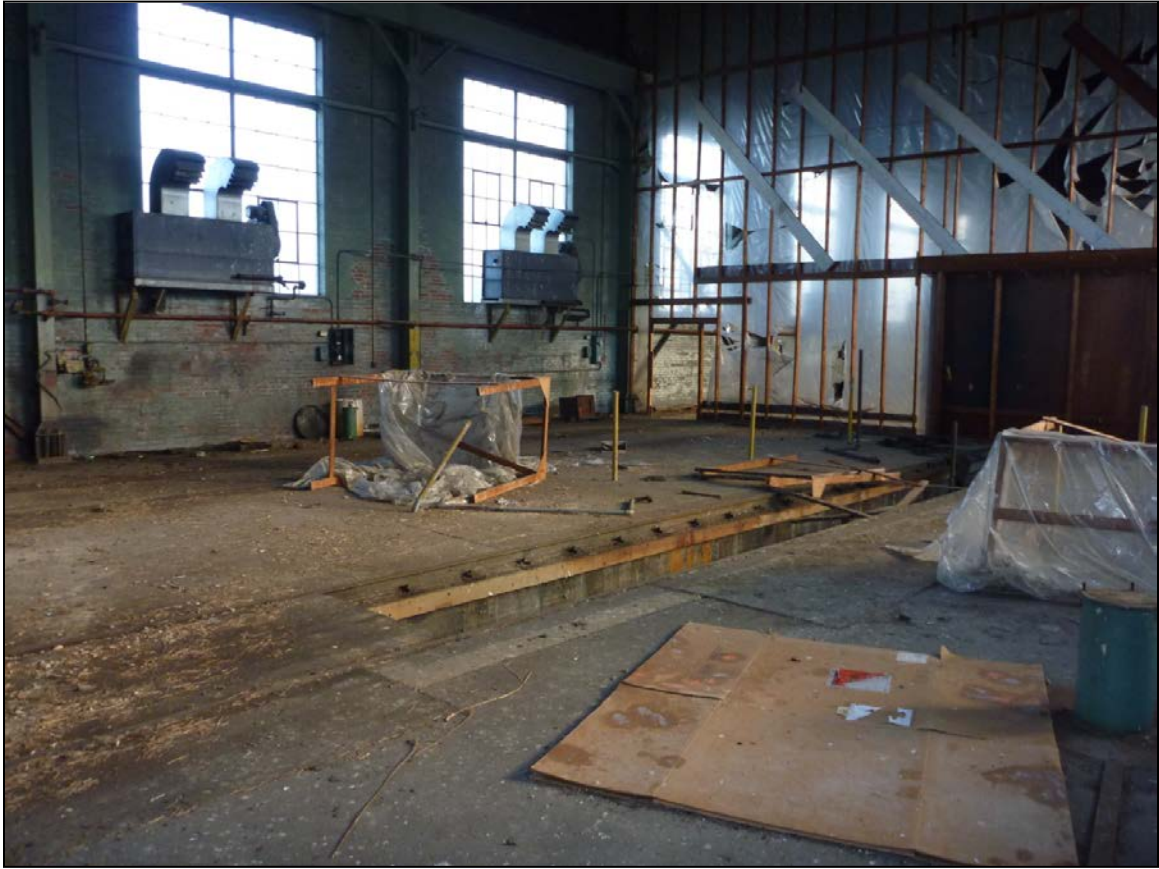
CC-RVAAP-70	East Classification Yard	Photograph Number: 002
Date: 11/09/2010	Direction of View: South	Photographer: Corey Pacer (SAIC)
<p>Description: Photograph to document the interior of Building 47-40. Two repair pits exist within the building; the eastern pit is visible in this photograph. Other equipment, debris, and structures still exist in the building, including pipes and fixtures on walls and the ceiling. Animal waste and vegetative debris were observed throughout the building. Some portions of the concrete floor are stained.</p>

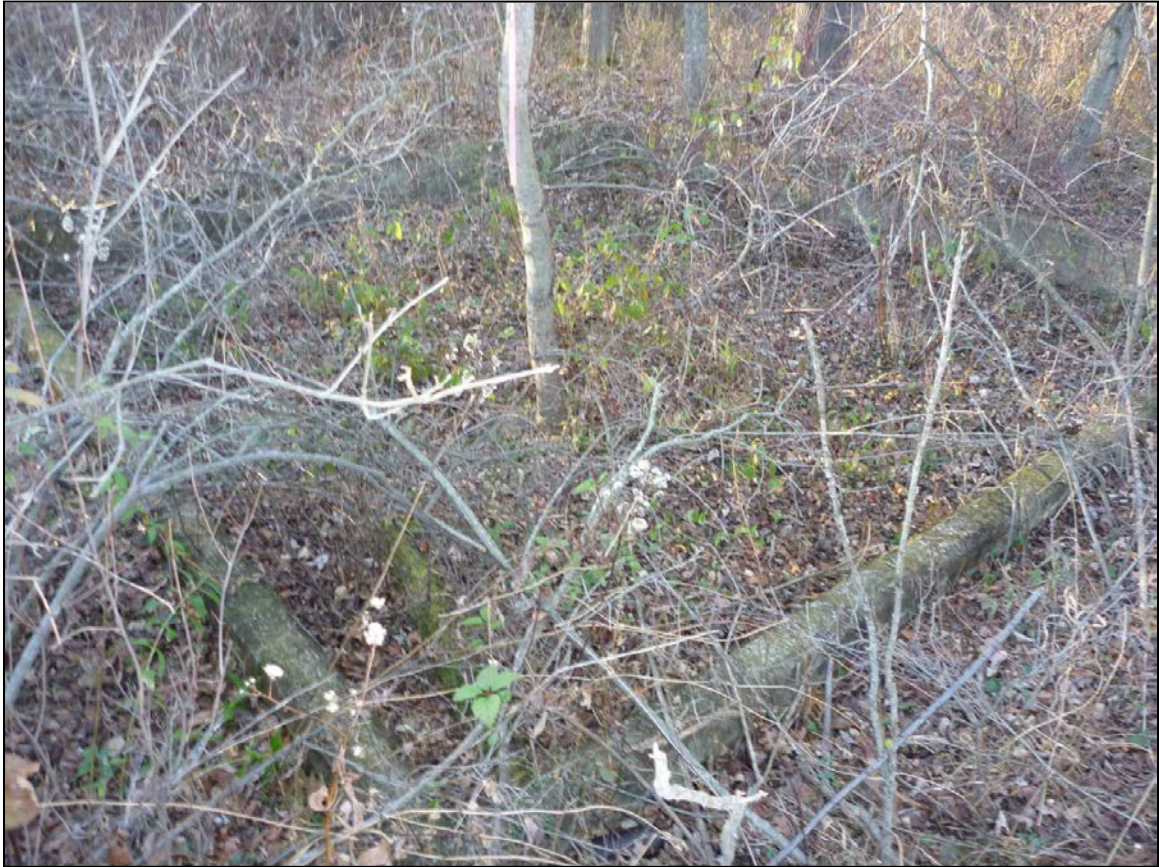
CC-RVAAP-70	East Classification Yard	Photograph Number: 003
Date: 11/09/2010	Direction of View: Northwest	Photographer: Corey Pacer (SAIC)
Description: This photograph documents the sludge basin. The concrete walls of the basin can be clearly seen. The interior of the basin is vegetated and is composed of a sandy soil.

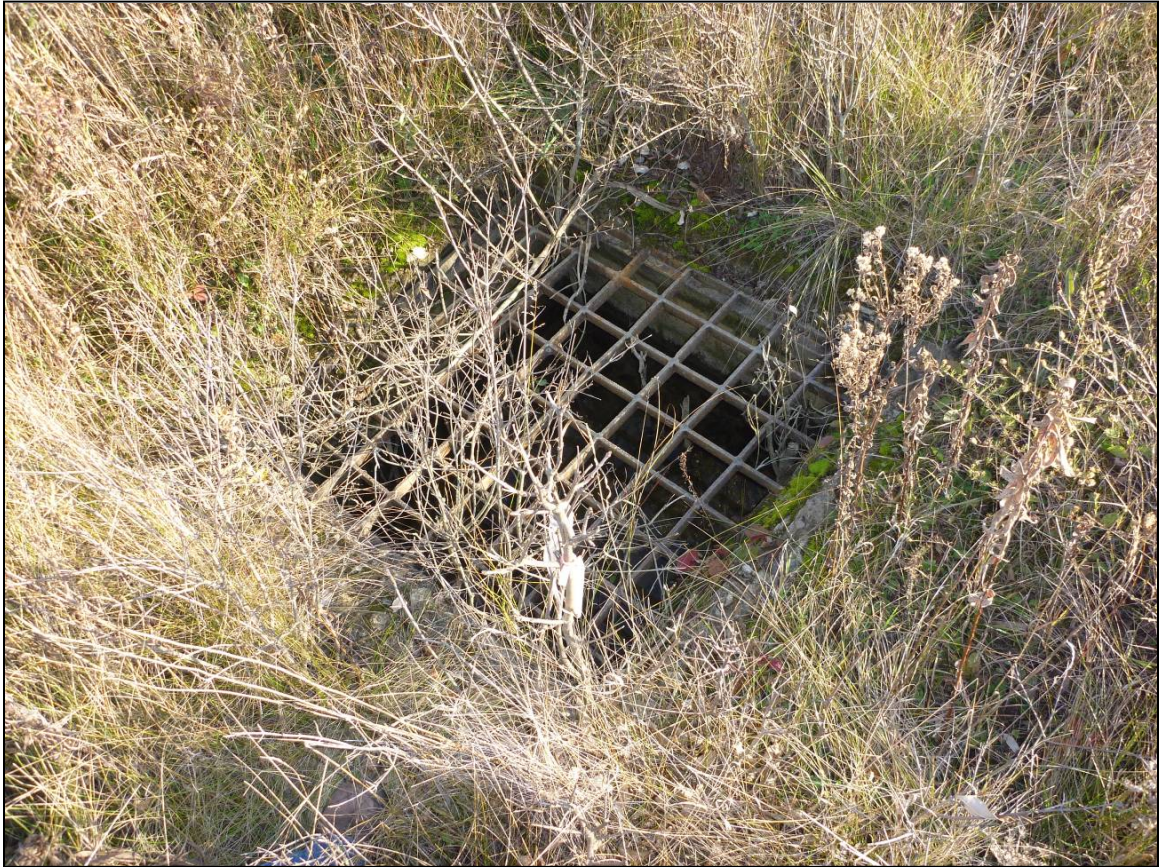
CC-RVAAP-70	East Classification Yard	Photograph Number: 004
Date: 11/09/2010	Direction of View: South	Photographer: Corey Pacer (SAIC)
Description: Photograph of one of several catch basins still present within the East Classification Yard. This catch basin is believed to be Inlet 4.

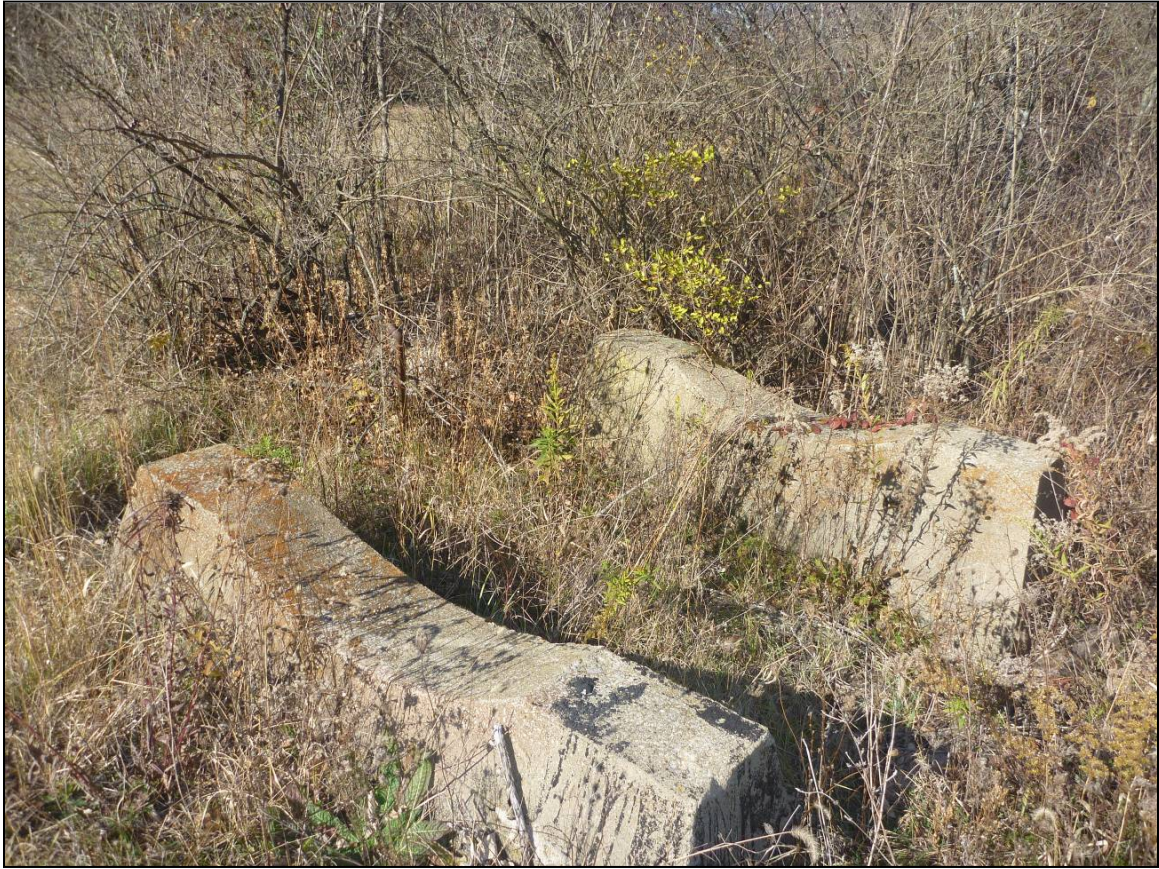
CC-RVAAP-70	East Classification Yard	Photograph Number: 005
Date: 11/09/2010	Direction of View: South	Photographer: Corey Pacer (SAIC)
Description: Photograph documents a concrete structure south of the East Classification Yard that may have served as a base for an above-ground storage tank (AST) used for the wash rack.

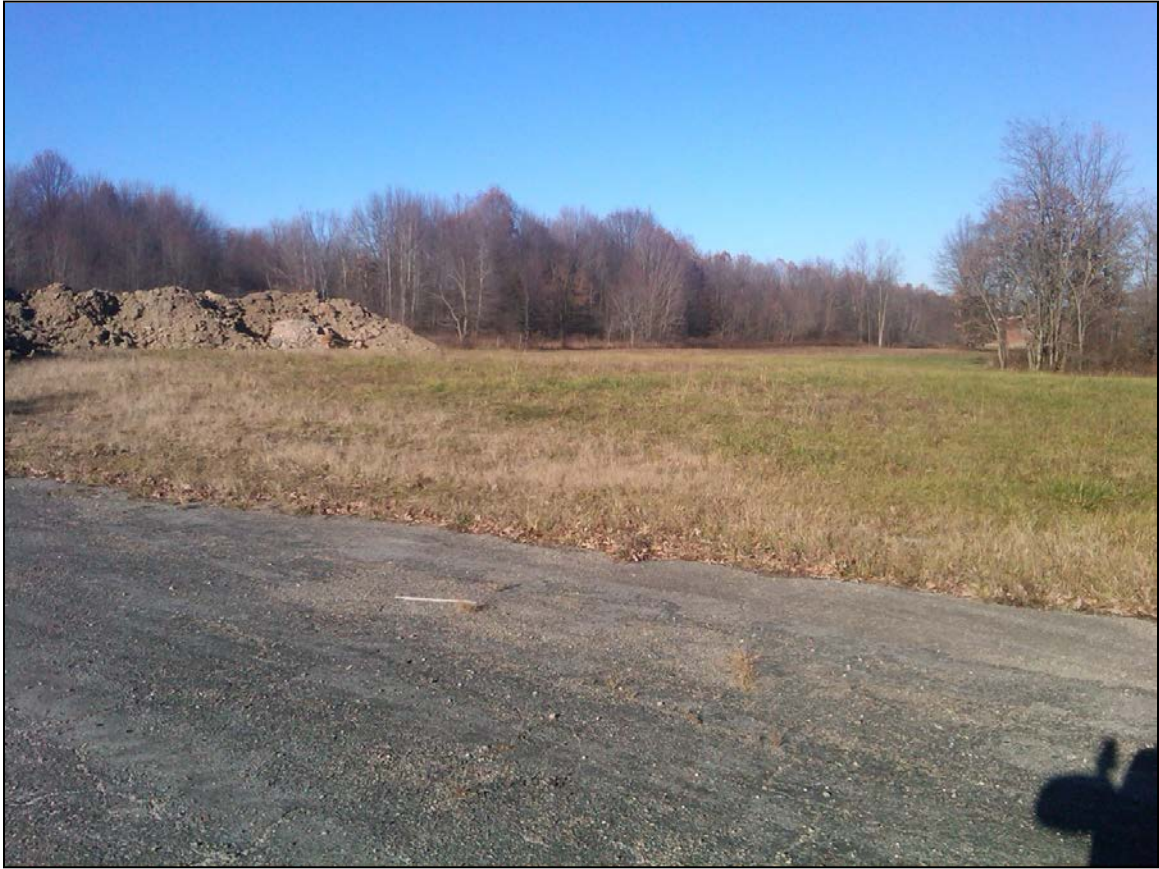
CC-RVAAP-72	Facility-Wide USTs	Photograph Number: 001
Date: 11/10/2010	Direction of View: Northeast	Photographer: Amanda Trenton (SAIC)
Description: Photograph documents former Fire Station No. 2 (Building 1103), the location of RV-88. No structures, including vent pipes, remain at the site. This area is now used to stockpile soil.

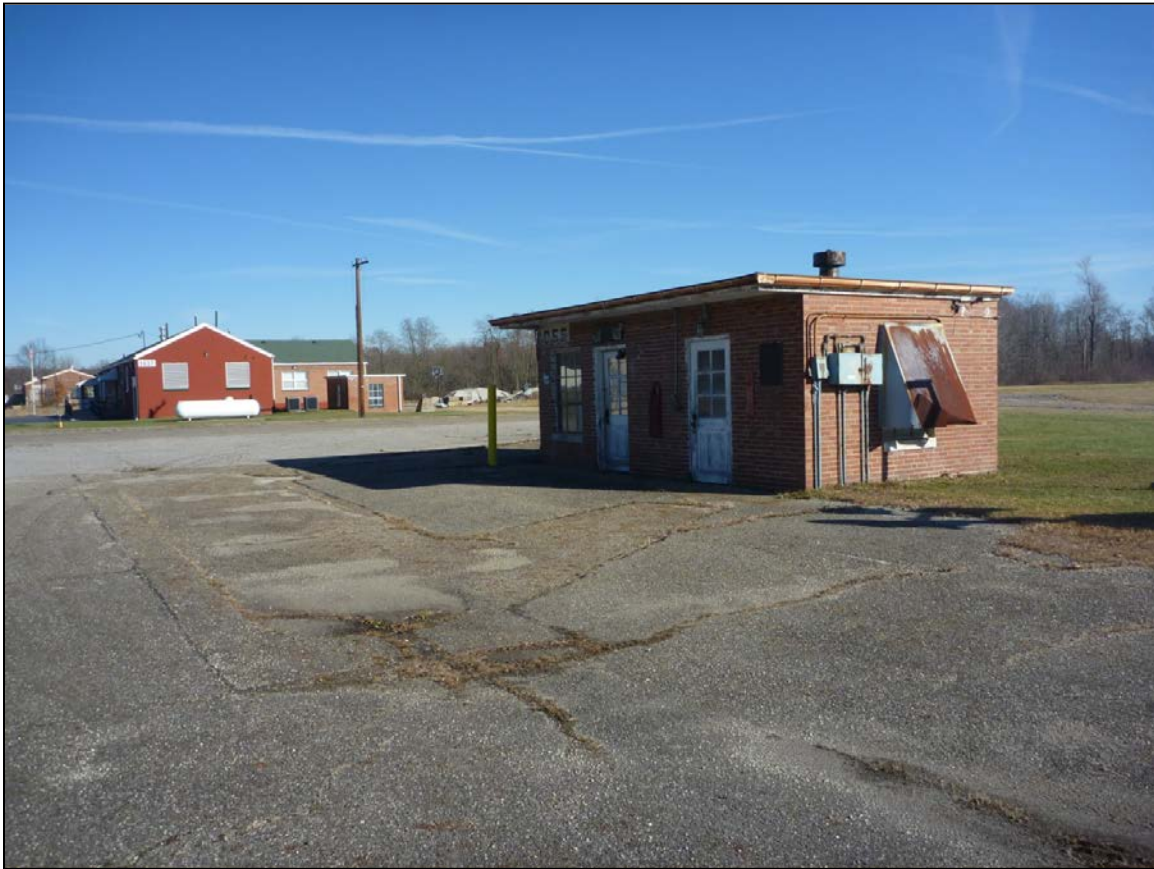
CC-RVAAP-72	Facility-Wide USTs	Photograph Number: 002
Date: 11/12/2010	Direction of View: Northeast	Photographer: Amanda Trenton (SAIC)
<p>Description: Photograph documents former George Road Service Station (Building 1055) in Administration Area. There were four former USTs at this location: RV-1, RV-2, RV-80, and CC-RVAAP-72-07. Areas that have been repaved indicate where piping and islands have been removed.</p>

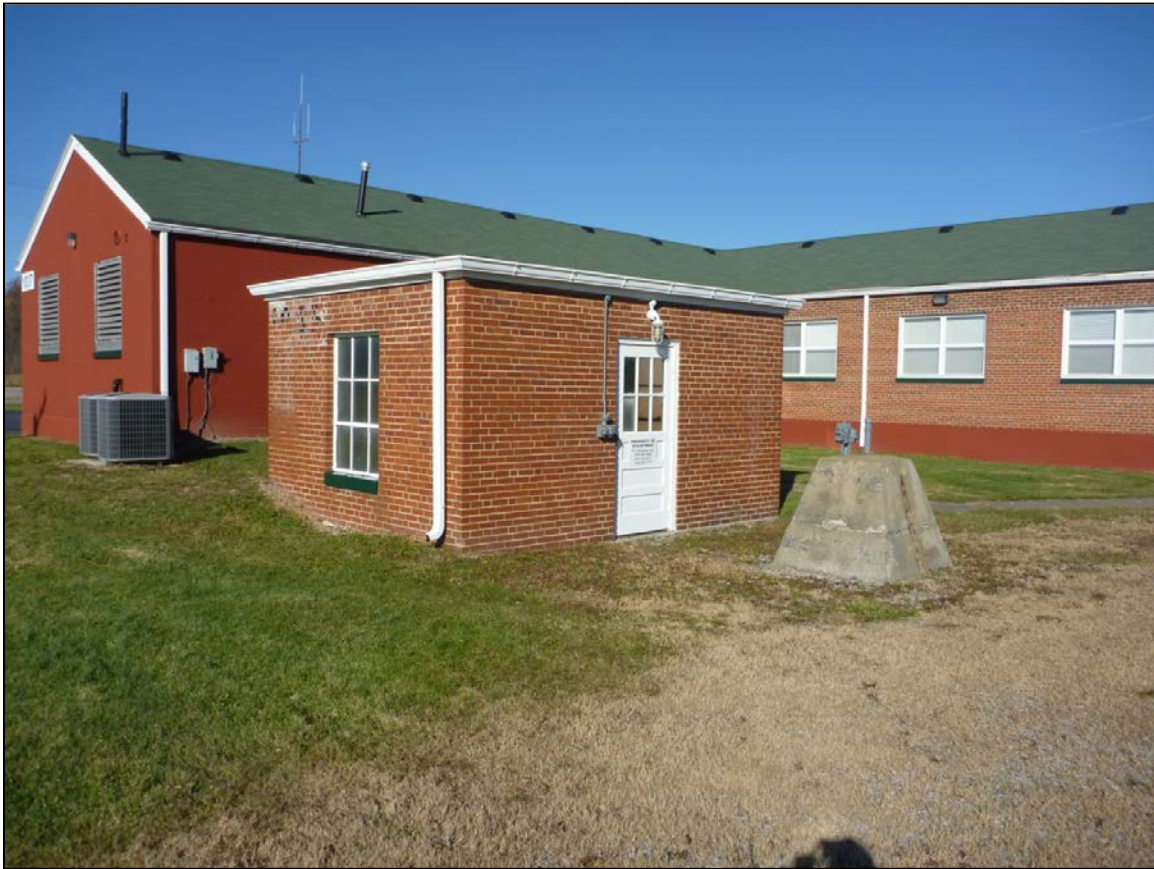
CC-RVAAP-72	Facility-Wide USTs	Photograph Number: 003
Date: 11/12/2010	Direction of View: Northwest	Photographer: Amanda Trenton (SAIC)
Description: Photograph documents former Pump House and former area of UST RV-23 in the Administration Area (Building 1045). Building and concrete island remains, but UST and piping have been removed.

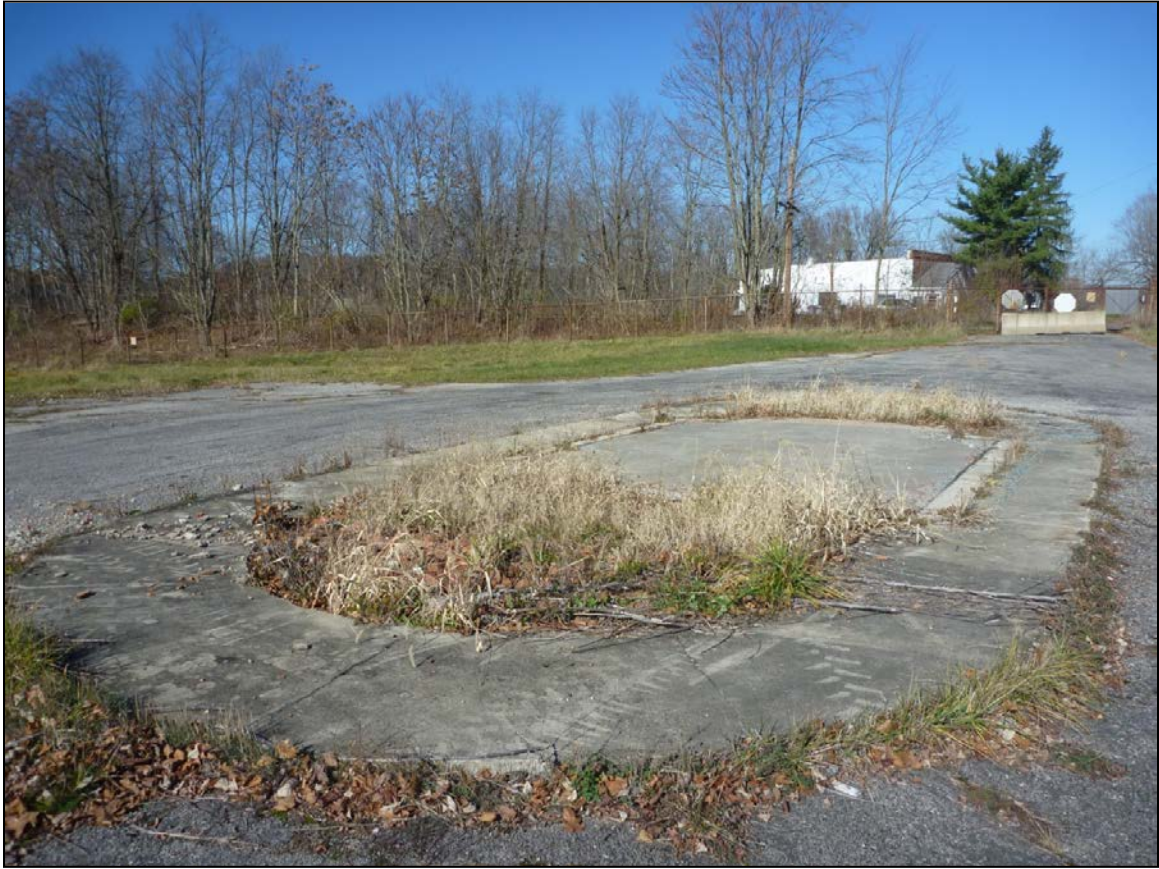
CC-RVAAP-72	Facility-Wide USTs	Photograph Number: 004
Date: 11/12/2010	Direction of View: Northwest	Photographer: Amanda Trenton (SAIC)
Description: Photograph documents former Guardhouse and former location of UST RV-47 at North Line Road and Route 80 Road. The building and all UST structures have been removed.
