Appendix M
Property Visit Photographs

CC-RVAAP-68
Electric Substations (East, West, and No. 3)

**COMPLIANCE RESTORATION SITES
RAVENNA ARMY ANNUNITION
PLANT - RAVENNA, OHIO**

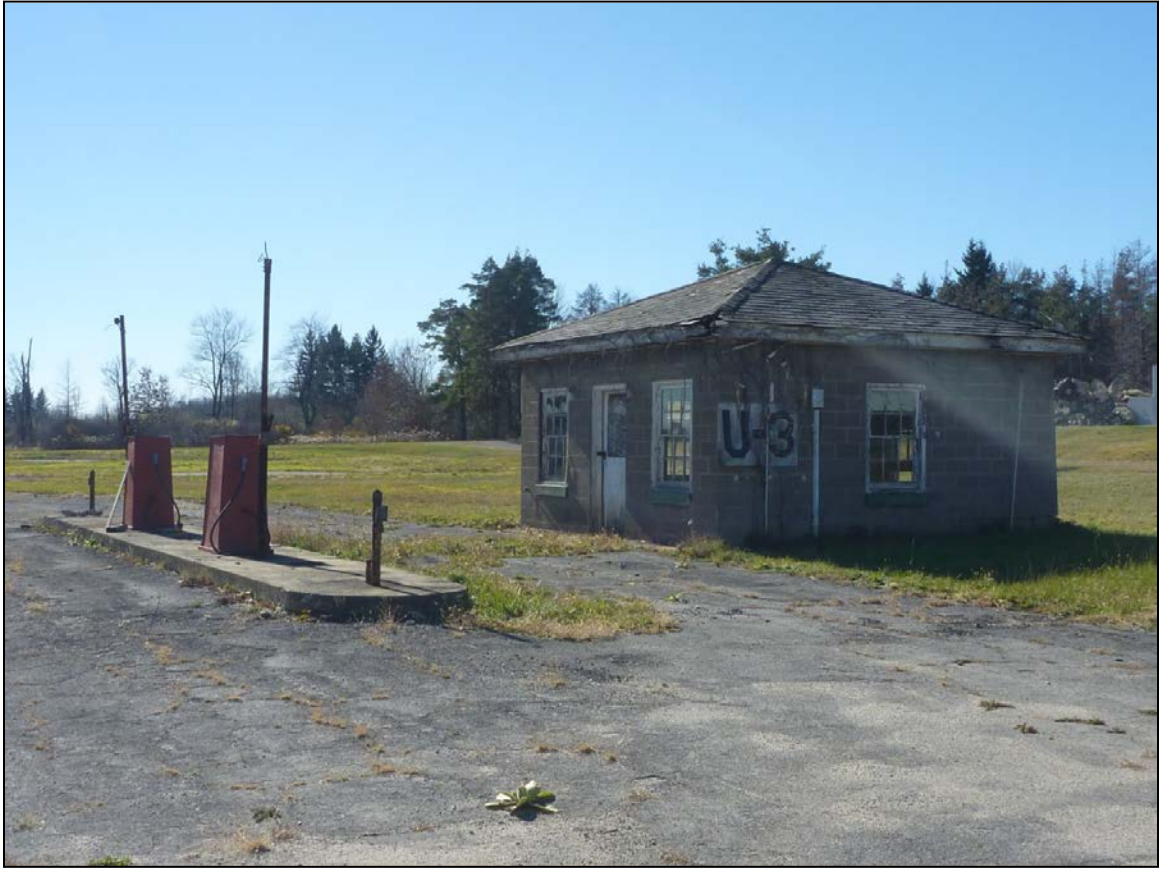
CC-RVAAP-72	Facility-Wide USTs	Photograph Number: 005
Date: 11/12/2010	Direction of View: Southwest	Photographer: Amanda Trenton (SAIC)
<p>Description: Photograph documents Building U-3, a former service station, within the Depot. The concrete pump island still remains, and some vent pipes are visible on the north face of the building. USTs RV-15 and RV-16 were removed at Building U-3 and provided with an no further action closure status. One UST, CC-RVAAP-72-01, may still exist at Building U-3.</p>

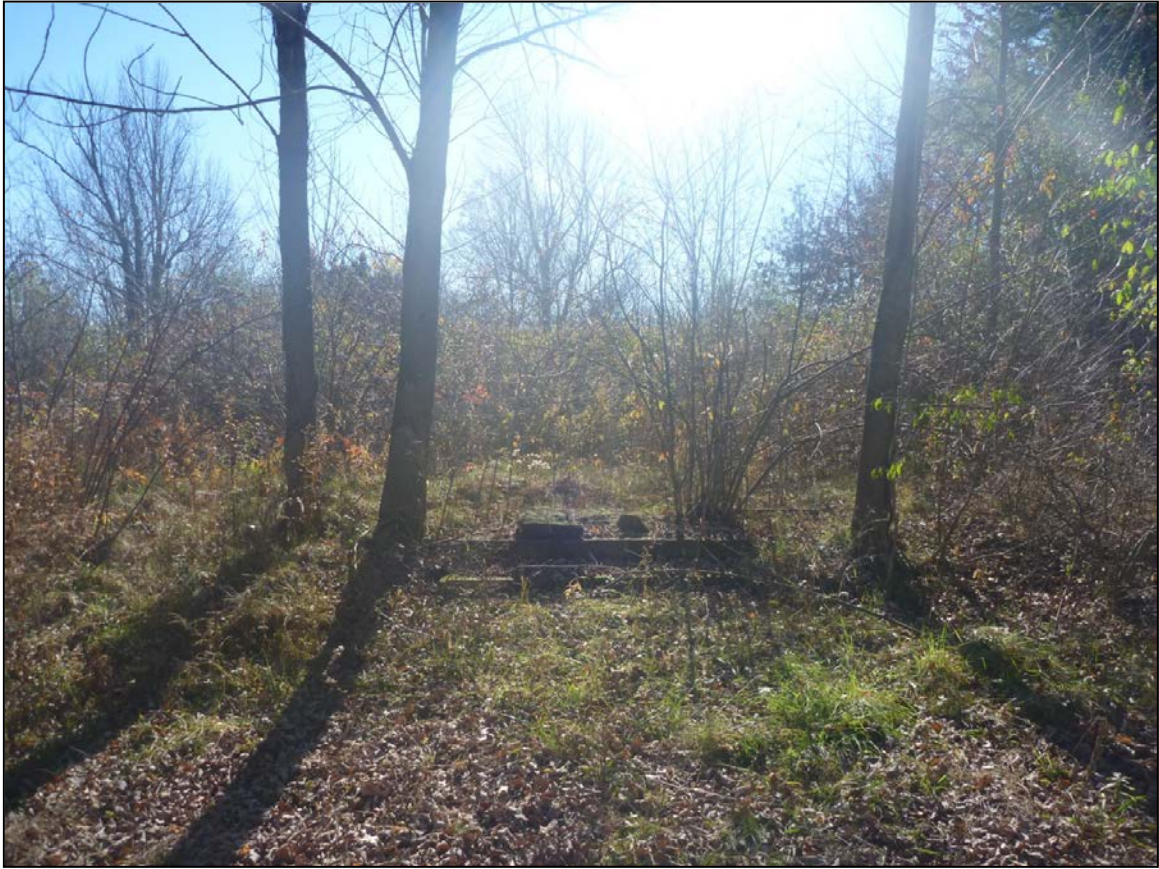
CC-RVAAP-72	Facility-Wide USTs	Photograph Number: 006
Date: 11/12/2010	Direction of View: South	Photographer: Amanda Trenton (SAIC)
Description: Steps to former Bolton Mansion (EE-102) in Depot Area remain. A documented removal of the UST (RV-46) at the Bolton Mansion could not be located as part of the historical records review. Portions of the building footprint remain but are covered with vegetation.

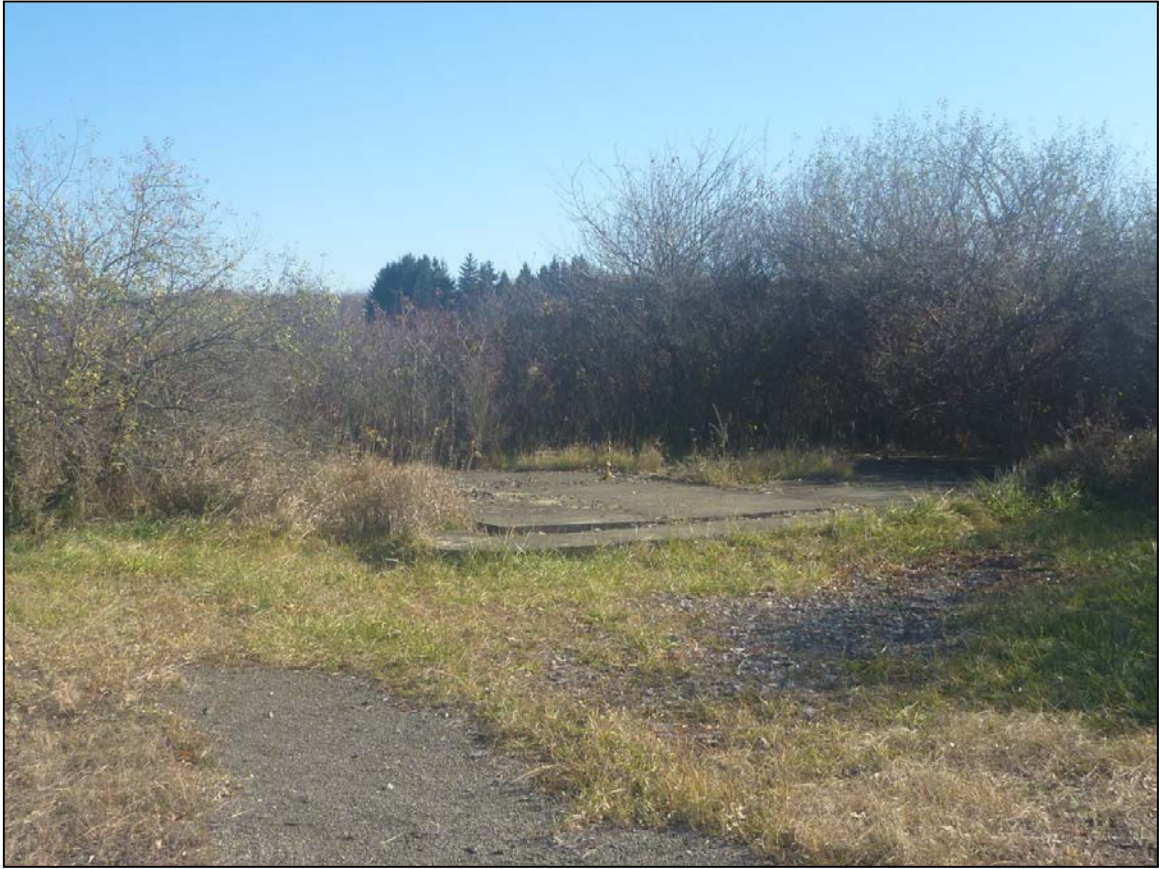
CC-RVAAP-72	Facility-Wide USTs	Photograph Number: 007
Date: 11/12/2010	Direction of View: South	Photographer: Amanda Trenton (SAIC)
Description: The building footprint for the A-6 service station in Depot Area still remains. Four USTs (RV-17, RV-18, RV-19, and RV-97) were present at this location. All UST structures are no longer present.

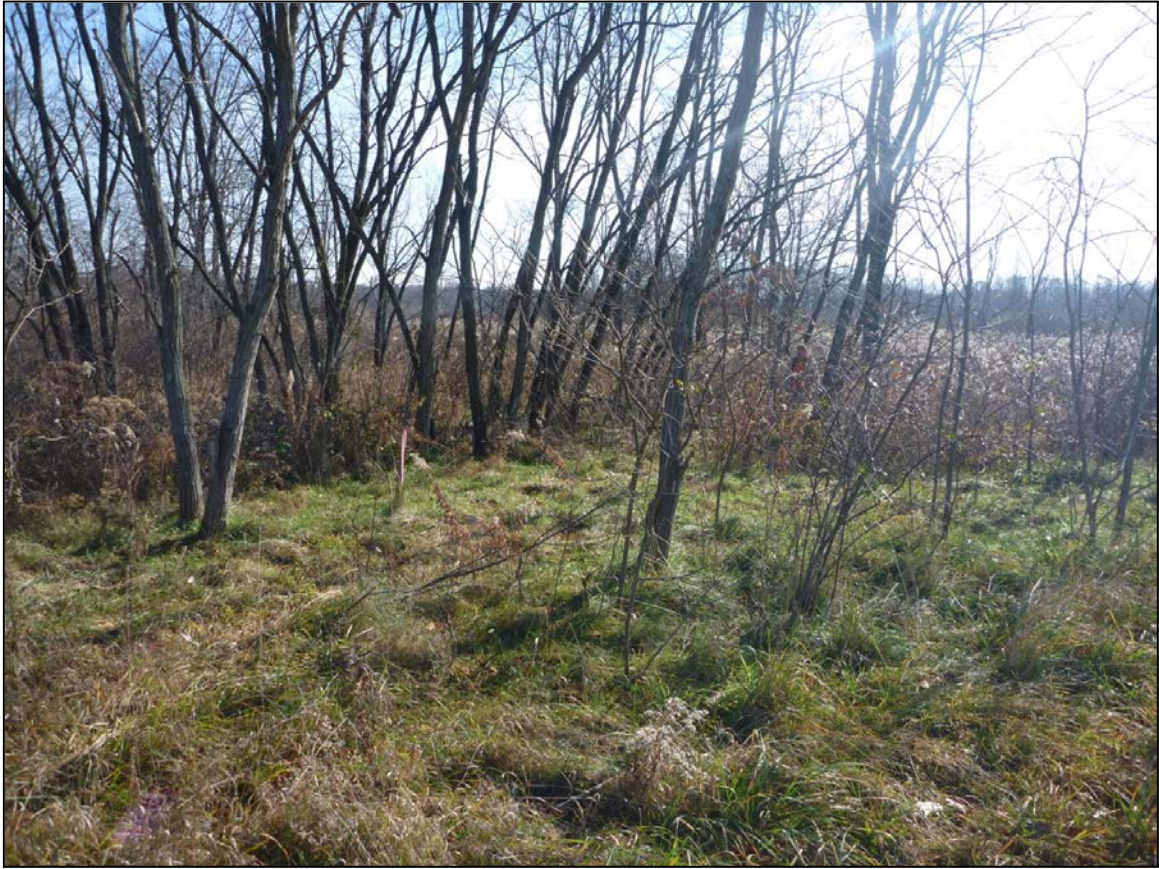
CC-RVAAP-72	Facility-Wide USTs	Photograph Number: 008
Date: 11/15/2010	Direction of View: East	Photographer: Amanda Trenton (SAIC)
<p>Description: Area of the former north service station within Atlas Scrap Yard. Some concrete slabs remain. No UST vent pipes or structures were observed. This former service station was documented to have four USTs (CC-RVAAP-72-02, CC-RVAAP-72-03, CC-RVAAP-72-04, and CC-RVAAP-72-05). A documented removal for USTs at this location could not be located as part of the historical records review.</p>

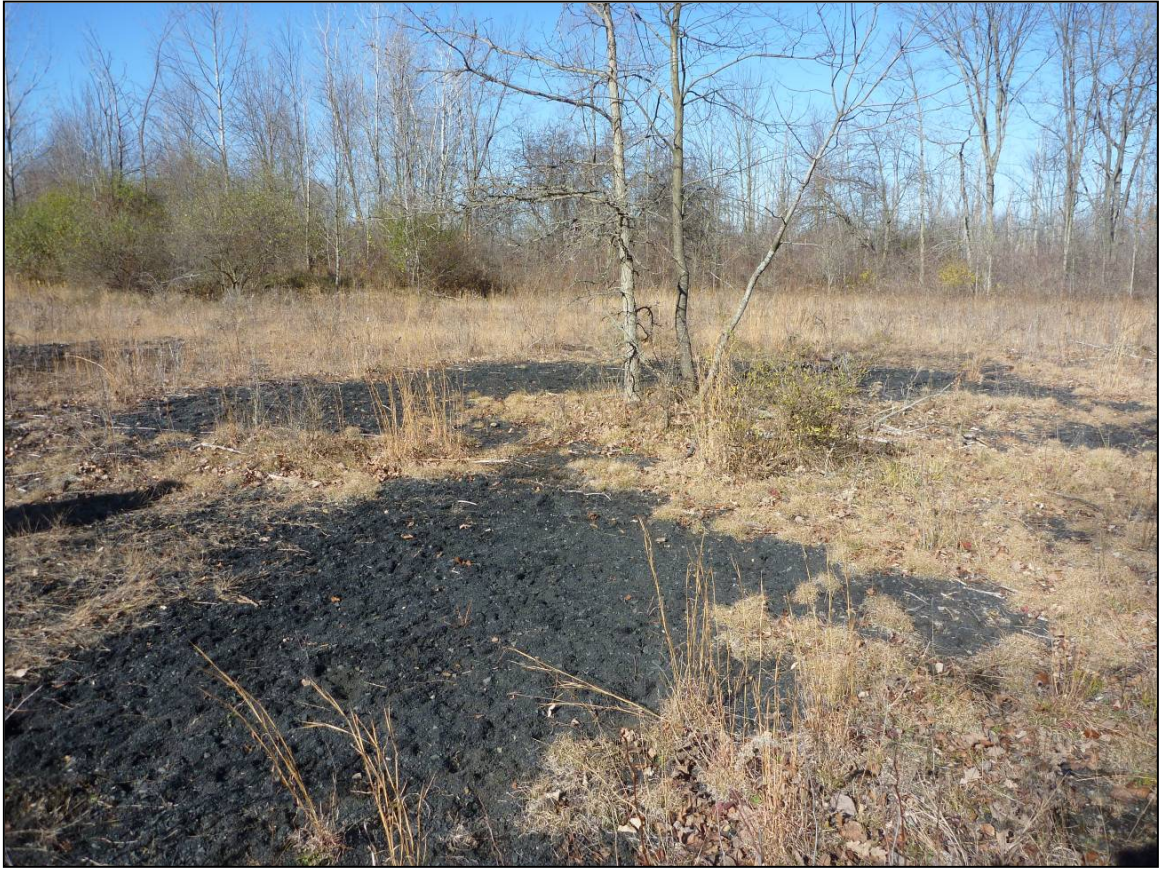
CC-RVAAP-73	Facility-Wide Coal Storage	Photograph Number: 001
Date: 11/12/2010	Direction of View: East	Photographer: Amanda Trenton (SAIC)
Description: Photograph to document evidence of coal pile remains at the North Line Road Coal Tipple.

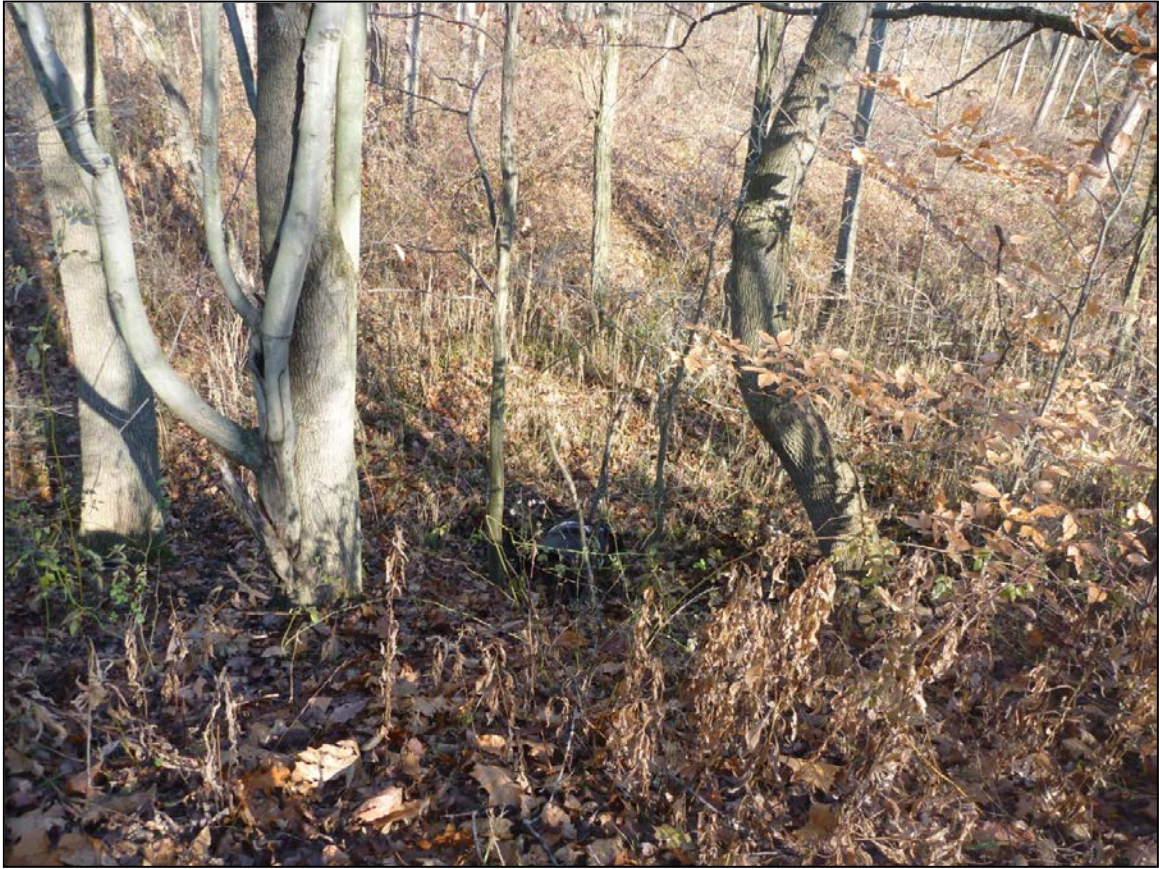
CC-RVAAP-73	Facility-Wide Coal Storage	Photograph Number: 002
Date: 11/15/2010	Direction of View: North	Photographer: Amanda Trenton (SAIC)
Description: Photograph to document evidence of coal pile remains at the Sand Creek Coal Tipple. Evidence of debris, including the steel drum in the center of the photograph, was present at the Sand Creek Coal Tipple north of the railroad tracks.

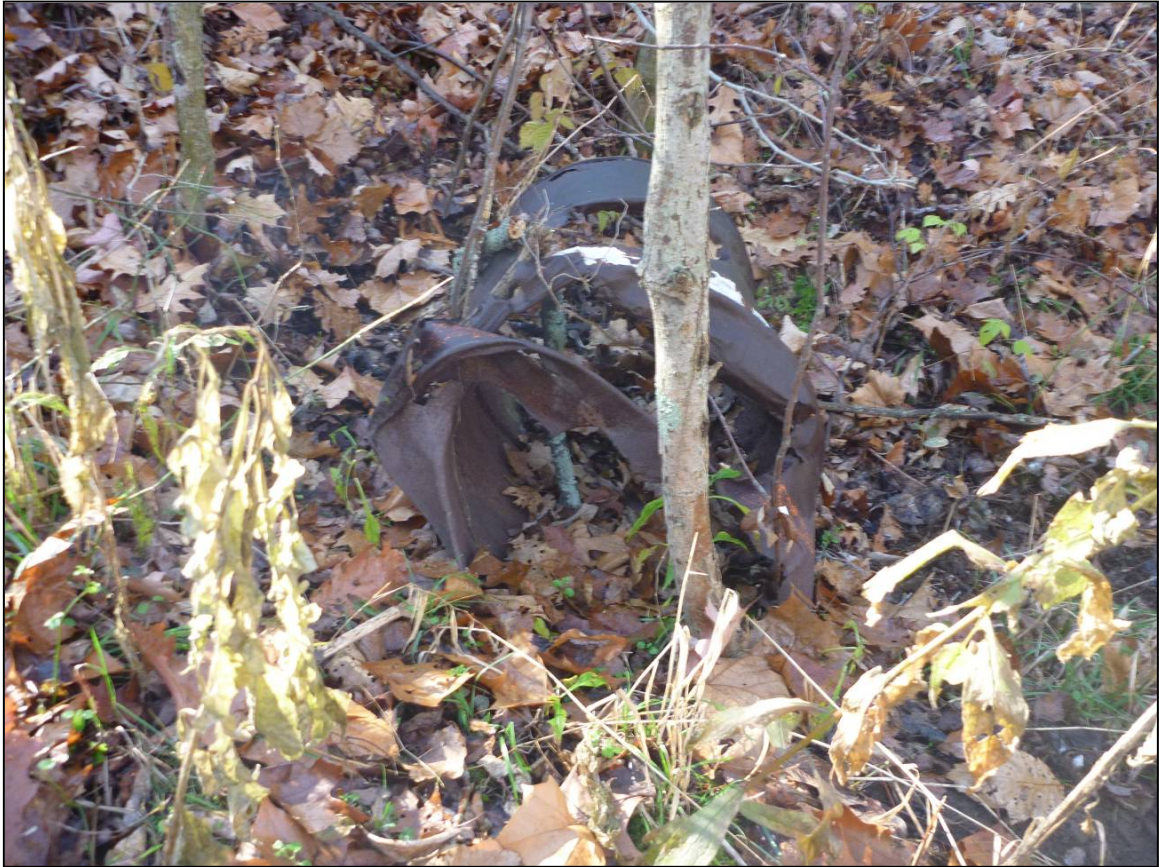
CC-RVAAP-73	Facility-Wide Coal Storage	Photograph Number: 003
Date: 11/15/2010	Direction of View: North	Photographer: Amanda Trenton (SAIC)
Description: Photograph to document evidence of rusted 55-gal steel drum and coal remains at the Sand Creek Coal Tipple.

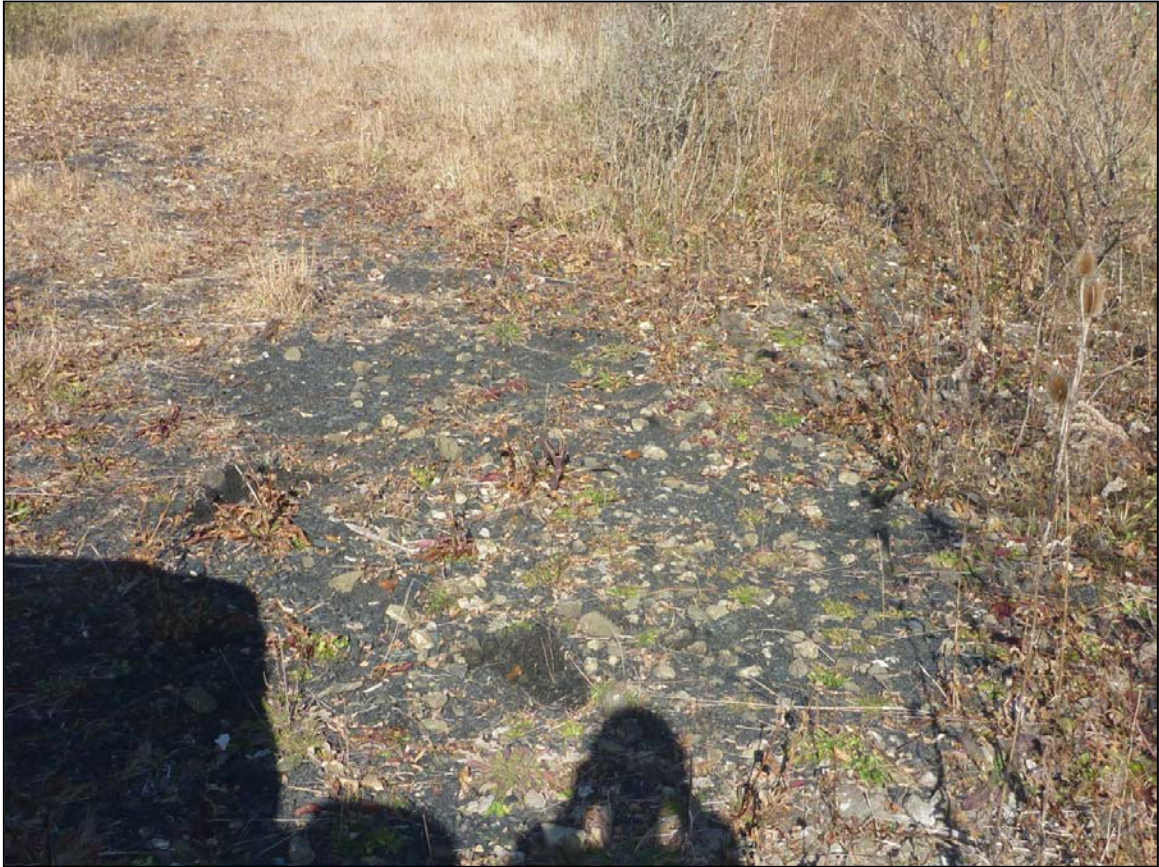
CC-RVAAP-73	Facility-Wide Coal Storage	Photograph Number: 004
Date: 11/10/2010	Direction of View: North	Photographer: Amanda Trenton (SAIC)
Description: Photograph to document evidence of unnamed coal storage site south of the East Classification Yard near the suspected wash rack.

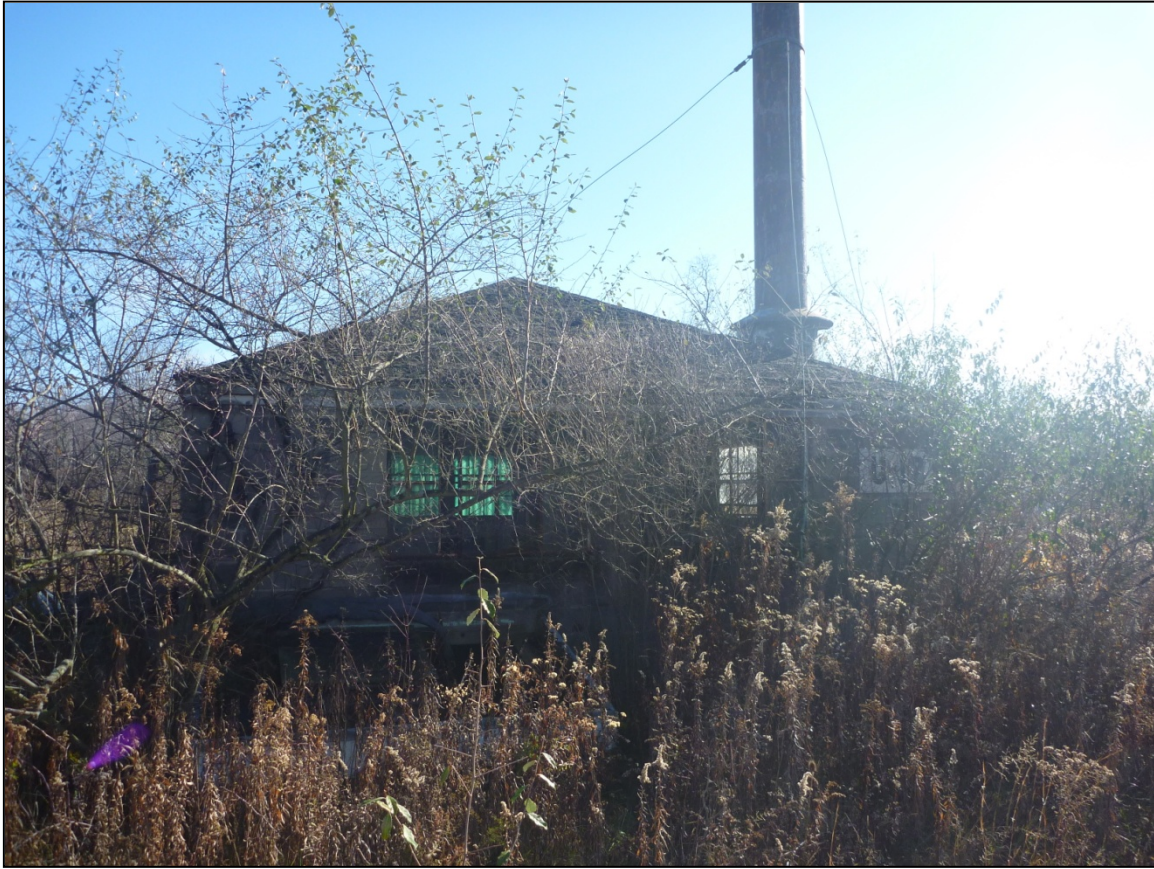
CC-RVAAP-73	Facility-Wide Coal Storage	Photograph Number: 005
Date: 11/10/2010	Direction of View: East	Photographer: Amanda Trenton (SAIC)
Description: Photograph to document evidence of former coal storage site at F-15. No evidence of coal storage was observed.

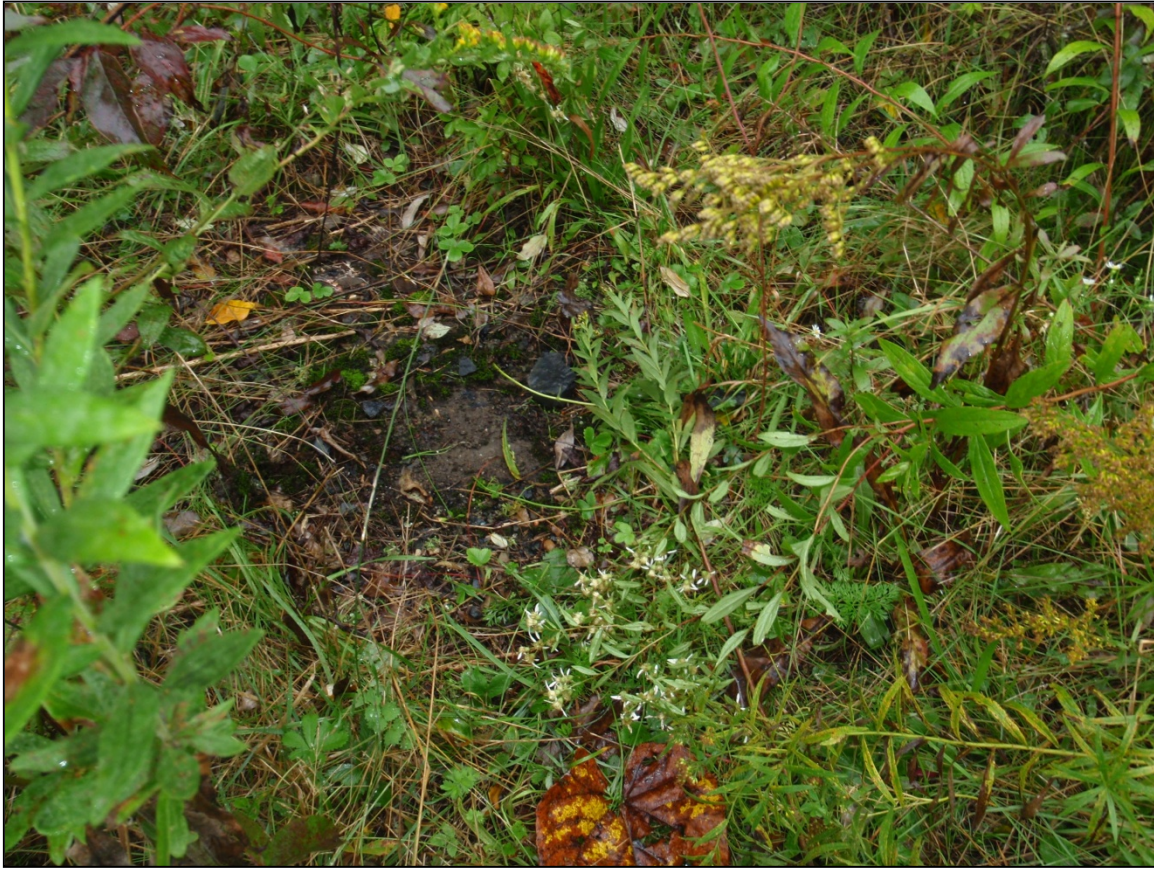
CC-RVAAP-73	Facility-Wide Coal Storage	Photograph Number: 006
Date: 9/30/2011	Direction of View: Northwest	Photographer: Amanda Trenton (SAIC)
Description: Photograph to document evidence of former coal storage site at Building U-16. Minimal coal was observed at Building U-16.

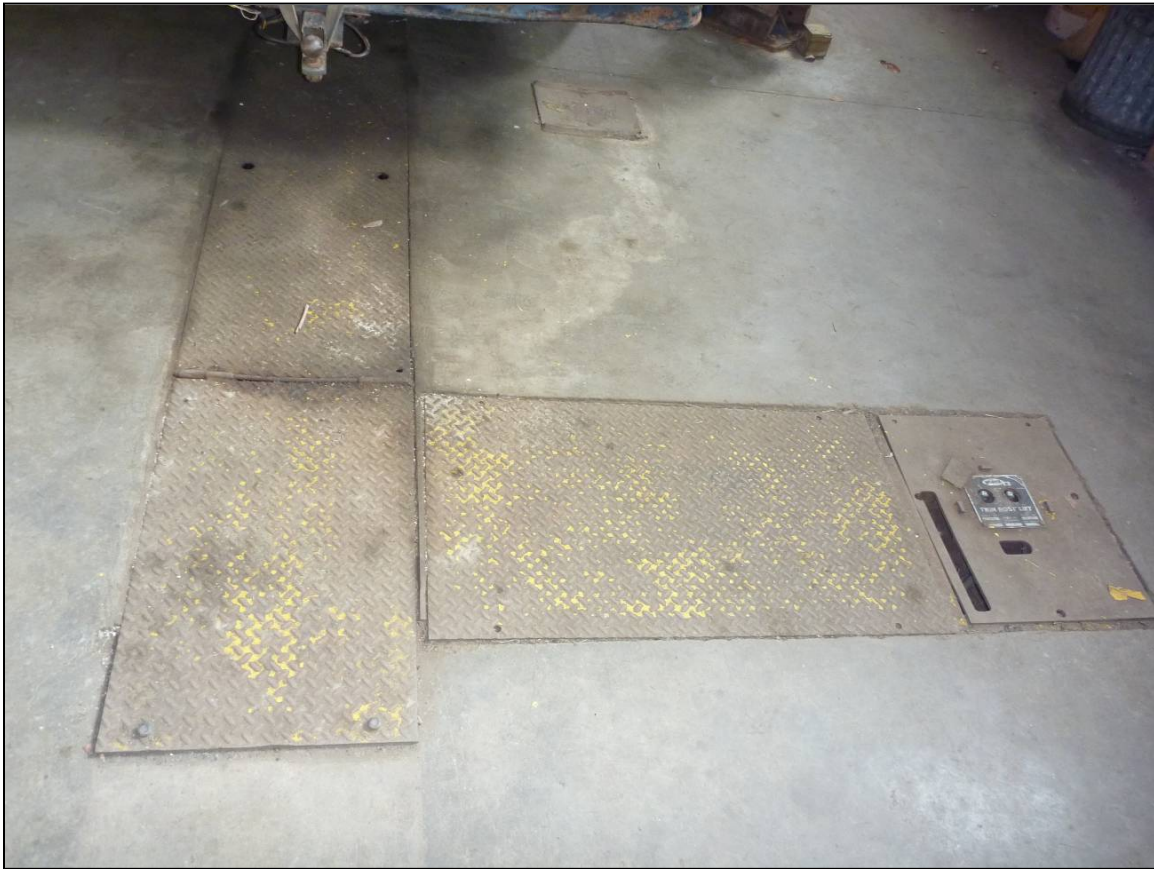
CC-RVAAP-74	Bldg 1034 Hydraulic Lift	Photograph Number: 001
Date: 11/10/2010	Direction of View: East	Photographer: Amanda Trenton (SAIC)
Description: Photograph to document remnants of the former hydraulic lift in Building 1034. These panels are on the concrete floor of the building. The black tag reads "Weaver Twin Post Lift; Model No. EC-105M; Serial No 3FM163; Capacity 24000."

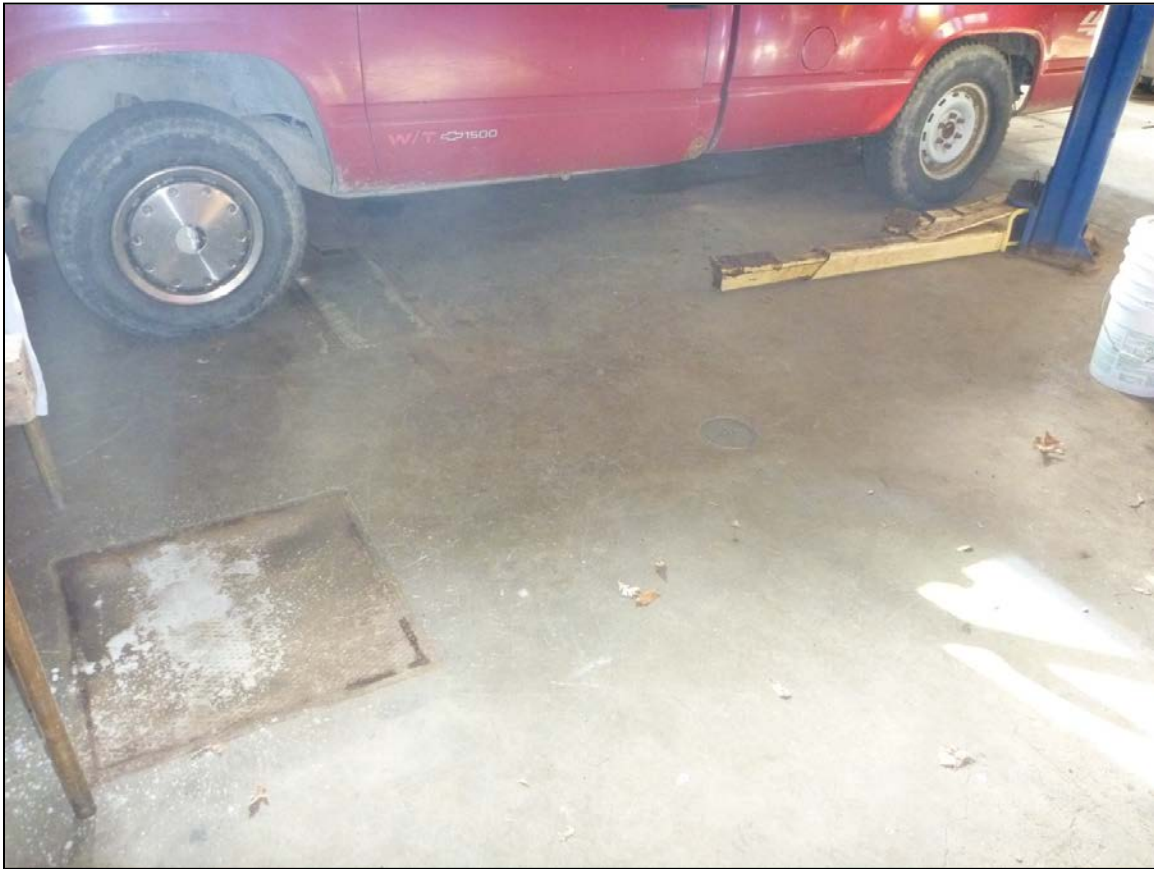
CC-RVAAP-74	Bldg 1034 Hydraulic Lift	Photograph Number: 002
Date: 11/10/2010	Direction of View: South	Photographer: Amanda Trenton (SAIC)
<p>Description: Photograph to document remnants of the former hydraulic lift in Building 1034. This square vault was not opened but apparently contains below-grade components of the lift. From this photograph, it is clear the current lift is installed in roughly the same location as the former hydraulic lift.</p>

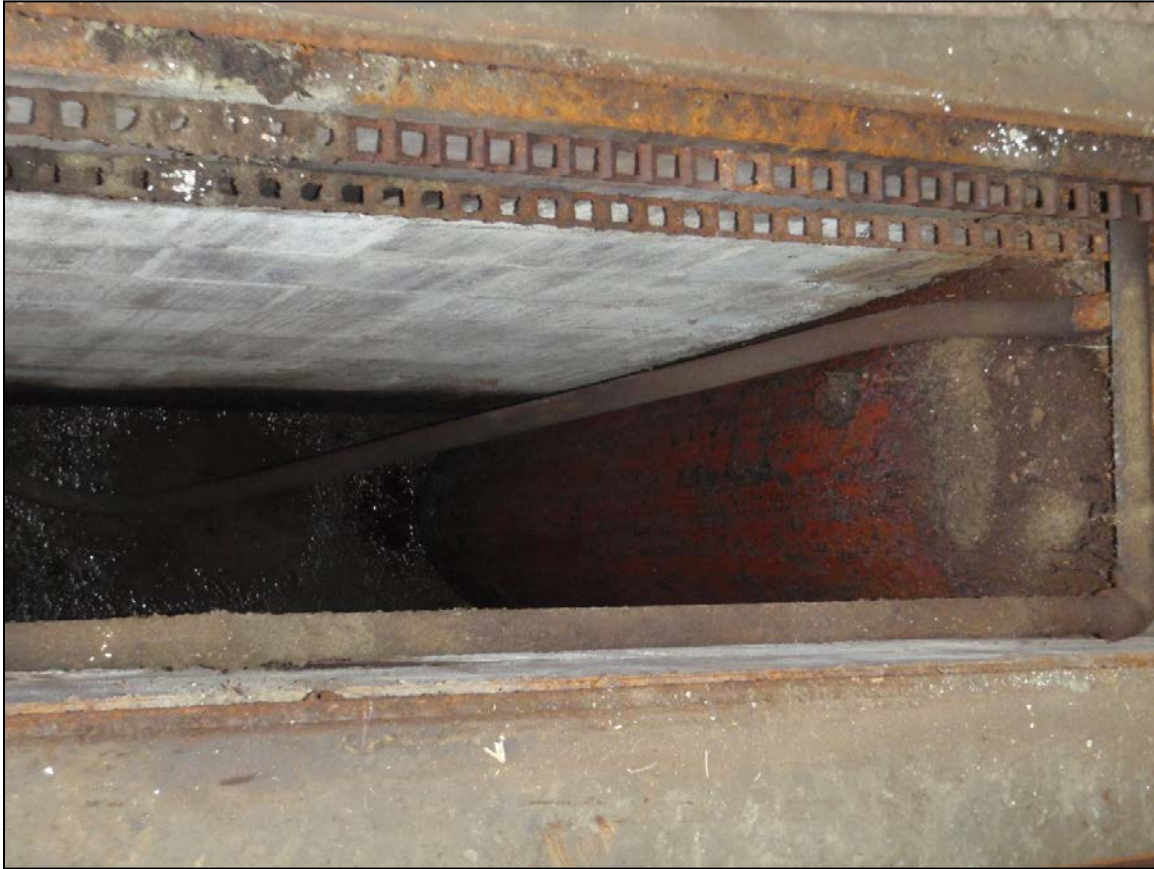
CC-RVAAP-74	Bldg 1034 Hydraulic Lift	Photograph Number: 003
Date: 08/31/2011	Direction of View: South	Photographer: Corey Pacer (SAIC)
Description: Photograph to document remnant site features of the former hydraulic lift in Building 1034. This vault contains below-grade components of the lift. The hydraulic oil tank and associated piping is in the right of this photograph.

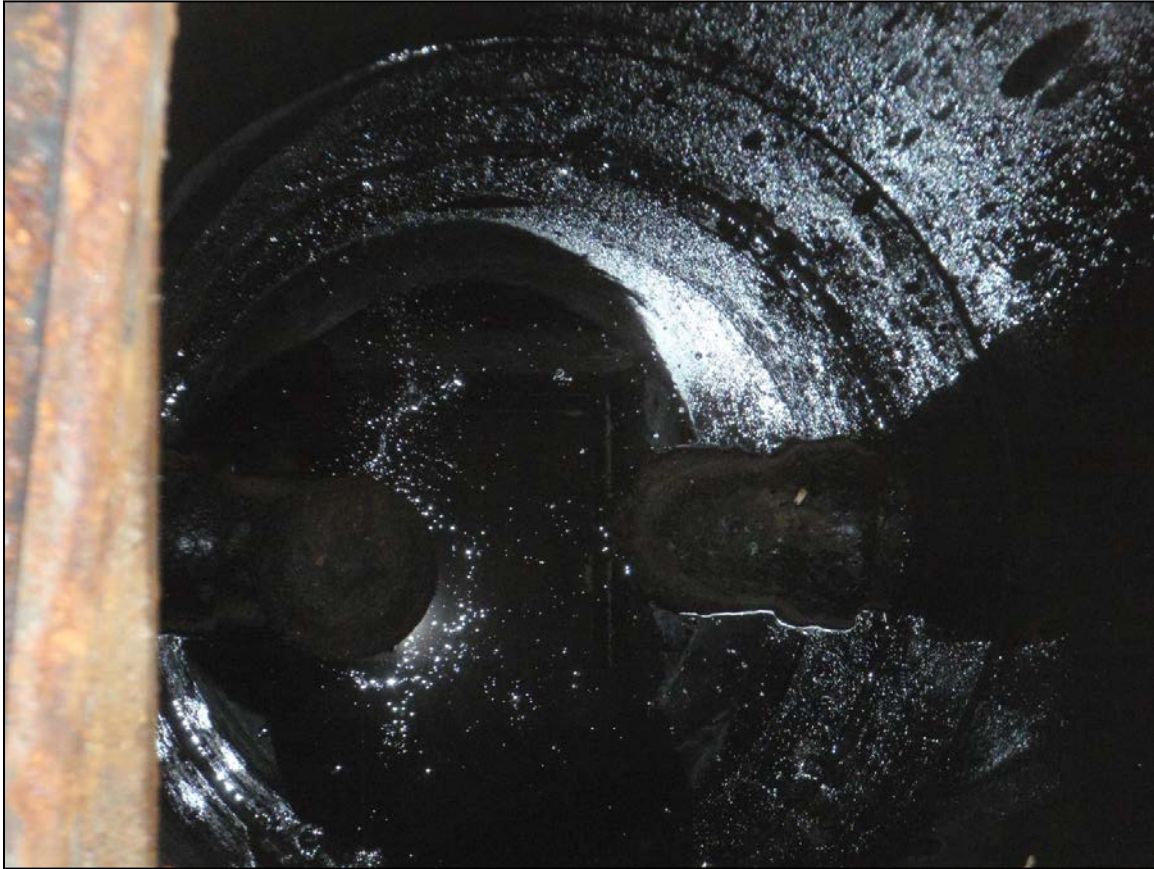
CC-RVAAP-74	Bldg 1034 Hydraulic Lift	Photograph Number: 004
Date: 08/31/2011	Direction of View: South	Photographer: Corey Pacer (SAIC)
Description: Photograph to document remnant site features of the former hydraulic lift in Building 1034. This photograph documents the condition of the former oil/water separator sump pit. This sump pit is approximately 12 ft deep with some water present in the pit.

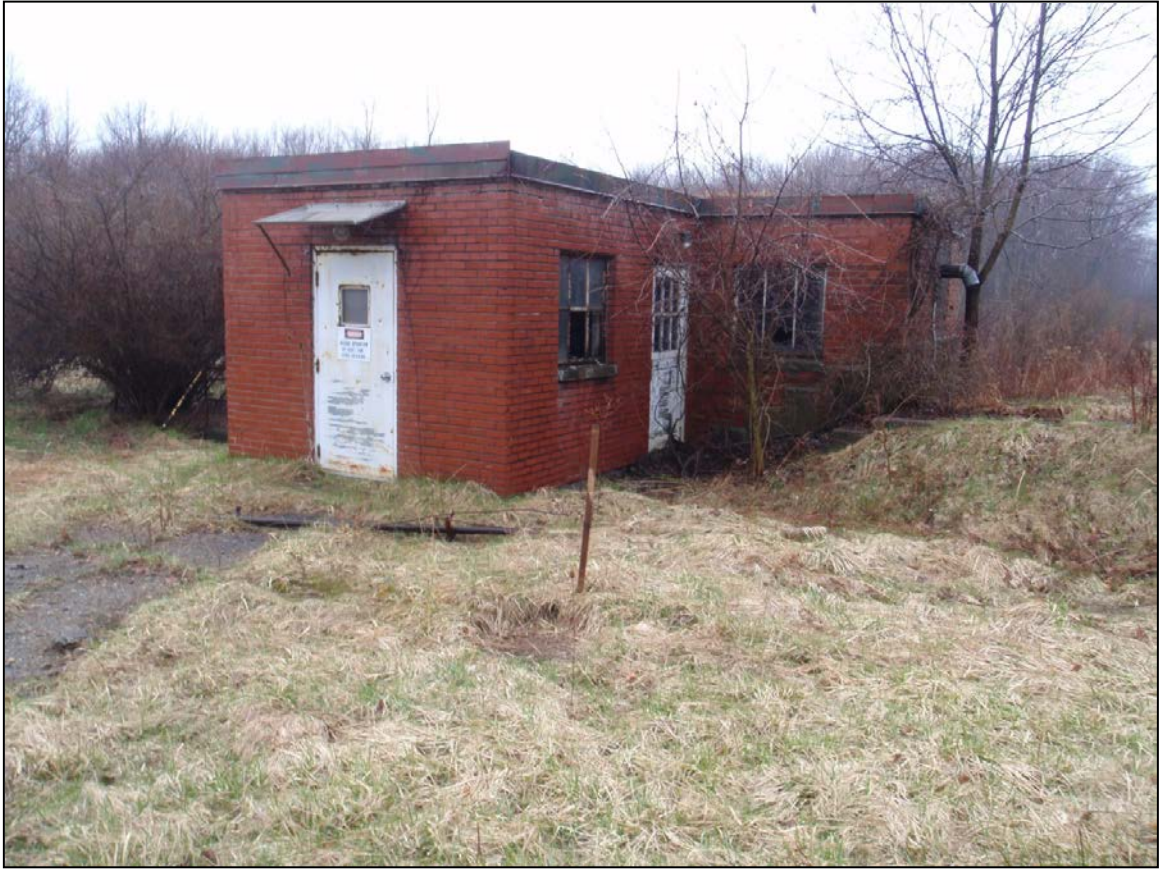
CC-RVAAP-75	George Road Sewage Treatment Plant	Photograph Number: 001
Date: 4/08/2011	Direction of View: West	Photographer: Amanda Trenton (SAIC)
Description: Photograph to document the George Road Sewage Treatment Plant main building where the suspected mercury spill occurred. The staked item in the center of the photograph is sanitary manhole MH-P1.

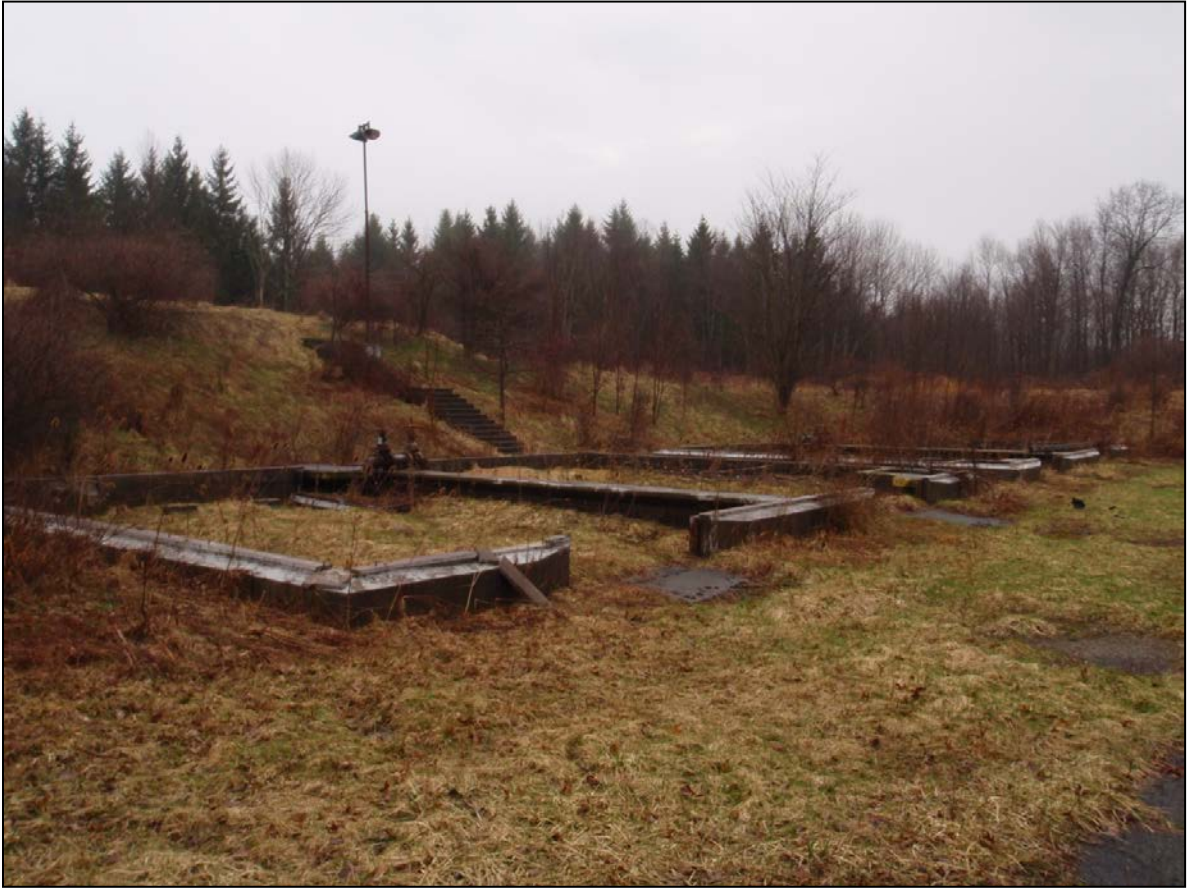
CC-RVAAP-75	George Road Sewage Treatment Plant	Photograph Number: 002
Date: 4/08/2011	Direction of View: Northeast	Photographer: Amanda Trenton (SAIC)
Description: Photograph of the former sludge drying basins at the George Road Sewage Treatment Plant.

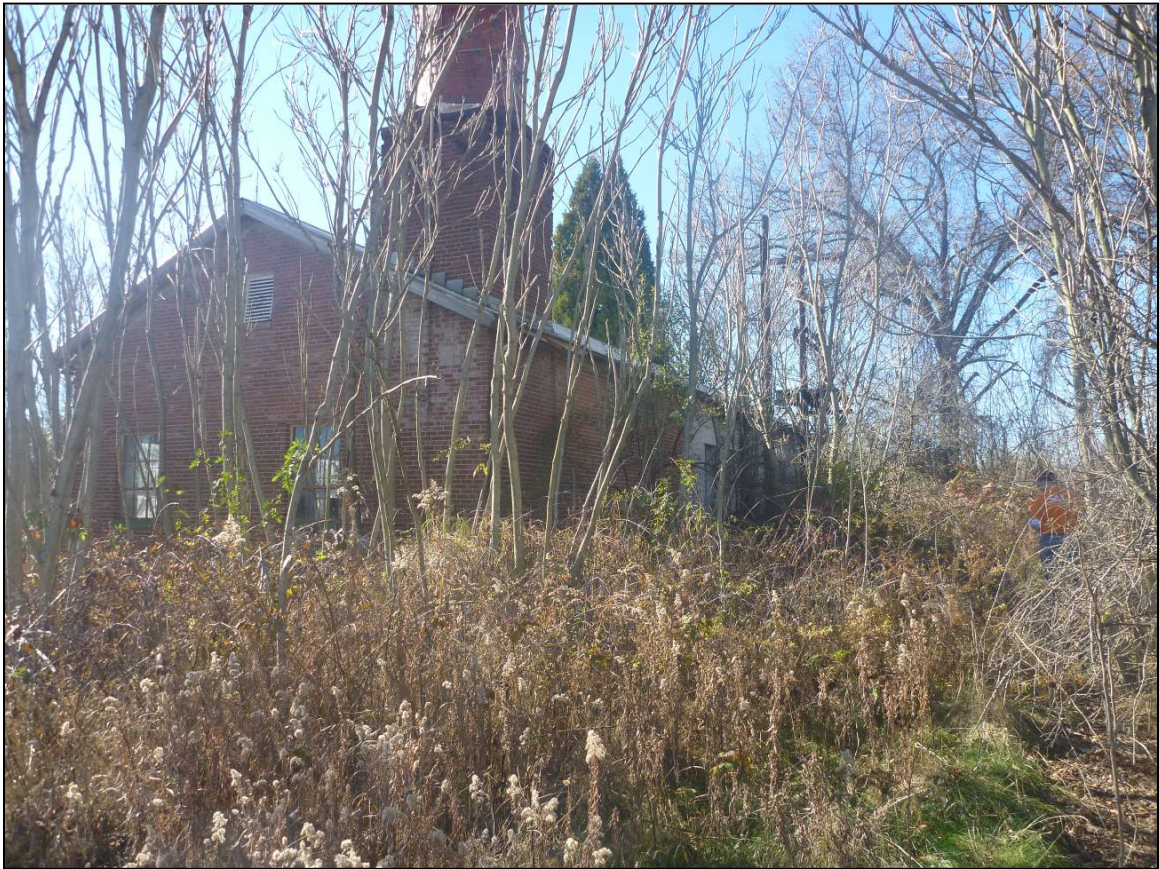
CC-RVAAP-76	Depot Area	Photograph Number: 001
Date: 11/12/2010	Direction of View: West	Photographer: Corey Pacer (SAIC)
Description: Photograph of the Bolton Milk House, Building A-1, at the Ravenna Army Ammunition Plant.

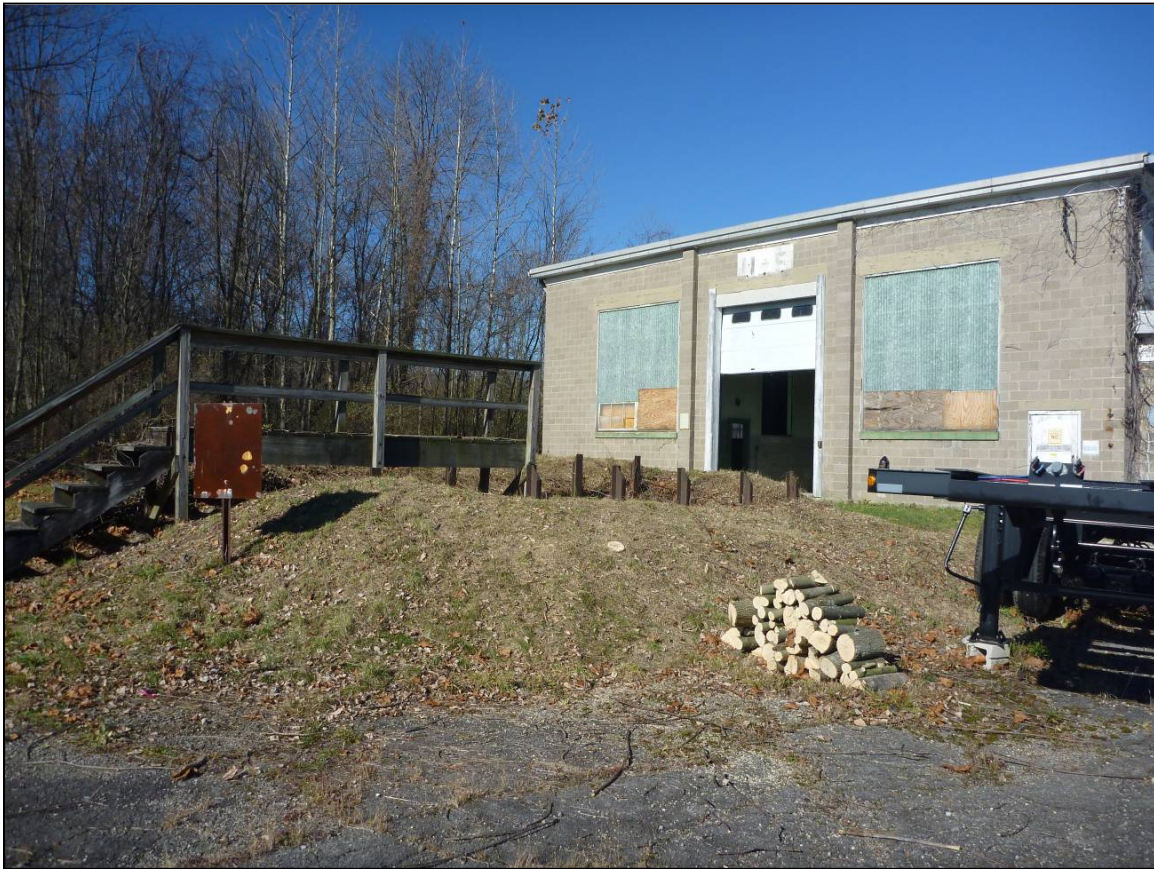
CC-RVAAP-76	Depot Area	Photograph Number: 002
Date: 11/10/2010	Direction of View: Northwest	Photographer: Corey Pacer (SAIC)
Description: Photograph of Building U-5 and the former location of the AST and earthen berm located on the south side of the building. Stanchions from the AST are still present.

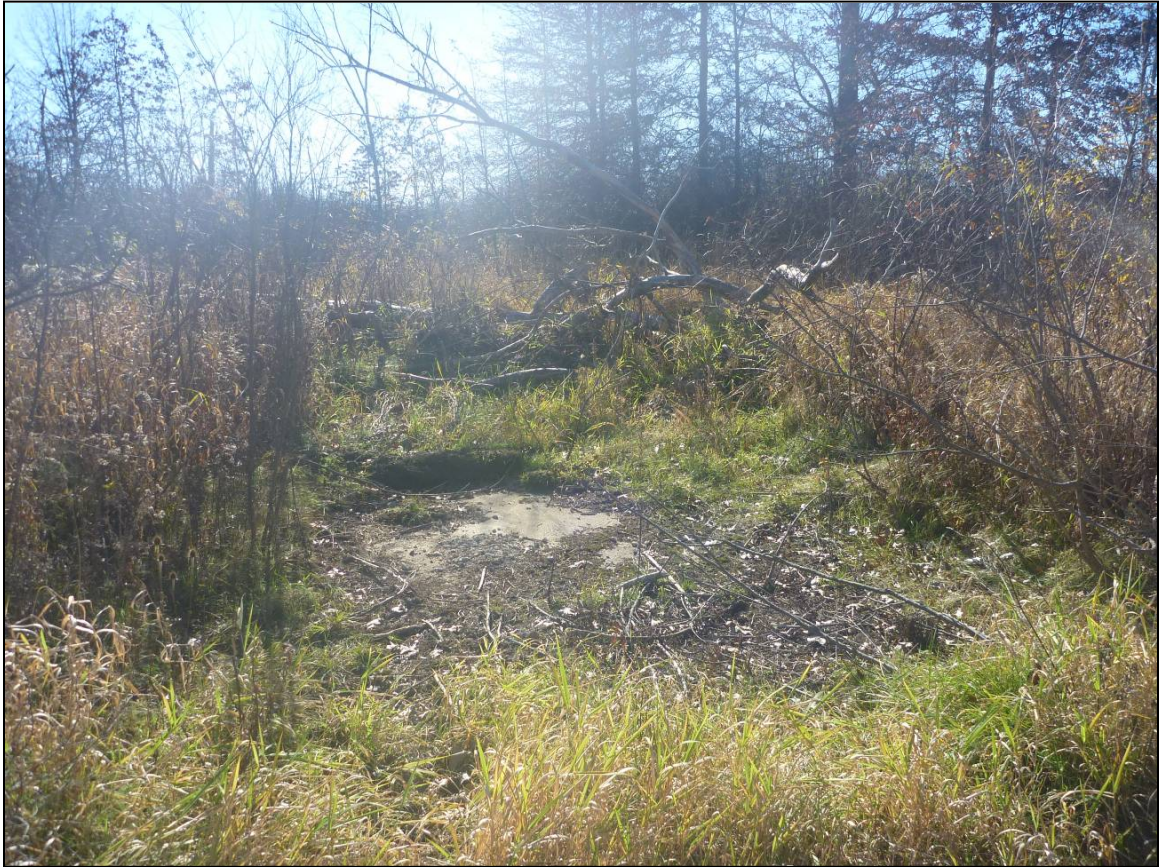
CC-RVAAP-76	Depot Area	Photograph Number: 003
Date: 11/12/2010	Direction of View: Northwest	Photographer: Corey Pacer (SAIC)
Description: Photograph of concrete building slab at Building U-13. No evidence of stressed vegetation at the former building.

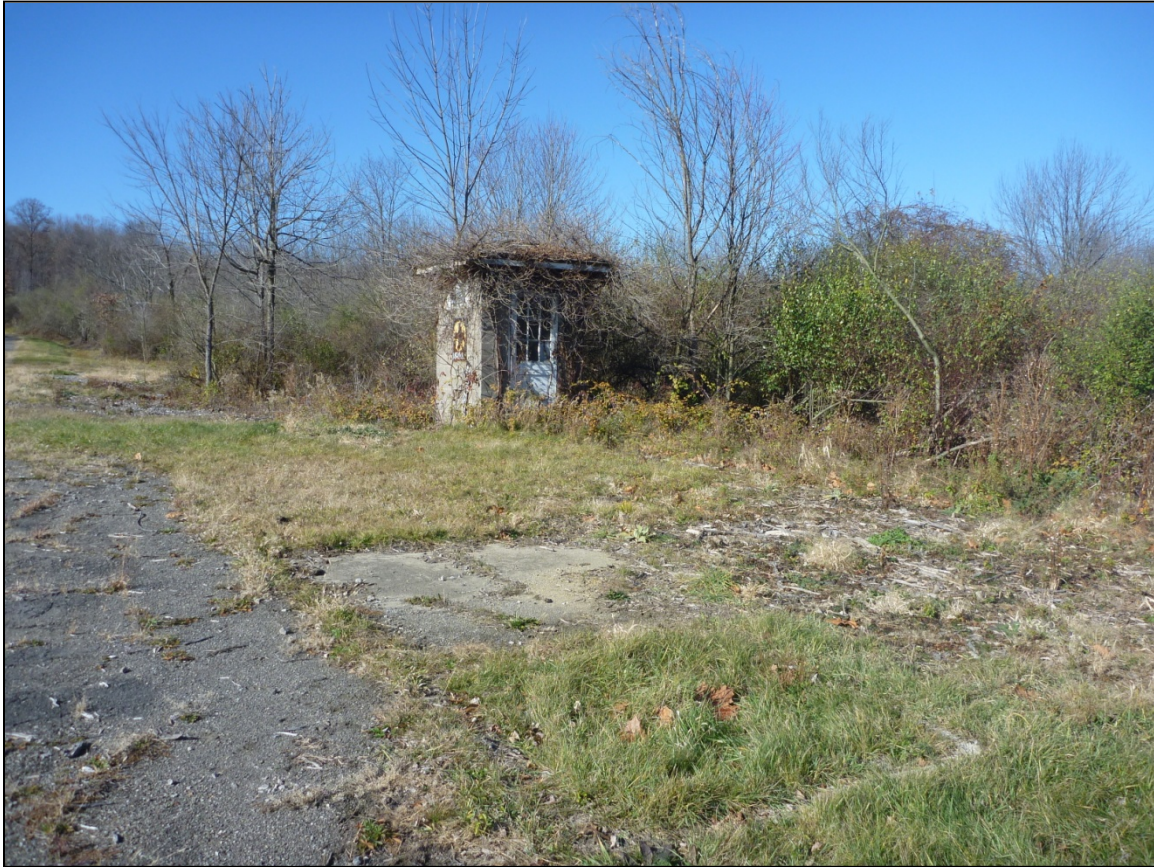
CC-RVAAP-76	Depot Area	Photograph Number: 004
Date: 11/12/2010	Direction of View: Northwest	Photographer: Corey Pacer (SAIC)
Description: Photograph of Building U-6, the former diesel fuel station. USTs have been removed. No evidence of stressed vegetation at the former building.

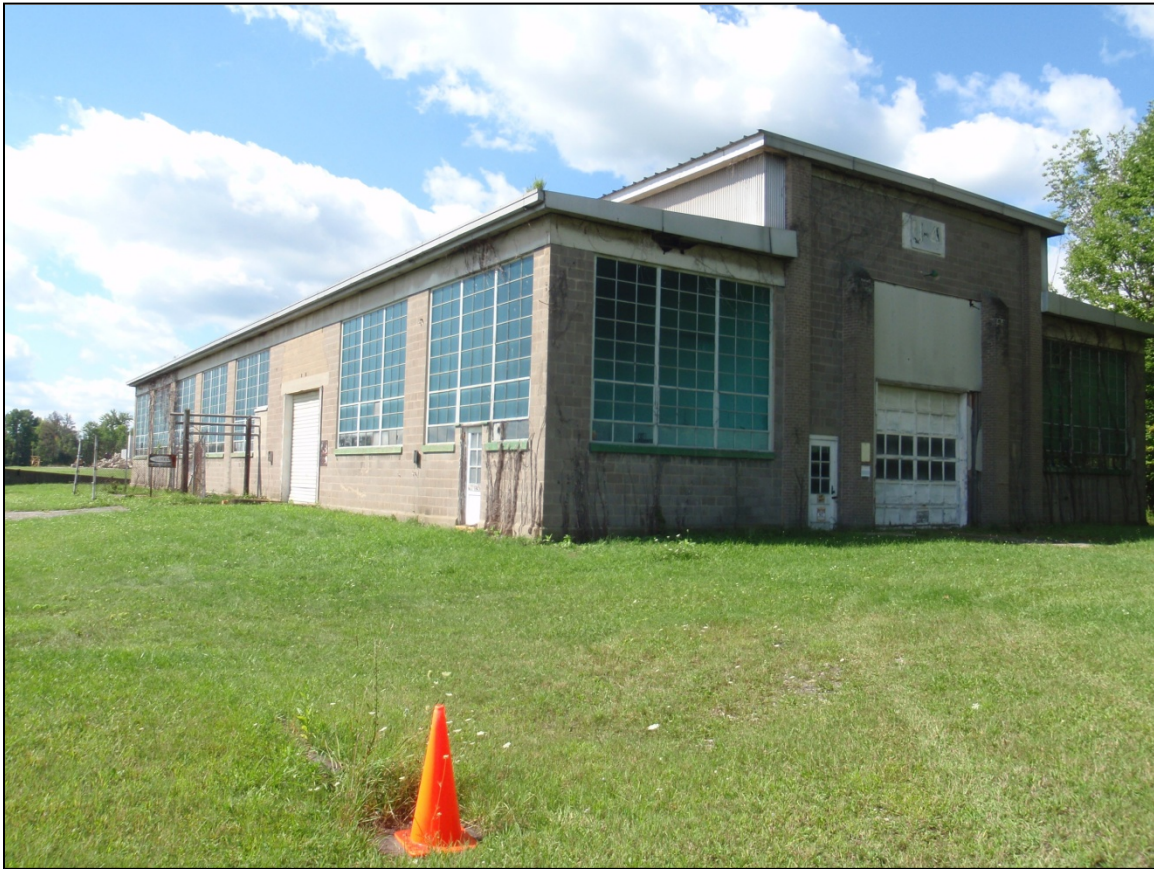
CC-RVAAP-76	Depot Area	Photograph Number: 005
Date: 11/12/2010	Direction of View: Southwest	Photographer: Corey Pacer (SAIC)
Description: Photograph of Building U-4. No evidence of stressed vegetation or MEC at the building. OHARNG currently uses this building for ongoing activities.
