Appendix M
Property Visit Photographs

CC-RVAAP-68
Electric Substations (East, West, and No. 3)

**COMPLIANCE RESTORATION SITES
RAVENNA ARMY ANNUNITION
PLANT - RAVENNA, OHIO**

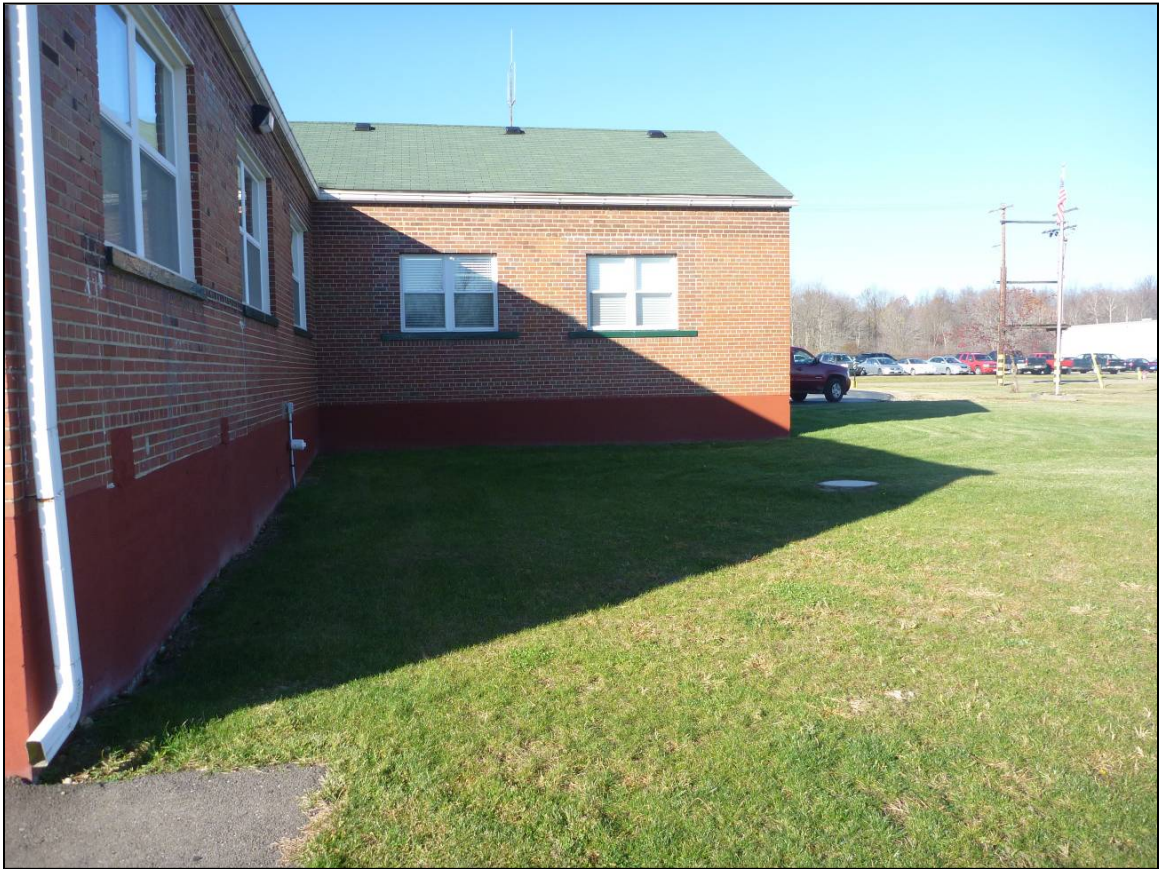
CC-RVAAP-77	Laundry Waste Water Sump	Photograph Number: 001
Date: 11/12/2010	Direction of View: West	Photographer: Corey Pacer (SAIC)
Description: Photograph to document the location of the former laundry waste water sump at Building 1037. The white circle (concrete) documents the location of the former sump.

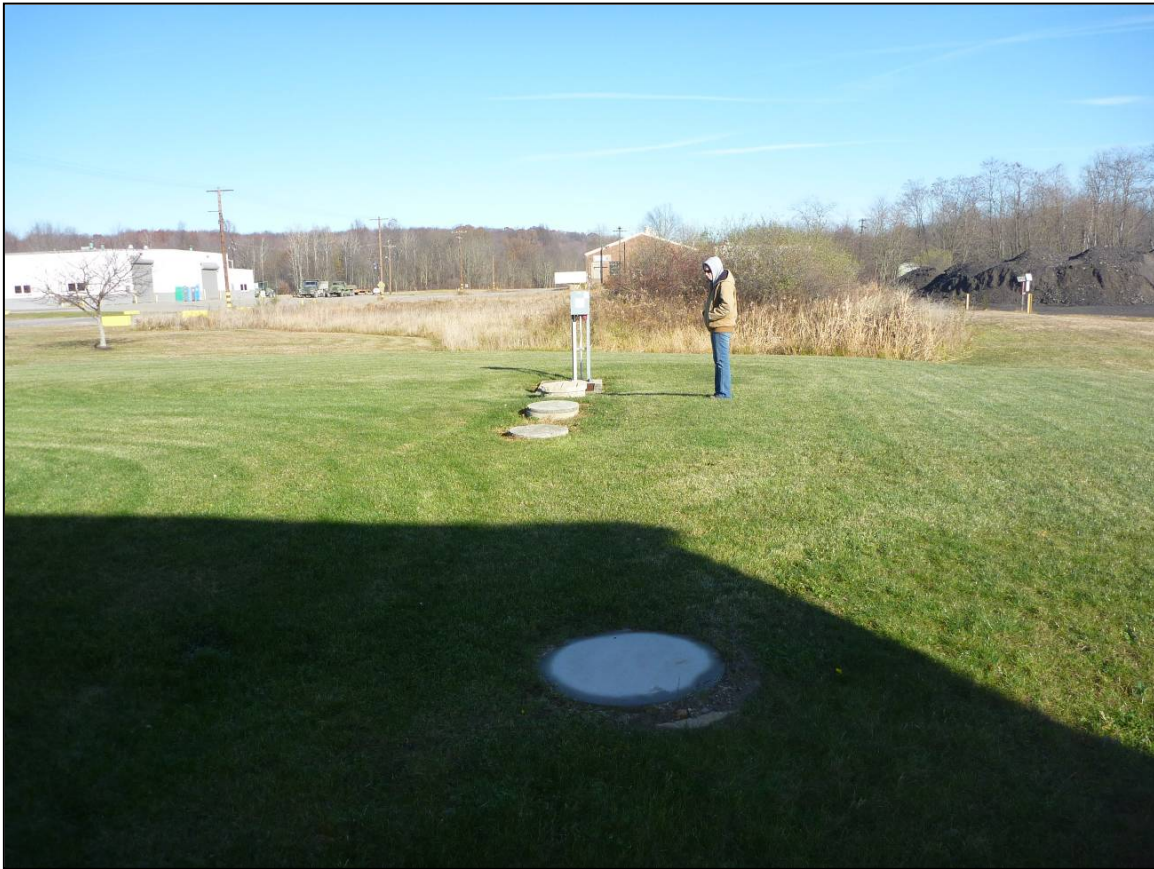
CC-RVAAP-77	Laundry Waste Water Sump	Photograph Number: 002
Date: 11/12/2010	Direction of View: North	Photographer: Corey Pacer (SAIC)
Description: Photograph to document the location of the former laundry waste water sump at Building 1037. The white circle (concrete) in the foreground documents the location of the former sump. The concrete circles in the background are current systems that are not associated with the laundry building.
