QUARTERLY EFFECTIVENESS EVALUATION REPORT (#3)

**O & M TRIP's #8, #9, #10
(HIGH FLOW INSPECTION) & #11**

Quarterly Effectiveness Evaluation Report #3
Sand Creek Barrier System
Time Critical Response Action (TCRA) for the Rocket Ridge Area of
Open Demolition Area #2

Project No:	W912QR-09-C-0084	QEE Report No:	Vista 03
Date of QEE Site Visit:	6-21-11		
Time Period Covered by QEE Report:	From 4-26-11		
	To: 6-21-11		
Dates of O&M Trip During Period Covered by QEE Report:	4-26-11 #8		
	5-24-11 #9	6-2-11 #10 (High Flow Inspection)	
	6-21-11 #11

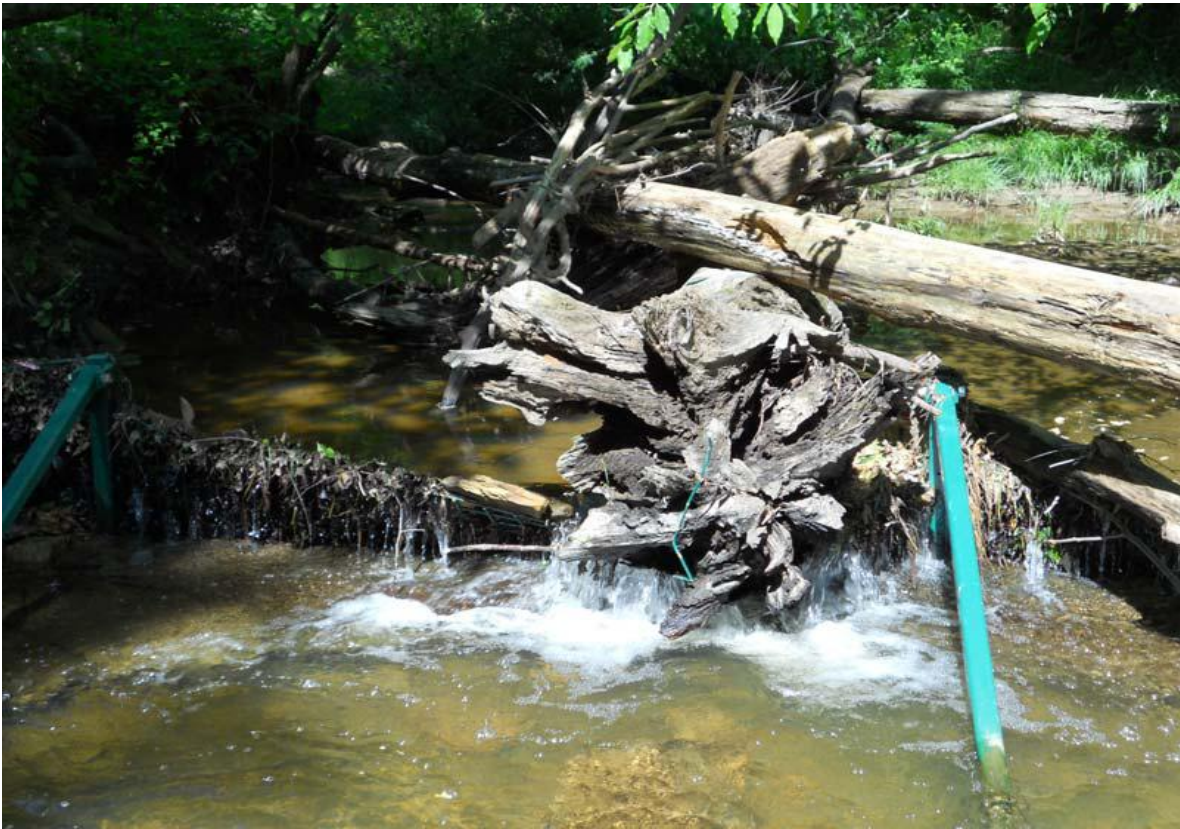
During the 6-2-11 High Water Flow Inspection several trees and deposits of sand stone were found. This had damaged the barriers. The trees and sand stone were removed and the barriers were repaired to their original condition. (See attached photos.)

PICTURES SHOWING DAMAGE TO BARRIERS.

Maintenance performed: Removed all materials from screens. Repaired barriers in June, 2011.

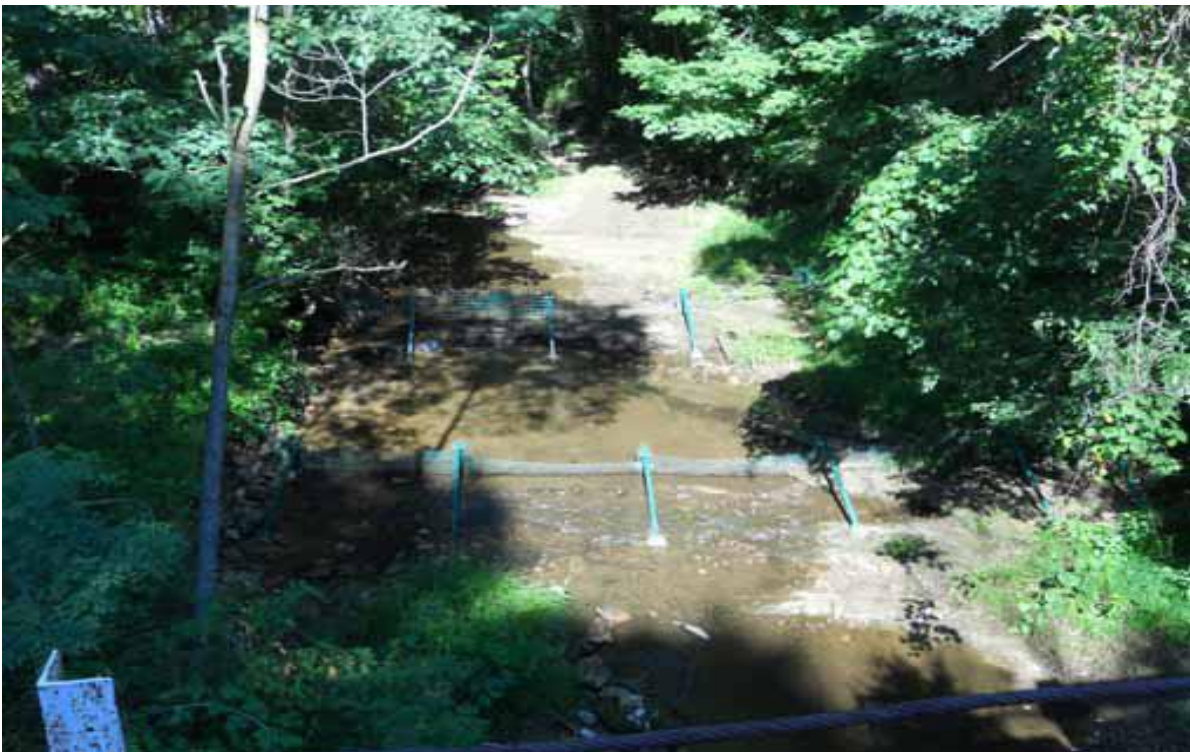
All barrier components are intact and solidly anchored. Most screen panels are bowed due to water pressure building up when water flow is limited because of debris build up. (See photos.)

The deflection in the screen panels does not limit the effective performance of the barrier system.

PICTURES SHOWING BARRIERS UPON DEPARTURE.
