APPENDIX M
SEWER LINE VIDEO SURVEY REPORT

Sanitary Sewer

Storm Sewer

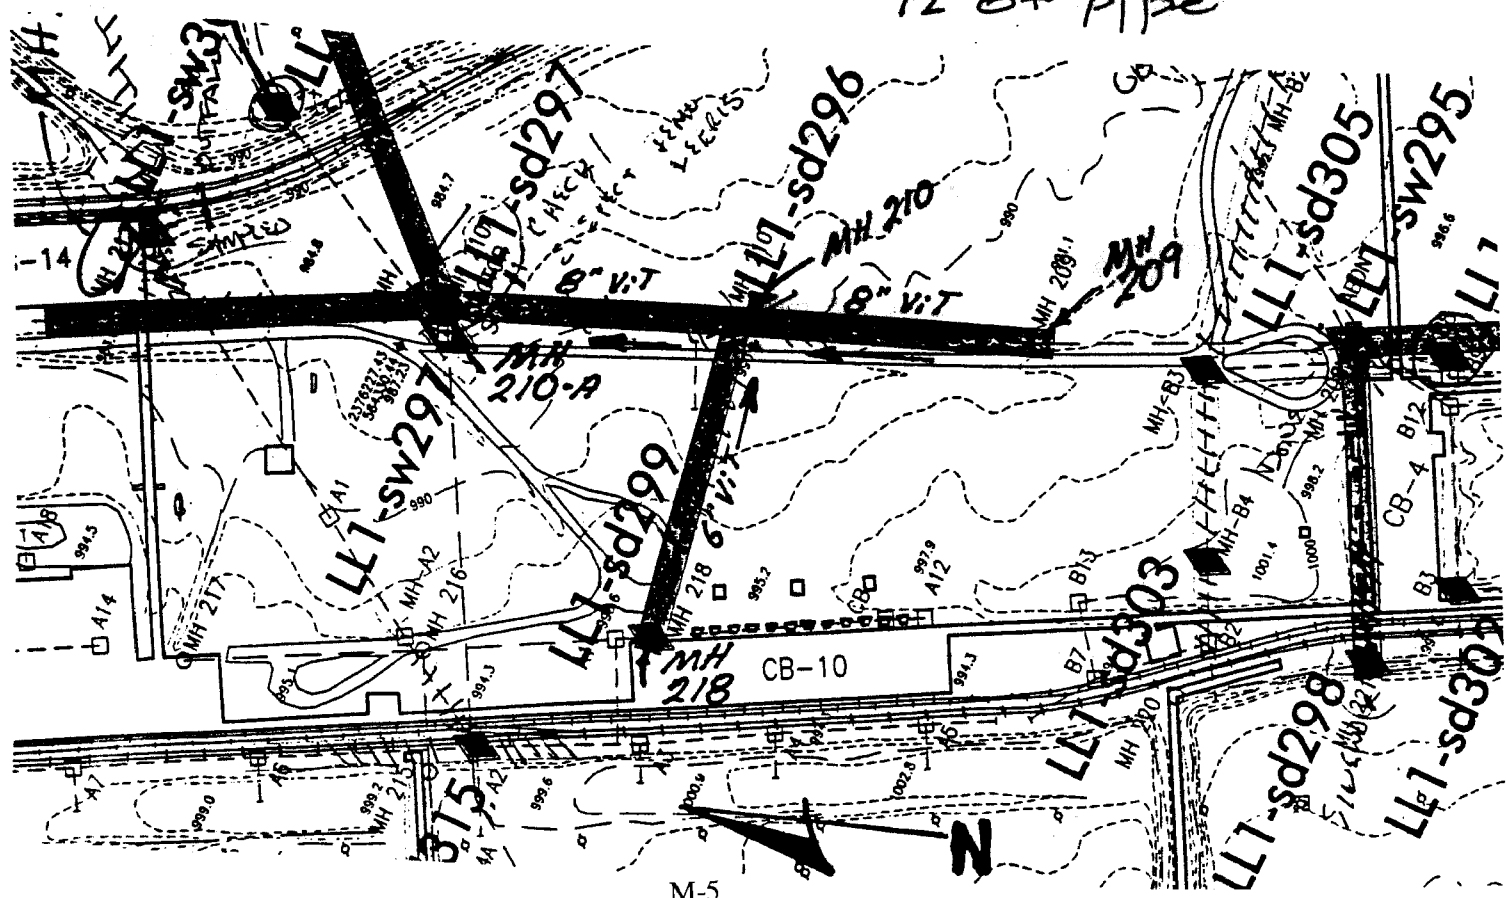
Condition Being Investigated: General Condition MH 210 ↑ at drop

Footage	Remarks	Footage	Remarks
27	MH 211 U.S. to MH 209 <i>(Note: MH 211 should be MH 210)</i>	71	Lt. Roots
27	Lt. Roots	75	Offset Jt / Slight Crack
40	Hairline Crack	77	Mortar Dep @ Jt.
43	Dip in Line	80	Deposit @ Jt.
50	Calcium / Mortar Dep.	84	Deposit @ Jt.
62	Calcium / Mortar Dep	86	Deposit
68	Slight Offset Jt.	184	Heavy Roots

✶ 190 Too MANY ROOTS
 COULD NOT PASS
 ROOTS COVER OVER
 1/2 of pipe

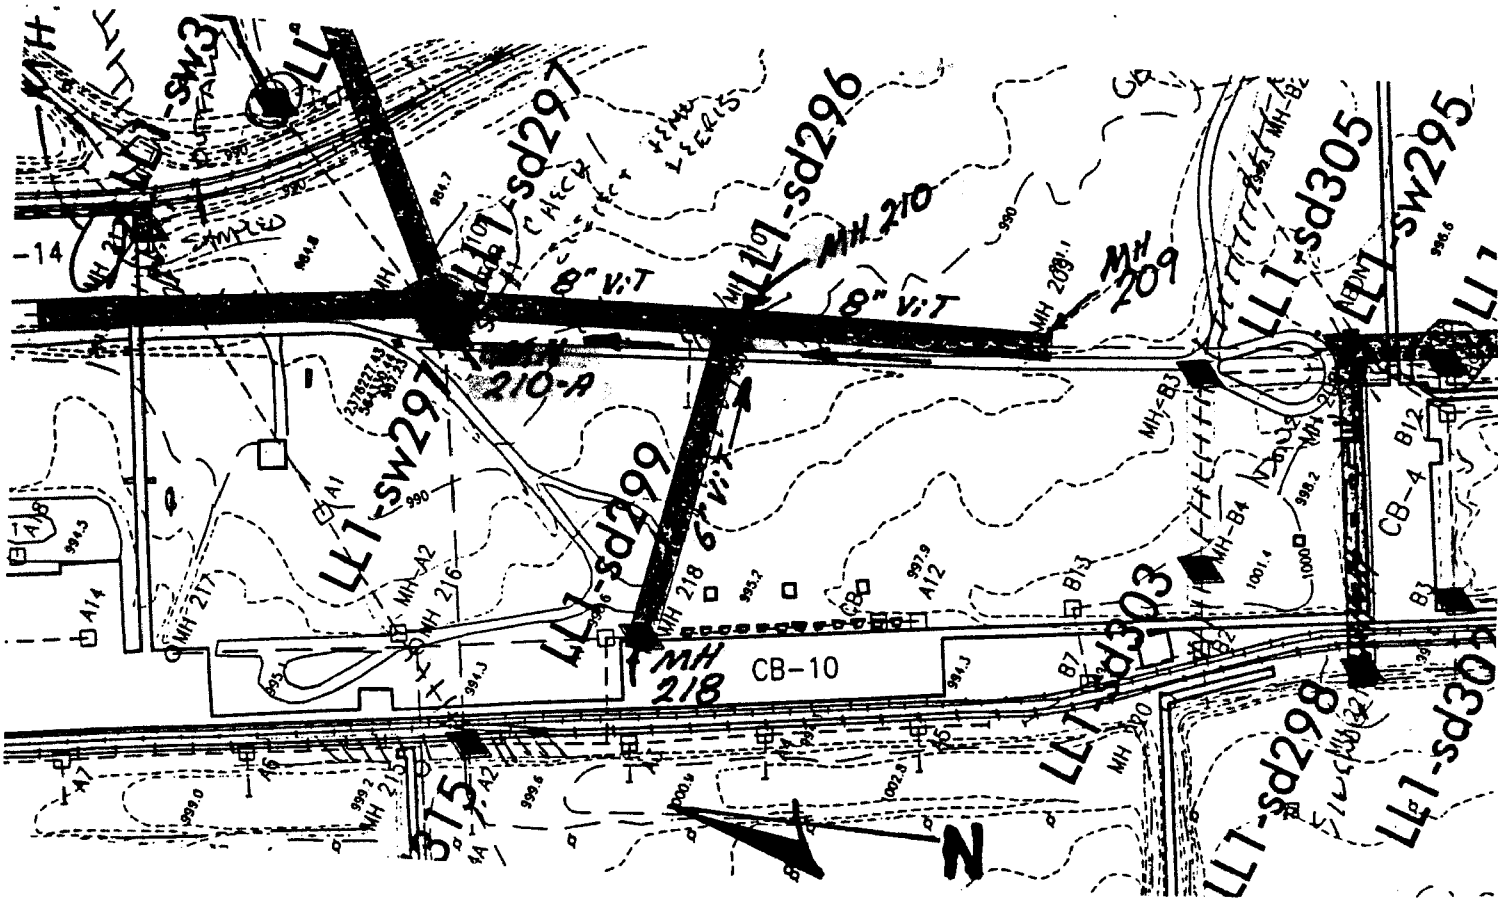
Footage	Remarks	Footage	Remarks
0	MH 210 DS to 210A	0	MH 210 to 218
3	2" offset st.	2	6" LINE - this is
6	3" offset st. 3" HIGH		a high line
	COULD NOT GO		could not do
	FURTHER

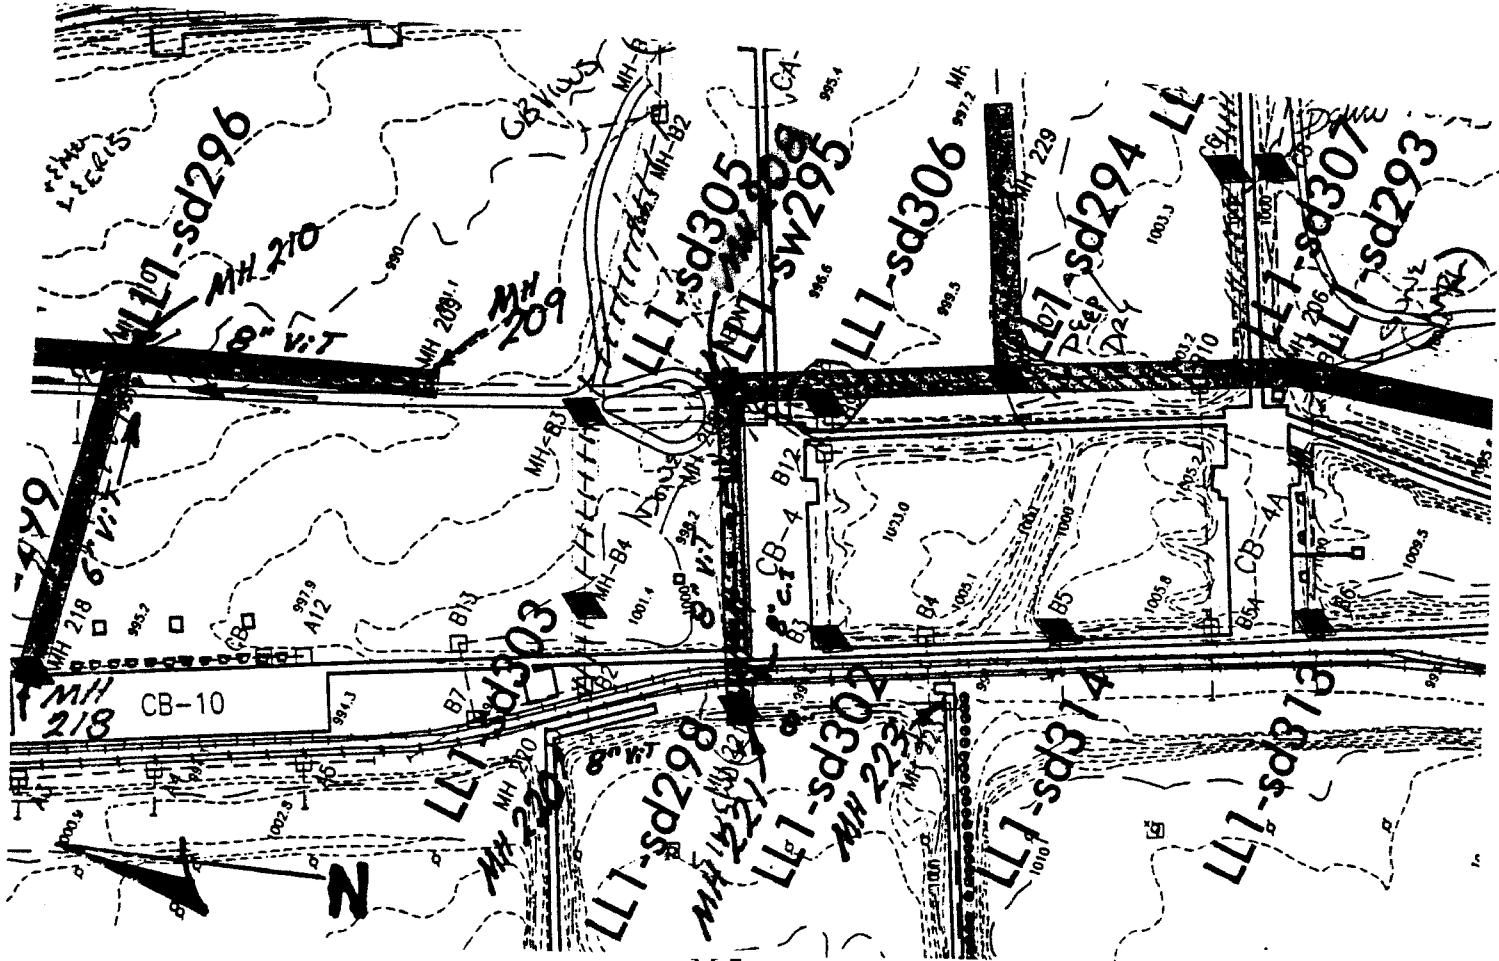
Footage	Remarks	Footage	Remarks
032	MH 221 - 208		
32	Cast Iron Changes from Cast Iron to Clay		
38	Morton Deposits		
45	Morton Deposits		
55	— Decided to stop tape - seen enough.

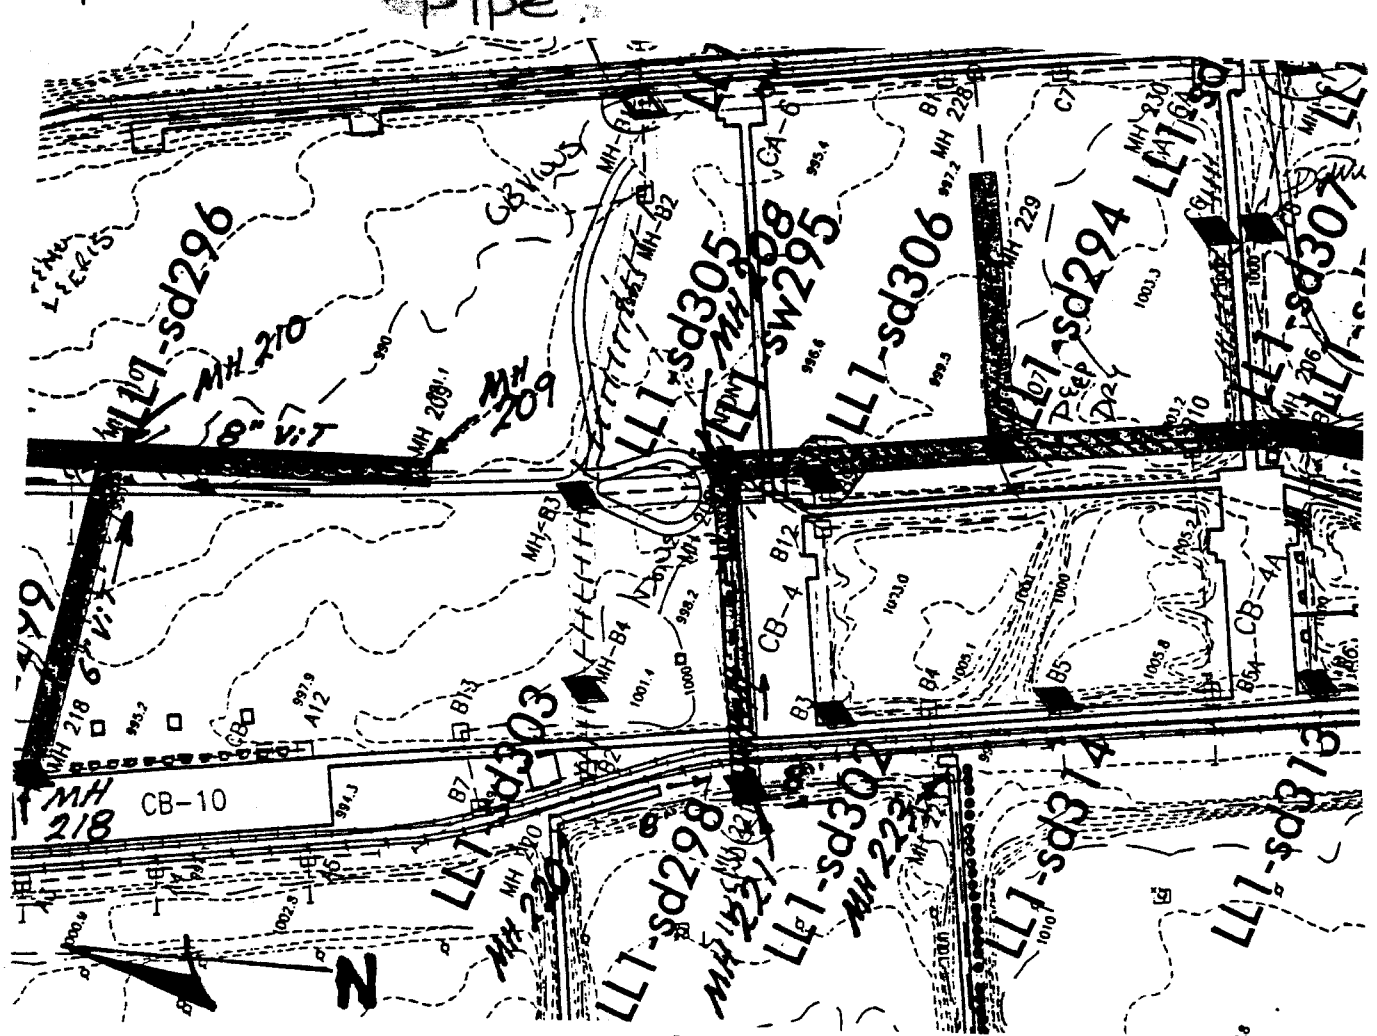
Footage	Remarks	Footage	Remarks
0	MH 221 to MH 222 (MH-223)		
16	Slight Cracks		
22	Mortar Deposits		
41	Offset Str / Cracks		
50	STOP TV'ing - Decided we had seen enough Pipe.

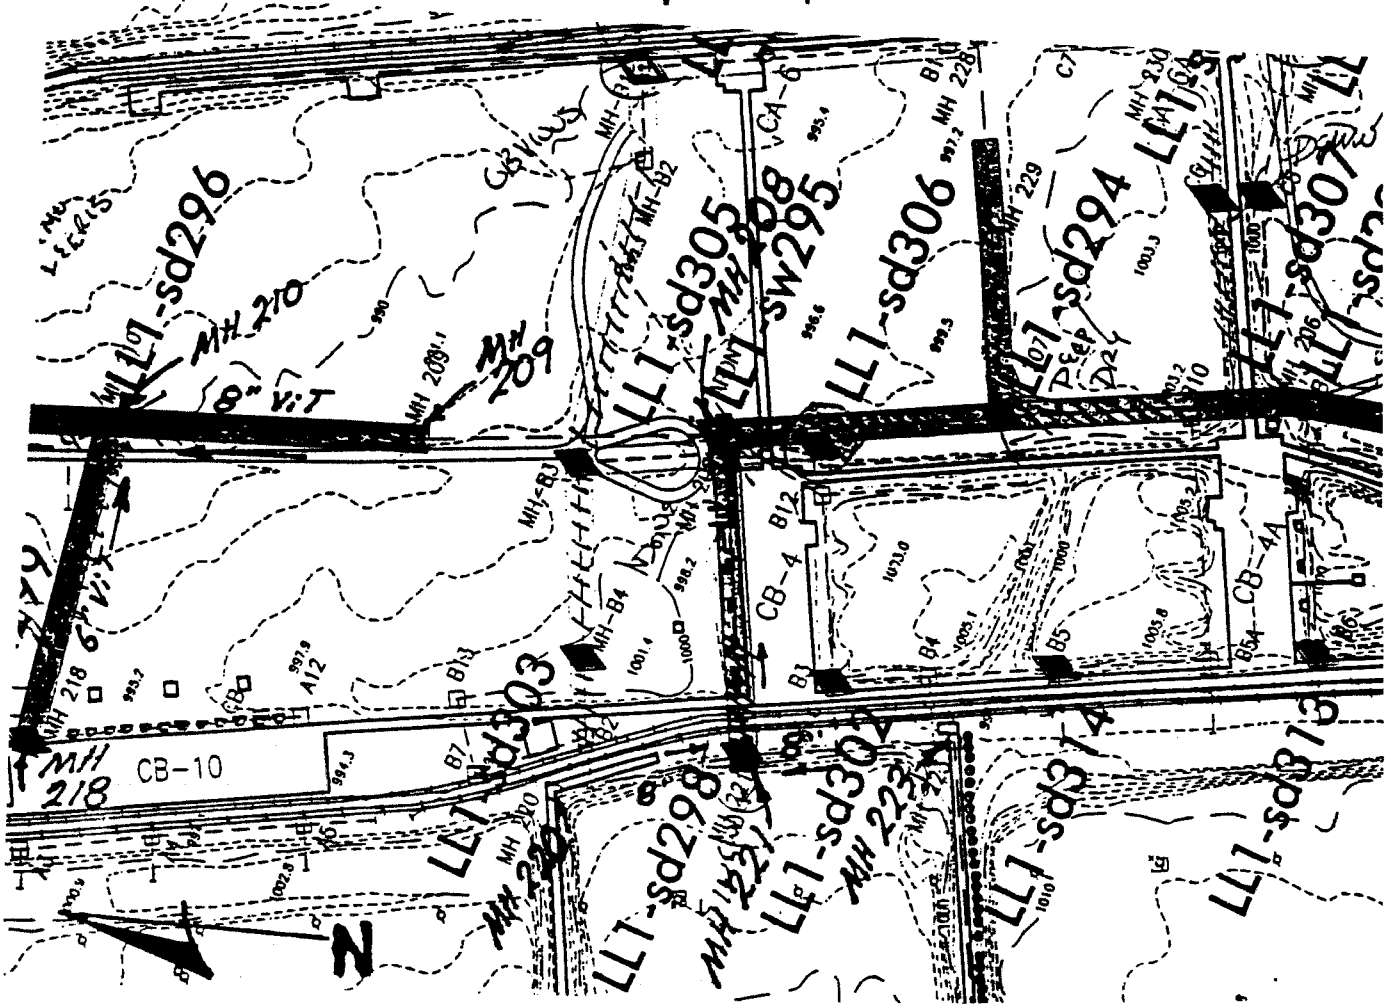
Footage	Remarks	Footage	Remarks
0	MH 221 / 220		
1	Roots		
15	Heart Debris - Pulled out could not go any further

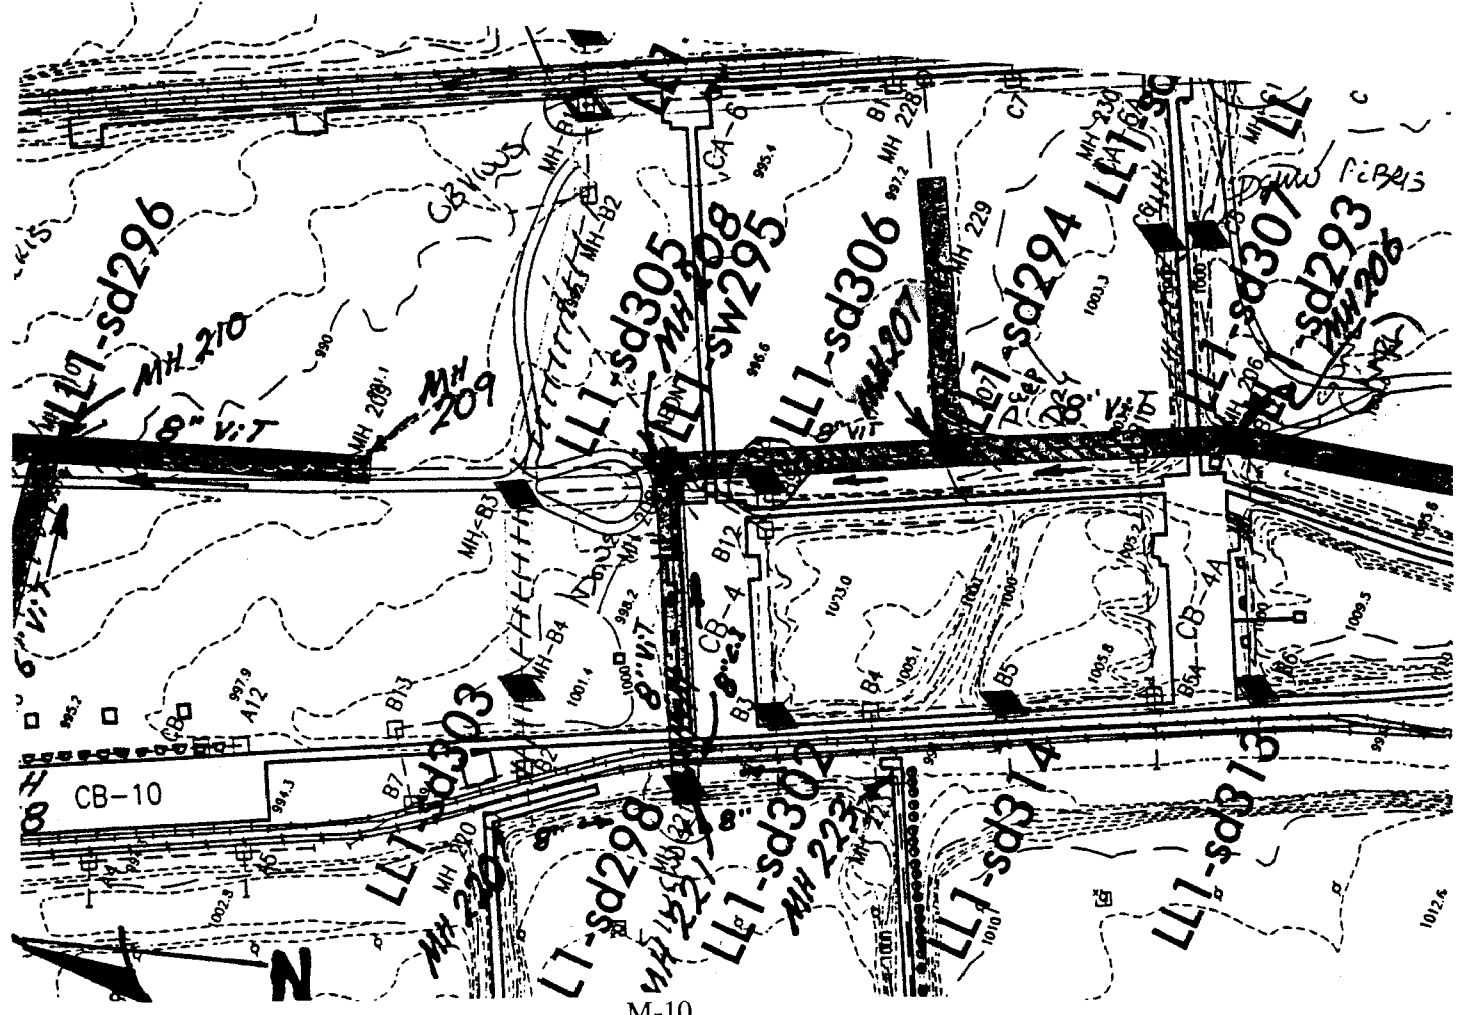
Footage	Remarks	Footage	Remarks
0-6	MH 207 U.S. to 206		
	Too much debris		
	LOST CONNECTION

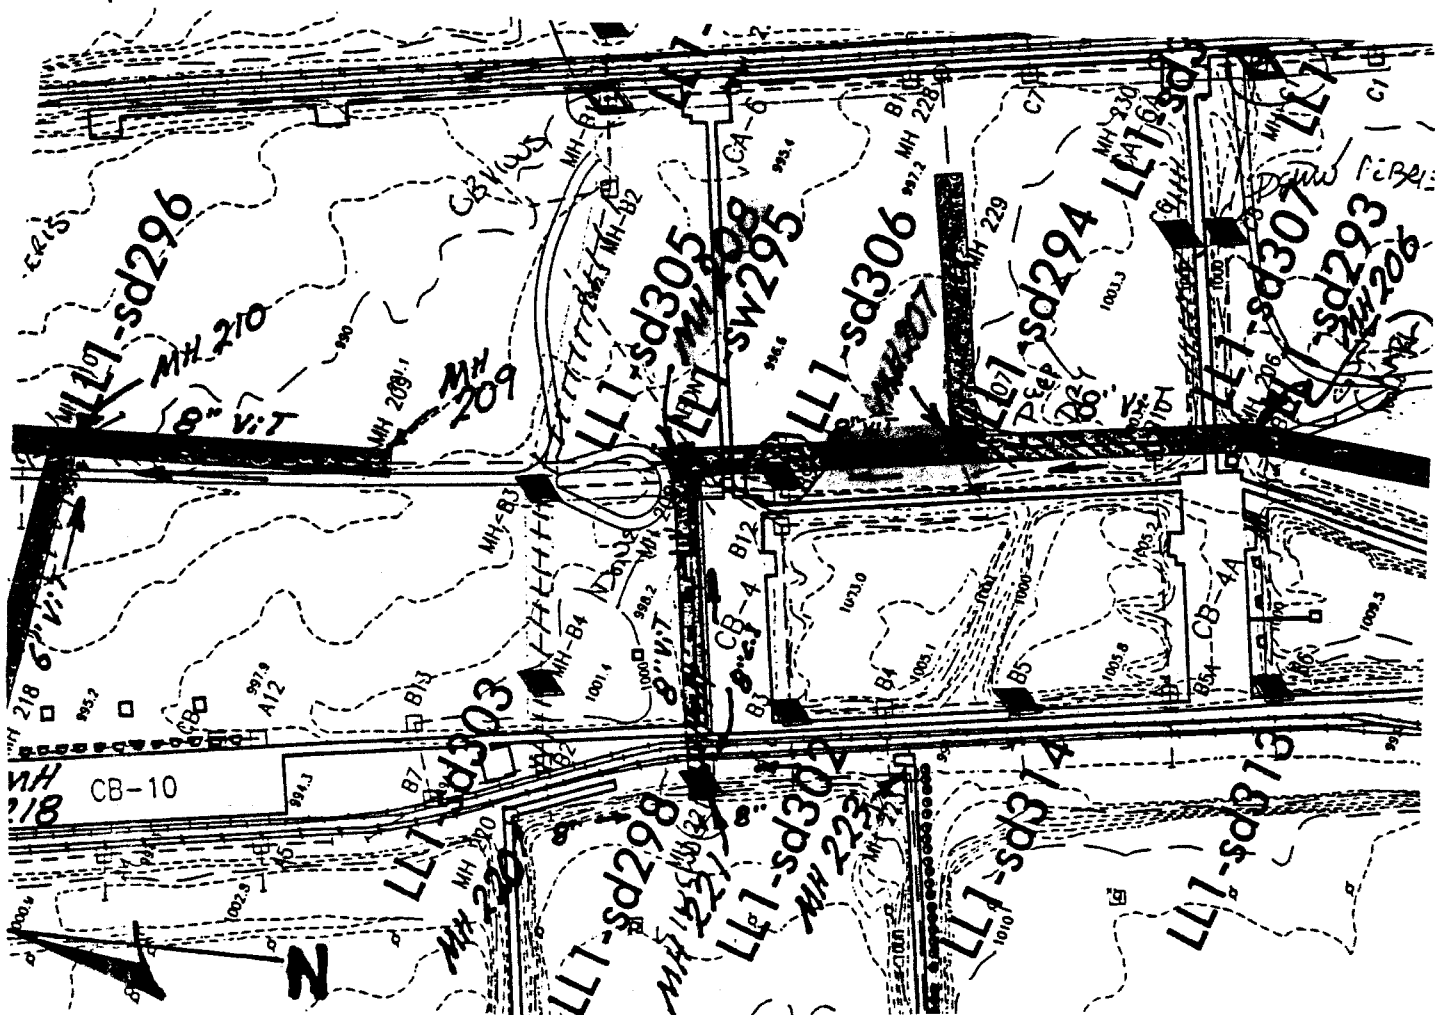
Footage	Remarks	Footage	Remarks
8	MH 207 DS to 208	97	Mortar @ Jt.
10	Mortar Deposit		STOP
51	Belly / Dip in Line		Decided we had
52	Medium Debris		seen enough
56	Medium Debris		
76	Medium Debris		
82	Heavy Debris

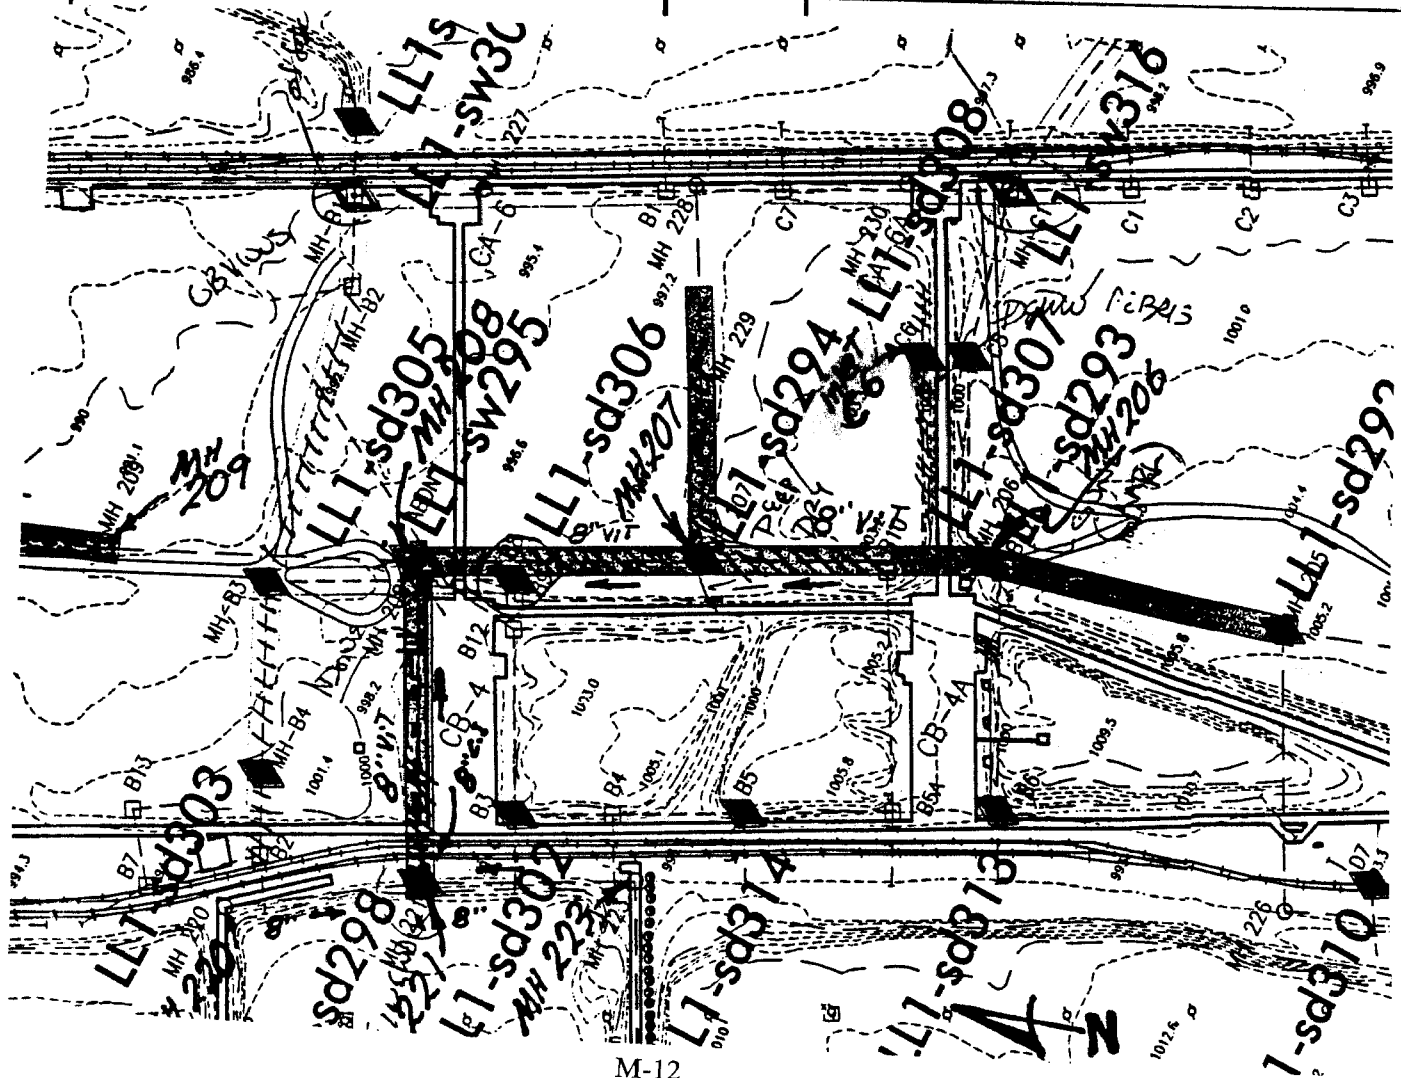
Footage	Remarks	Footage	Remarks
0	Inlet C6 to CBAA		
5	COULD NOT CONTINUE TRASH DEBRIS

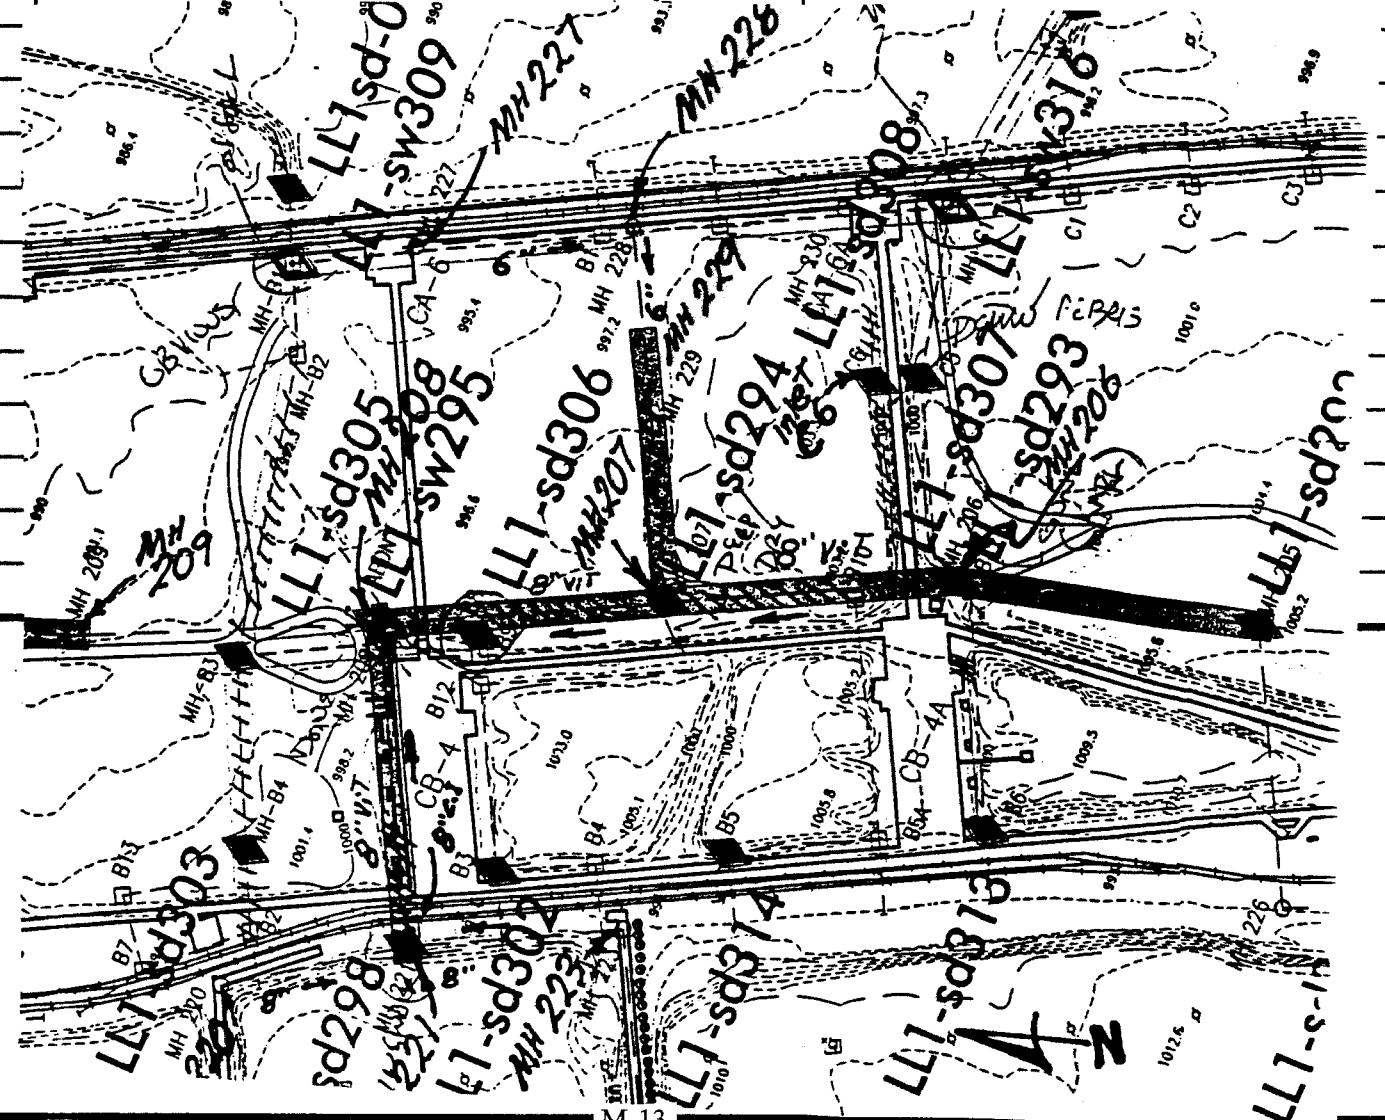
Footage	Remarks	Footage	Remarks
0	MH 228 headed west to MH 229		
3'	THREE BRICK OR ROCK		
	COULD NOT PASS

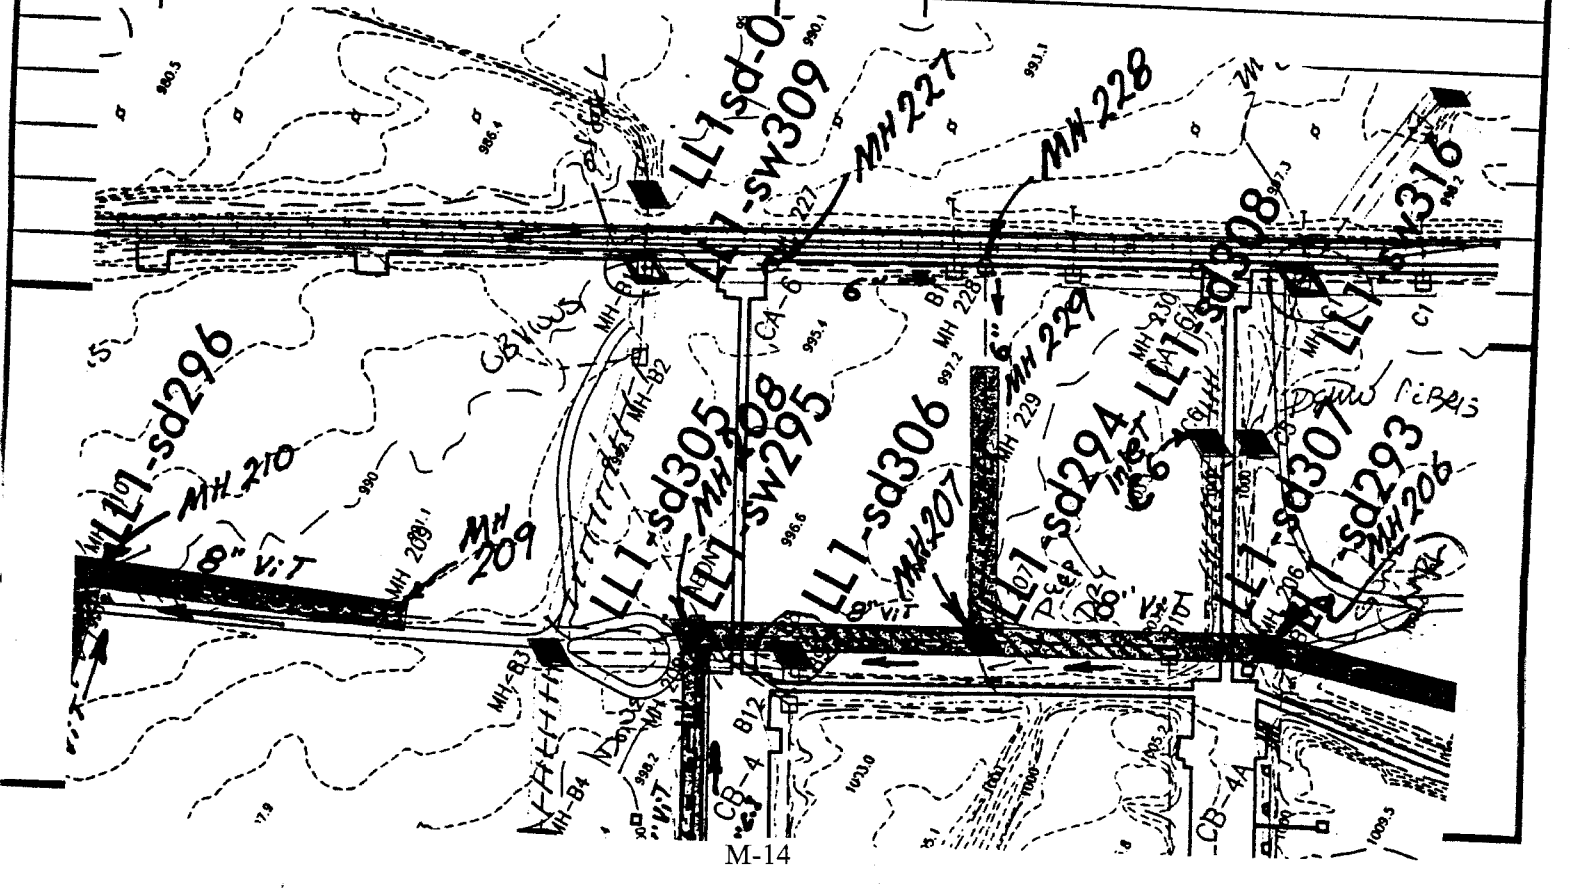
Footage	Remarks	Footage	Remarks
0	MH 228 headed north to MH 227		
1	- Large amount of debris built up in invert		
32	Mortar Deposit		
45	Mortar Deposit		
52	Mortar Deposit		
	- Could NOT PUSH SMALL CAMERA ANY FURTHER -

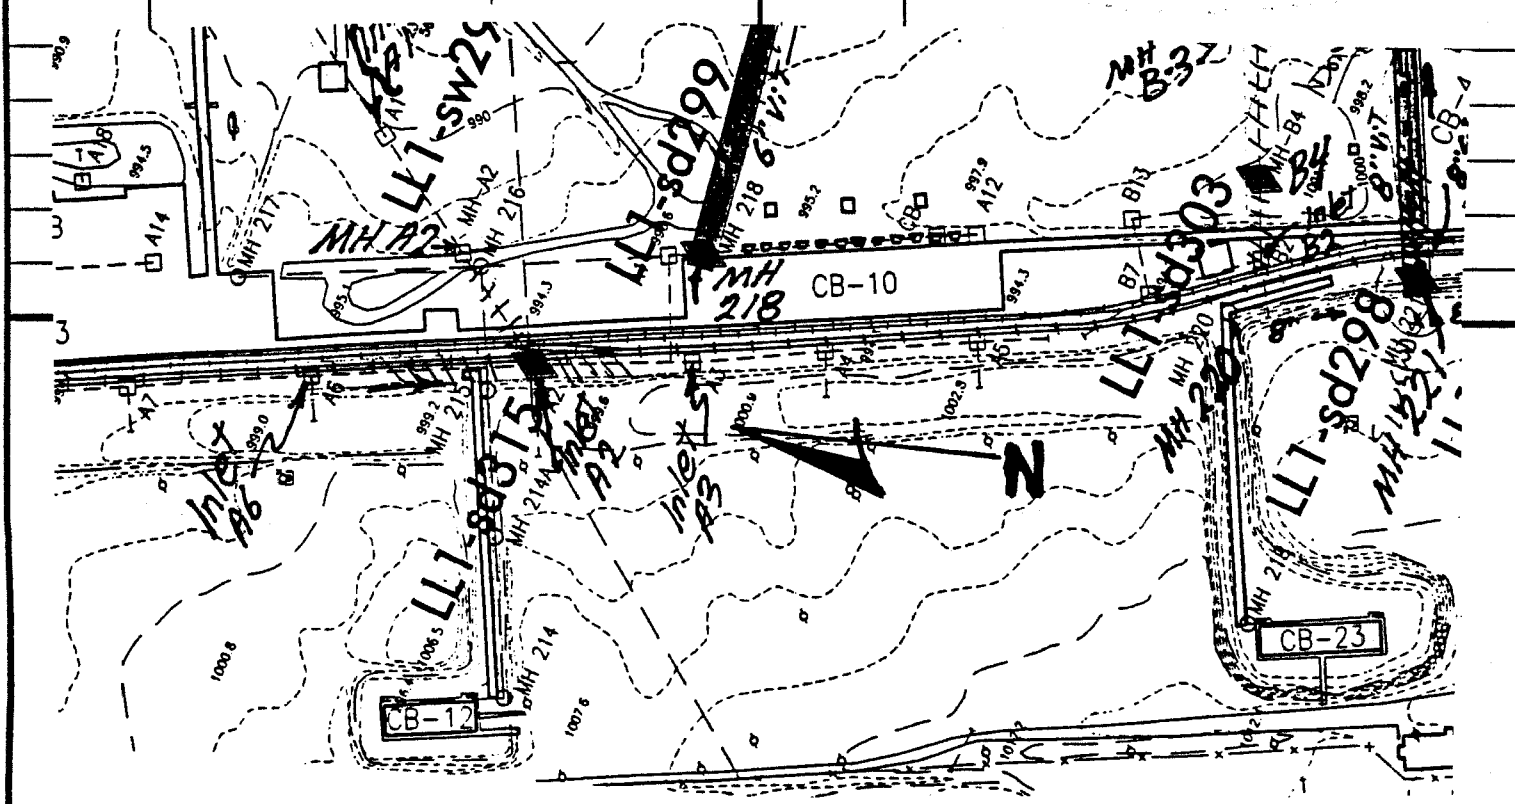
Footage	Remarks	US	Footage	Remarks
0	Inlet A2 to Inlet A6			
10	Large Debris			
24	STRESS CRACK			
35	Medium Debris			
42	Medium Debris			
52	STRESS CRACK			
61	Metal in Pipe			
64	STRESS CRACK			
118	STRESS CRACK			
131	STRESS CRACK			
156	Inlet A6

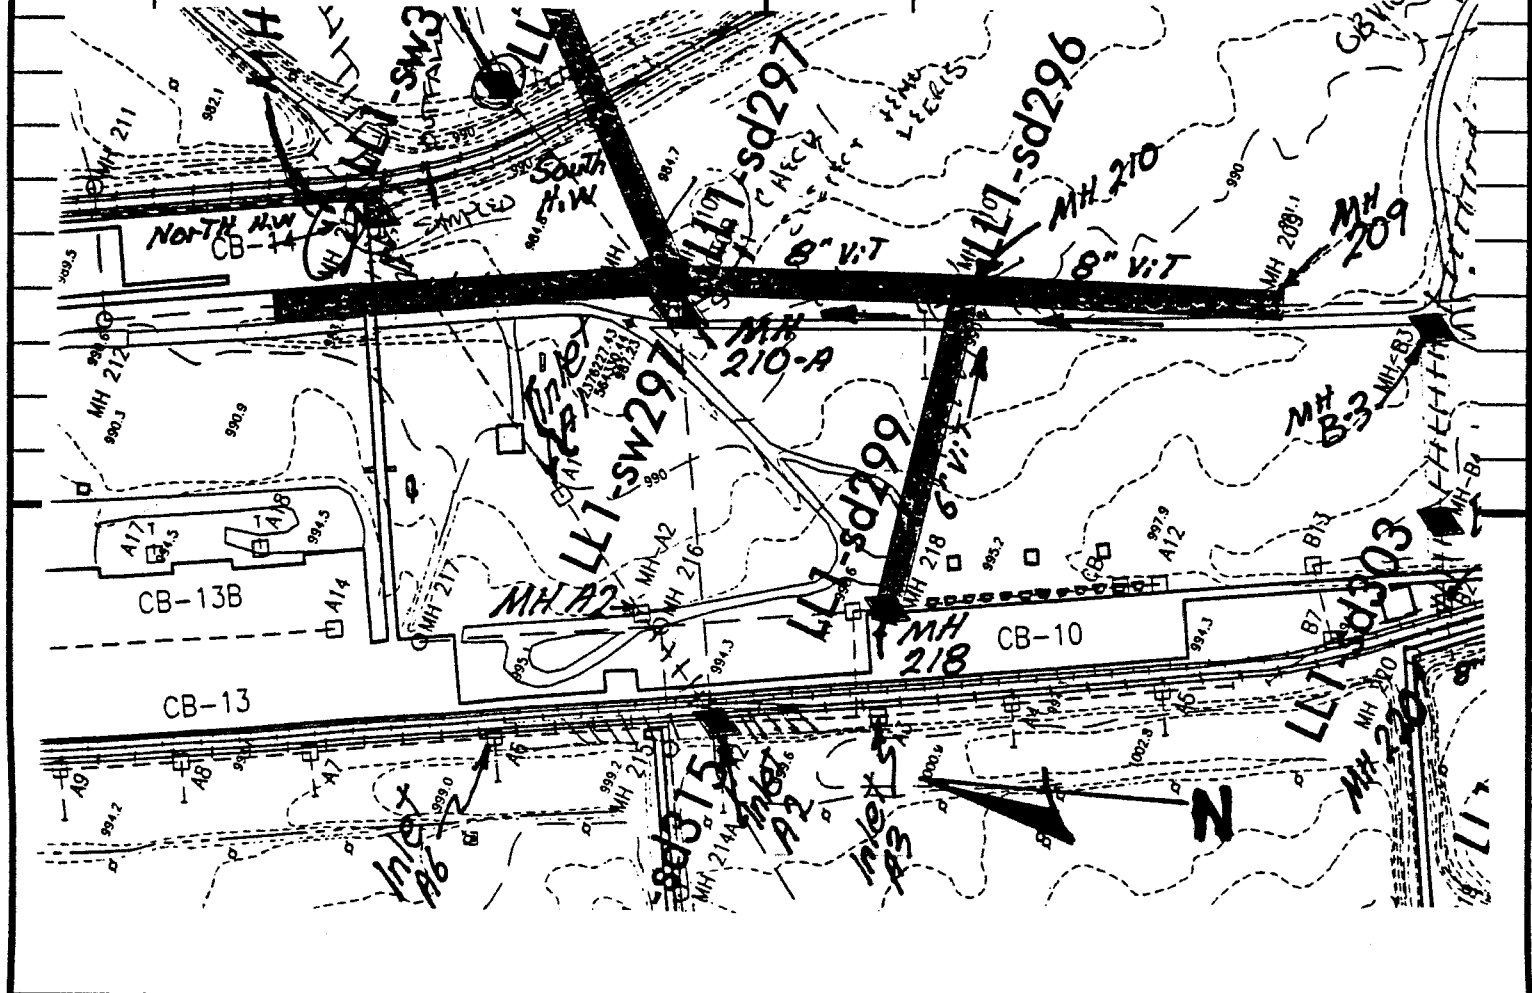
Footage	Remarks	Footage	Remarks
0	Inlet A2 US to Inlet A3		
10	STRESS CRACK		
86	Pipe Missing/Void *		
101	Flap left - w/wood *		
	STUCK INSIDE

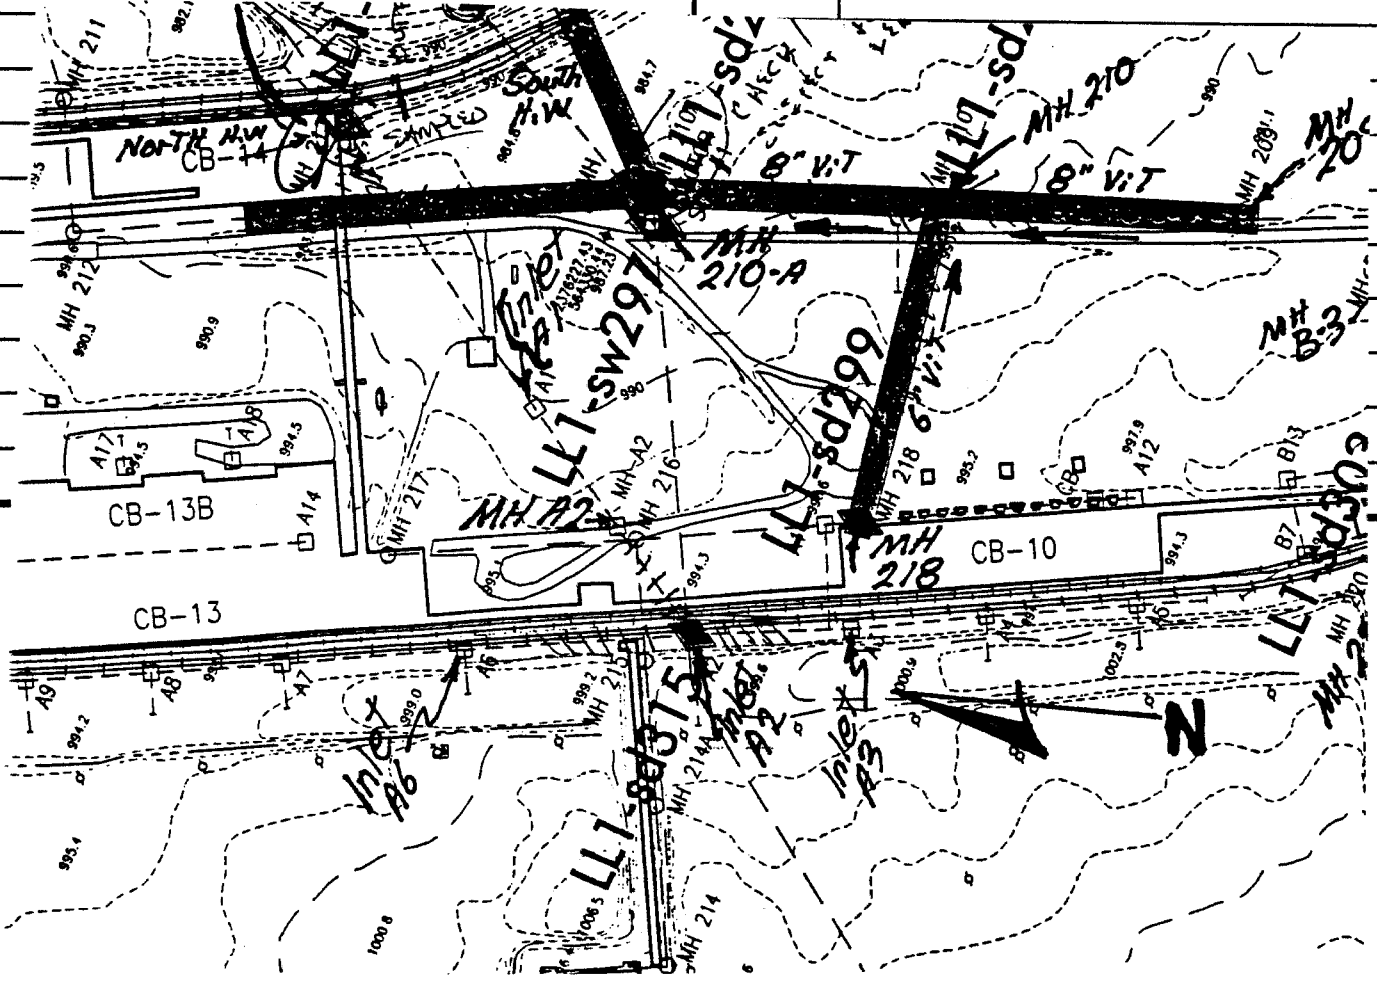
Footage	Remarks	Footage	Remarks
0	Inlet A2 D-S to MH A2		
18	Light CRACK		
20	Light CRACK		
49	Light CRACK		
100	Mineral Deposit SEEN ENOUGH

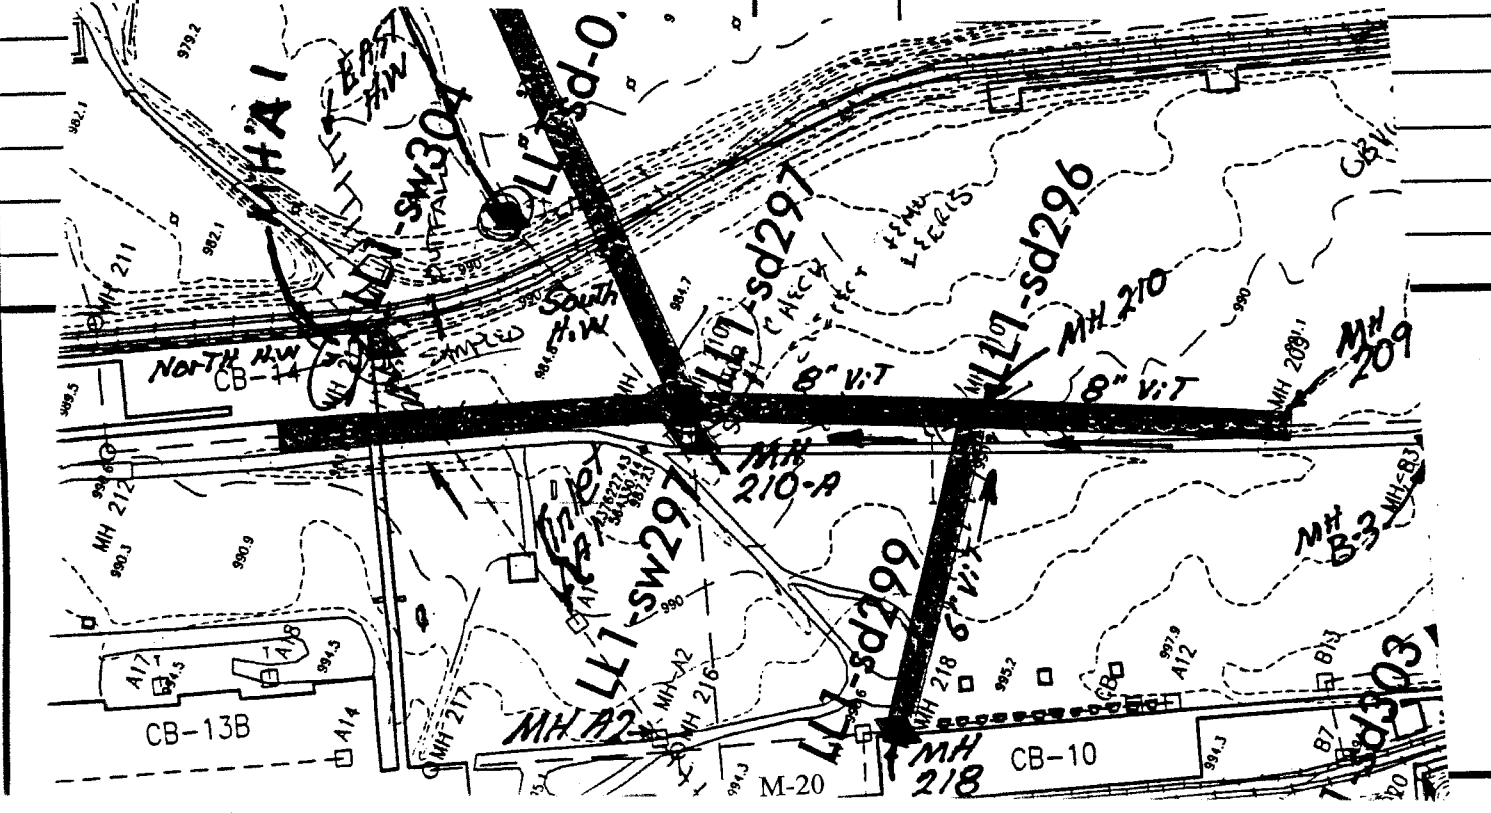
Footage	Remarks	Footage	Remarks
	MH A1 45' TO Inlet A1		
0	Inlet A1 to MH A1		
11	STRESS CRACK		
32	STRESS CRACK		
41	STRESS CRACK		
82	STRESS CRACK		
87	Mortar Deposit		
102	Light Debris		
102	Large CRACK		
107	STRESS CRACK		
150	STOP		
	Good Pipe

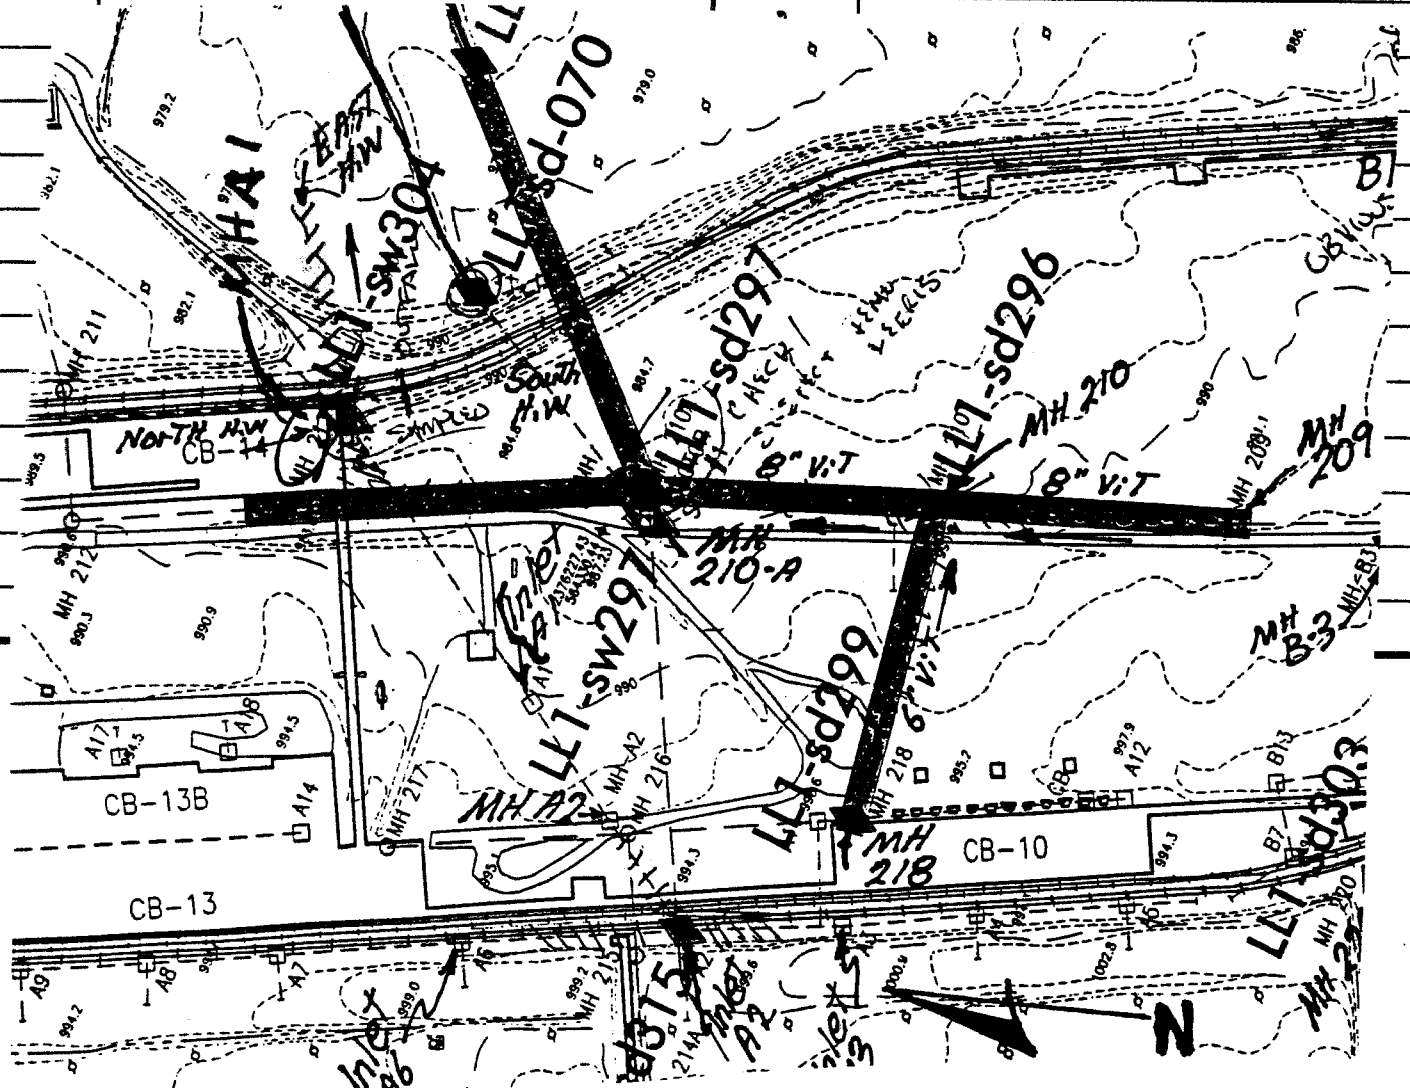
Footage	Remarks	D.S.	Footage	Remarks
0	MHA1 East to Headwall			
8	Heavy Debris			
48	Broken Pipe	*		
100	Headwall
