APPENDIX M
SEWER LINE VIDEO SURVEY REPORT

Sanitary Sewer

Storm Sewer

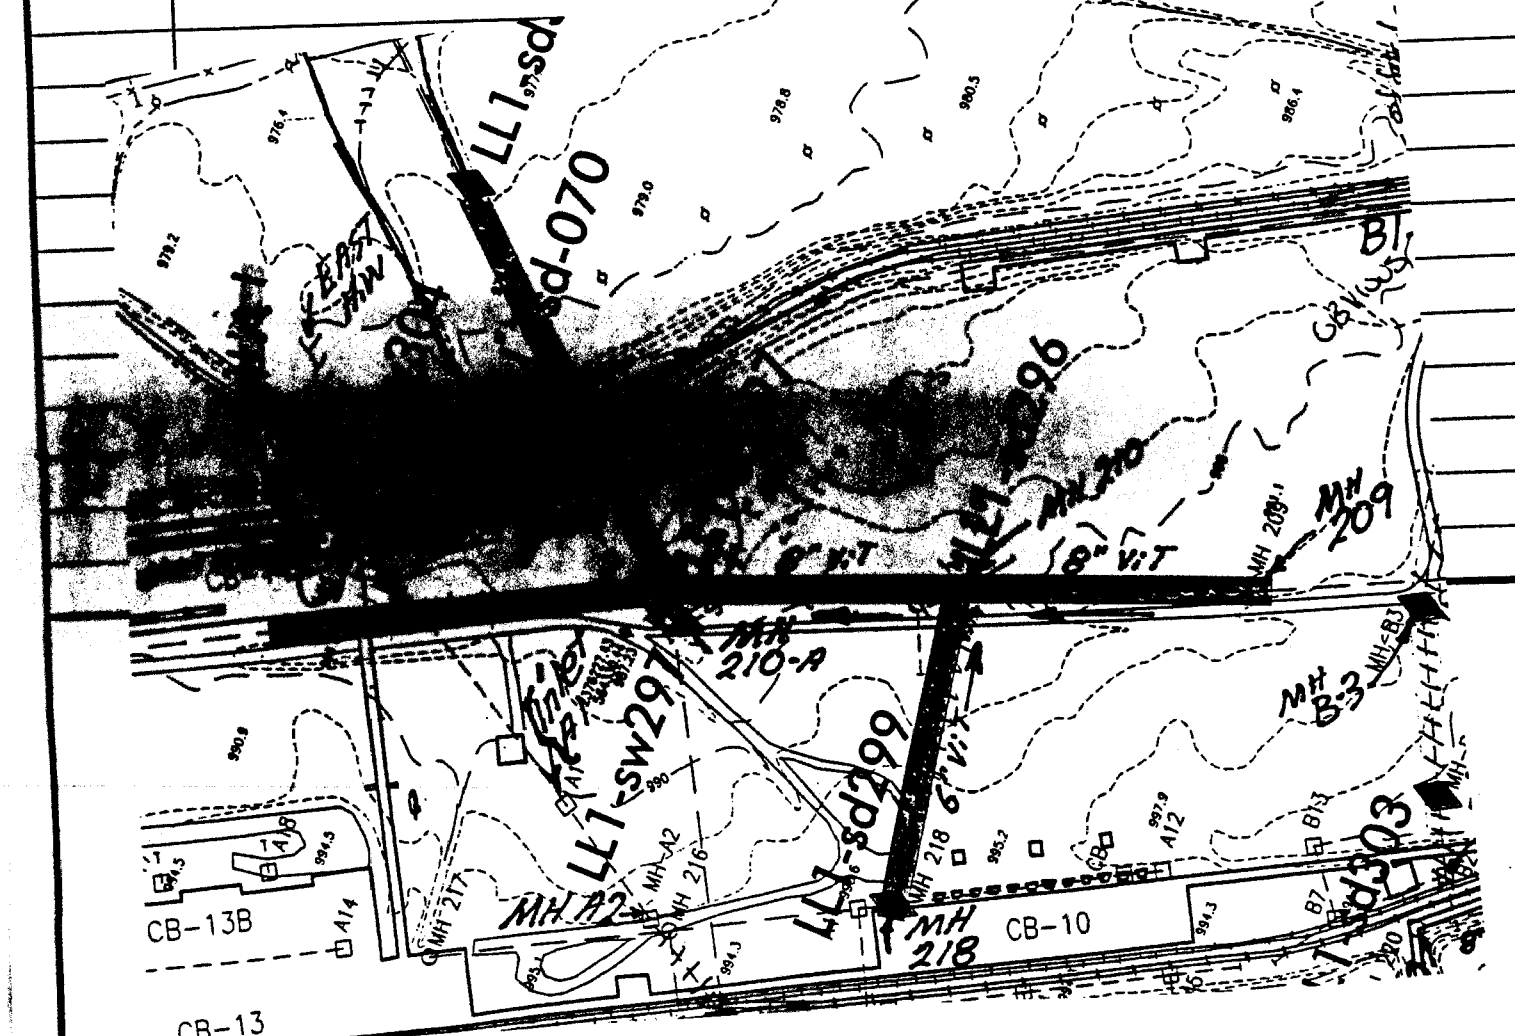
Footage	Remarks	US	South	Footage	Remarks
0	A1 to Headwall 24"			0	A1 to Headwall 24"
8	Tap Left			3	Headwall
16	Crack w Bottom				
80	Headwall

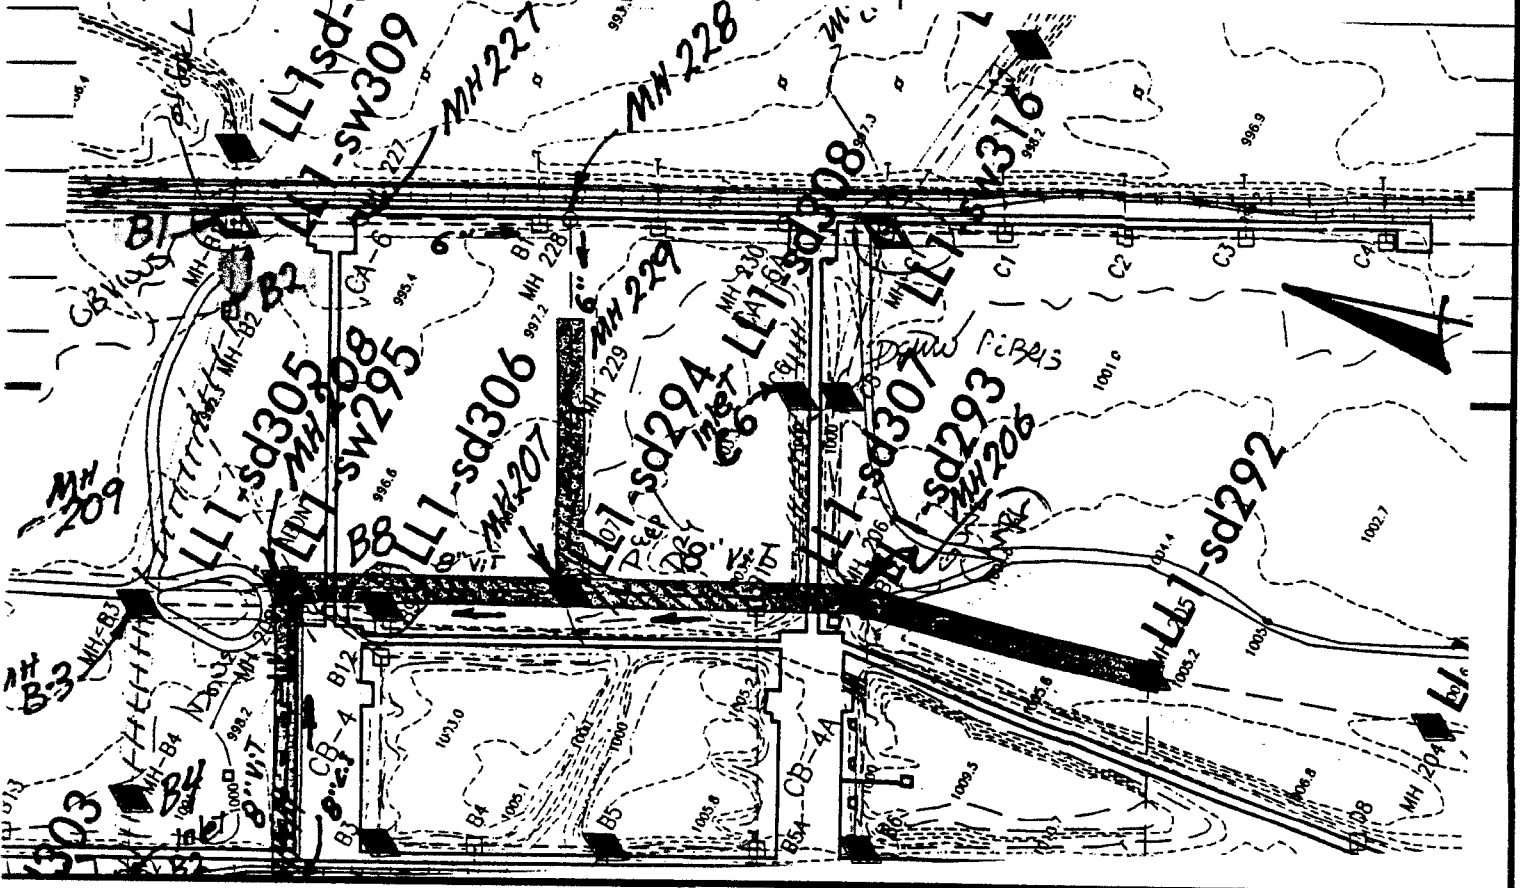
Footage	Remarks	Footage	Remarks
0	MH B2 / MH B1		
7	HEAVY HEAVY DEBRIS COULD NOT CONTINUE		
*	NOTE MH B2 and outlet were both unaccessible - too much Debris

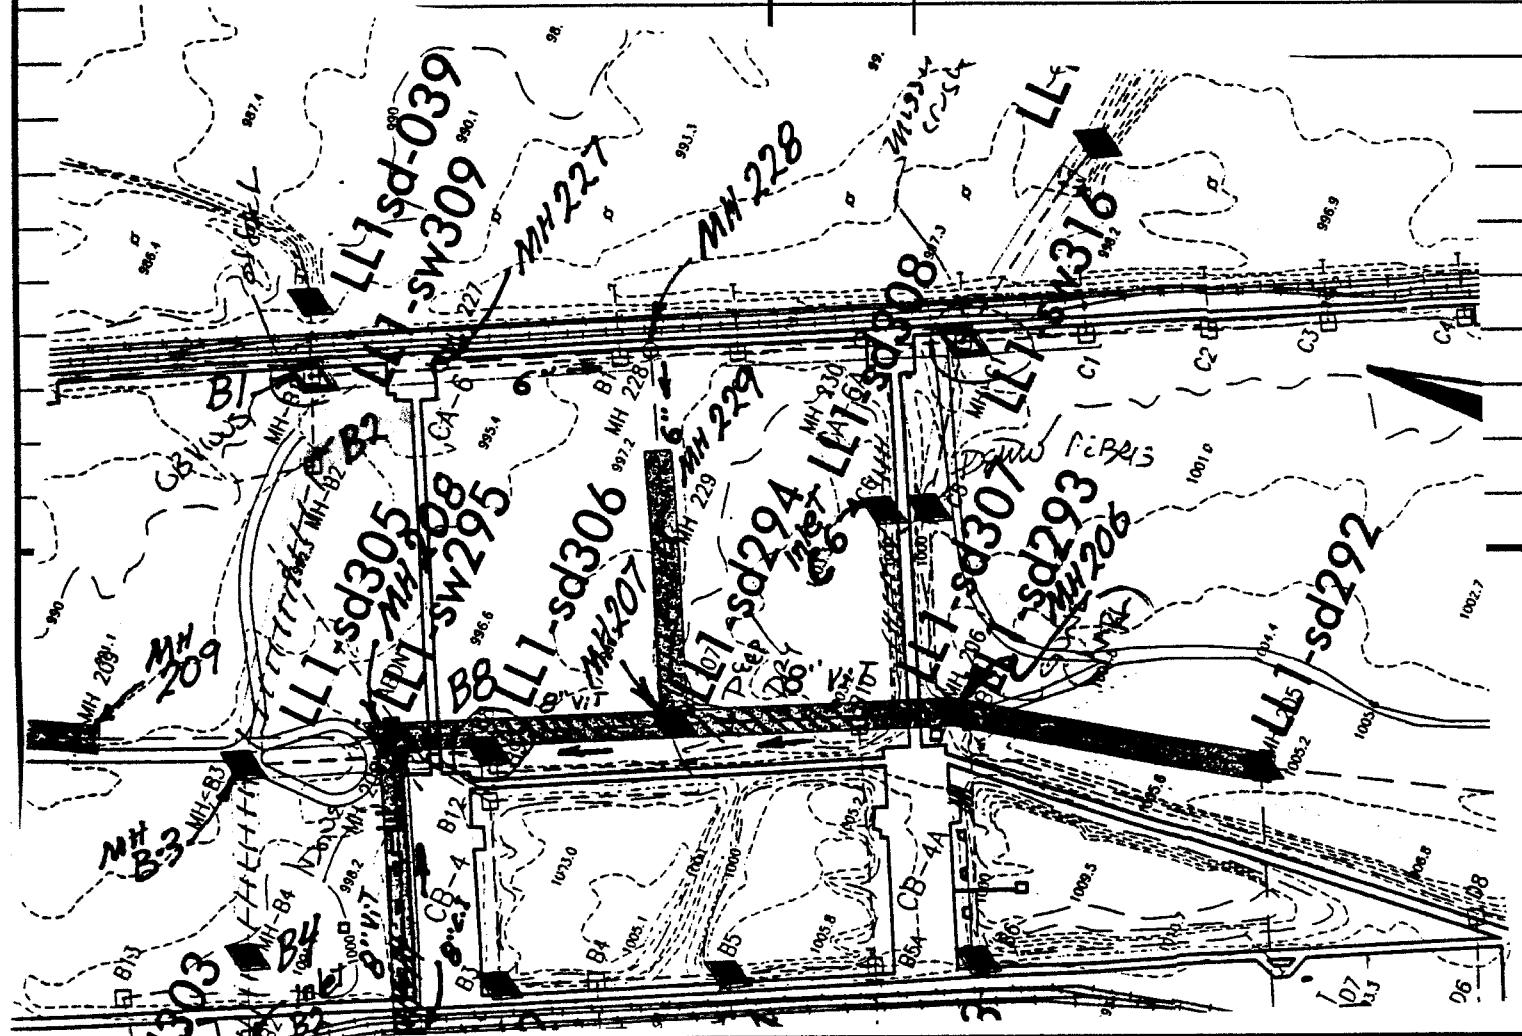
Footage	Remarks	Footage	Remarks
96	MH B2 U.S. to B3		
100	Changes to Brick		Pipe crossing
150	Changes back Clay		above 30" line
	STOP		
	SEEN ENDOFT

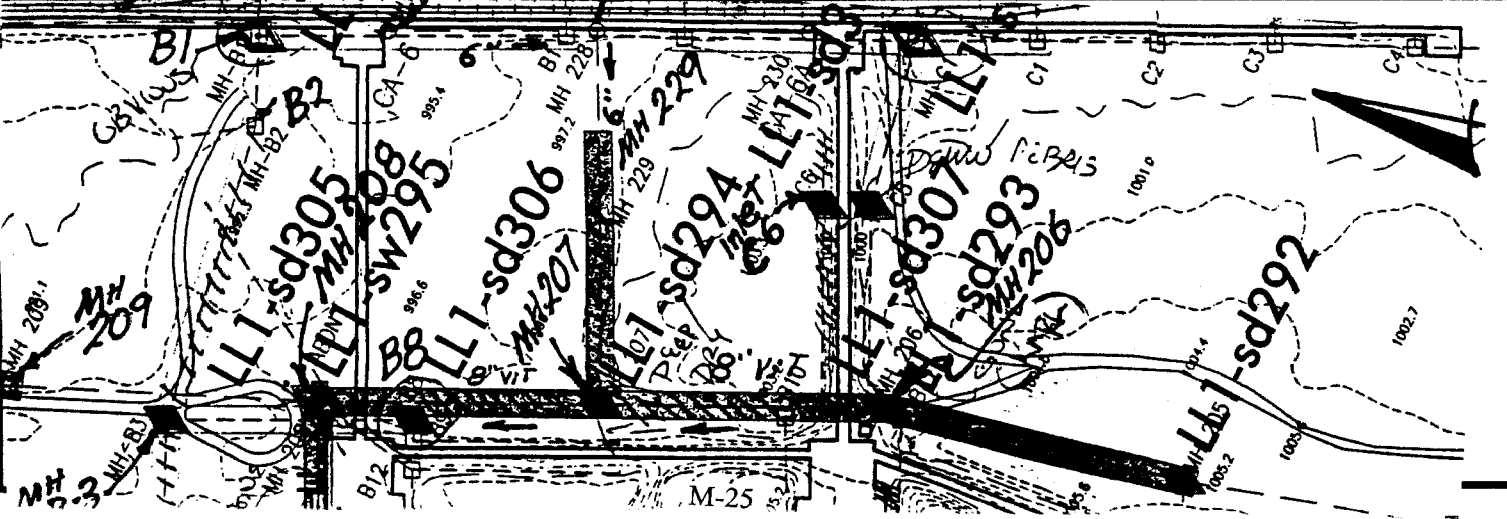
Footage	Remarks	Footage	Remarks
0	B3 DS to B2		
12	Cracks / Heavy Pcbng		
18	Cracks		
21	"		
30	4 pt Crack		
32	Loss of Shape		
20	Cracks / Bottom		
113	Crack / Infiltration		
122	" "		
176	Mortar Dep		
195	Crack @ Bottom		
219	Mortar Dep		
350	M Met where we left off @ B2/B3		
	Total Distance 400 ft.

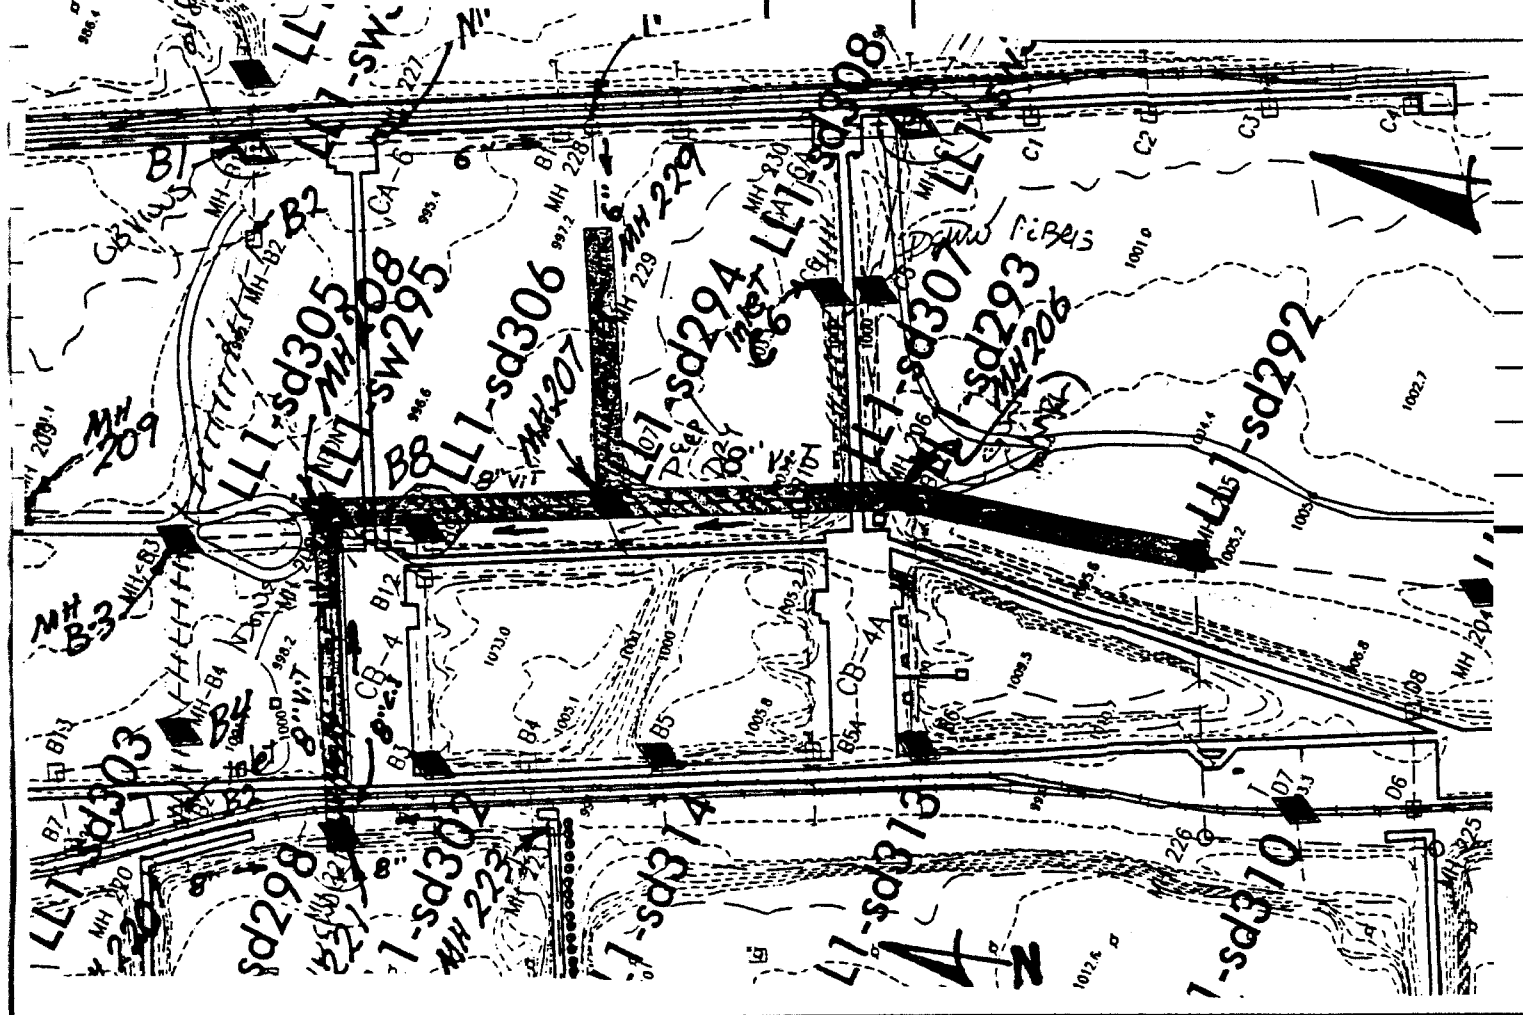
Footage	Remarks	Footage	Remarks
6	B3 U.S. to B4		
22	Too Much DEBRIS

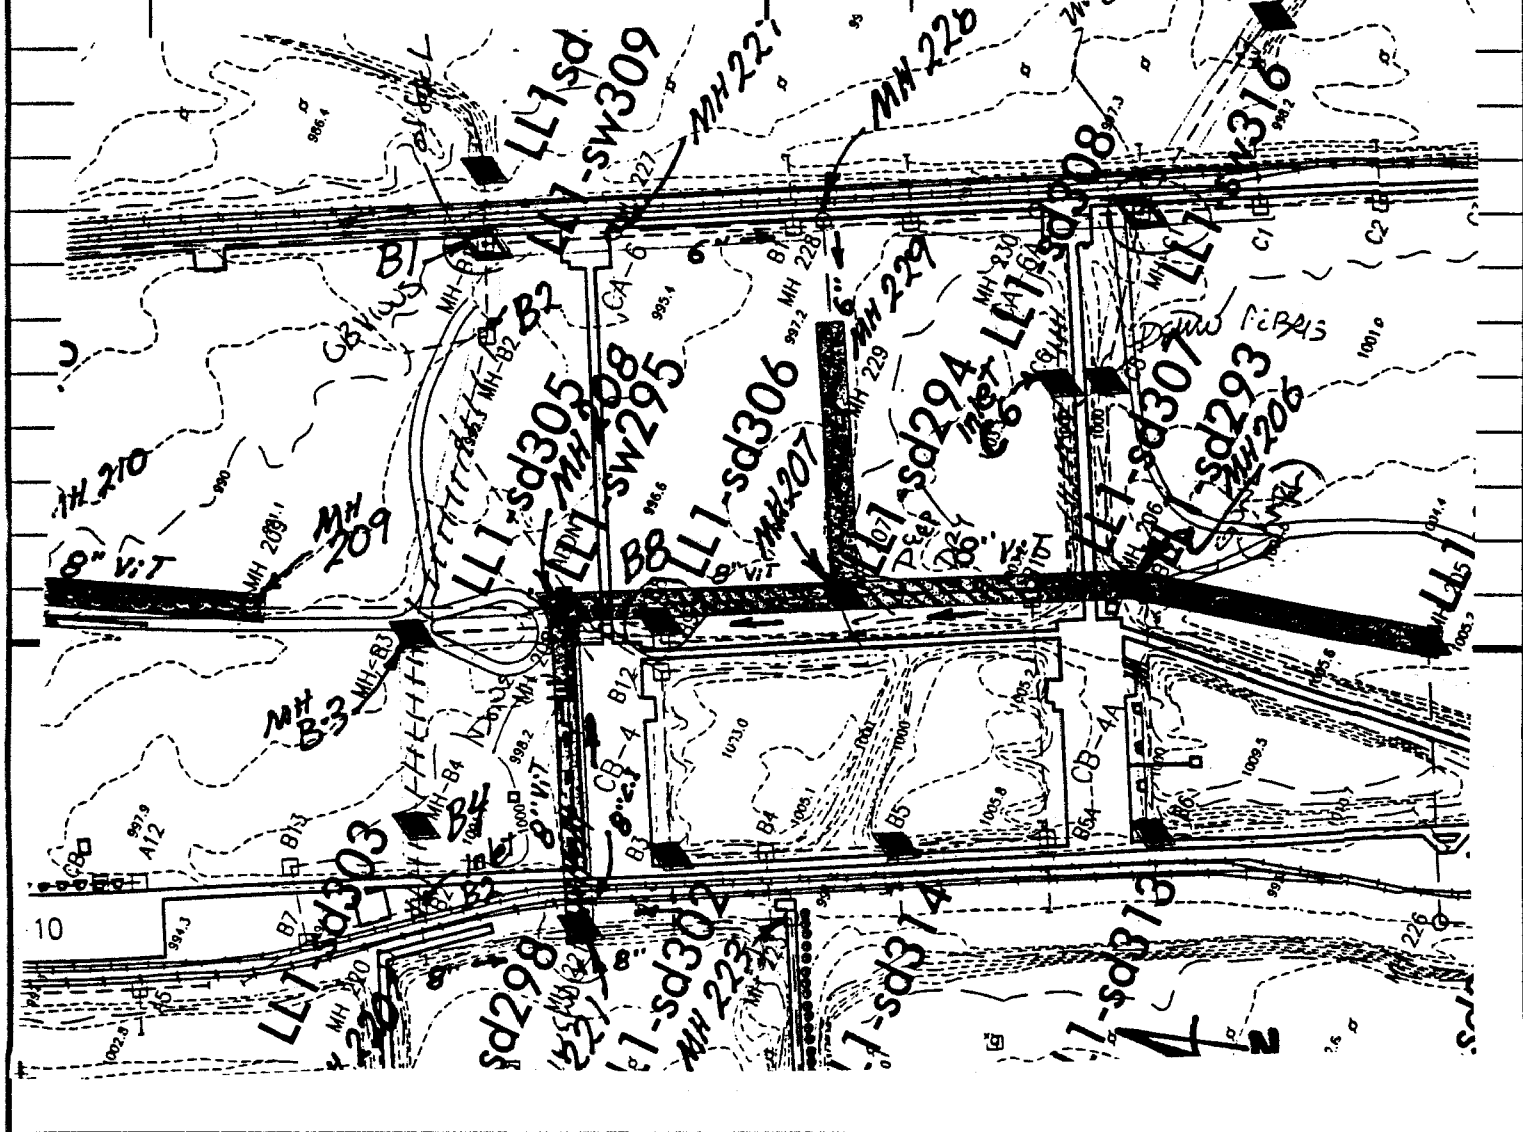
Footage	Remarks	Footage	Remarks
0	MH B3 US to Ink + B8 B8		
3	HEAVY DEBRIS - BROKEN DOWN PIPE

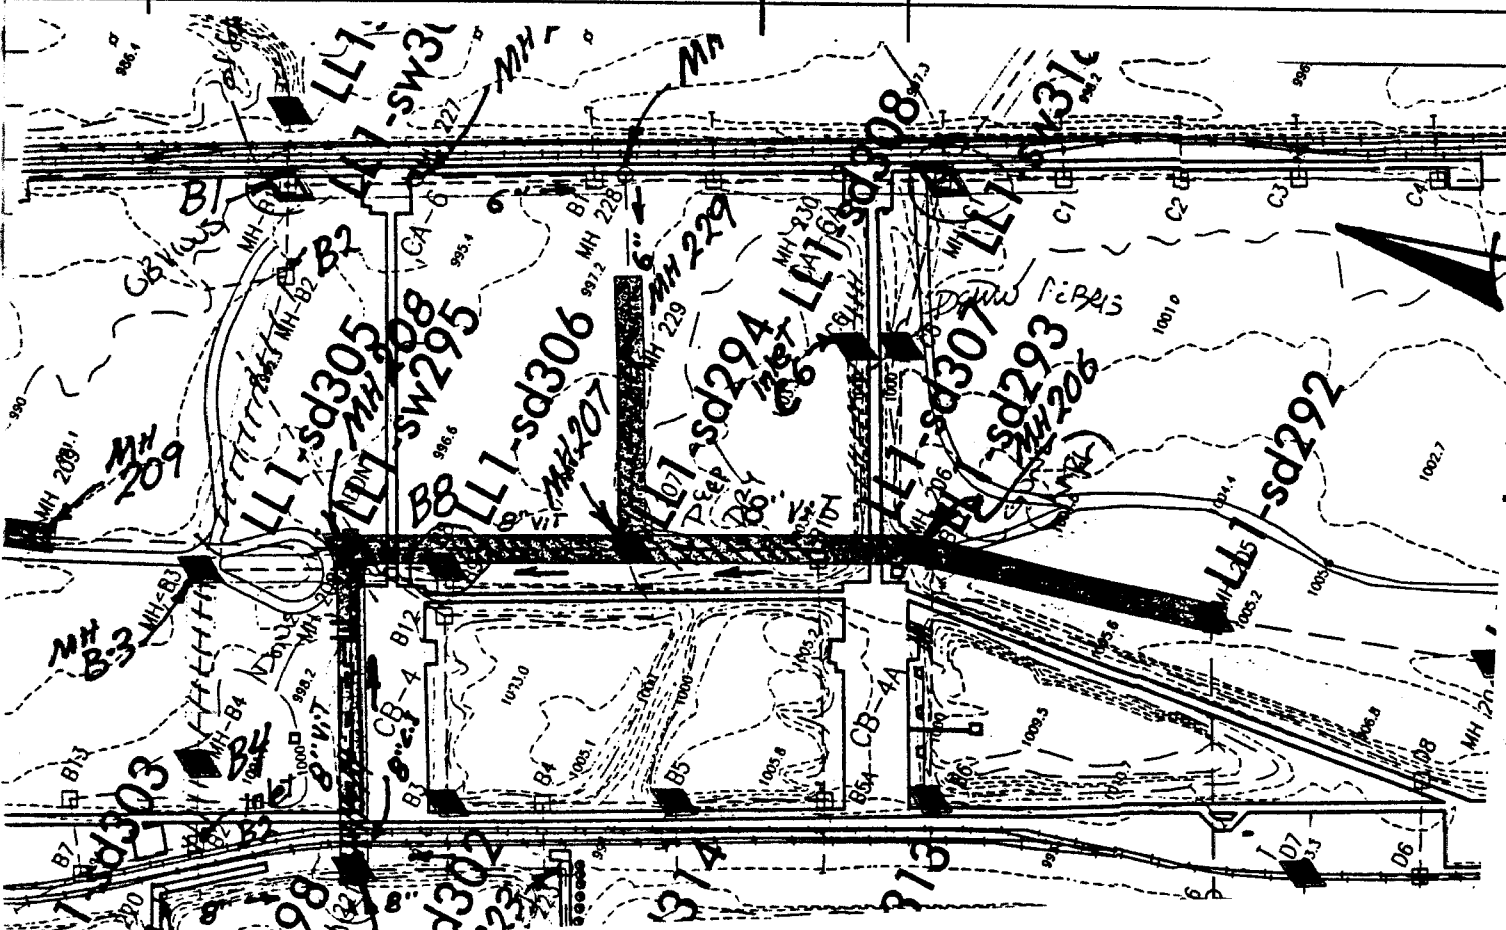
Footage	Remarks	Footage	Remarks
0	MH B4 @ S to B3		
62	Light Crack		
67	Light Crack		
186	HEAVY DEBRIS		
190	COULD NOT GO ANY FURTHER

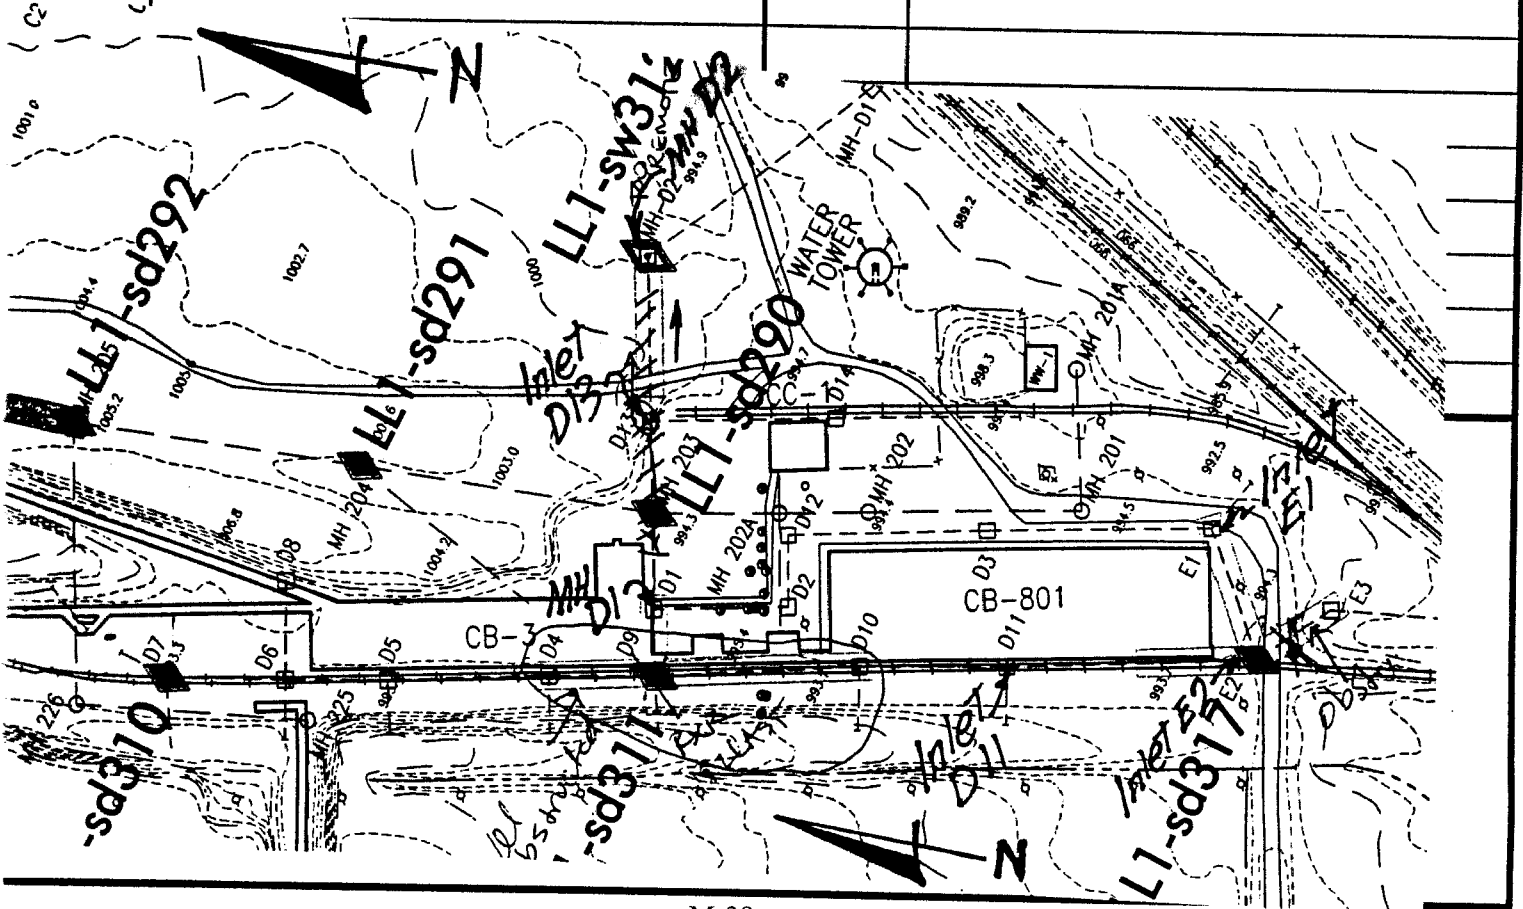
Footage	Remarks	Footage	Remarks
0	Inlet D13 to MH D2	0	D13 U.S. to D1
10	Could not pass BIG ROCK	20	Lt Crack
20		30	Med Crack
		43	Cracks - offset 2
		100	Lt Cracks
		120	3 PT CRACK
		172	HEAVY DEBRIS could not pass

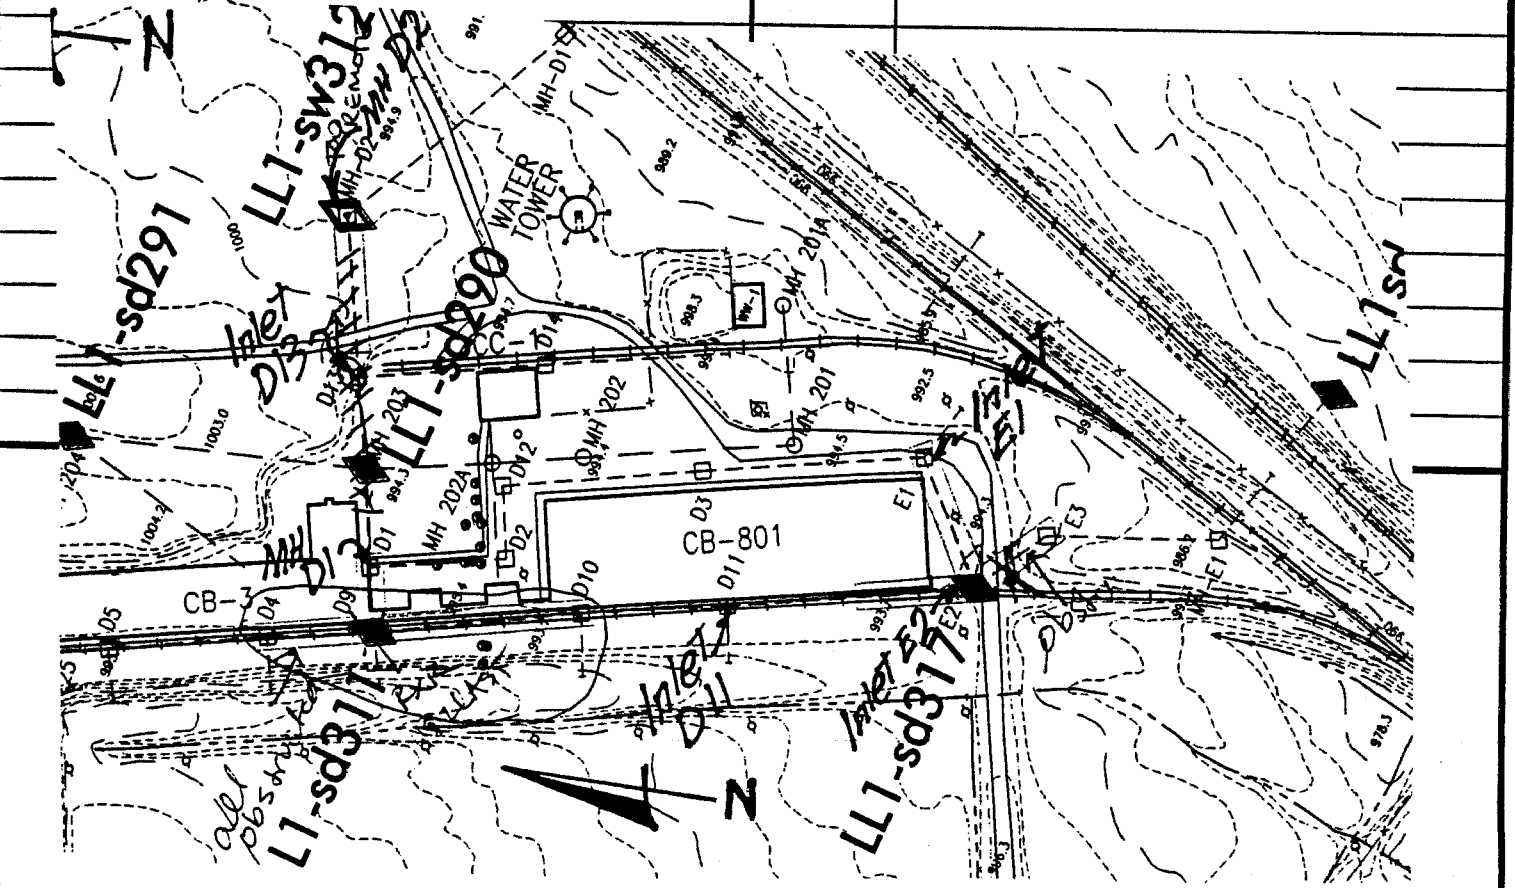
Footage	Remarks	Footage	Remarks
	16 E2 H.S. U.S.		E1 U.S. TO D11
0	Inlet E2 to E1	0	E1 DS to D11
29	Lt. Creek	50	STOP
38	Lt. Creek		LOOKS GOOD
50	STOP		
	LOOKS GOOD
