APPENDIX N
SEWER LINE VIDEO SURVEY REPORT

Subject: Storm and Sanitary Sewer Video Survey Data for Phase II Remedial Investigations (RIs) at Load Lines 1, 2, 3, 4 and 12

INSPECTION REPORT

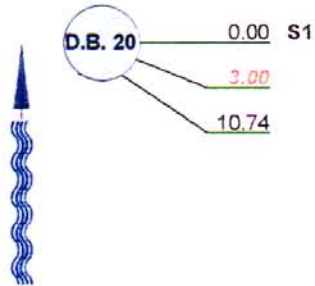
inspection begins at downstream manhole, START
debris Heavy!!!!
 camera blocked, inspection abandoned, END Debris is ti
 Heavy!!!!!!!

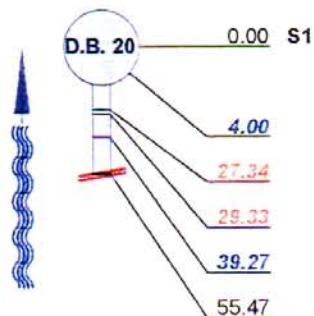
Longitudinal Crack, at 03 o'clock

debris

Longitudinal Crack, at 02 o'clock

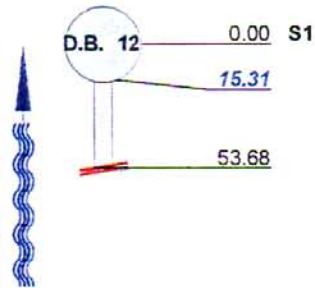
Longitudinal Crack, at 02 o'clock

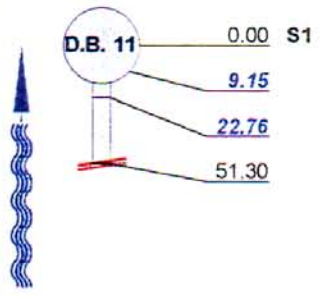
inspection begins at downstream manhole, START
Longitudinal Crack, at 03 o'clock
Longitudinal Crack, at 02 o'clock
 inspection abandoned, END Seen Enough!!!

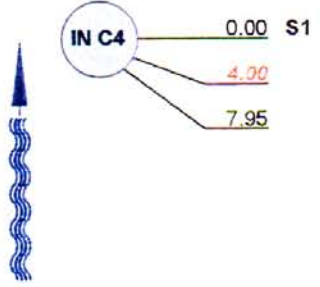
inspection begins at downstream manhole, START
debris Heavy!!!!
 camera blocked, inspection abandoned, END too heavy to pass!!!!

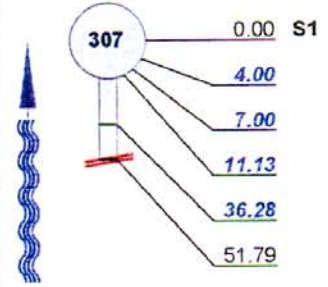
inspection begins at downstream manhole, START
scale/mineral deposits medium from 08 to 10 o'clock
scale/mineral deposits medium from 07 to 04 o'clock
scale/mineral deposits medium from 08 to 10 o'clock
scale/mineral deposits medium from 07 to 10 o'clock
 inspection abandoned, END Seen Enough!!!!

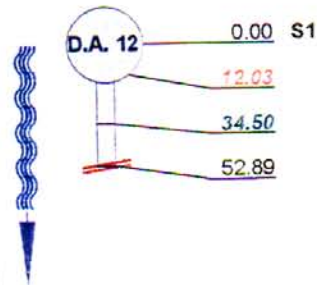
inspection begins at upstream manhole, START metal in mouth of pipe
debris

roots light

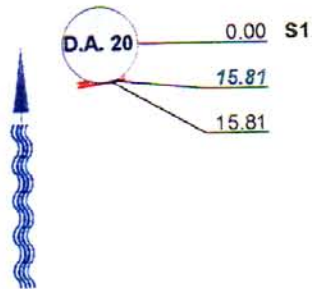
inspection begins at downstream manhole, START
camera under water
 camera blocked, inspection abandoned, END too much debris
 and water to see anything!!!!!!

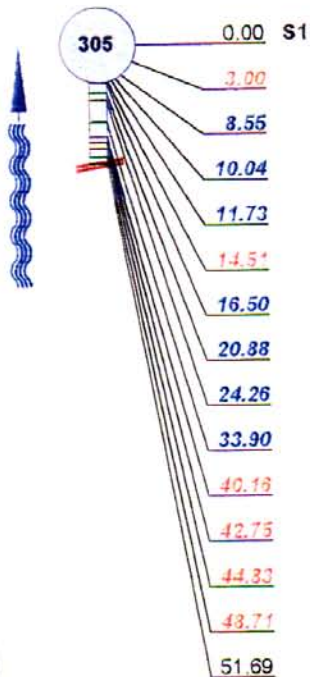
inspection begins at downstream manhole, START
Infiltration Dripping at 02 o'clock
scale/mineral deposits medium from 08 to 10 o'clock
scale/mineral deposits medium from 03 to 05 o'clock
scale/mineral deposits medium from 08 to 10 o'clock
Infiltration Dripping at 09 o'clock
scale/mineral deposits medium from 08 to 10 o'clock
scale/mineral deposits medium from 09 to 10 o'clock
scale/mineral deposits medium from 03 to 04 o'clock
scale/mineral deposits medium from 08 to 10 o'clock
scale/mineral deposits heavy from 09 to 11 o'clock
scale/mineral deposits heavy from 07 to 10 o'clock
scale/mineral deposits heavy from 02 to 05 o'clock
scale/mineral deposits heavy from 08 to 10 o'clock
 inspection abandoned, END Seen Enough!!!

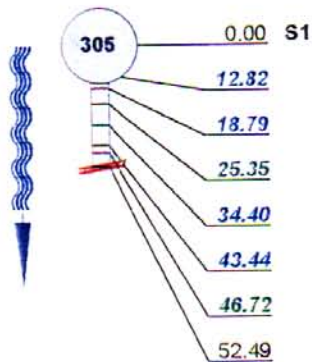
inspection begins at upstream manhole, START
scale/mineral deposits medium from 08 to 10 o'clock
scale/mineral deposits medium from 03 to 04 o'clock
scale/mineral deposits light from 03 to 05 o'clock
scale/mineral deposits medium from 01 to 03 o'clock
Circumferential Crack, from 10 to 11 o'clock
scale/mineral deposits light from 08 to 09 o'clock
 inspection abandoned, END Seen Enough!!!!

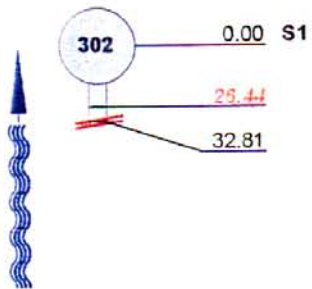
debris

camera blocked, inspection abandoned, END Debris too heavy to pass

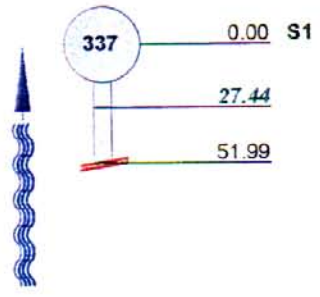
separated joint slight

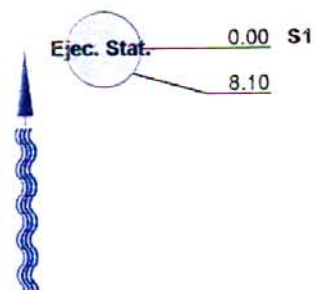
inspection begins at downstream manhole, START
 camera blocked, inspection abandoned, END Too merky to see anything!!!!!!

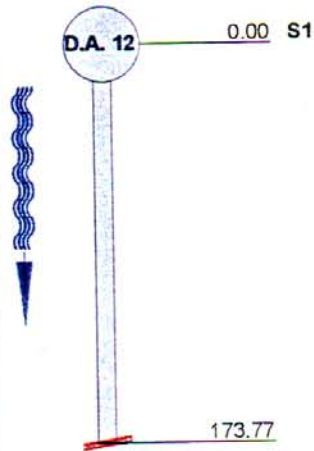
inspection abandoned, END Could not pass big rocks!!!!

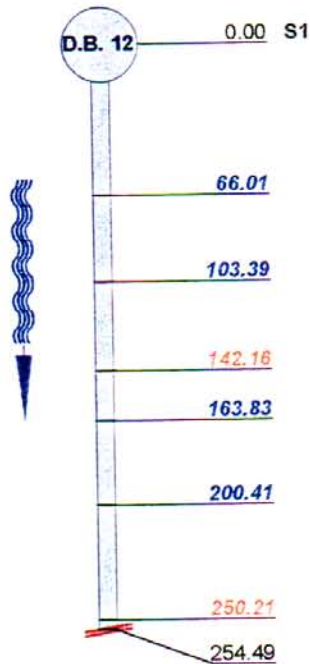
Longitudinal Crack, at 09 o'clock

Longitudinal Crack, at 04 o'clock

Longitudinal Fracture at 06 o'clock

Longitudinal Crack, at 12 o'clock

Longitudinal Crack, at 10 o'clock w/infiltration

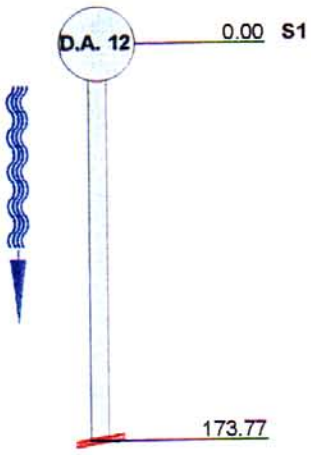
inspection abandoned, END Could not pass big rocks!!!!

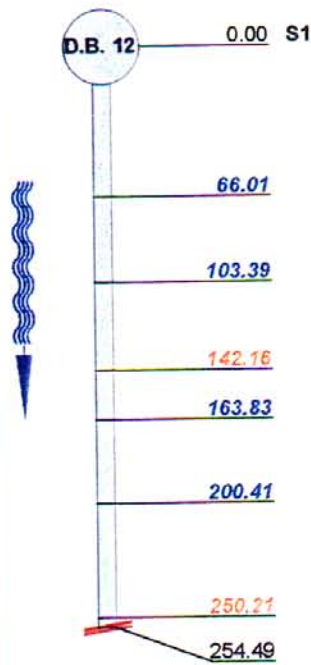
Longitudinal Crack, at 09 o'clock

Longitudinal Crack, at 04 o'clock

Longitudinal Fracture at 06 o'clock

Longitudinal Crack, at 12 o'clock

Longitudinal Crack, at 10 o'clock w/infiltration
