APPENDIX N
SEWER LINE VIDEO SURVEY REPORT

Subject: Storm and Sanitary Sewer Video Survey Data for Phase II Remedial Investigations (RIs) at Load Lines 1, 2, 3, 4 and 12

INSPECTION REPORT

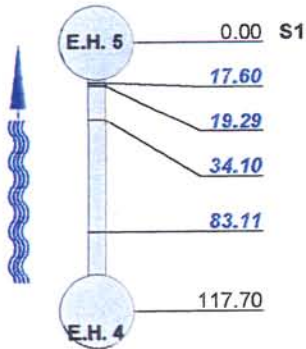
inspection begins at downstream manhole, START
Longitudinal Crack, at 02 o'clock
Longitudinal Crack, at 08 o'clock
Longitudinal Crack, at 09 o'clock
Multiple Cracks, from 02 to 05 o'clock
 inspection ends at upstream manhole, END

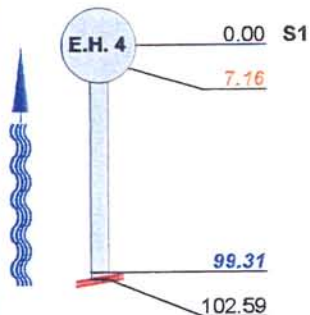
debris Heavy!!!!

Circumferential Crack, from 01 to 02 o'clock

camera blocked, inspection abandoned, END Heavy Rocks!!!!!!!

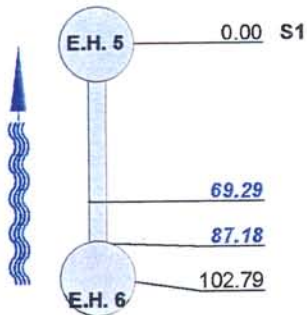
Longitudinal Crack, at 10 o'clock

Longitudinal Crack, at 02 o'clock

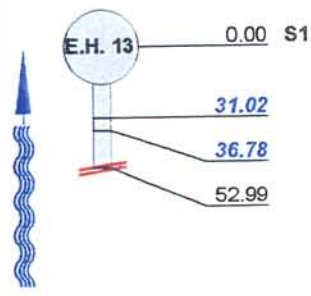
Longitudinal Crack, at 10 o'clock

Longitudinal Crack, at 04 o'clock

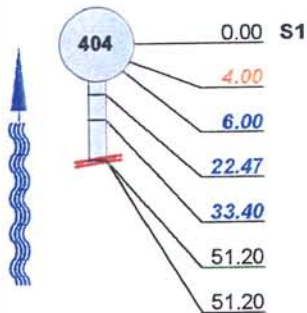
inspection begins at upstream manhole, START
debris
Longitudinal Crack, at 10 o'clock
corrosion medium
corrosion medium
pipe material changes at this point to VCP from Cast Iron
inspection abandoned, END Seen Enough

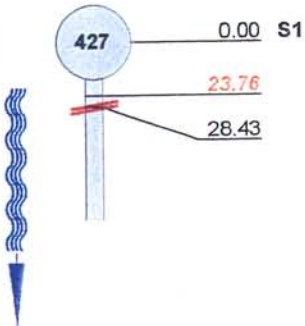
roots heavy

camera blocked, inspection abandoned, END Blocked by piece of pipe
