APPENDIX N
SEWER LINE VIDEO SURVEY REPORT

Subject: Storm and Sanitary Sewer Video Survey Data for Phase II Remedial Investigations (RIs) at Load Lines 1, 2, 3, 4 and 12

INSPECTION REPORT

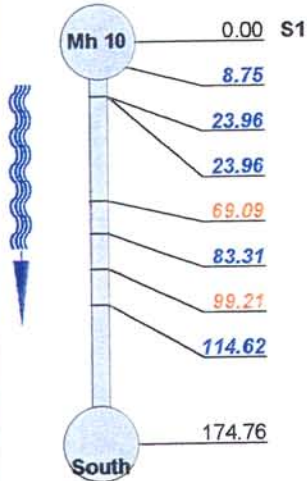
Circumferential Crack, from 09 to 12 o'clock

Longitudinal Crack, at 06 o'clock

Longitudinal Crack, at 10 o'clock

Multiple Fractures from 09 to 11 o'clock

Multiple Cracks, from 06 to 12 o'clock

Hole in pipe at 09 o'clock

Multiple Cracks, from 12 to 06 o'clock

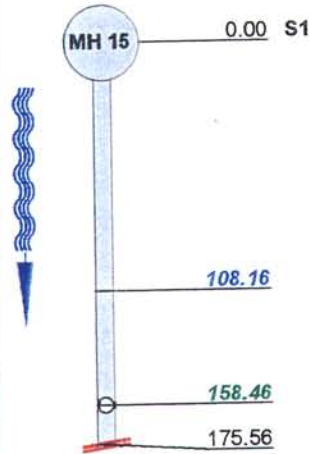
Circumferential Crack, from 07 to 10 o'clock

break-in-connection, at 12 o'clock

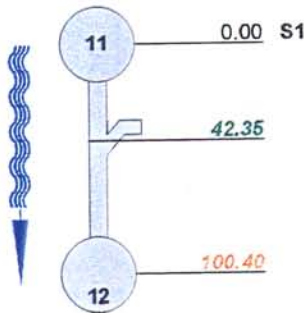
break-in-connection, at 10 o'clock

debris Large rock!!!!!!1

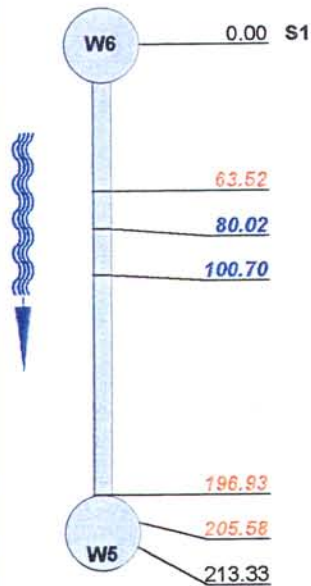
debris
roots medium
roots medium

scale/mineral deposits heavy from 08 to 09 o'clock
debris

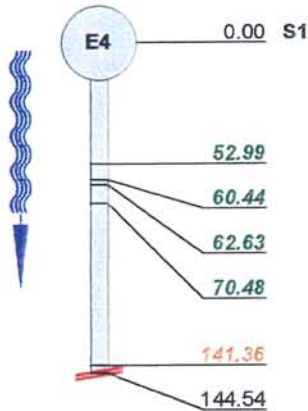
roots light

debris

camera blocked, inspection abandoned, END Can't pass heavy mud!

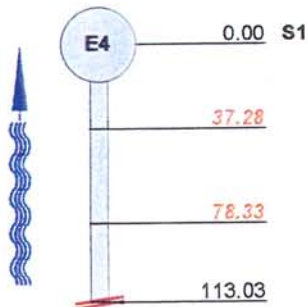
debris

debris Heavy!!!!!!

camera blocked, inspection abandoned, END Debris too heavy to pass!!!!
