**Draft**  
**2015 Annual Land Use Control Monitoring Report,**  
**RVAAP-01 Ramsdell Quarry Landfill**  
**and**  
**RVAAP-05 Winklepeck Burning Grounds**

**Camp Ravenna Joint Military Training Center**  
**Former Ravenna Army Ammunition Plant**  
**Portage and Trumbull Counties, Ohio**

**Contract No. W912QR-13-C-0031**

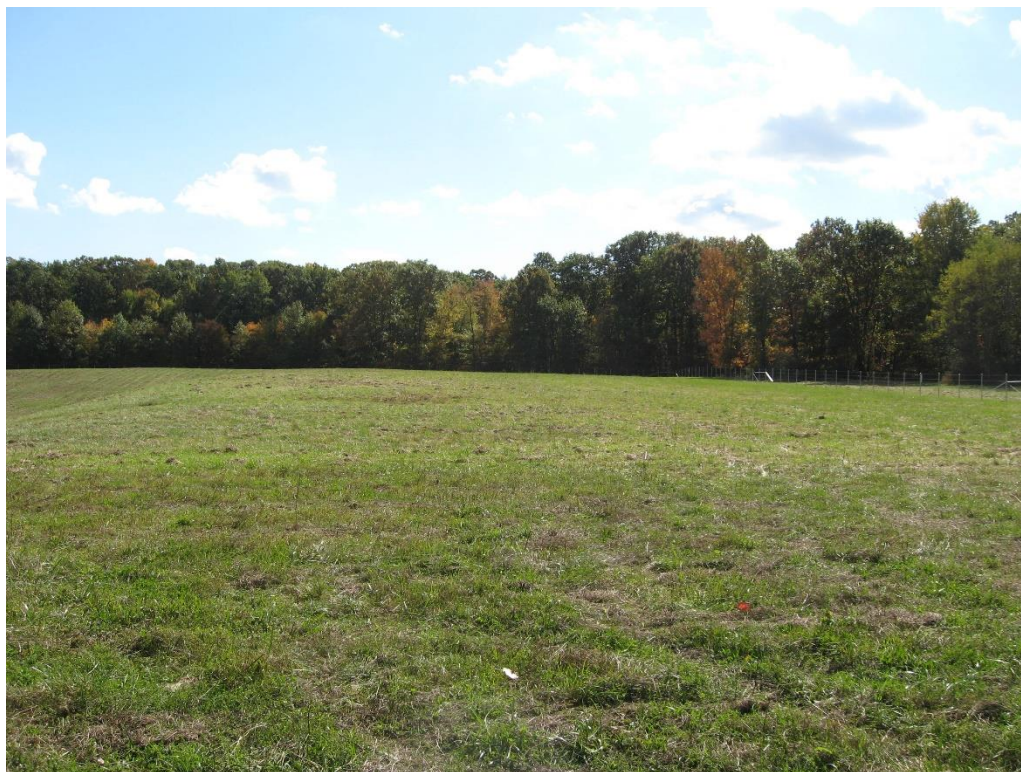
West side of Ramsdell Quarry Landfill, looking south from west gate.

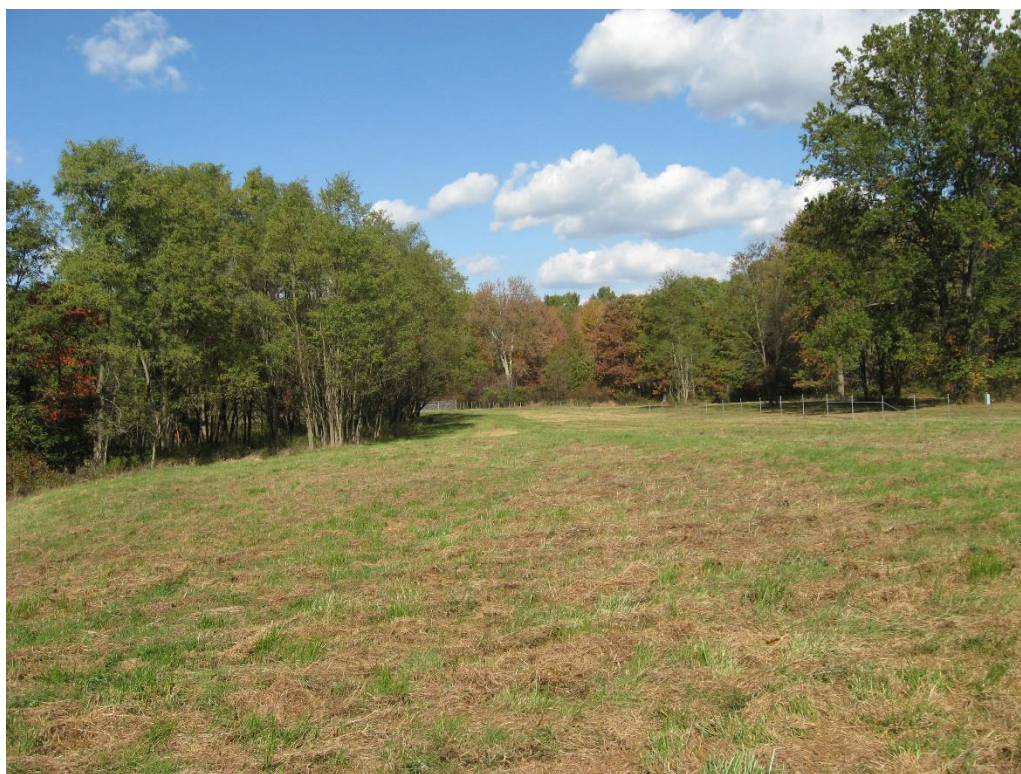
East side of Ramsdell Quarry Landfill, looking north from southeast corner.

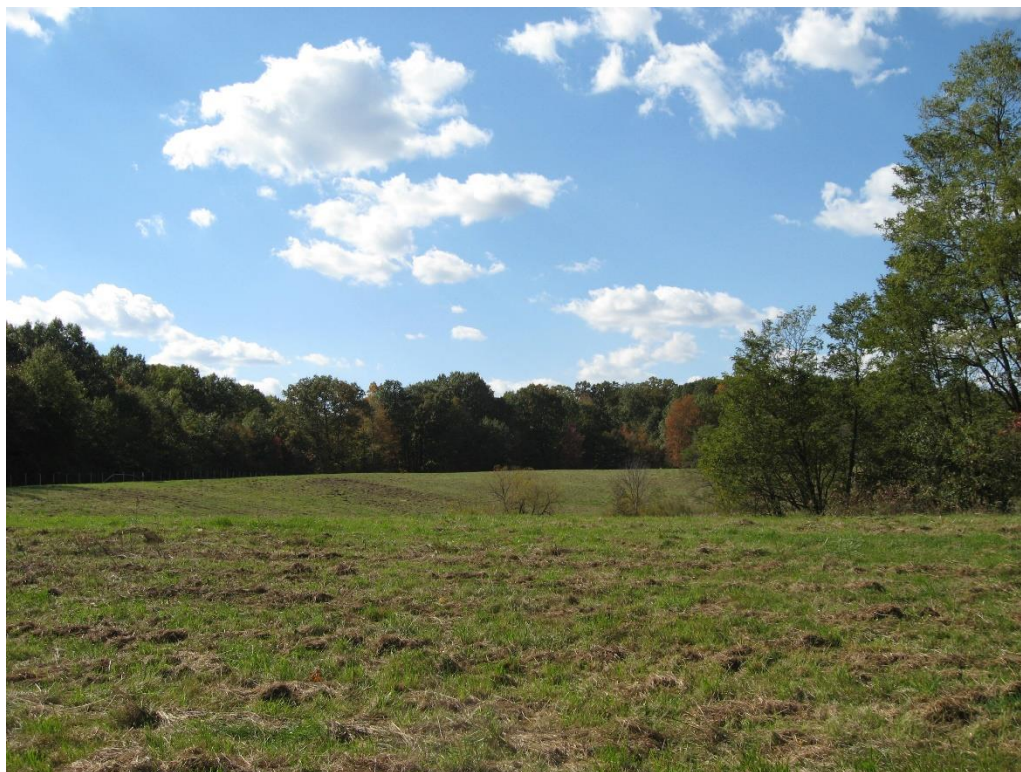
East and south side of Ramsdell Quarry Landfill, looking southwest from east side.

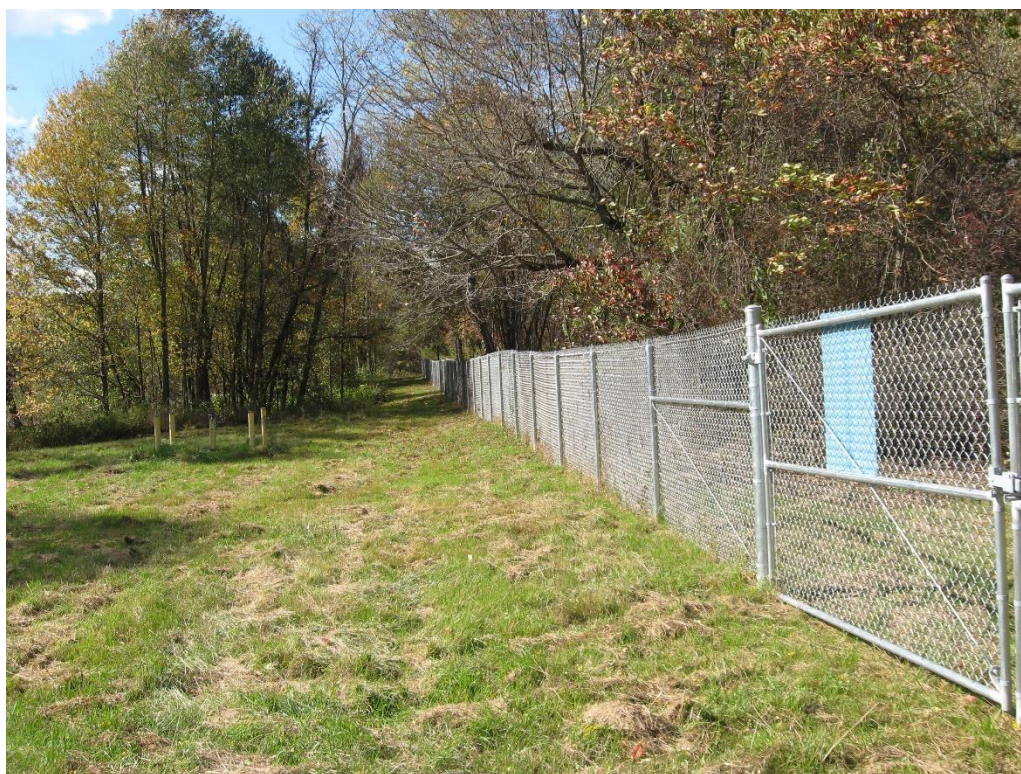
The RQL fencing and gate are intact and in good condition. There are no deficiencies with the fence and gates.

East gate and north fence of Ramsdell Quarry Landfill, looking west from east gate.
