2016 Annual Land Use Control Monitoring Report,

RVAAP-01 Ramsdell Quarry Landfill

RVAAP-05 Winklepeck Burning Grounds

Camp Ravenna Joint Military Training Center

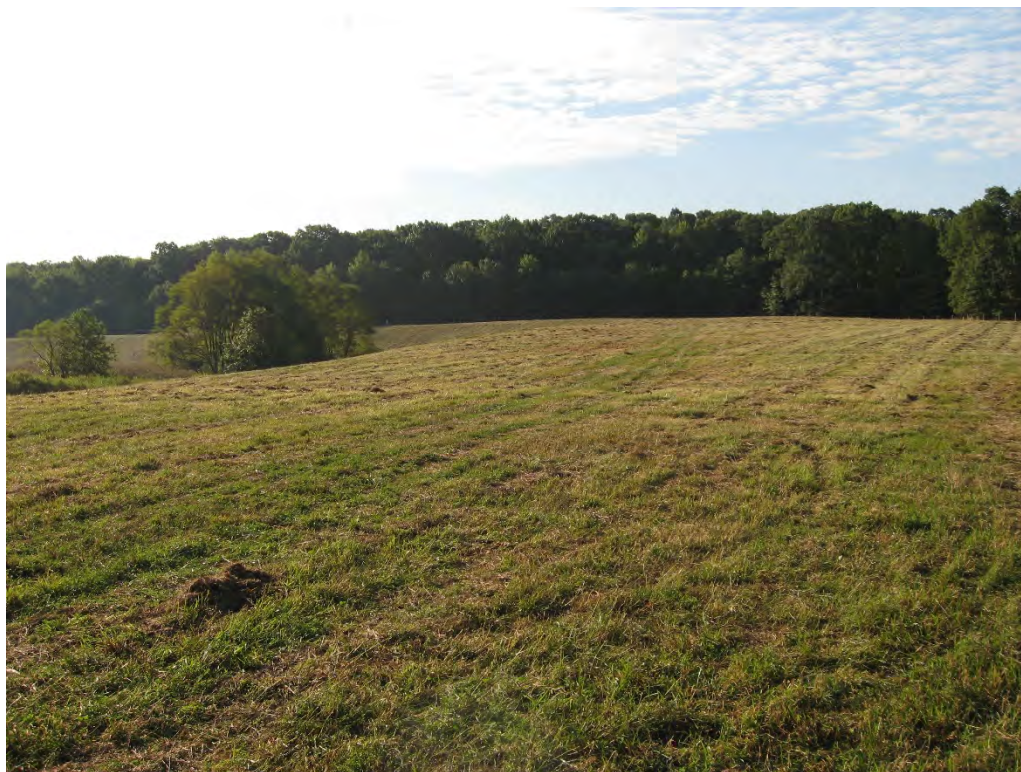
West side of Ramsdell Quarry Landfill, looking south from west gate.

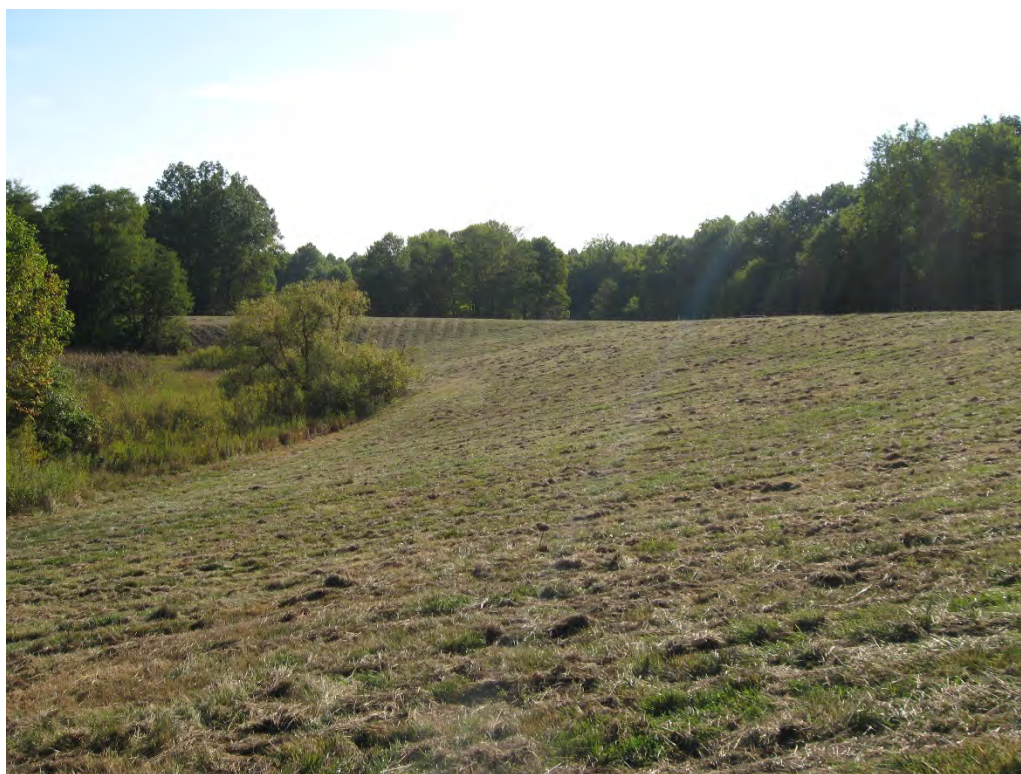
South side of Ramsdell Quarry Landfill, looking east from southwest corner.

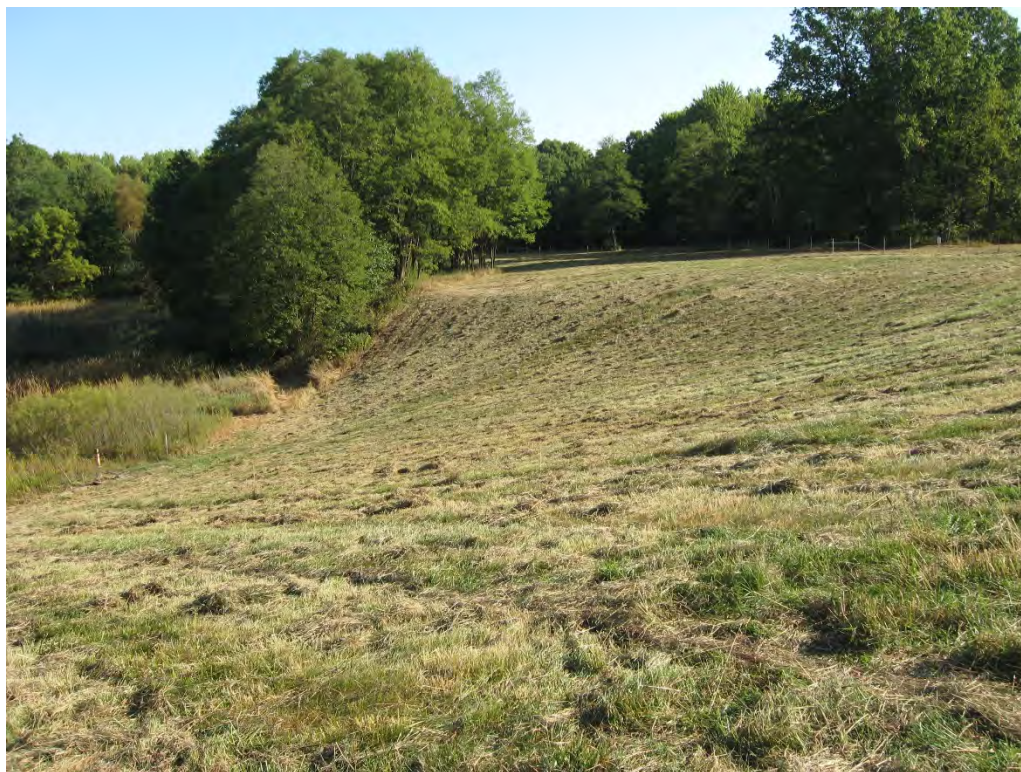
East side of Ramsdell Quarry Landfill, looking north from southeast corner.

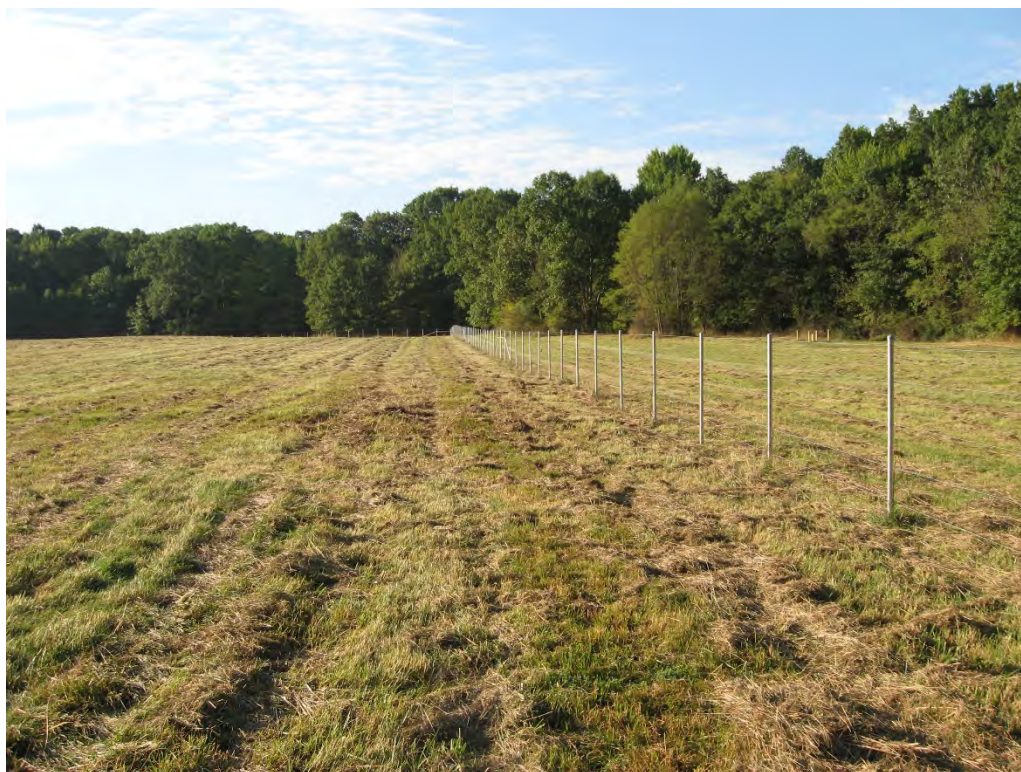
Land Use Control fence along west side of Ramsdell Quarry Landfill, looking south from northwest corner.

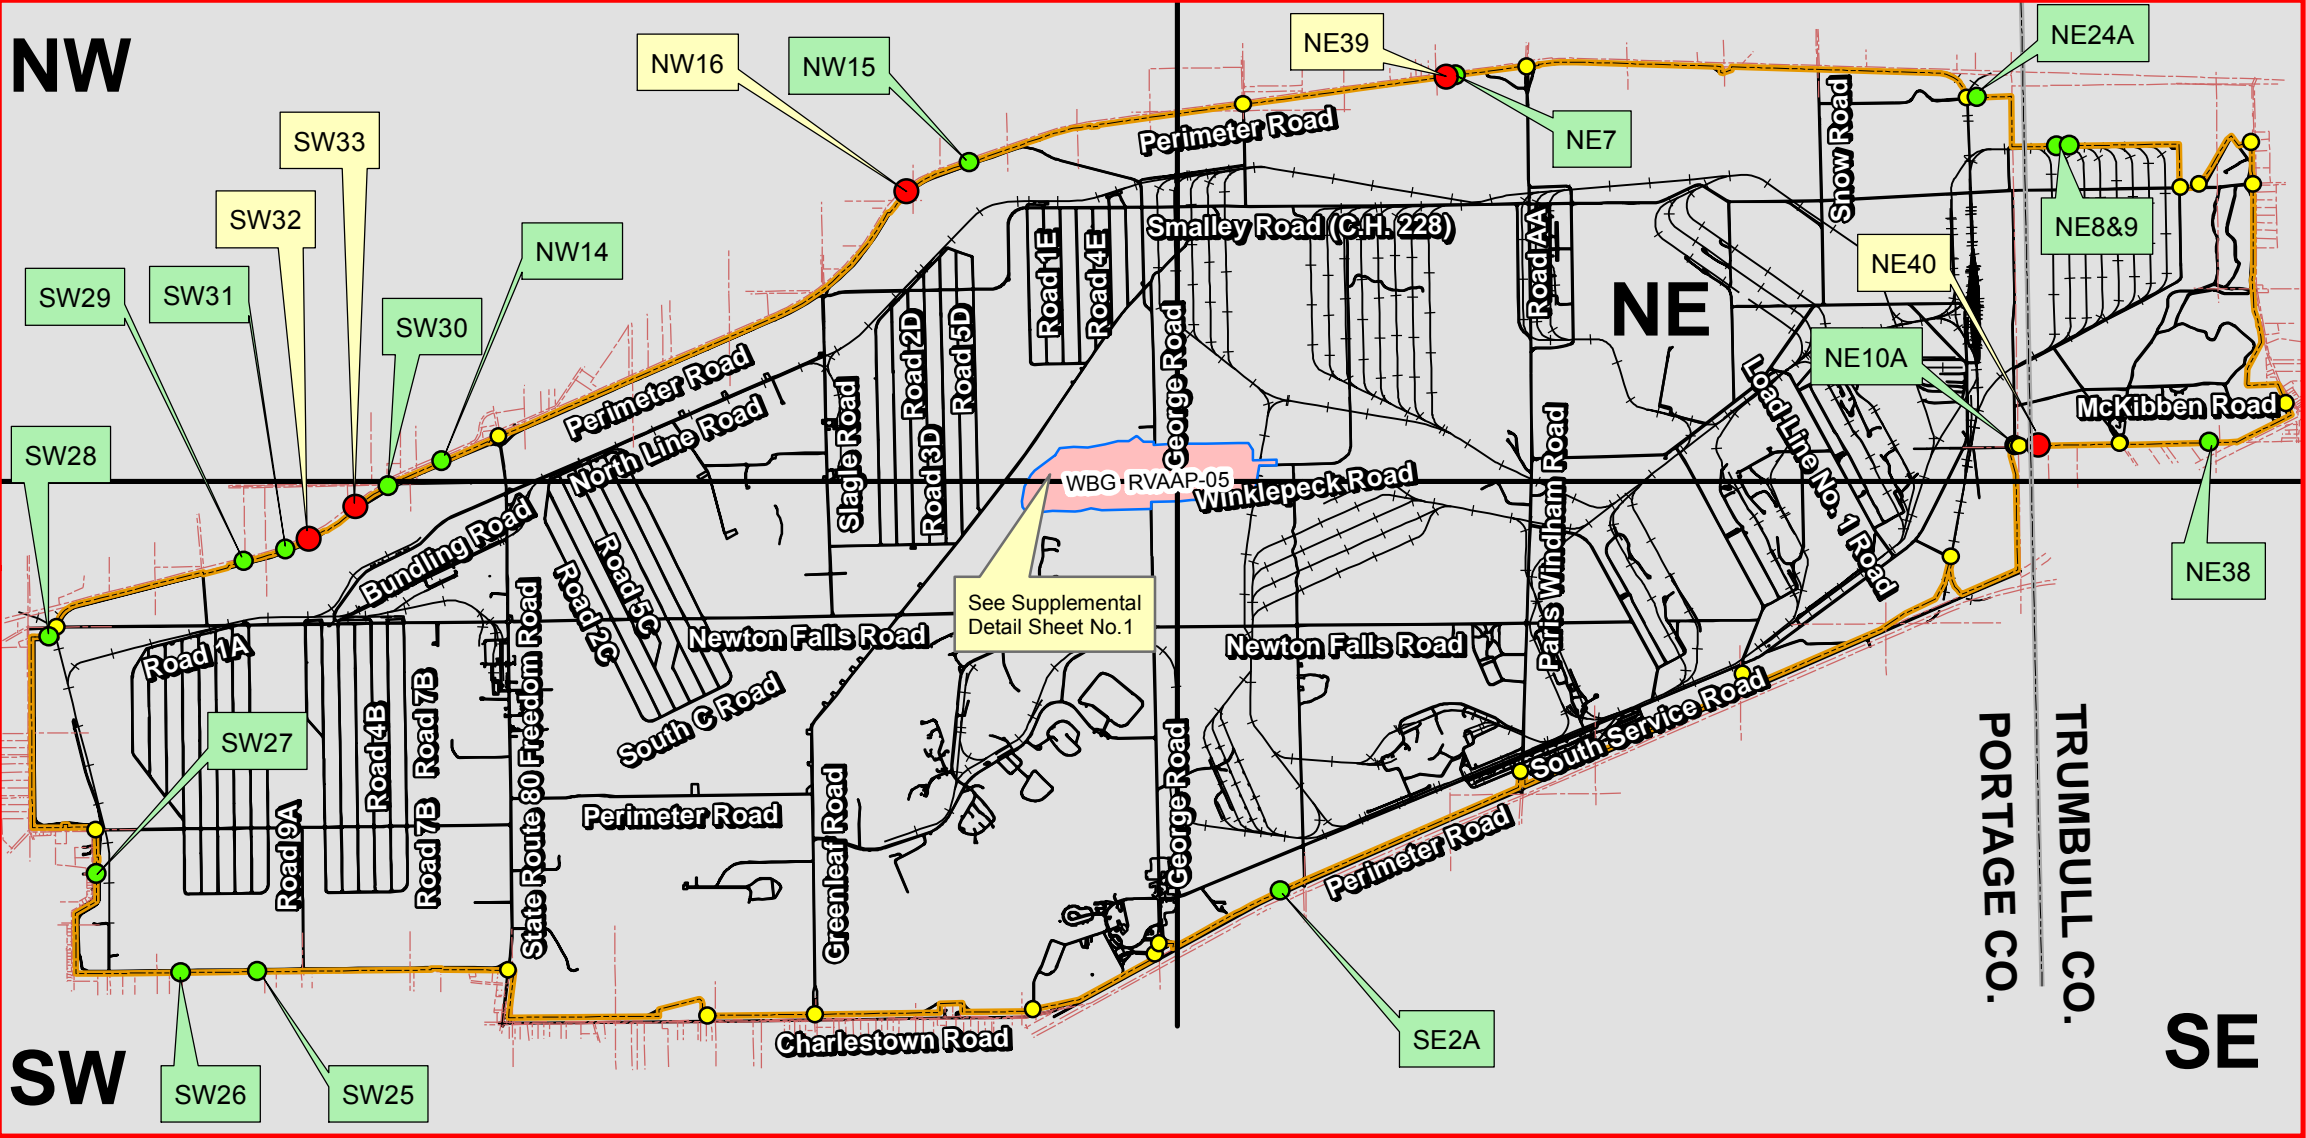
FIGURE 1 INDEX MAP TO FACILITY PERIMETER FENCE INSPECTION

- Opening in fence (2'±) and/or fabric missing/damaged (5 locations)
- Repaired (16 Locations)
- Gates (26 locations for reference only, no detail sheets)
All gates appear to be maintained and are in working order

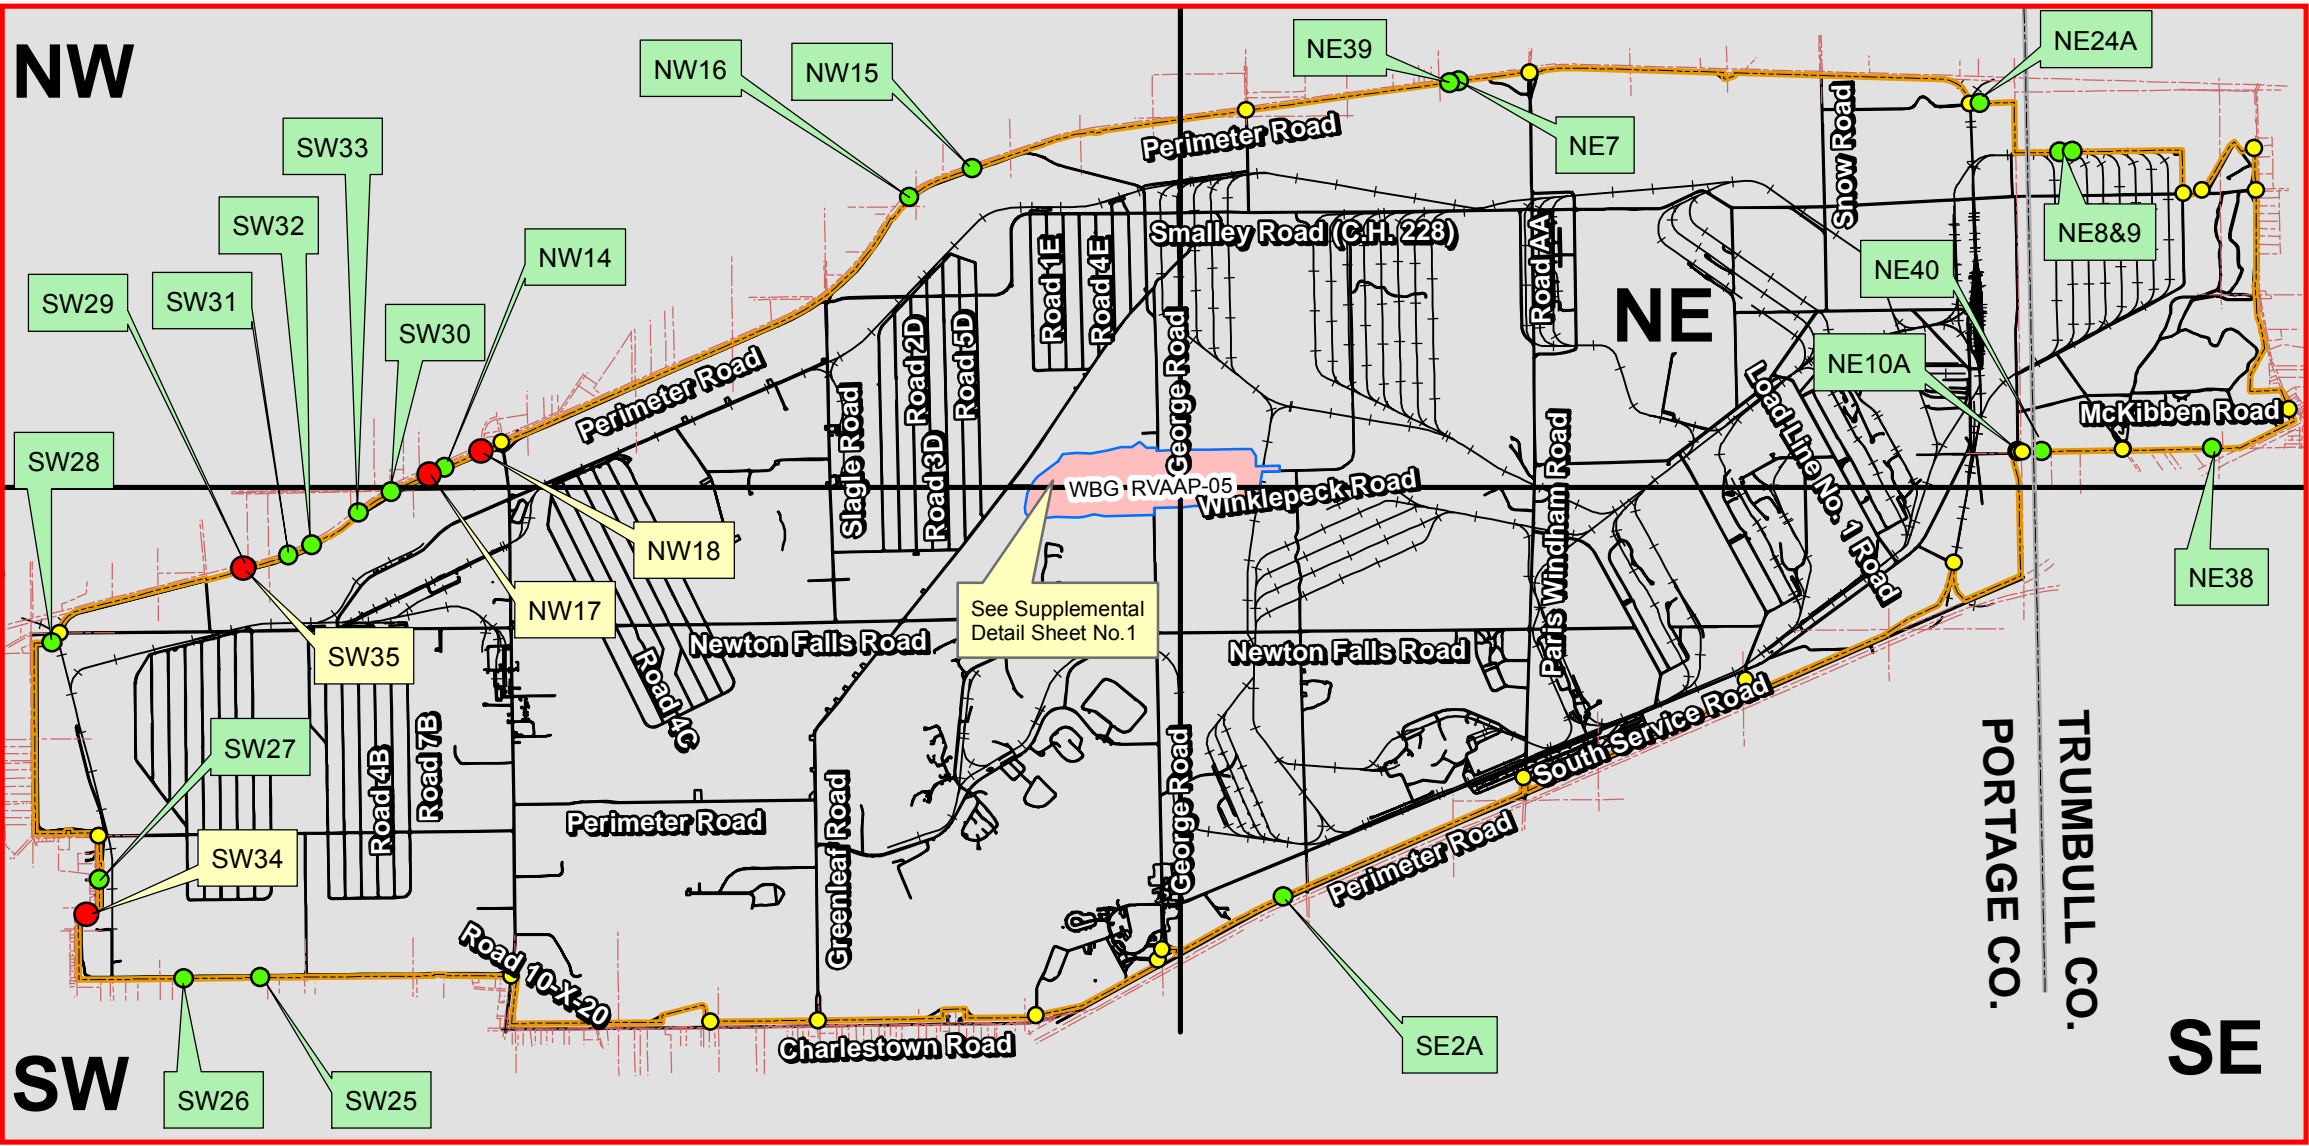
FIGURE 1 INDEX MAP TO FACILITY PERIMETER FENCE INSPECTION

- Opening in fence (2'≥) and/or fabric missing/damaged (4 locations)
- Repaired (21 Locations)
- Gates (26 locations for reference only, no detail sheets)
All gates appear to be maintained and are in working order

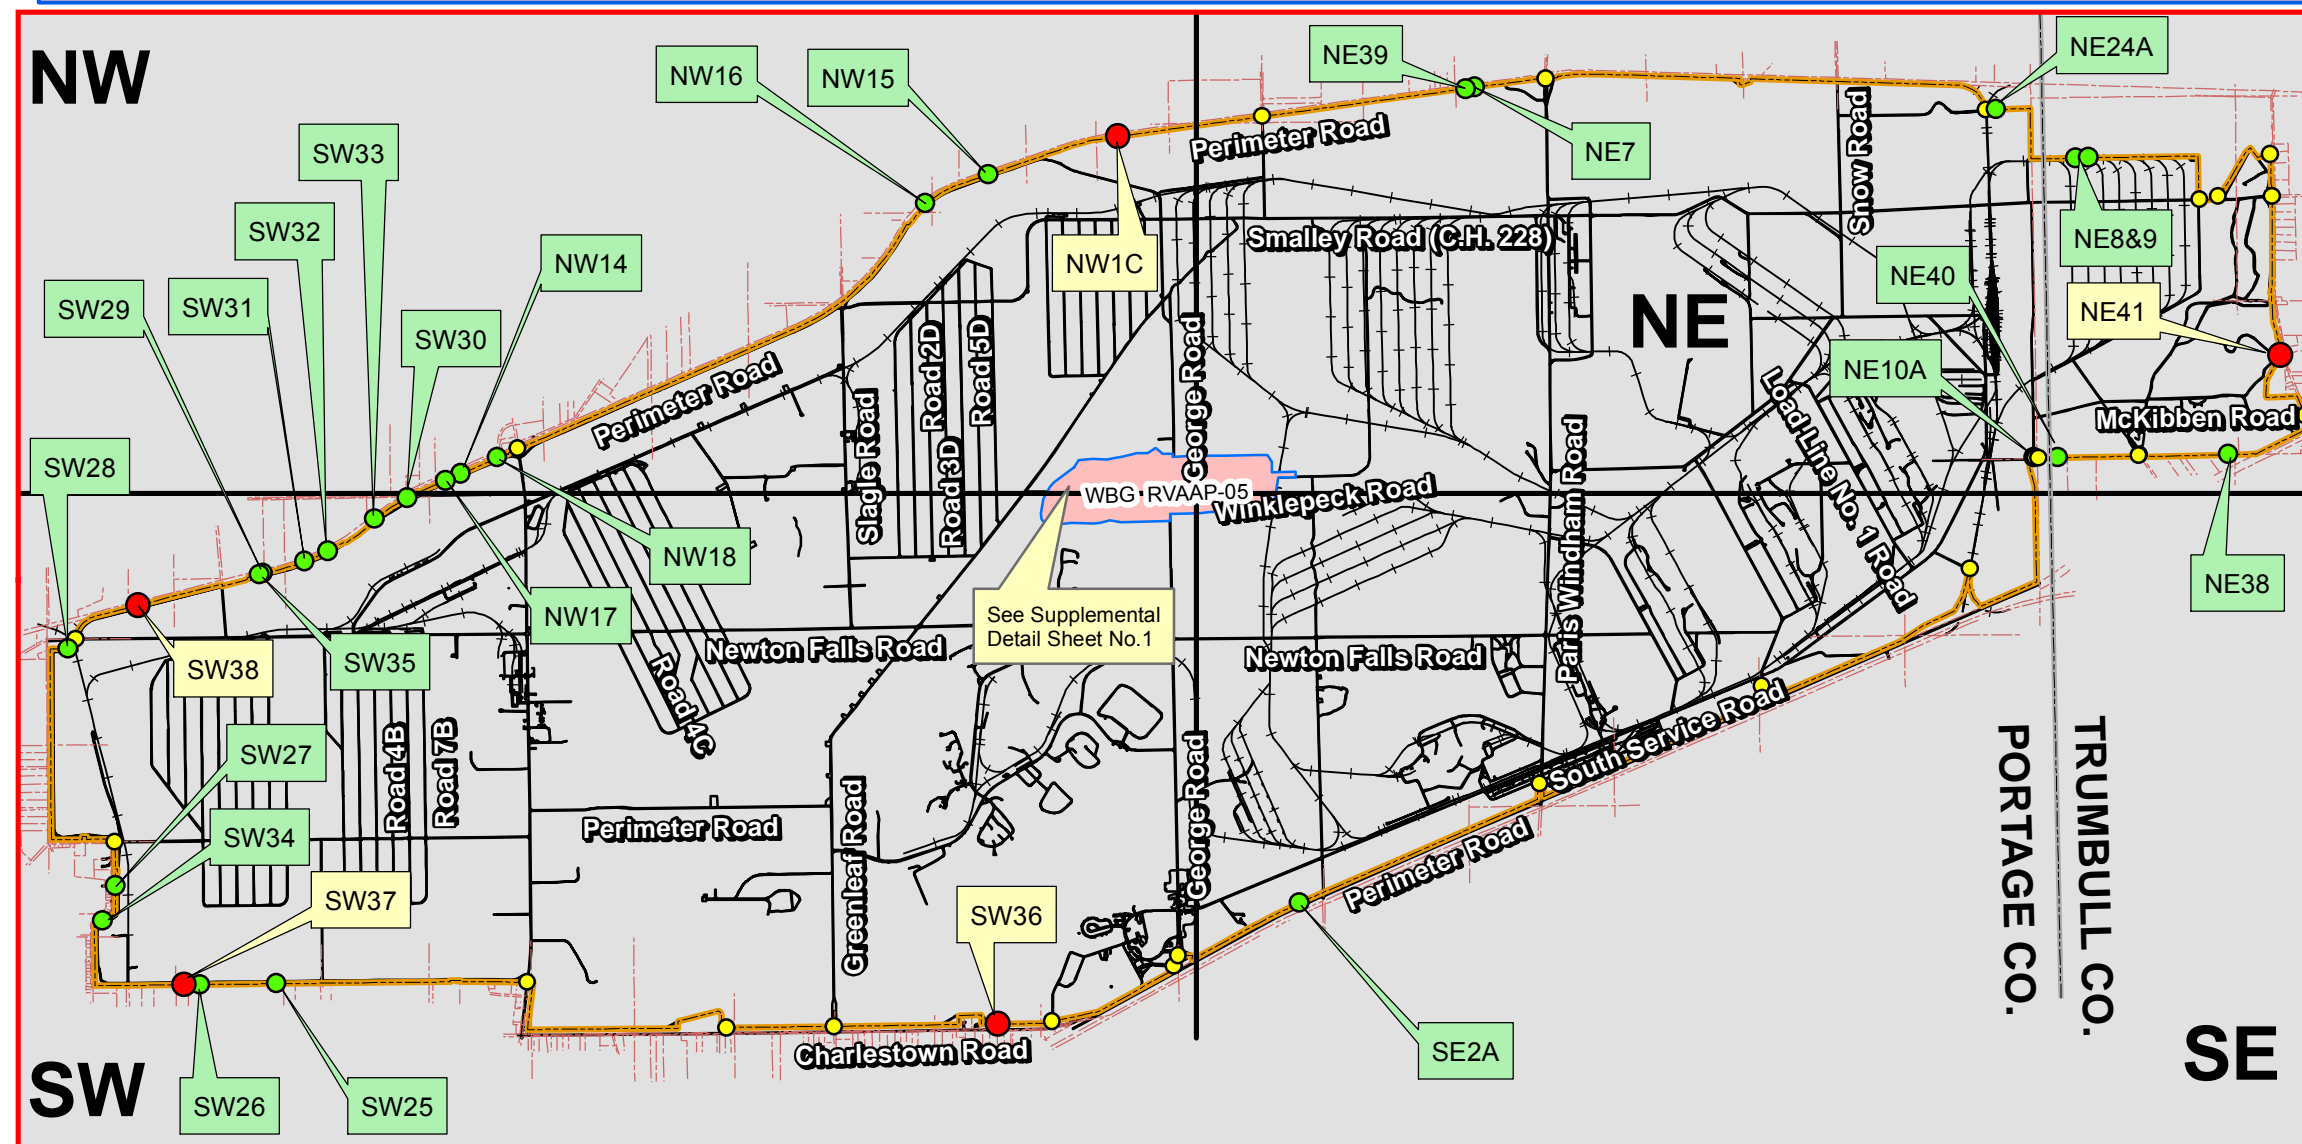
FIGURE 1 INDEX MAP TO FACILITY PERIMETER FENCE INSPECTION

- Opening in fence (2'±) and/or fabric missing/damaged (5 locations)
- Repaired (25 Locations)
- Gates (26 locations for reference only, no detail sheets)
All gates appear to be maintained and are in working order
