1. REPORT DATE (DD-MM-YYYY) 13-02-2015		2. REPORT TYPE Draft			3. DATES COVERED (From - To) November 2011 to September 2013	
4. TITLE AND SUBTITLE Remedial Investigation Report for RVAAP-032-R-01 40mm Firing Range MRS, Version 1.0				5a. CONTRACT NUMBER W912DR-09-D-0005		
				5b. GRANT NUMBER N/A		
				5c. PROGRAM ELEMENT NUMBER N/A		
				5d. PROJECT NUMBER 136147

6. AUTHOR(S) Rachel Daly, David Crispo, P.E.				5e. TASK NUMBER 1300120		
				5f. WORK UNIT NUMBER N/A		
7. PERFORMING ORGANIZATION NAME(S) AND ADDRESS(ES) CB&I Federal Services LLC 150 Royall Street Canton, MA 02021				8. PERFORMING ORGANIZATION REPORT NUMBER N/A

14. ABSTRACT This Remedial Investigation (RI) Report presents the findings and conclusions of the RI field activities conducted at the RVAAP-032-R-01 40mm Firing Range Munitions Response Site (MRS) between November 2011 and February 2012 at the former Ravenna Army Ammunition Plant. The purpose of the RI Report was to determine whether the 40mm Firing Range MRS warranted further response action pursuant to the Comprehensive Environmental Response, Compensation, and Liability Act of 1980 and the National Oil and Hazardous Substances Pollution Contingency Plan. M

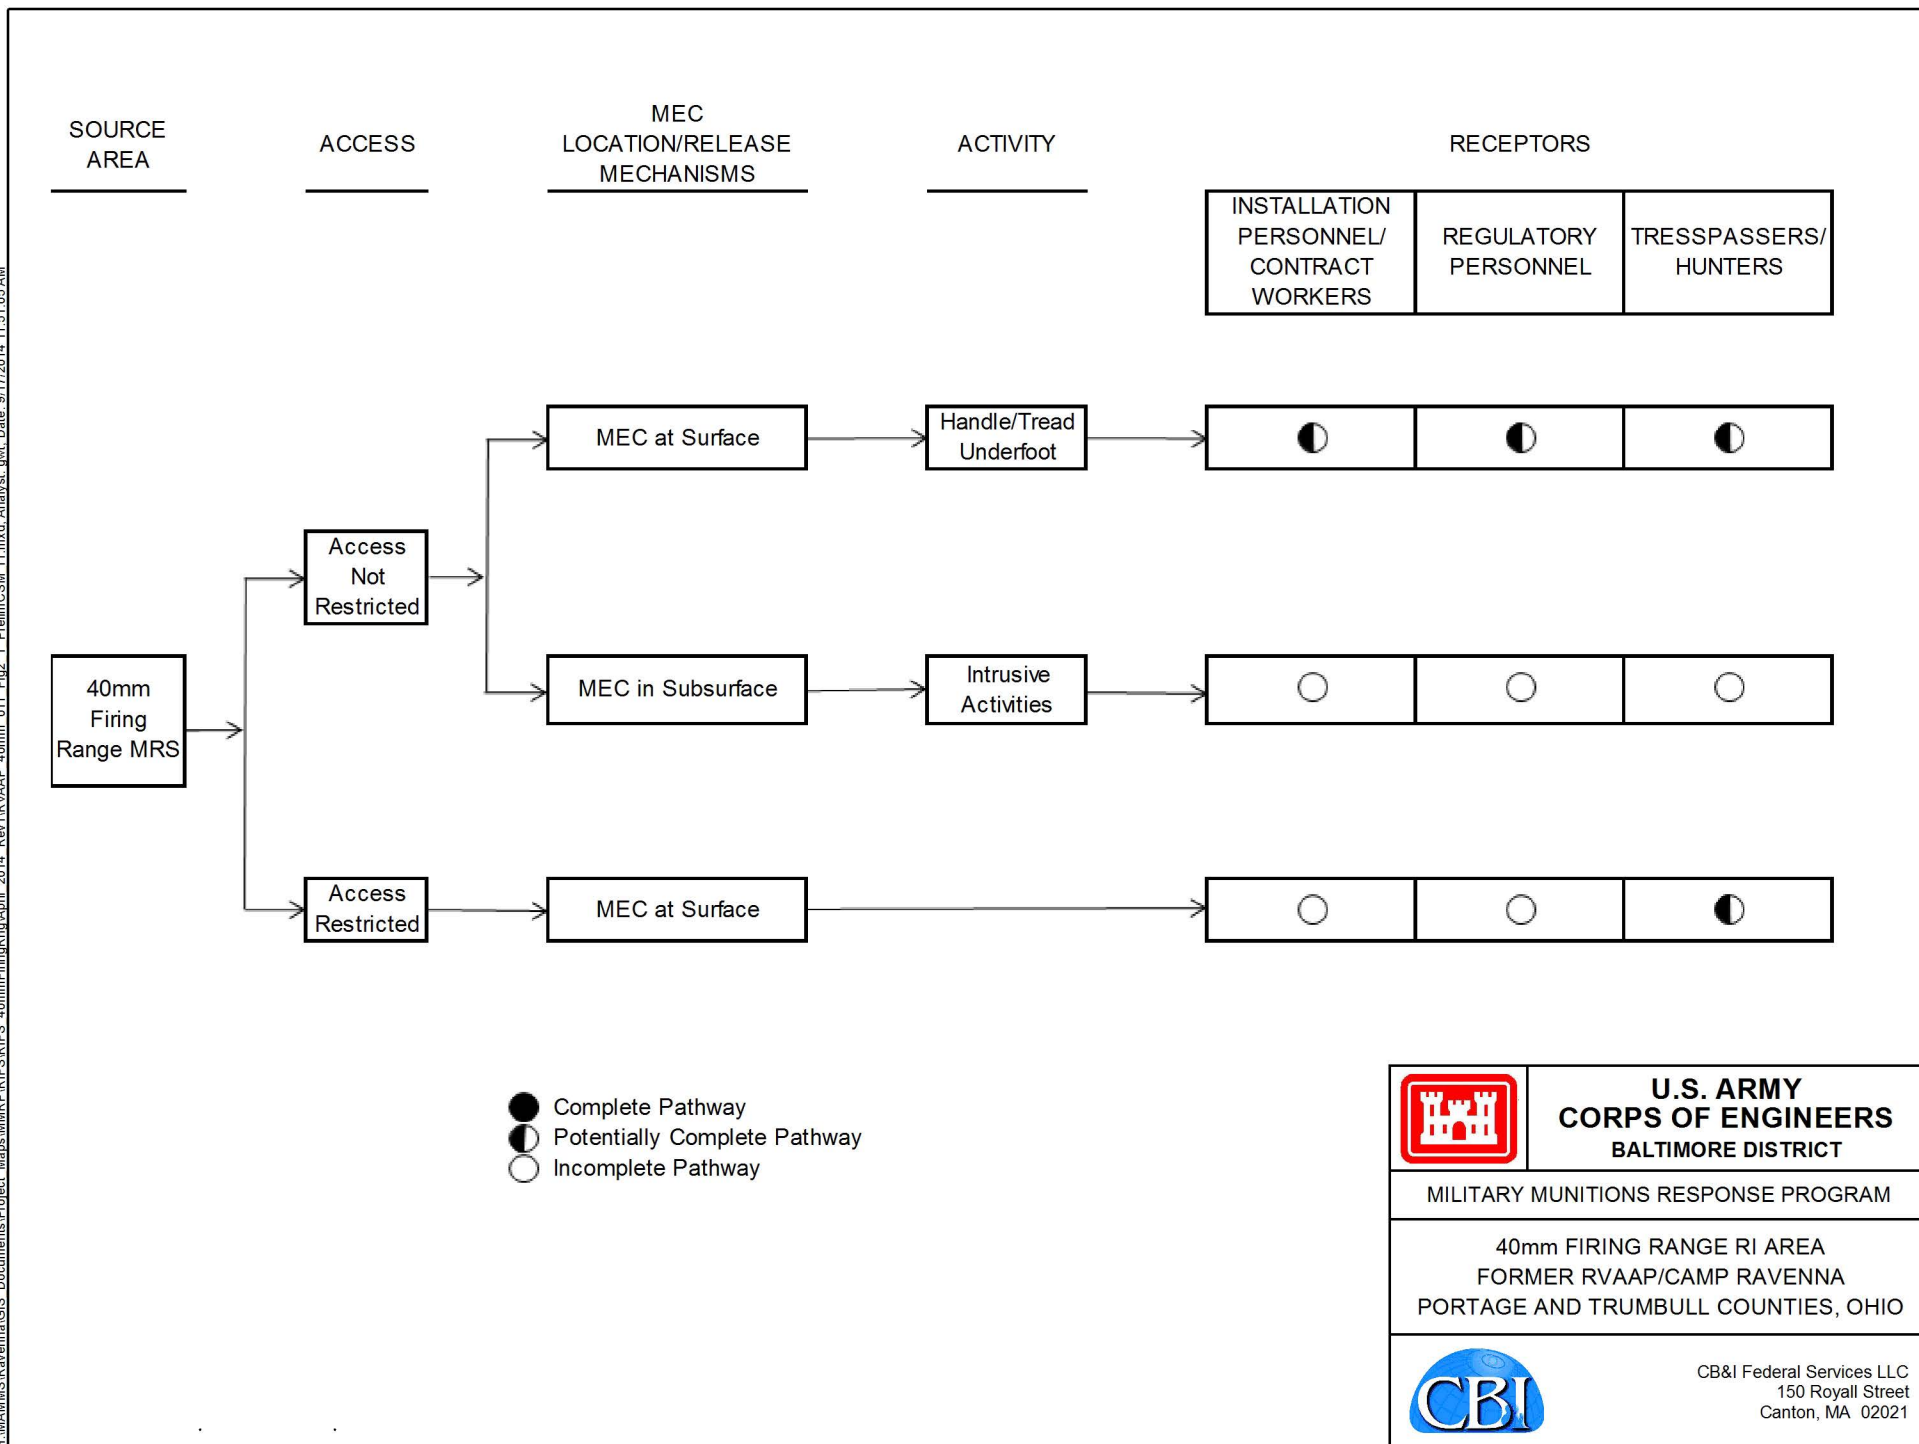
FIGURE 2-1 PRELIMINARY MEC CONCEPTUAL SITE MODEL

- **Sources**—Use of the area as a target/test range for 40mm grenade cartridges was considered to be the primary source of potentially explosive MEC at the 40mm Firing Range MRS. Based on review of archival records and available documentation, the principle source area at the 40mm Firing Range is the impact area and downrange of the target area which resulted in the potential for MEC to be present in surface and subsurface soils.

- **Activity**—Human activities considered for the preliminary CSM included natural resource management and maintenance activities that were performed at an infrequent basis.
- **Access**—Access to the 40mm Firing Range MRS at the time of the SI was not restricted, and there were no known access controls present.
- **Receptors**—At the time of the SI, current and reasonably anticipated receptors for MEC included facility personnel, contractors (including maintenance personnel), regulatory personnel, and possibly trespassers and hunters. The ecological receptors (biota) identified in the SI Report (e²M, 2008) were the state-listed species identified as being present at the facility and listed in **Table 1-3**. If present, MEC on the ground surface and subsurface could have been accessed by receptors.

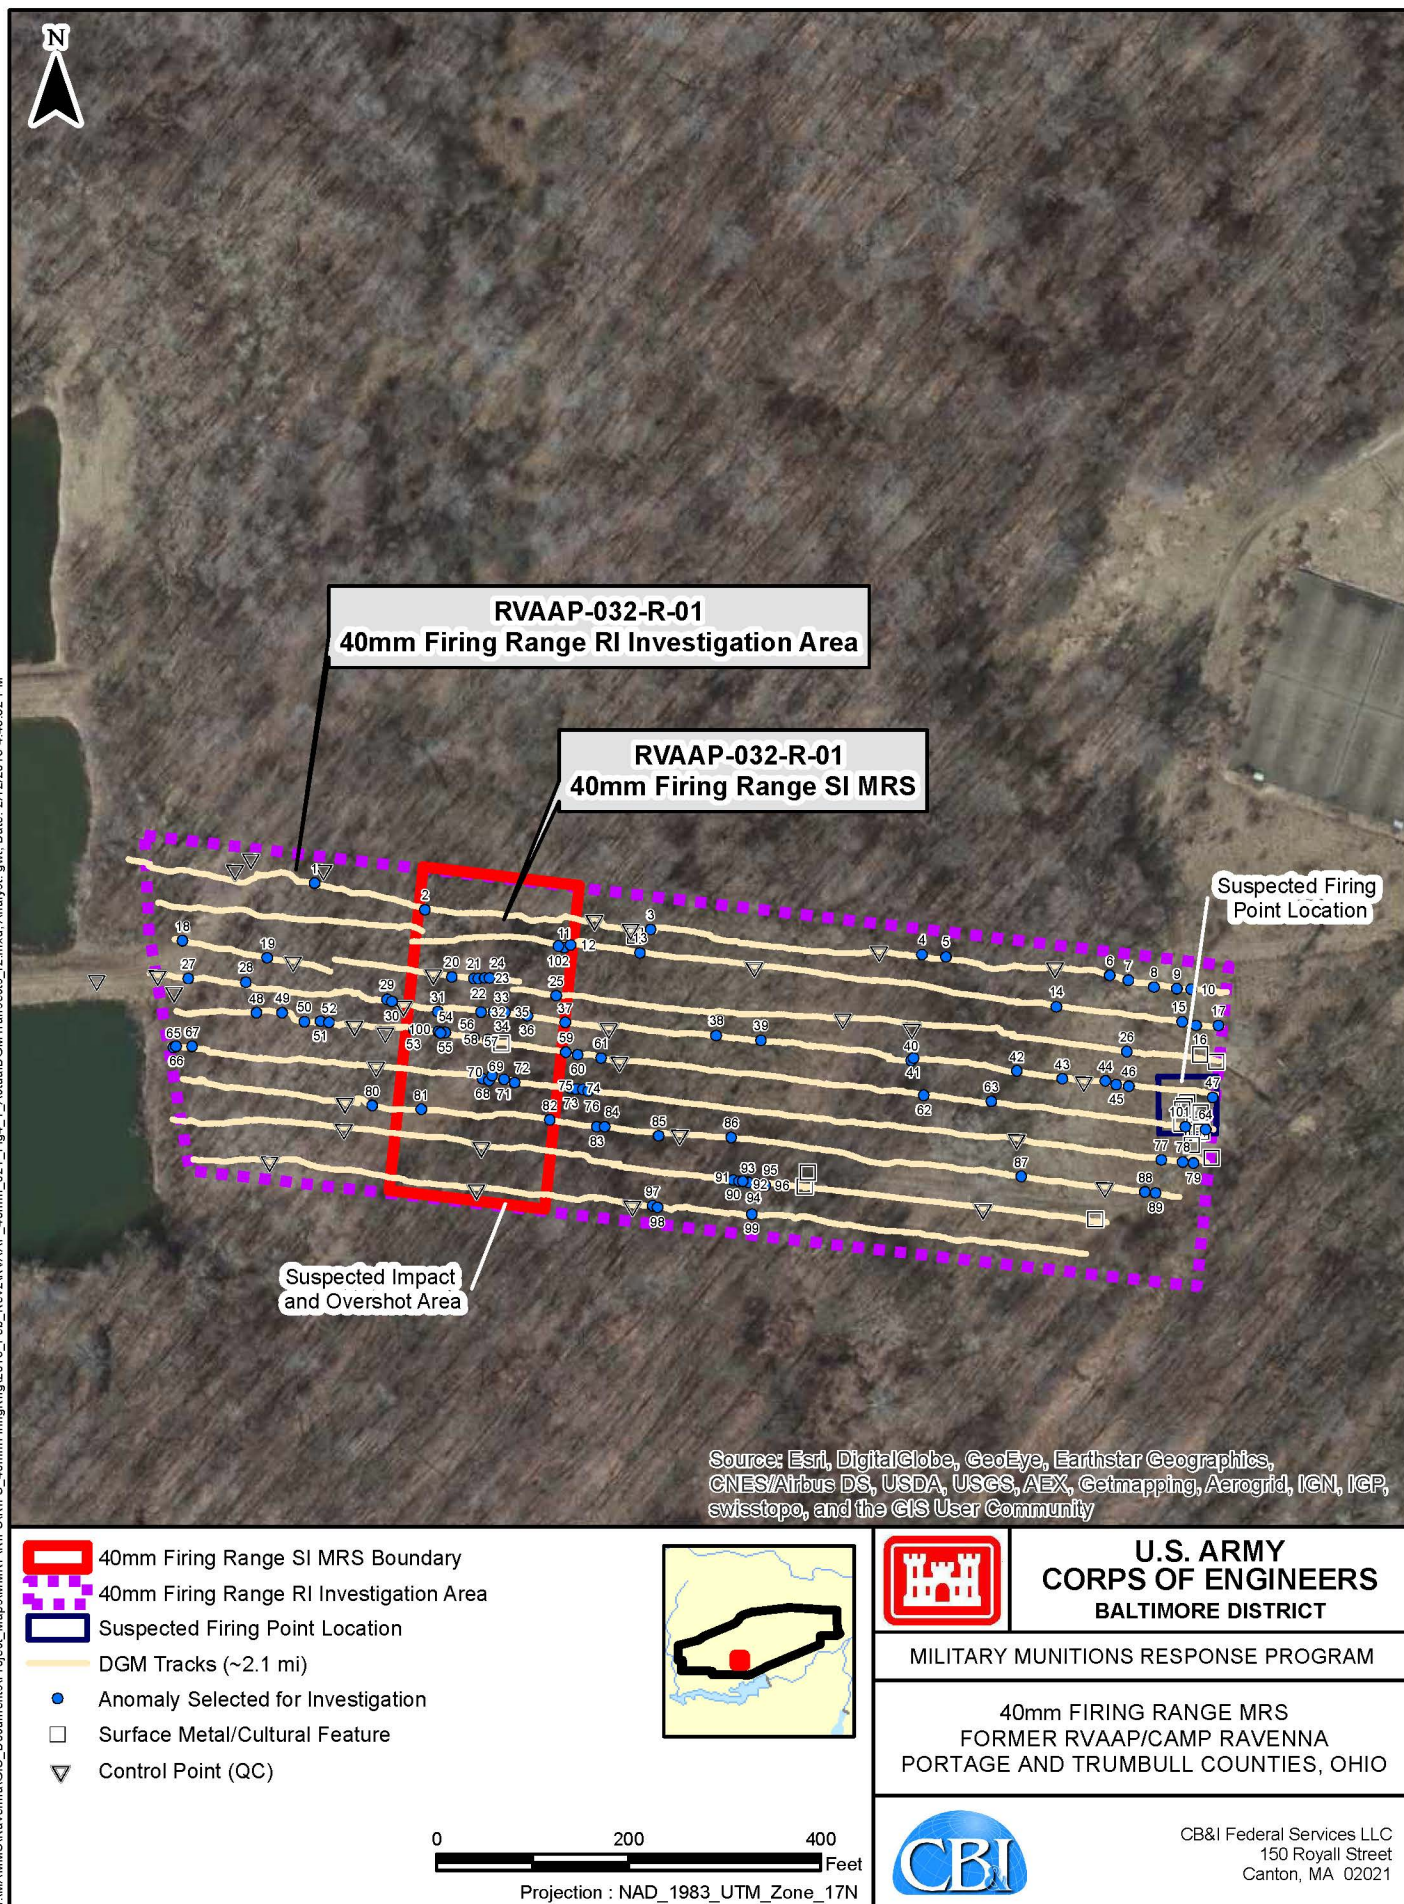
FIGURE 4-1 ACTUAL DGM TRANSECTS

Figure 4-1 illustrates transects where the areas of actual DGM survey coverage were performed during the RI field activities in addition to the anomalies selected for intrusive investigation along those transects. **Figure 4-2** and **Figure 4-3** display the results of the EM61-MK2 survey. **Figure 4-2** provides a sensitive color-scale that highlights all single point anomalies above a signal threshold of 8 mV, while **Figure 4-3** uses a coarse color-scale to delineate the major aggregates of buried metal with increased definition.
