**Remedial Action Report
for Soil, Sediment, and Surface Water
at RVAAP-48 Anchor Test Area**

**Ravenna Army Ammunition Plant
Portage and Trumbull Counties, Ohio**

**Contract No. W912QR-04-D-0028
Delivery Order No. 0001**

April 16, 2015

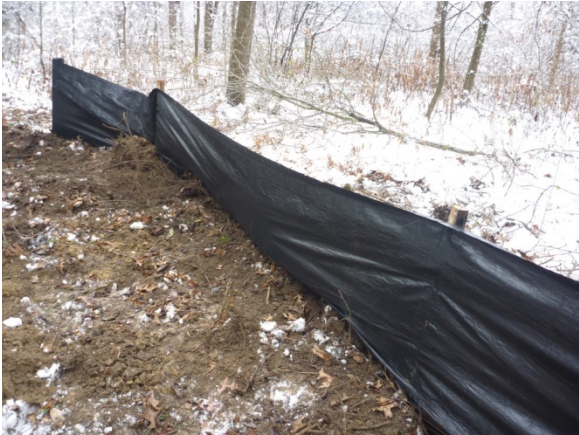
Photograph 5-1. Silt Fence Installed Downgradient of Excavation Area

In accordance with the RD, silt fencing was installed to prevent siltation from the construction area. In addition to the specifications of the RD, a straw bale check dam was placed within the ditch line paralleling Wilcox-Wayland Road immediately down gradient of the haul route access point. Photograph 5-1 shows the silt fence, and Photograph 5-2 shows the straw bale check dam. Excavation areas were opened at the beginning of each day and covered with impermeable plastic sheeting at the end of each day's activities, where appropriate. Stormwater controls were inspected by the Leidos Construction Manager on a daily basis during construction activities and on a weekly basis between construction phases. Completed reports are presented in Appendix E.

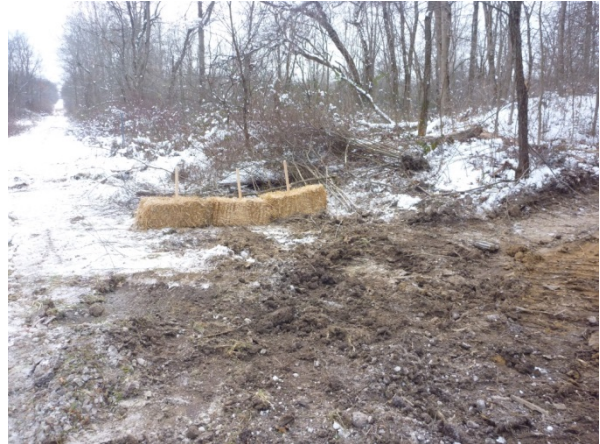
Photograph 5-2. Straw Bale Check Dam Paralleling Wilcox-Wayland Road

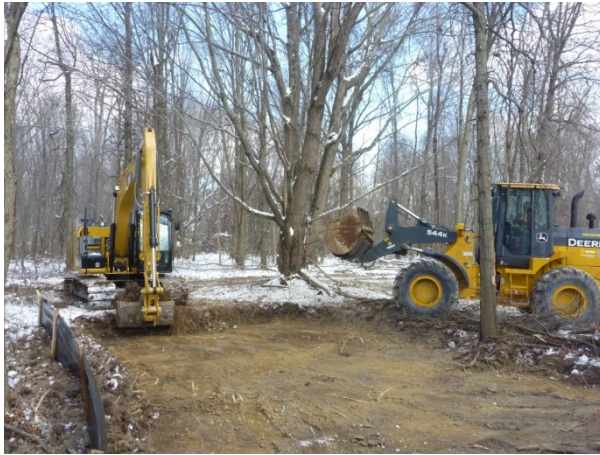
Photograph 6-1. Removing Surface Soil from Anchor Test Area

Soil removal activities began on November 18, 2014 and were completed on November 19, 2014. During the soil removal activities, a total of 45 tons of non-hazardous soil was placed in roll-off boxes, staged on site in the parking lot of Building 1036, and transported for acceptance to Envirite of Ohio in Canton, Ohio. The following sections describe the soil removal activities in further detail.

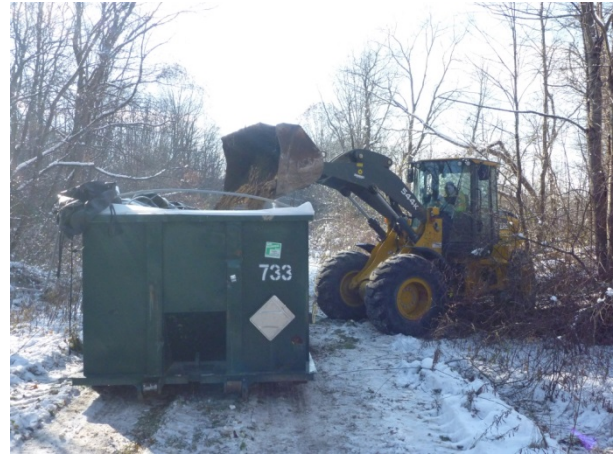
Photograph 6-2. Loading Contaminated Soil into Roll-off Box

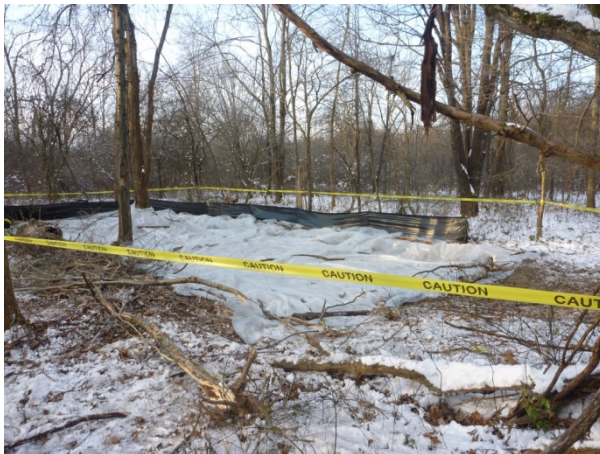
Photograph 6-3. Covered and Secured Excavated Area Upon Completing Soil Removal

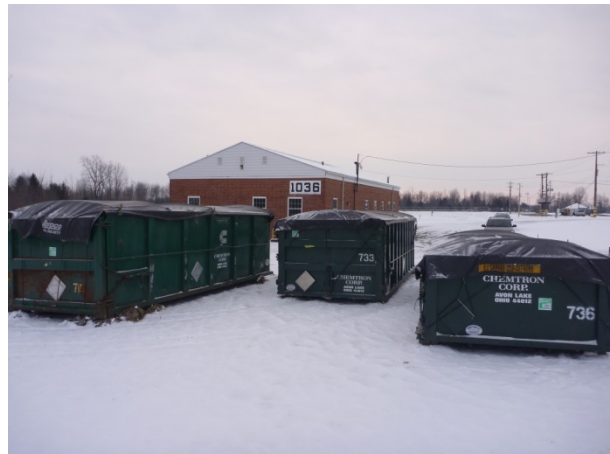
Photograph 6-4. Roll-off Boxes Staged at Building 1036 Parking Area

With the approval of the Camp Ravenna Environmental Office, the roll-off boxes were temporarily staged on site at the parking lot of Building 1036. On December 5, 2014 and December 6, 2014, all non-hazardous material was transported for acceptance to Envirite of Ohio, Inc. in Canton, Ohio. Photograph 6-3 shows the covered and secured excavated area after the soil removal activities took place. Photograph 6-4 shows the roll-off boxes staged at the Building 1036 parking area.

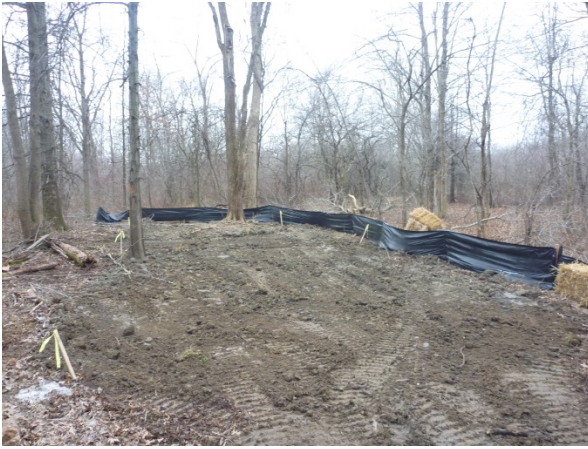
Photograph 7-1. Backfilled Excavation Area

Upon confirming that CUGs were attained and no further excavation was required, the excavation footprint was backfilled using soil from the approved source and graded to match the existing drainage pattern and neighboring and/or original elevations. The backfill material was graded and compacted. Photograph 7-1 shows the backfilled excavation area, and Photograph 7-2 shows the excavation area after seeding and mulching.

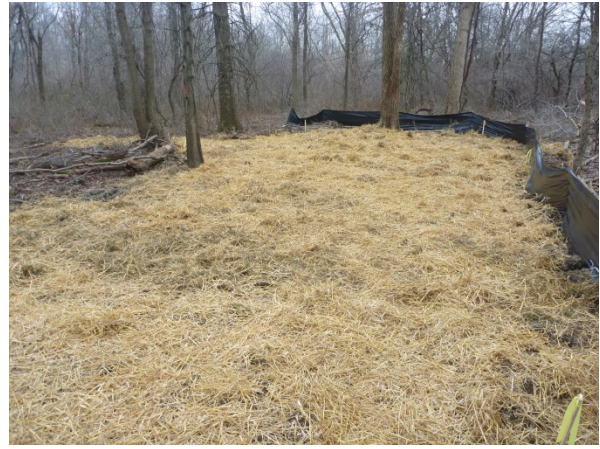
Photograph 7-2. Excavation Area after Backfill, Seeding, and Mulching

Re-vegetation and re-seeding of disturbed area took place during the week of December 8, 2014. Re-seeding the areas was performed with the prescribed seed mixtures detailed in Tables 8-3 and 8-4 of the RD. At the time of submission of this RAR, Leidos will continue to perform weekly inspections of the site and the silt fencing to ensure the storm water controls are intact. The inspection frequency may be reduced to at least once per month if runoff is unlikely due to weather conditions (e.g., snow, ice, ground frozen). Once vegetation is established to 70 percent coverage, the silt fencing and other storm water controls will be removed and disposed.
