1. REPORT DATE (DD-MM-YYYY) 25-08-2014		2. REPORT TYPE Final		3. DATES COVERED (From - To) June - October 2011		
4. TITLE AND SUBTITLE Remedial Investigation Report for RVAAP-050-R-01 Atlas Scrap Yard MRS, Version 2.0				5a. CONTRACT NUMBER W912DR-09-D-0005		
				5b. GRANT NUMBER N/A		
				5c. PROGRAM ELEMENT NUMBER N/A		
				5d. PROJECT NUMBER 136147

14. ABSTRACT This Remedial Investigation (RI) Report presents the findings and conclusions of the RI field activities conducted at the RVAAP-050-R-01 Atlas Scrap Yard Munitions Response Site (MRS) between June and October 2011 at the Ravenna Army Ammunition Plant. The purpose of the RI is to determine whether the Atlas Scrap Yard MRS warrants further response action pursuant to the Comprehensive Environmental Response, Compensation, and Liability Act of 1980 and the National Oil and Hazardous Substances Pollution Control Plan. More specifically, the RI is intended to determine the nature and extent of munitions and explosives of concern (MEC) and munitions constituents (MC) and subsequently determine the likely hazards and risks posed to human and environmental receptors by MEC and MC. This RI Report also presents additional data to

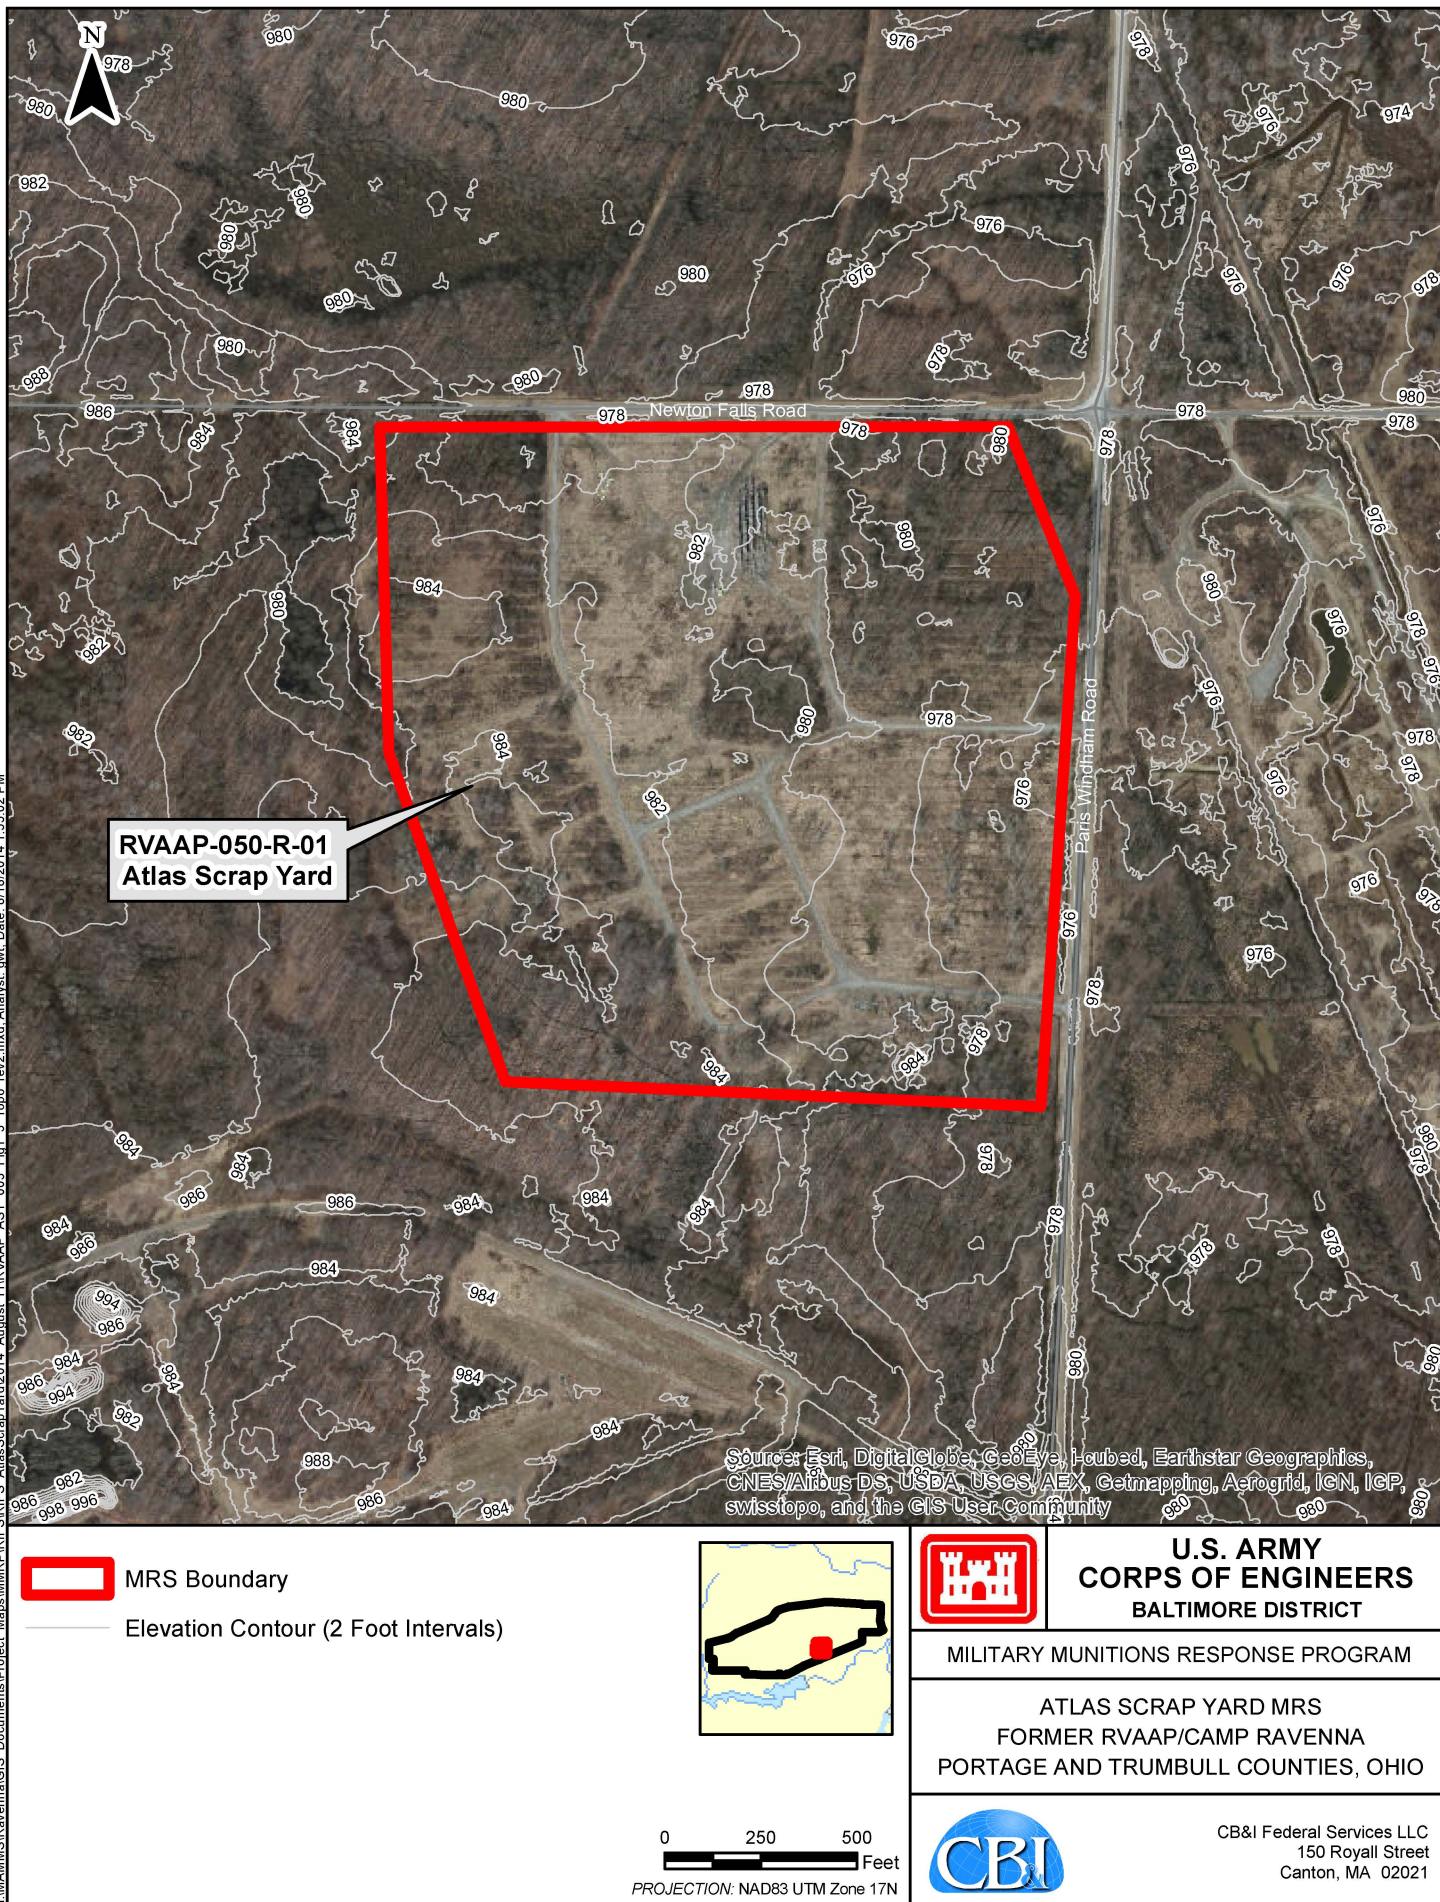
H:\MAMMS\RavennaGIS Documents\Project Maps\MMR\PRIS\AtlasScrapYard2014_August_r1\RAAP_ASY_003_Fig1_3_Topo_rev2.mxd, Analyst: gwt, Date: 8/18/2014 1:55:02 PM

The topography at the Atlas Scrap Yard MRS ranges from flat to gently rolling hills. The relative elevation at the MRS is approximately 980 feet above mean sea level. Natural drainage is toward the wetland area at the northeast portion of the MRS. The topographical features at the Atlas Scrap Yard MRS are presented in **Figure 1-3**.

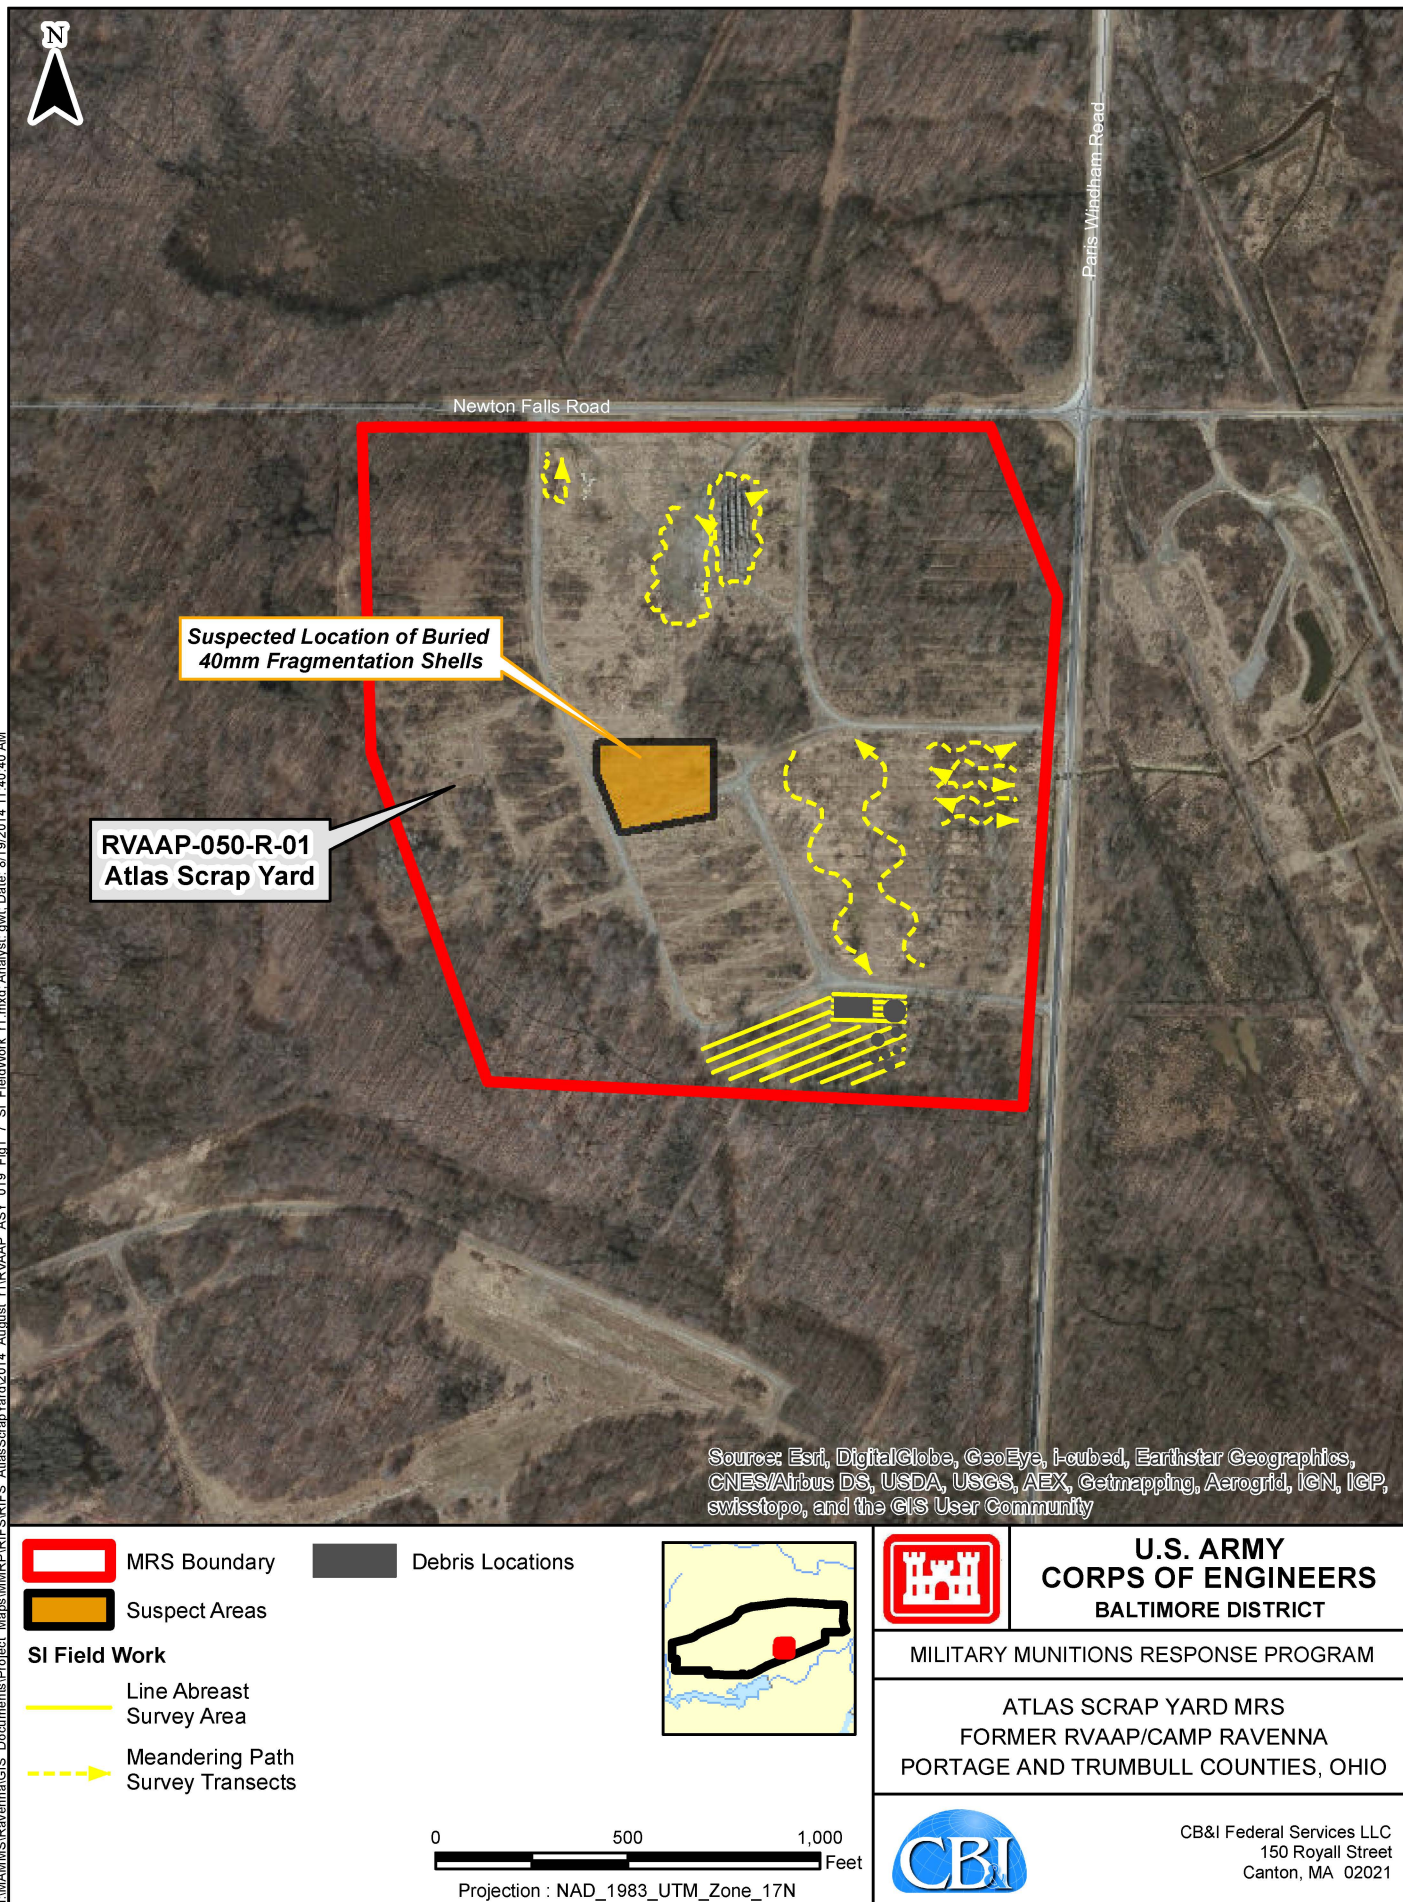
FIGURE 1-7 SI FIELD WORK AND FINDINGS

During the 2007 SI, an instrument- and metal-detector-assisted unexploded ordnance (UXO) survey was conducted in the south-central section of the MRS where MEC and MD were reported, and a meandering path survey was conducted around the remaining debris piles in the northern and eastern sections. No surface MEC or MD were found at any of the survey locations. The areas investigated at the Atlas Scrap Yard MRS during the SI field activities are presented on **Figure 1-7**.

At the time of the 2007 SI, the presence of demolition debris limited access to the south-central portion of the MRS. A few scattered subsurface anomalies were detected within this area and multiple subsurface anomalies were detected around three piles of debris; however, interference from the metal scrap in the debris piles may have been significant. Very few subsurface anomalies were recorded in the east-central portion of the MRS. As the potential 40 mm fragmentation shell burial area was identified after the completion of the SI field activities; it was not included in the SI survey.
