2.0 ENVIRONMENTAL SETTING

This chapter describes the physical characteristics of Load Line 3 and the surrounding environment that are factors in understanding potential contaminant transport pathways, receptors, and exposure scenarios for human health and ecological risks. The geology, hydrology, climate, and ecological characteristics of RVAAP were originally presented in Chapter 3.0 of the Phase I RI (USACE 1998). The preliminary CSM for Load Line 3 is presented at the end of this chapter.

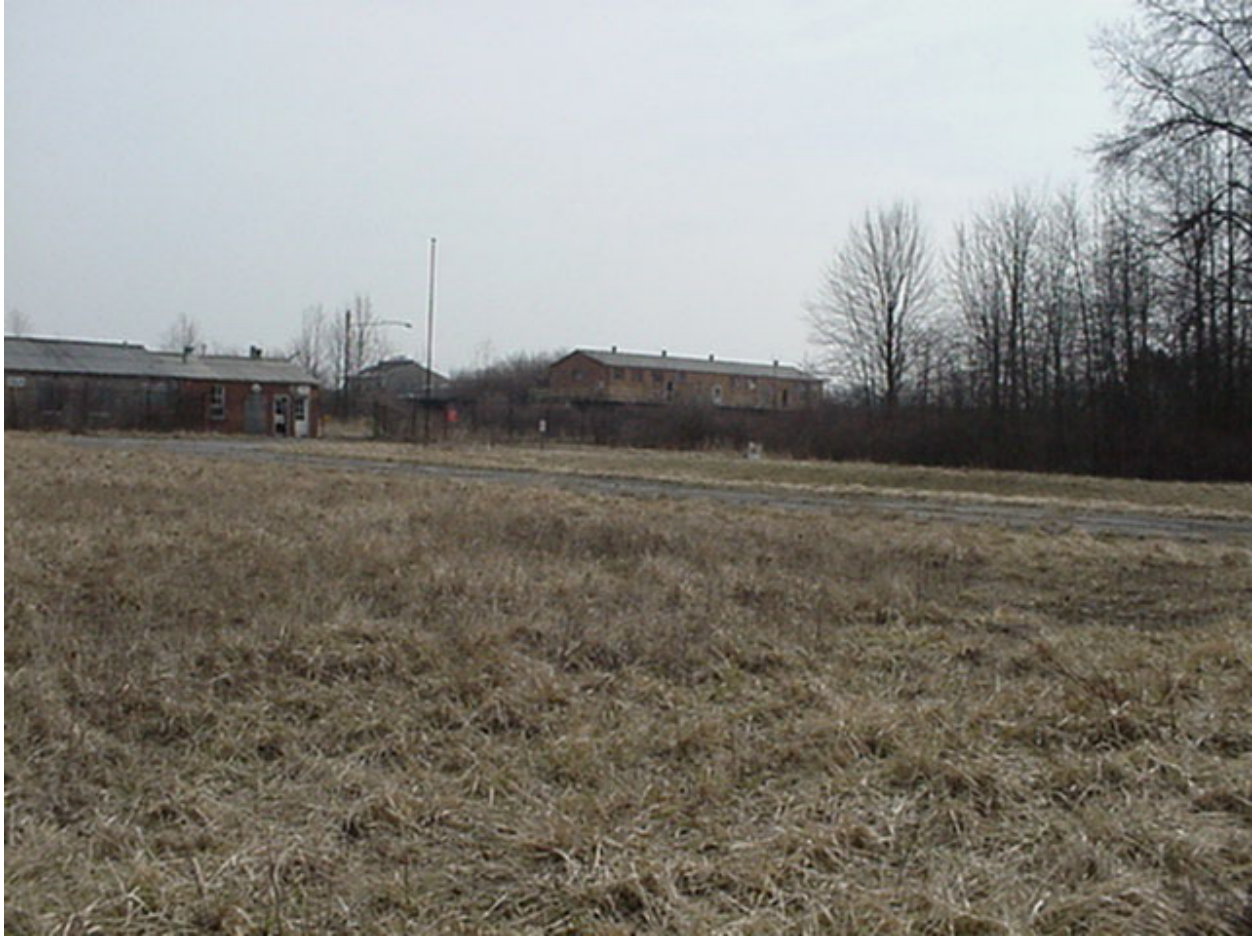
Figure 2-1. Site Conditions at Load Line 3, March 2003

Load Line 3 is situated in the southeastern quadrant of the RVAAP facility, as shown in [Figure 1-2](#). The load line is characterized by sloping topography on a reworked sandstone bedrock surface. Topography of Load Line 3 was mapped by USACE in 1998 on a 0.6-m (2-ft) contour interval, with an accuracy of 0.006 m (0.02 ft), from aerial photographs taken in 1997. This survey is the basis for the topographic features presented in the figures in this Phase II RI report. Elevations within the bounds of the AOC vary from approximately 299 to 311 m (980 to 1,020 ft) above mean sea level (amsl). Topographic elevations across most of the AOC generally decrease from east to the west and north towards Cobb's Pond and the stream entering Cobb's Pond. Along the southern most portion of the AOC, land surface elevations gently decrease to the south towards South Service Road. [Figure 2-1](#) illustrates current site conditions in the former production area (March 2003).

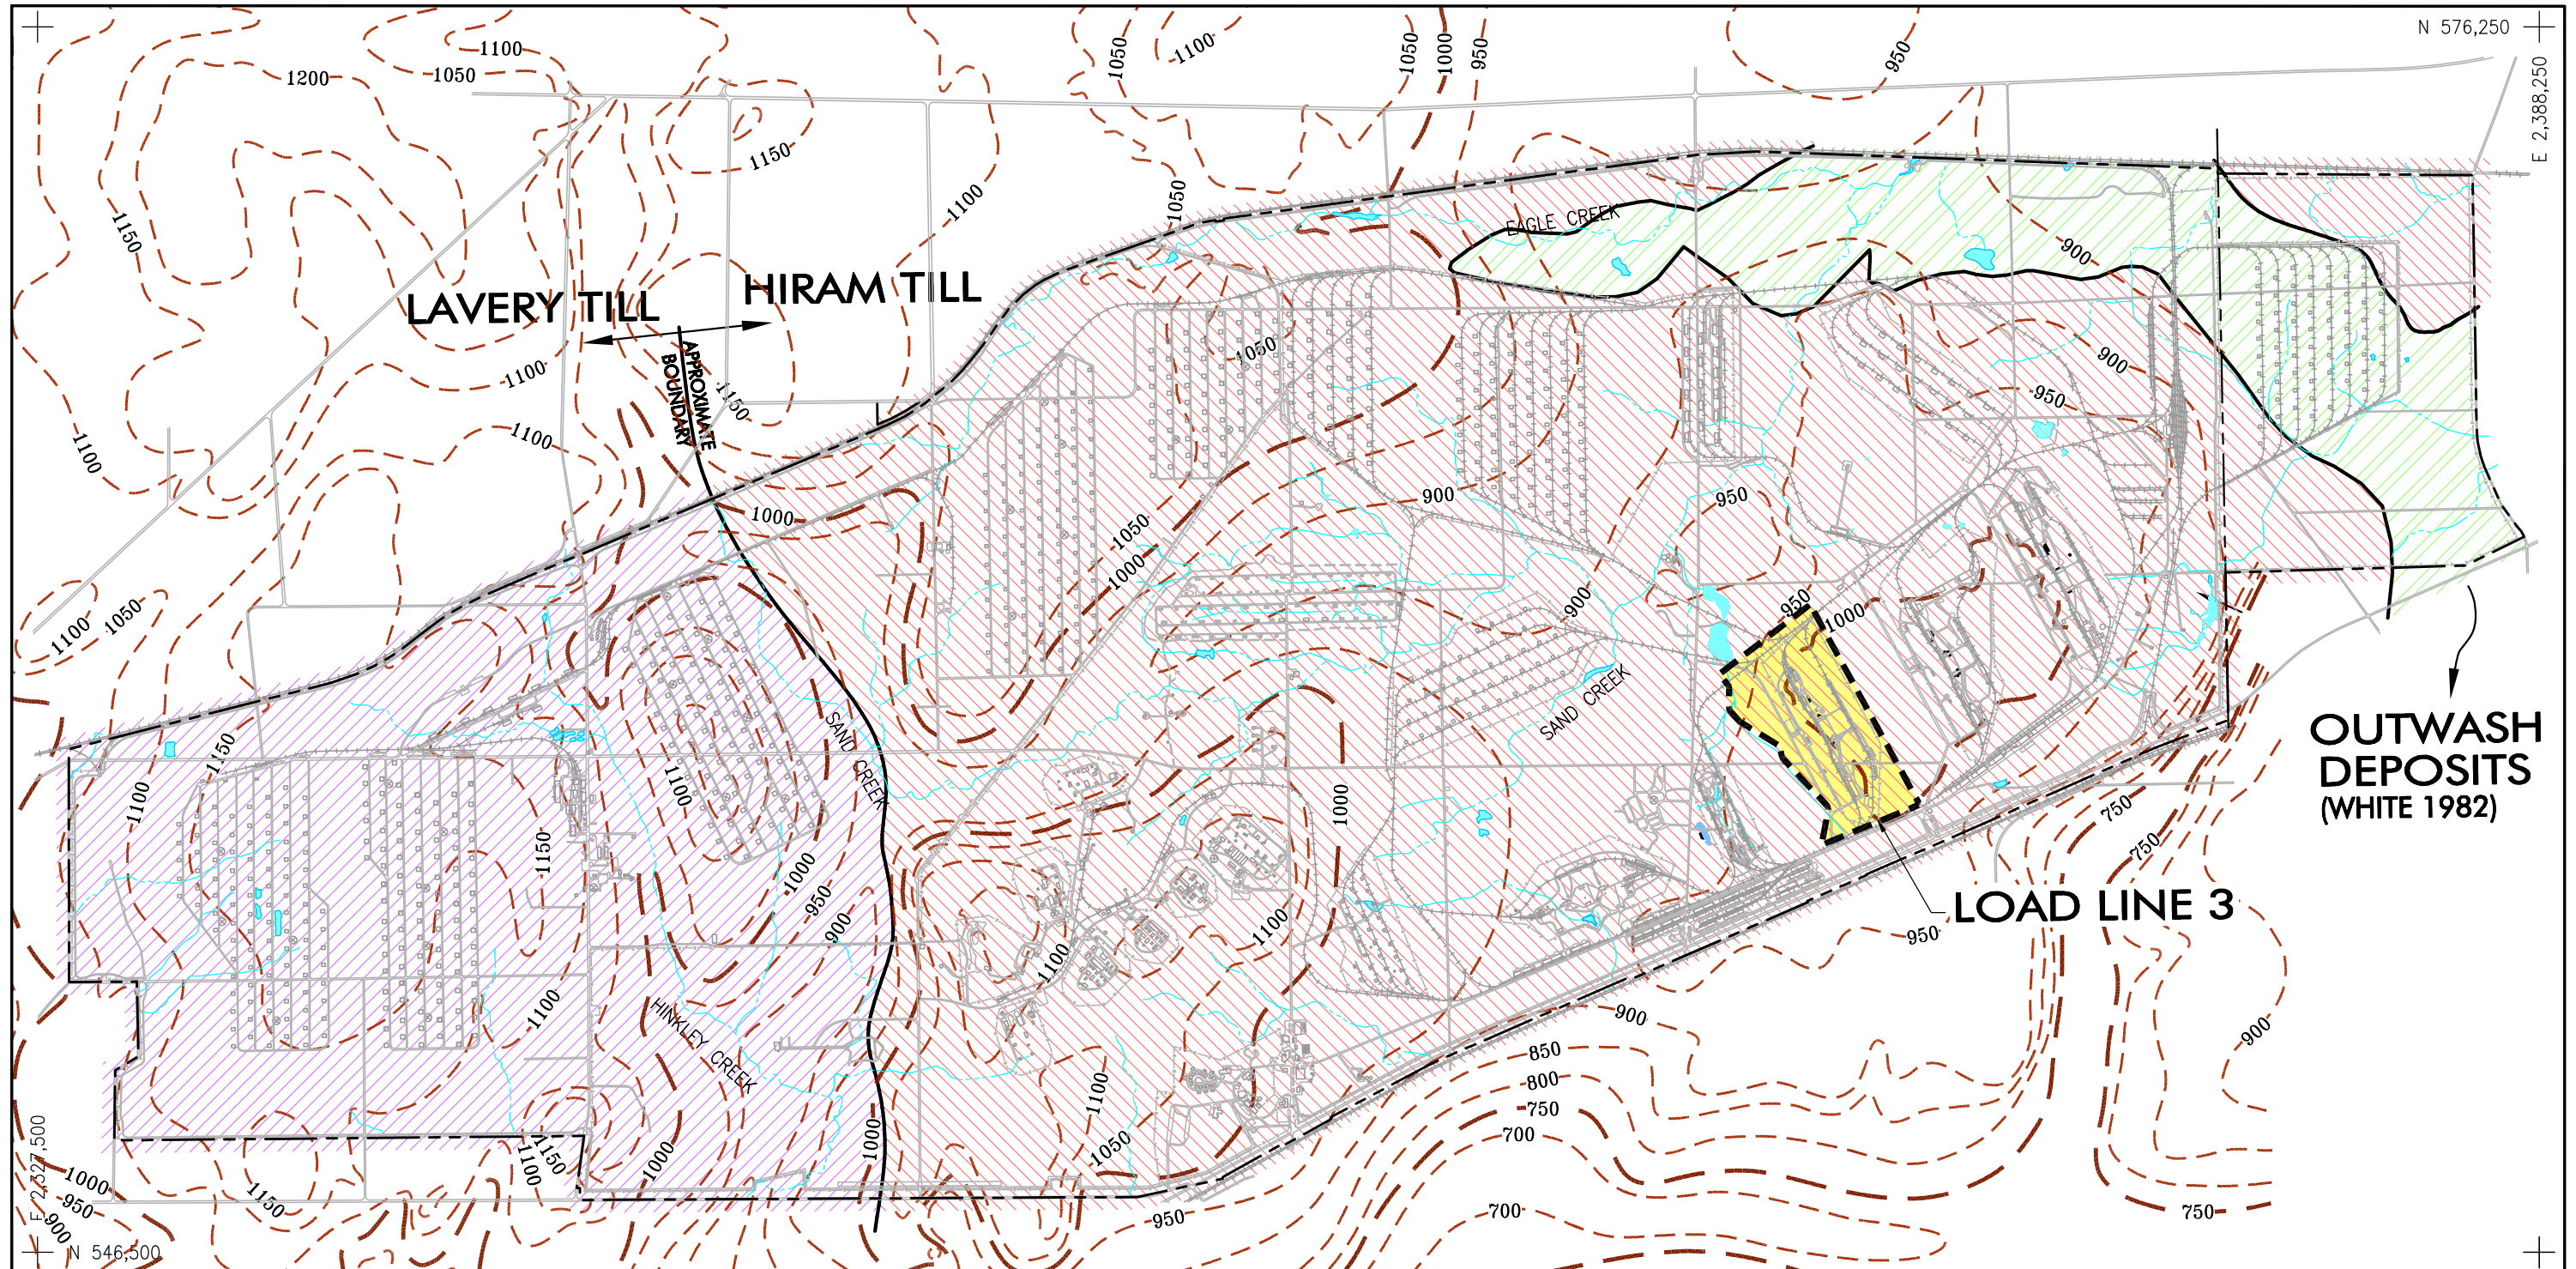
Figure 2-2. Geologic Map of Unconsolidated Deposits at RVAAP

Bedrock at RVAAP is overlain by deposits of the Wisconsin-aged Lavery Till in the western portion of the facility and the younger Hiram Till and associated outwash deposits in the eastern portion (Figure 2-2) (ODNR 1982). Unconsolidated glacial deposits vary considerably in their character and thickness across RVAAP, with these deposits absent in some of the eastern portions of the facility to an estimated 46 m (150 ft) in the south-central portion.

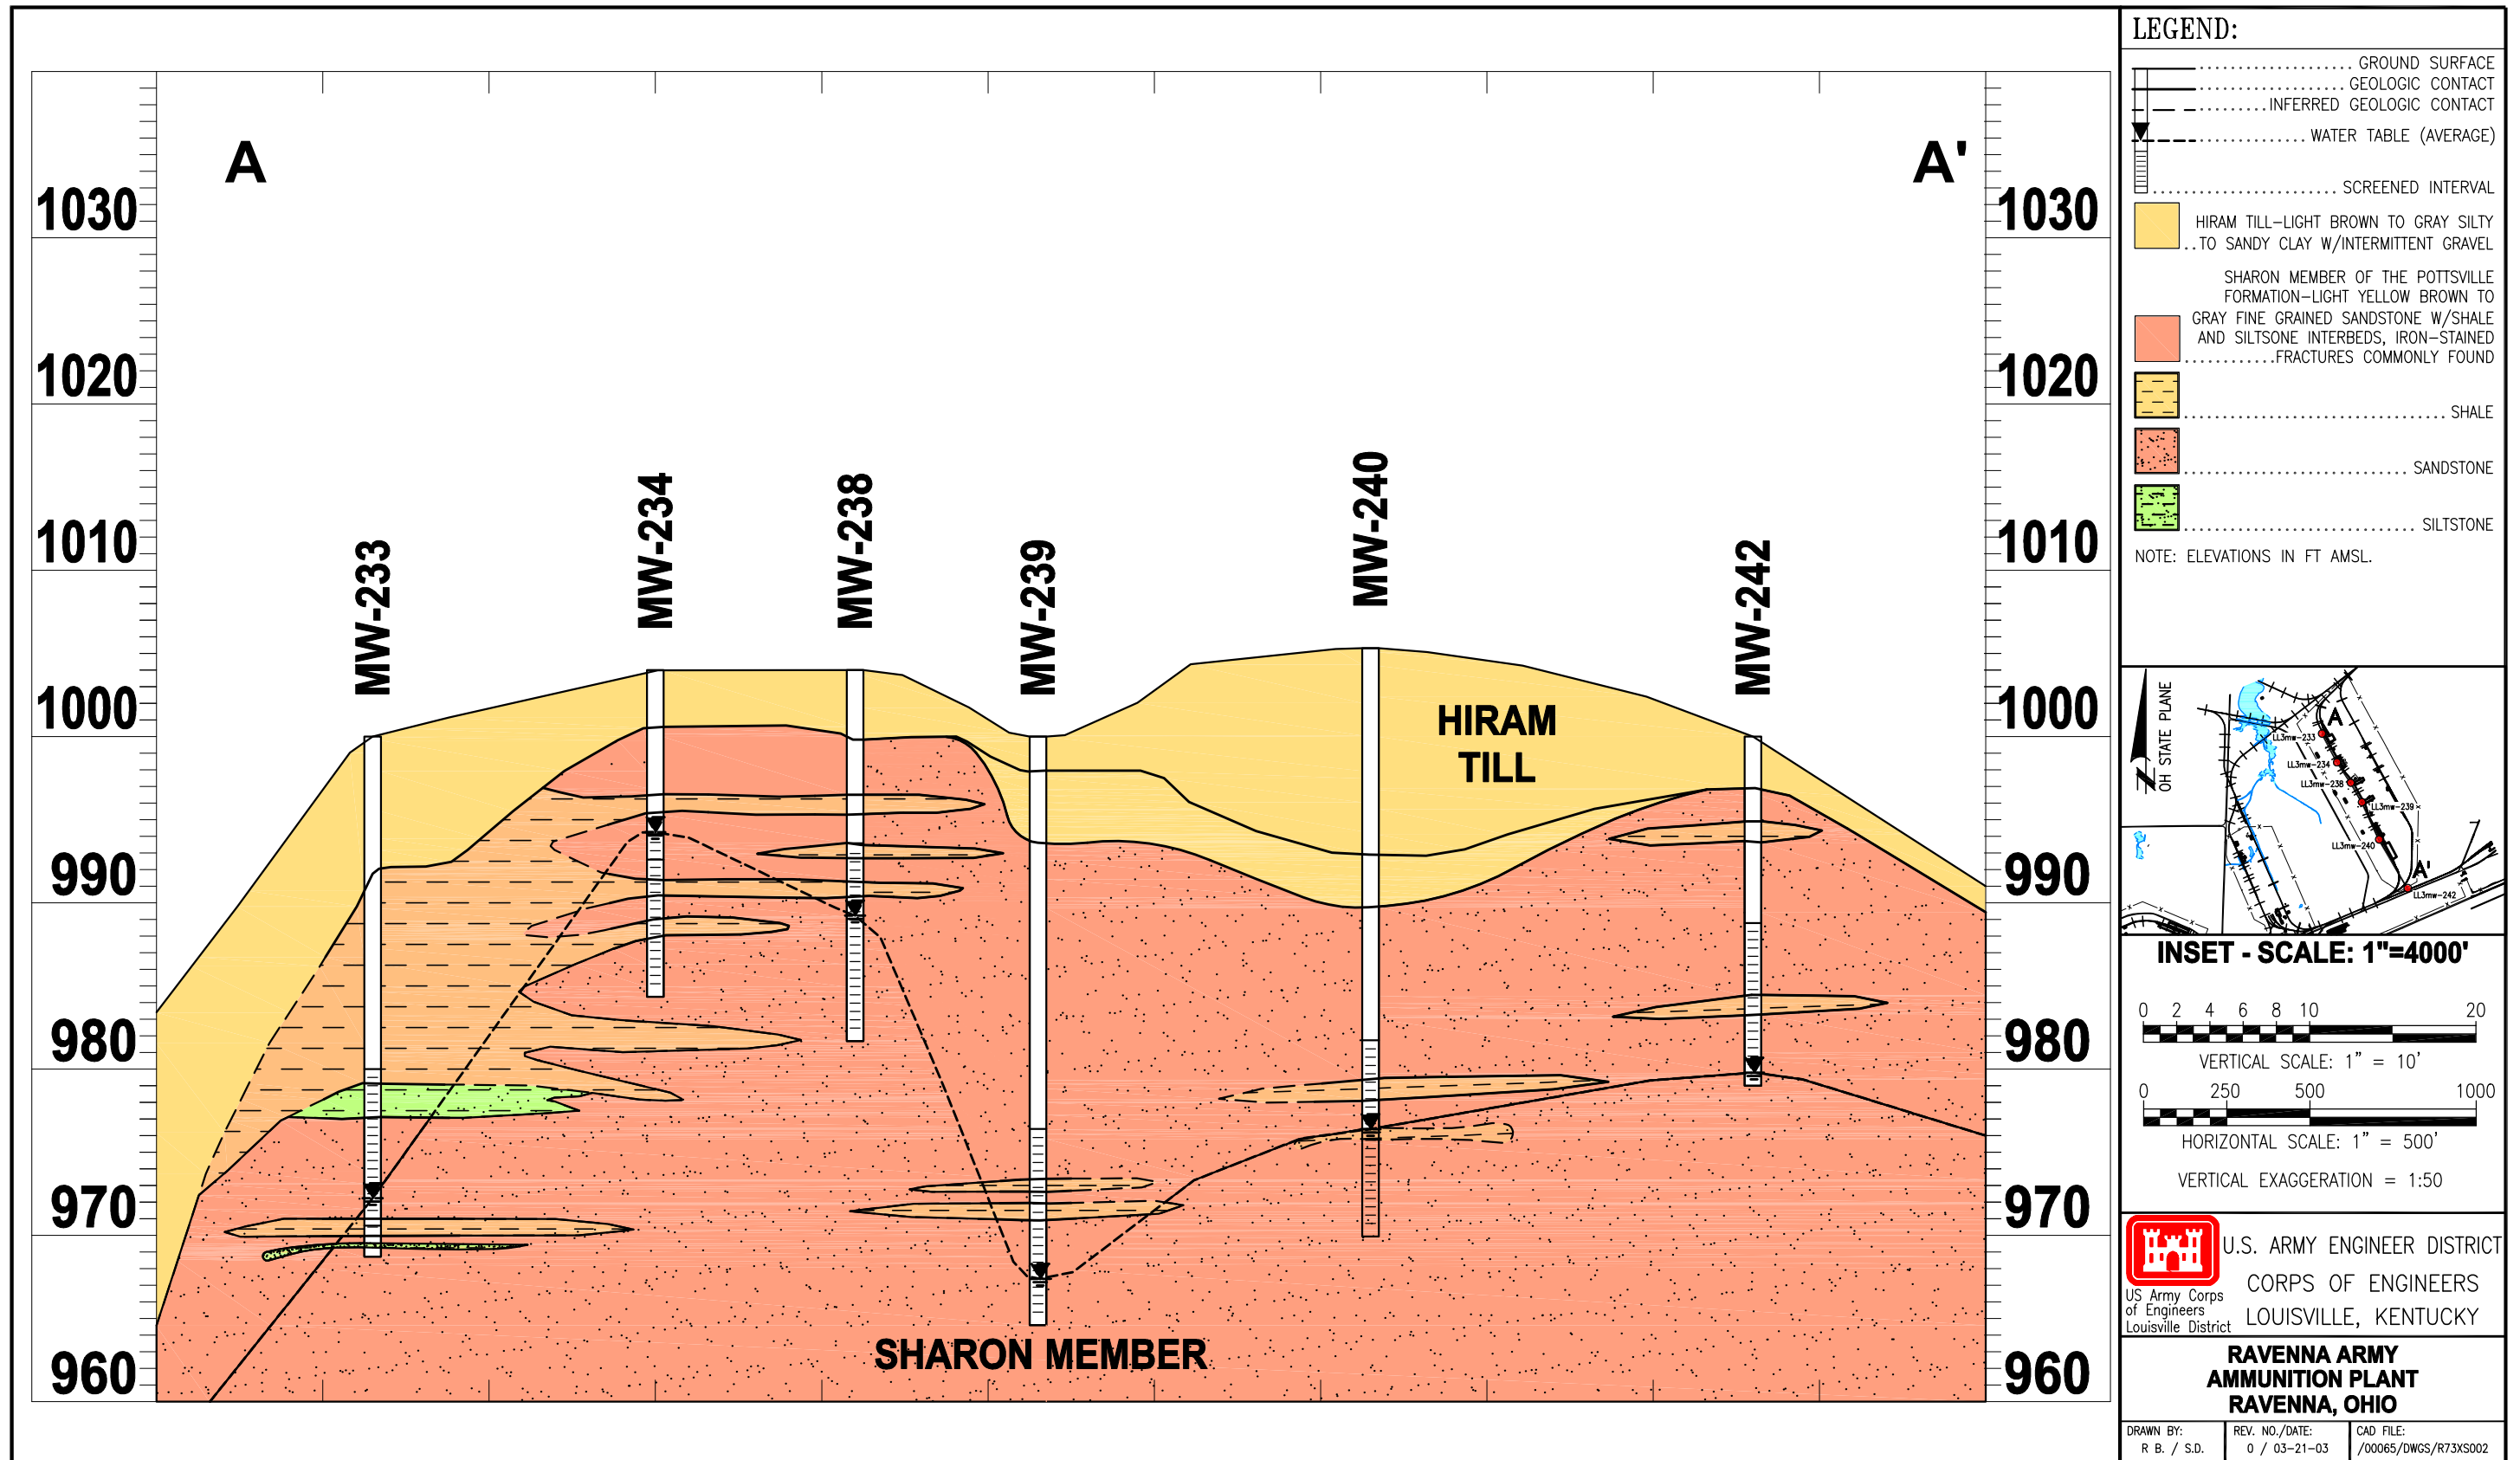
Figure 2-3. Generalized Geologic Cross Section of Unconsolidated and Consolidated Deposits at RVAAP at Load Line 3

Test pits, piezometer borings, and monitoring well borings provide the general geologic characteristics noted below for the unconsolidated and bedrock interval underlying Load Line 3. A generalized geologic cross section for the AOC from north to south is provided in [Figure 2-3](#).

Surface soil varies widely in character from one area to another due to lateral discontinuity within the glacial till and site disturbances; however, silty clays and silty sands dominate in the near surface interval. As noted in the boring logs for hand-augered soil sampling stations (Appendix A), some areas of the load line have been substantially reworked and contain sandy fill, gravel, ballast material, and slag. Concrete, rebar, nails, glass, paint chips, roofing materials, etc. exist at the ground surface in many areas, especially in the vicinity of buildings. In comparatively undisturbed areas where some test pits were excavated, the surface soil interval consisted of a brown (10YR5/3) silt. Additional geotechnical data collected during the Phase II RI are presented Chapter 4.0 and in the geotechnical laboratory report provided in Appendix K of this RI Report. Geologic logs for test pit areas are in Appendix E, and those for piezometers and monitoring wells are in Appendix C.

Range of depth to bedrock, which was encountered in all borings, varied from 1.1 m (3.5 ft) to 4.6 m (15 ft); the average thickness of the unconsolidated interval was only 2.1 m (7 ft) within the load line. The composition of unconsolidated materials is fairly uniform and consists primarily of a yellowish-brown (10YR5/4) silt to clayey silt with intermittent gravel. The unconsolidated materials typically have a stiff consistency and low plasticity and range from dry to moist.

The Sharon Conglomerate unit of the Sharon Member (Pottsville Formation) was encountered in all subsurface borings at Load Line 3, which ranged in depth from 6.4 to 11.6 m (21 to 38 ft). [Figure 2-3](#) illustrates bedrock lithologies encountered at Load Line 3. The underlying shale unit of the Sharon Member was not encountered in any boring at Load Line 3. The unit is characterized by a light yellowish-brown to brownish-gray, fine- to medium-grained sandstone, which commonly contains iron-stained fractures. In the vicinity of Load Line 3, shale lenses of varying thickness were commonly observed in subsurface borings. These shale lenses are comprised of light brownish gray to dark gray shale, typically 0.3 m (1 ft) in thickness or less. In the boring drilled for monitoring well LL3mw-233, a substantial interval of shale and siltstone was encountered. These shale lenses were also encountered in borings drilled during the Phase II RI at Load Line 2; however, their frequency and thickness were much greater at Load Line 3. The prevalence of shale in the Load Lines 2 and 3 vicinity was not observed during investigations at Load Line 1 and the Ramsdell Quarry to the northeast; the Sharon Conglomerate in these areas consists of a much more homogenous quartz sandstone with little observed shale. Further to the west at Load Line 12, an extensive dark gray shale was encountered in subsurface borings. The

observed facies changes implies a change of depositional environment across the southeastern portion of the facility with energetic conditions in the Load Line 1 and Ramsdell Quarry area, and increasingly quiescent conditions towards the south-central portion of RVAAP (e.g., vicinity of Load Lines 12 and 4).

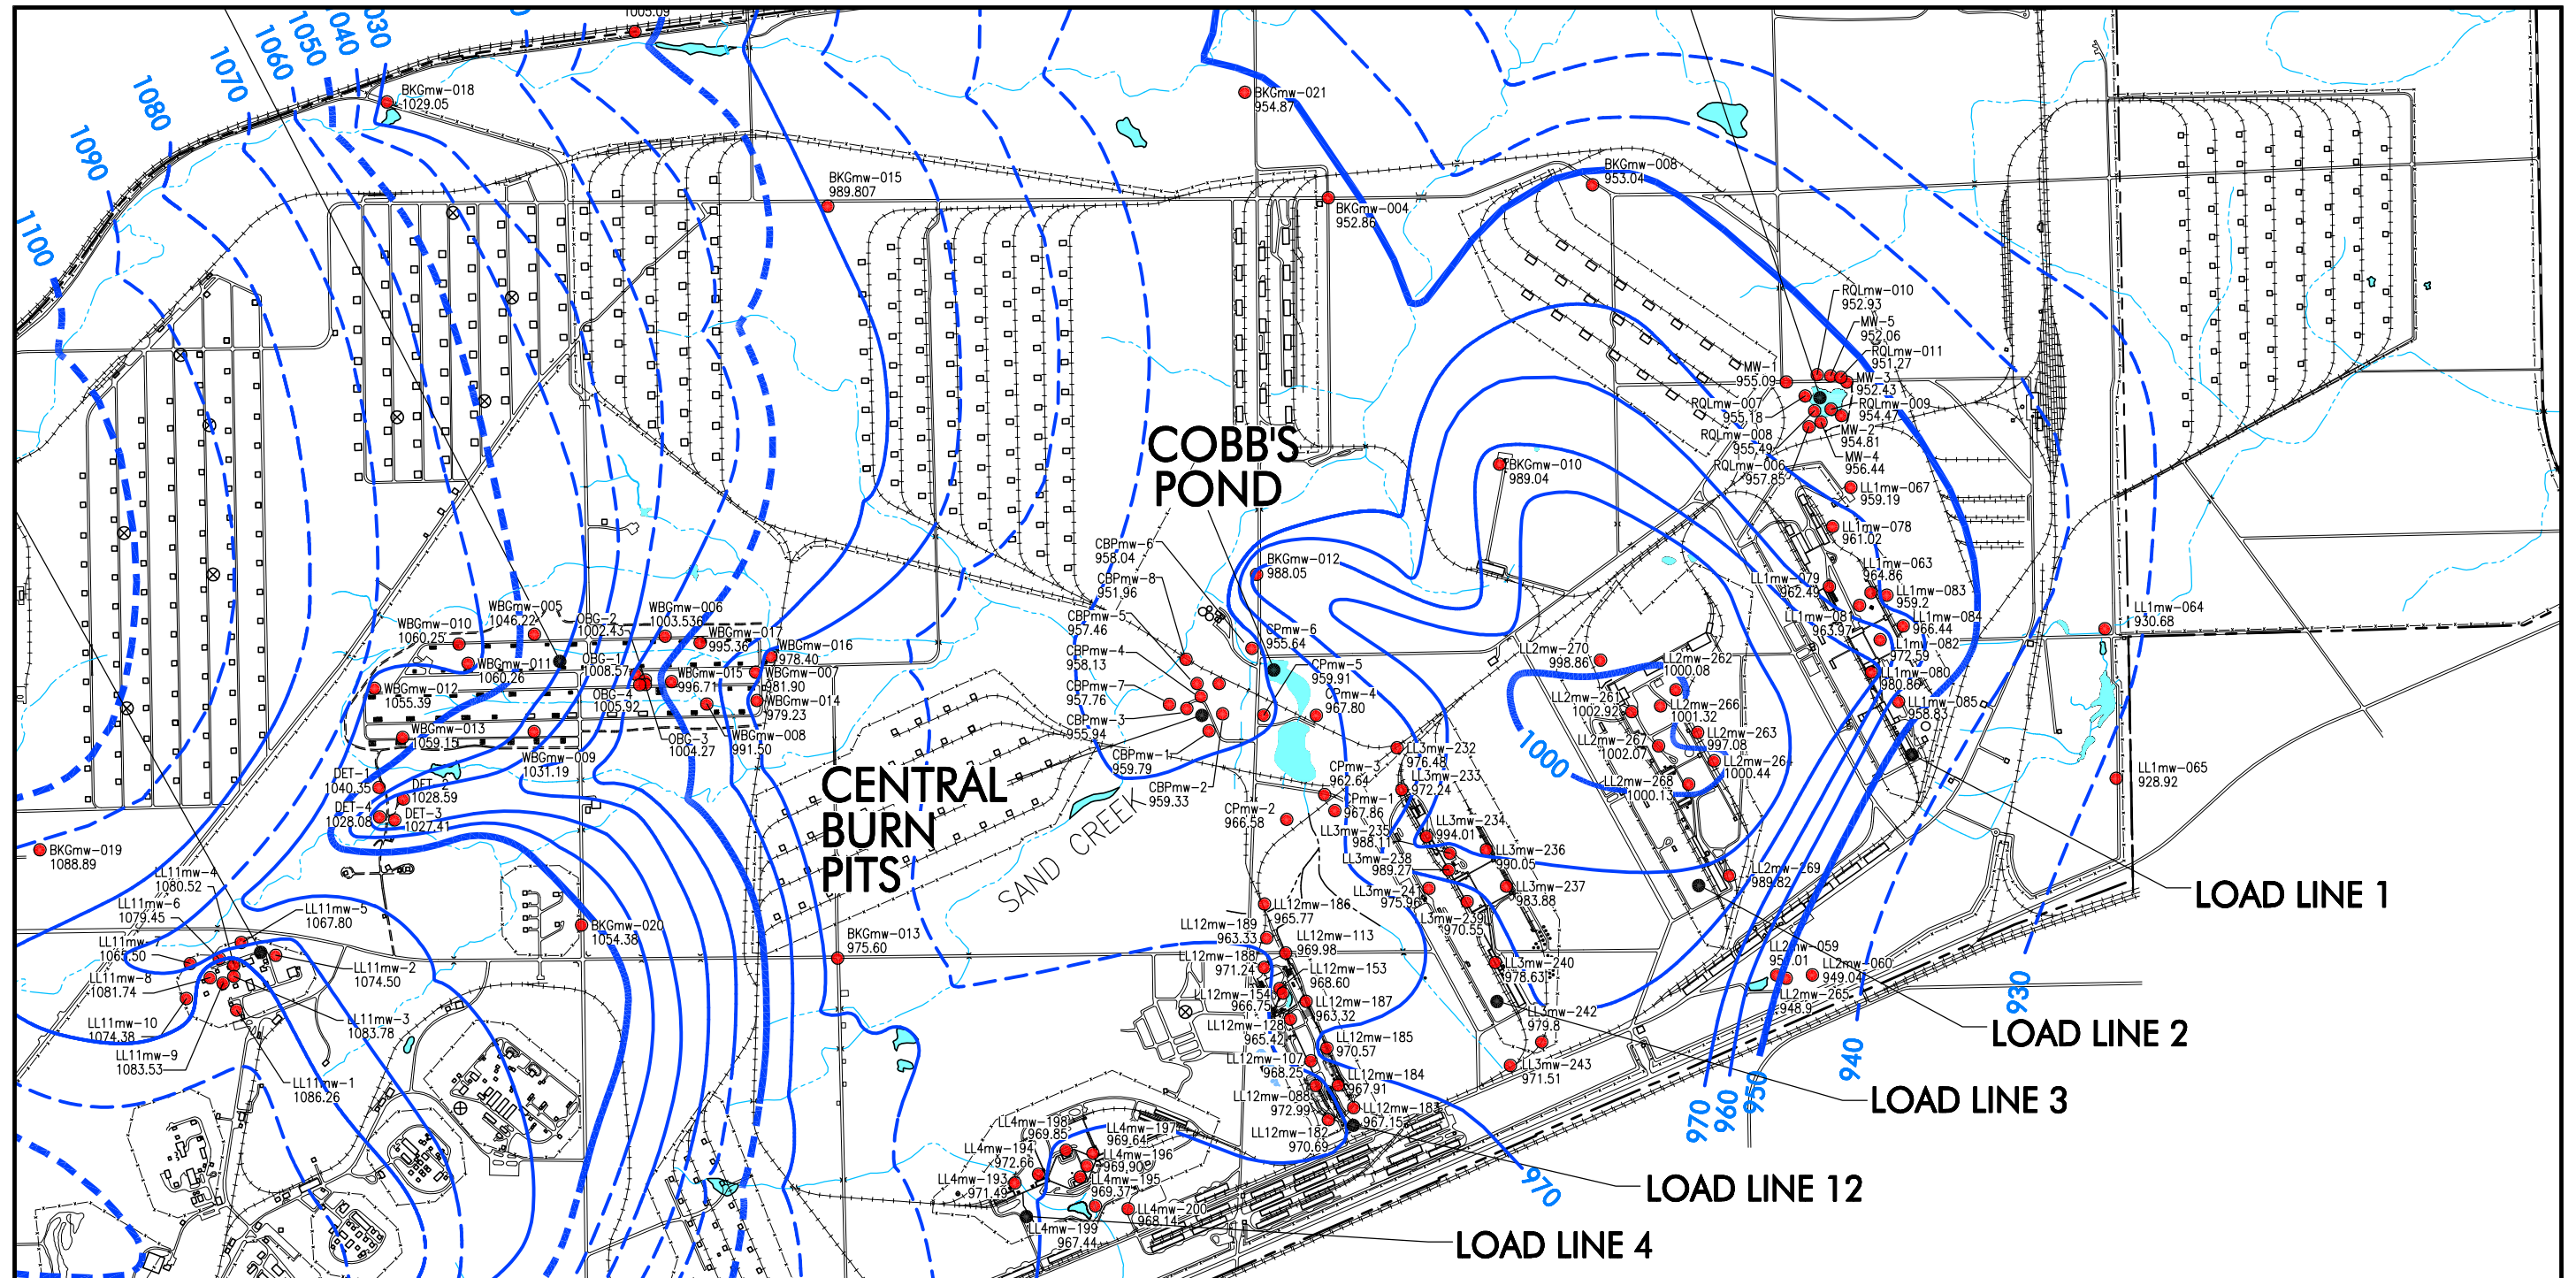
Figure 2-4. RVAAP Facility-wide Potentiometric Groundwater Surface, August 2001

A facility-wide water table map was constructed using water-level measurements taken during a 2-day period (August 27 and 28, 2001) as part of the Phase II RI field investigation (Figure 2-4). Monitoring wells from which data were obtained are all screened within the uppermost groundwater interval at

RVAAP, either at the water table or immediately below it. Both unconsolidated and bedrock zone wells are represented in the water level dataset; thus, the potentiometric map presents a generalized representation of the water table surface. Perennial streams and ponds present at RVAAP were considered as expressions of the water table surface. Thus, to augment water level data in areas that did not have adequate well coverage, elevations of perennial streams and ponds, estimated from topographic base map files, were used to infer water table elevations. Topographic surface controls from base map files were also used to guide placement of water table isopleths.

The facility-wide potentiometric map shows that the water table surface is a subdued representation of the topography of the region. The predominant groundwater flow direction is to the east, with water table elevations decreasing from a high of about 346 m (1,136 ft) amsl at well BKGmw-063 in the northwest portion of the facility to a low of about 283 m (928 ft) amsl southeast of Load Line 1 (well LL1mw-065). A significant potentiometric high centered around Load Line 2 is indicated in the southeastern portion of RVAAP. This potentiometric high results in localized radial flow vectors in this portion of the facility. A groundwater divide is inferred in the western portion of the facility based on surface stream and topographic elevations, although little potentiometric data exist in this region to confirm its presence.

At the watershed scale (i.e., Sand Creek, Hinkley Creek, South Fork of Eagle Creek), groundwater flow generally mirrors surface drainage patterns. Regional drainage patterns along Sand Creek in the northeast portion of RVAAP result in a localized perturbation in the overall flow direction to the north-northeast. In several locations along the southern boundary of RVAAP, south-southeast perturbations in the overall observed groundwater flow patterns are observed as follows:

- a localized south-southeasterly flow component from the potentiometric high area centered around Load Lines 1, 2, and 3 toward the facility boundary;
- a localized southerly flow component toward the facility boundary from the southernmost portion of Load Line 12;
- a localized southerly flow component toward the facility boundary from Load Line 4, which mirrors the direction of surface water flow in the unnamed tributary that drains this load line; and
- groundwater flow to the south in association with Hinkley Creek in the southwest portion of the site (i.e., NACA Test Area and Demolition Area 1 vicinity).

The potentiometric surface may be interpreted with a higher degree of confidence in the southeastern portion of RVAAP than in many other areas of the facility because of the density of monitoring wells present (i.e., vicinity of Cobb's Pond, Ramsdell Quarry, Load Lines 1 through 4, and Load Line 12). The potentiometric surface and water table gradients in the vicinity of Cobb's Pond, Load Line 12, and Load Line 4 are subdued when compared to other portions of RVAAP and appear to be influenced by the abundant large surface water features and wetlands present in these areas.

Greater uncertainty in interpretation of groundwater flow directions exists in the vicinity of Load Line 12 and Demolition Area 2. Potential subsurface geologic heterogeneities in the vicinity of Load Line 12 create a complex potentiometric surface that is difficult to interpret with existing data. An apparent narrow potentiometric low oriented in a north-south direction extends along the central portion of Load Line 12 from South Service Road towards Cobb's Pond. This potentiometric low was also evident from water table data collected during 2000, and, as presented in the Load Line 12 Phase II RI Report (USACE 2002), may be a representation of a zone of higher permeability, such as a channel deposit.

In the vicinity of Demolition Area 2, steep potentiometric gradients are inferred based on data from wells that existed in the area as of August 2001. Additional monitoring wells were installed at this AOC in the fall of 2002 as part of a Phase II RI. Data from the new Demolition Area 2 wells need to be included in any subsequent assessment of facility-wide potentiometric elevations and may alter the interpretation of gradients in this area.

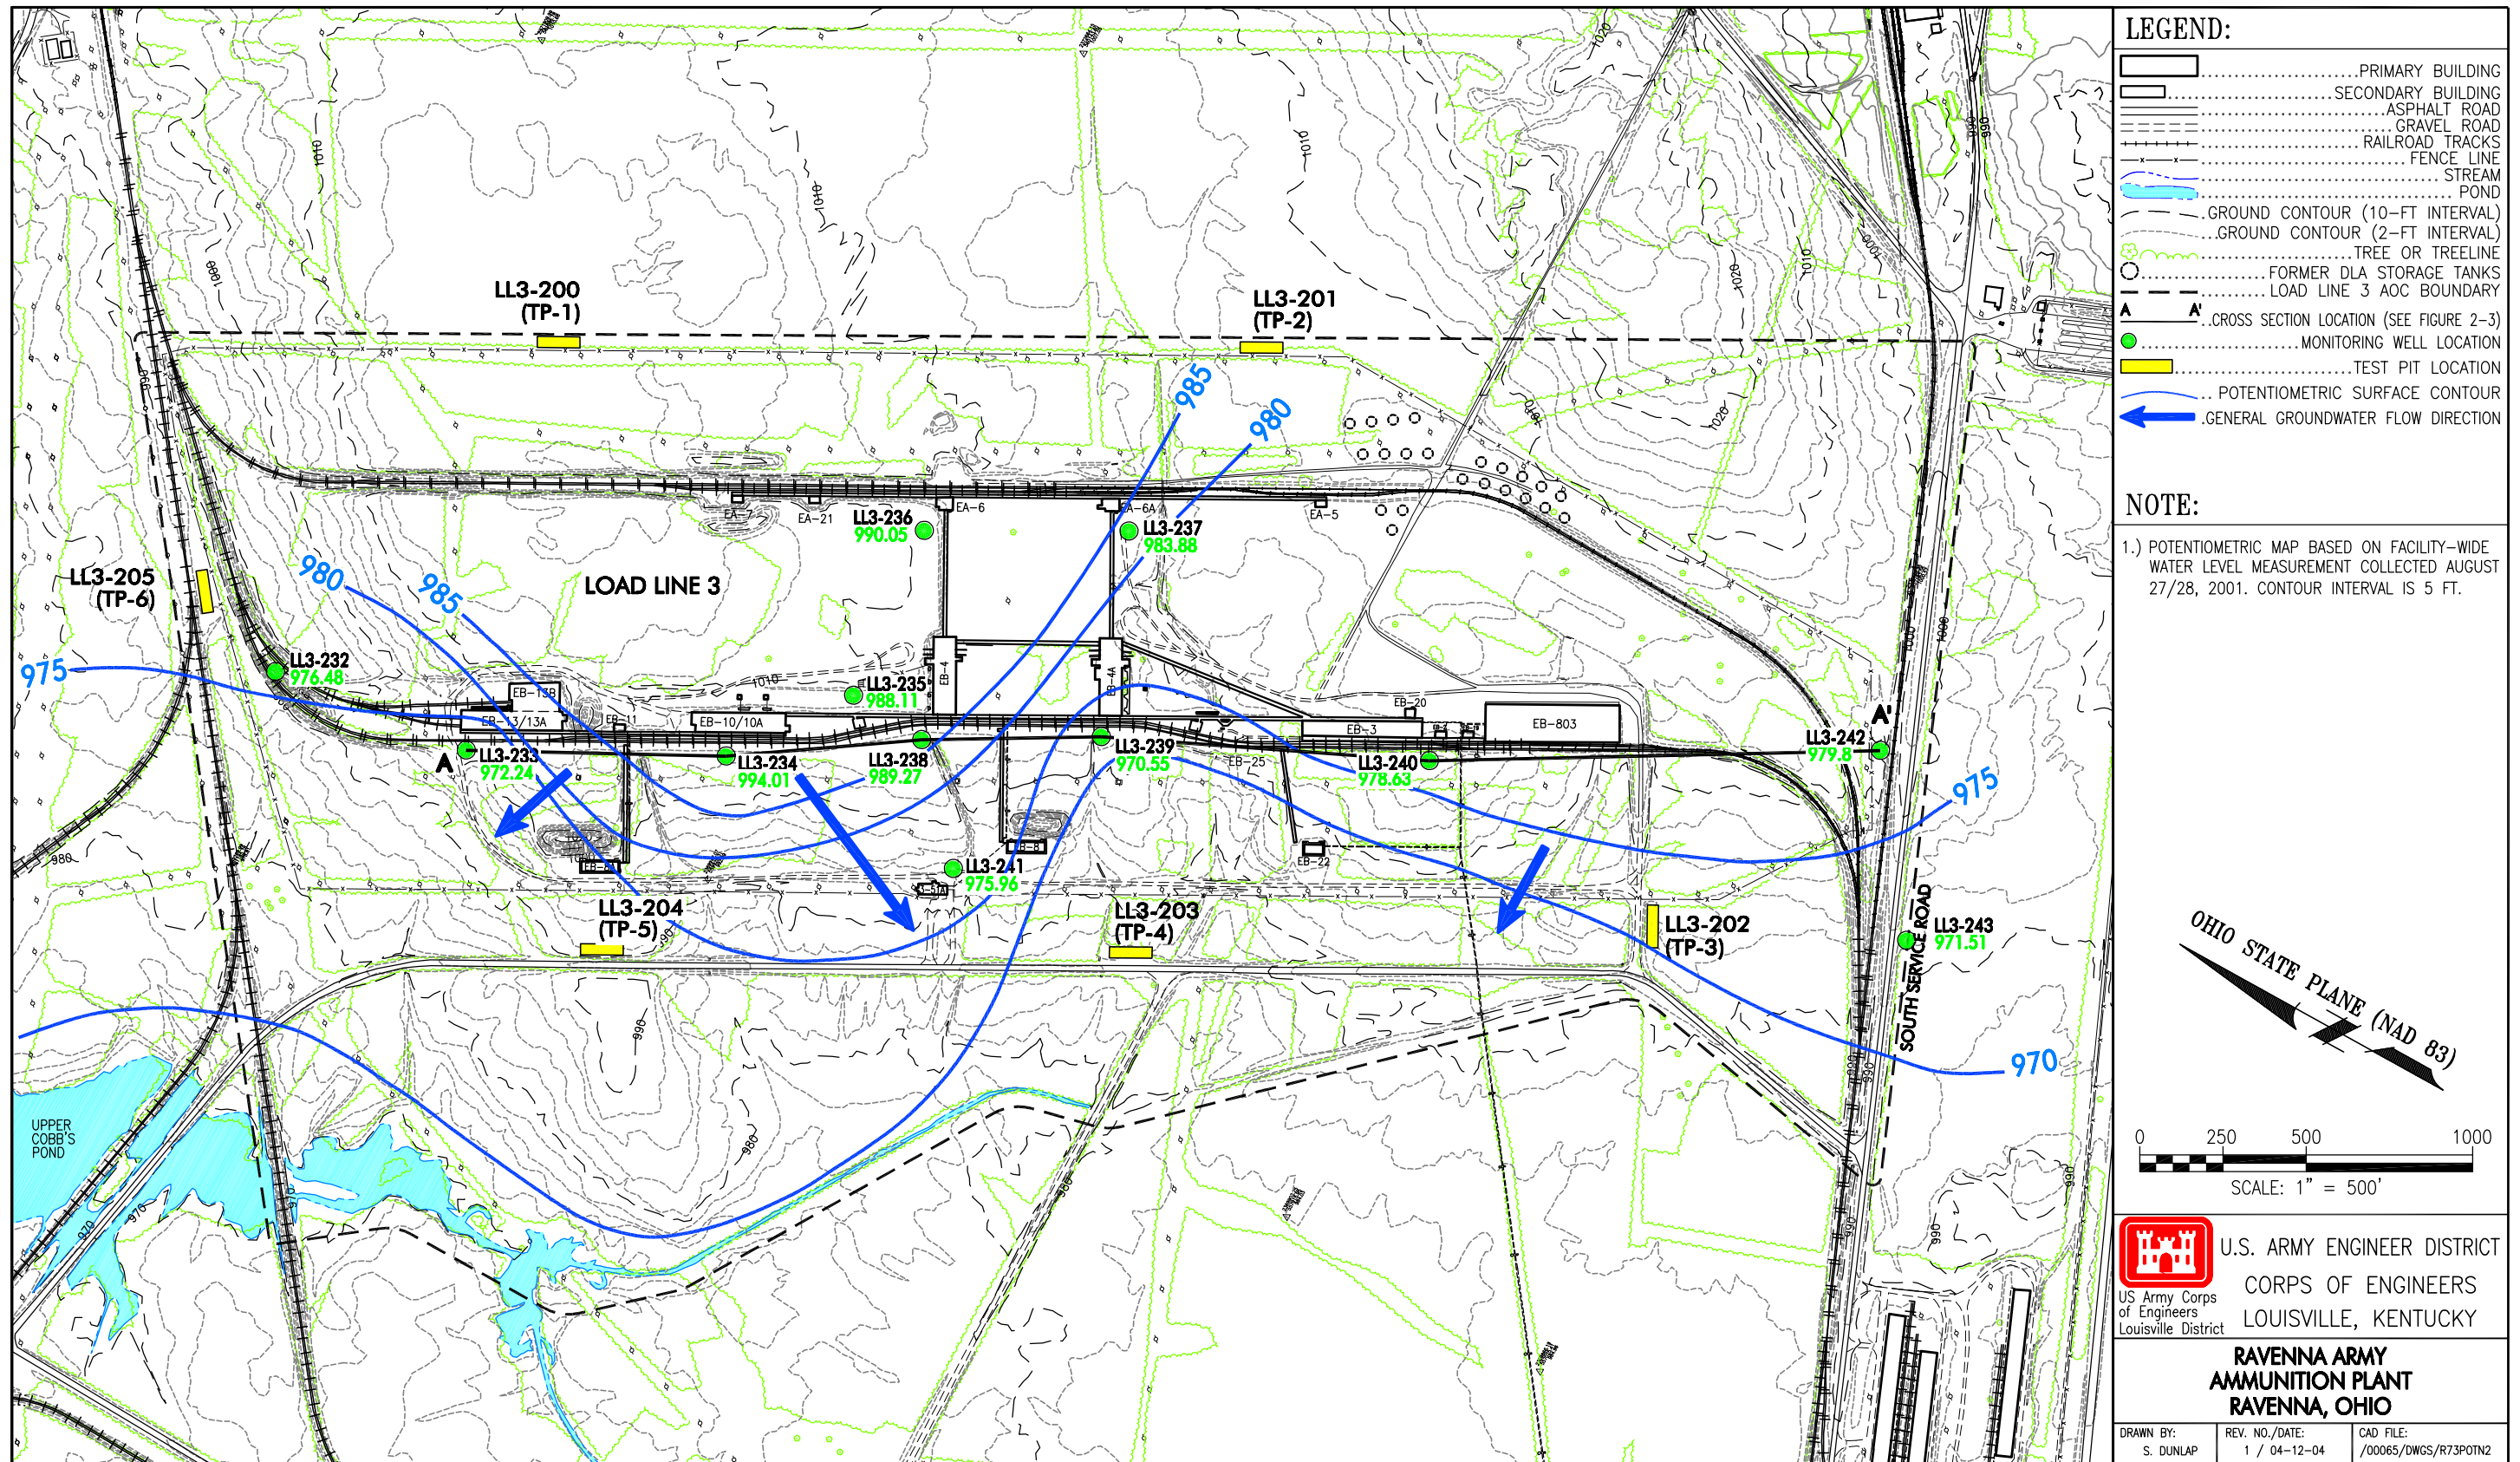
Figure 2-5. Potentiometric Groundwater Surface at Load Line 3, August 2001

All wells at Load Line 3 were screened within the Sharon Member conglomerate. A potentiometric surface map of Load Line 3 is provided in [Figure 2-5](#). This AOC-specific water table map was constructed using static water level data from 12 monitoring wells installed during the Phase II RI and reflects the interpretations of the facility-wide potentiometric surface characterization described in Section 2.4.1.3. In general, the potentiometric surface is a subdued replica of the regional topography. Shallow groundwater flow associated with Load Line 3 generally flows west-northwest towards the tributary entering Cobb's Pond and the Cobb's Pond complex itself. In the southern portion of the AOC, a southerly component of groundwater flow occurs off of the AOC.
