## 2.0 ENVIRONMENTAL SETTING

**RAVENNA ARMY AMMUNITION PLANT**  
**RAVENNA, OHIO**

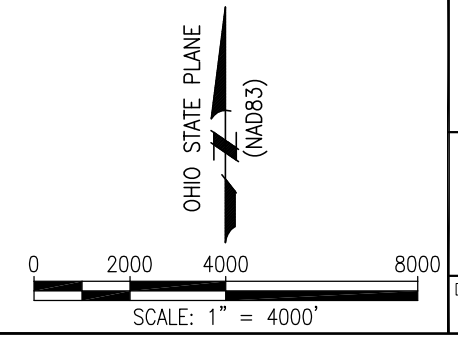
Figure 2-2. Geologic Map of Unconsolidated Deposits at RVAAP

Bedrock at RVAAP is overlain by deposits of the Wisconsin-aged Lavery Till in the western portion of the facility and the younger Hiram Till and associated outwash deposits in the eastern portion (Figure 2-2) (ODNR 1982). Unconsolidated glacial deposits vary considerably in their character and thickness across RVAAP, with these deposits absent in some of the eastern portion of the facility to an estimated 46 m (150 ft) in the south-central portion.

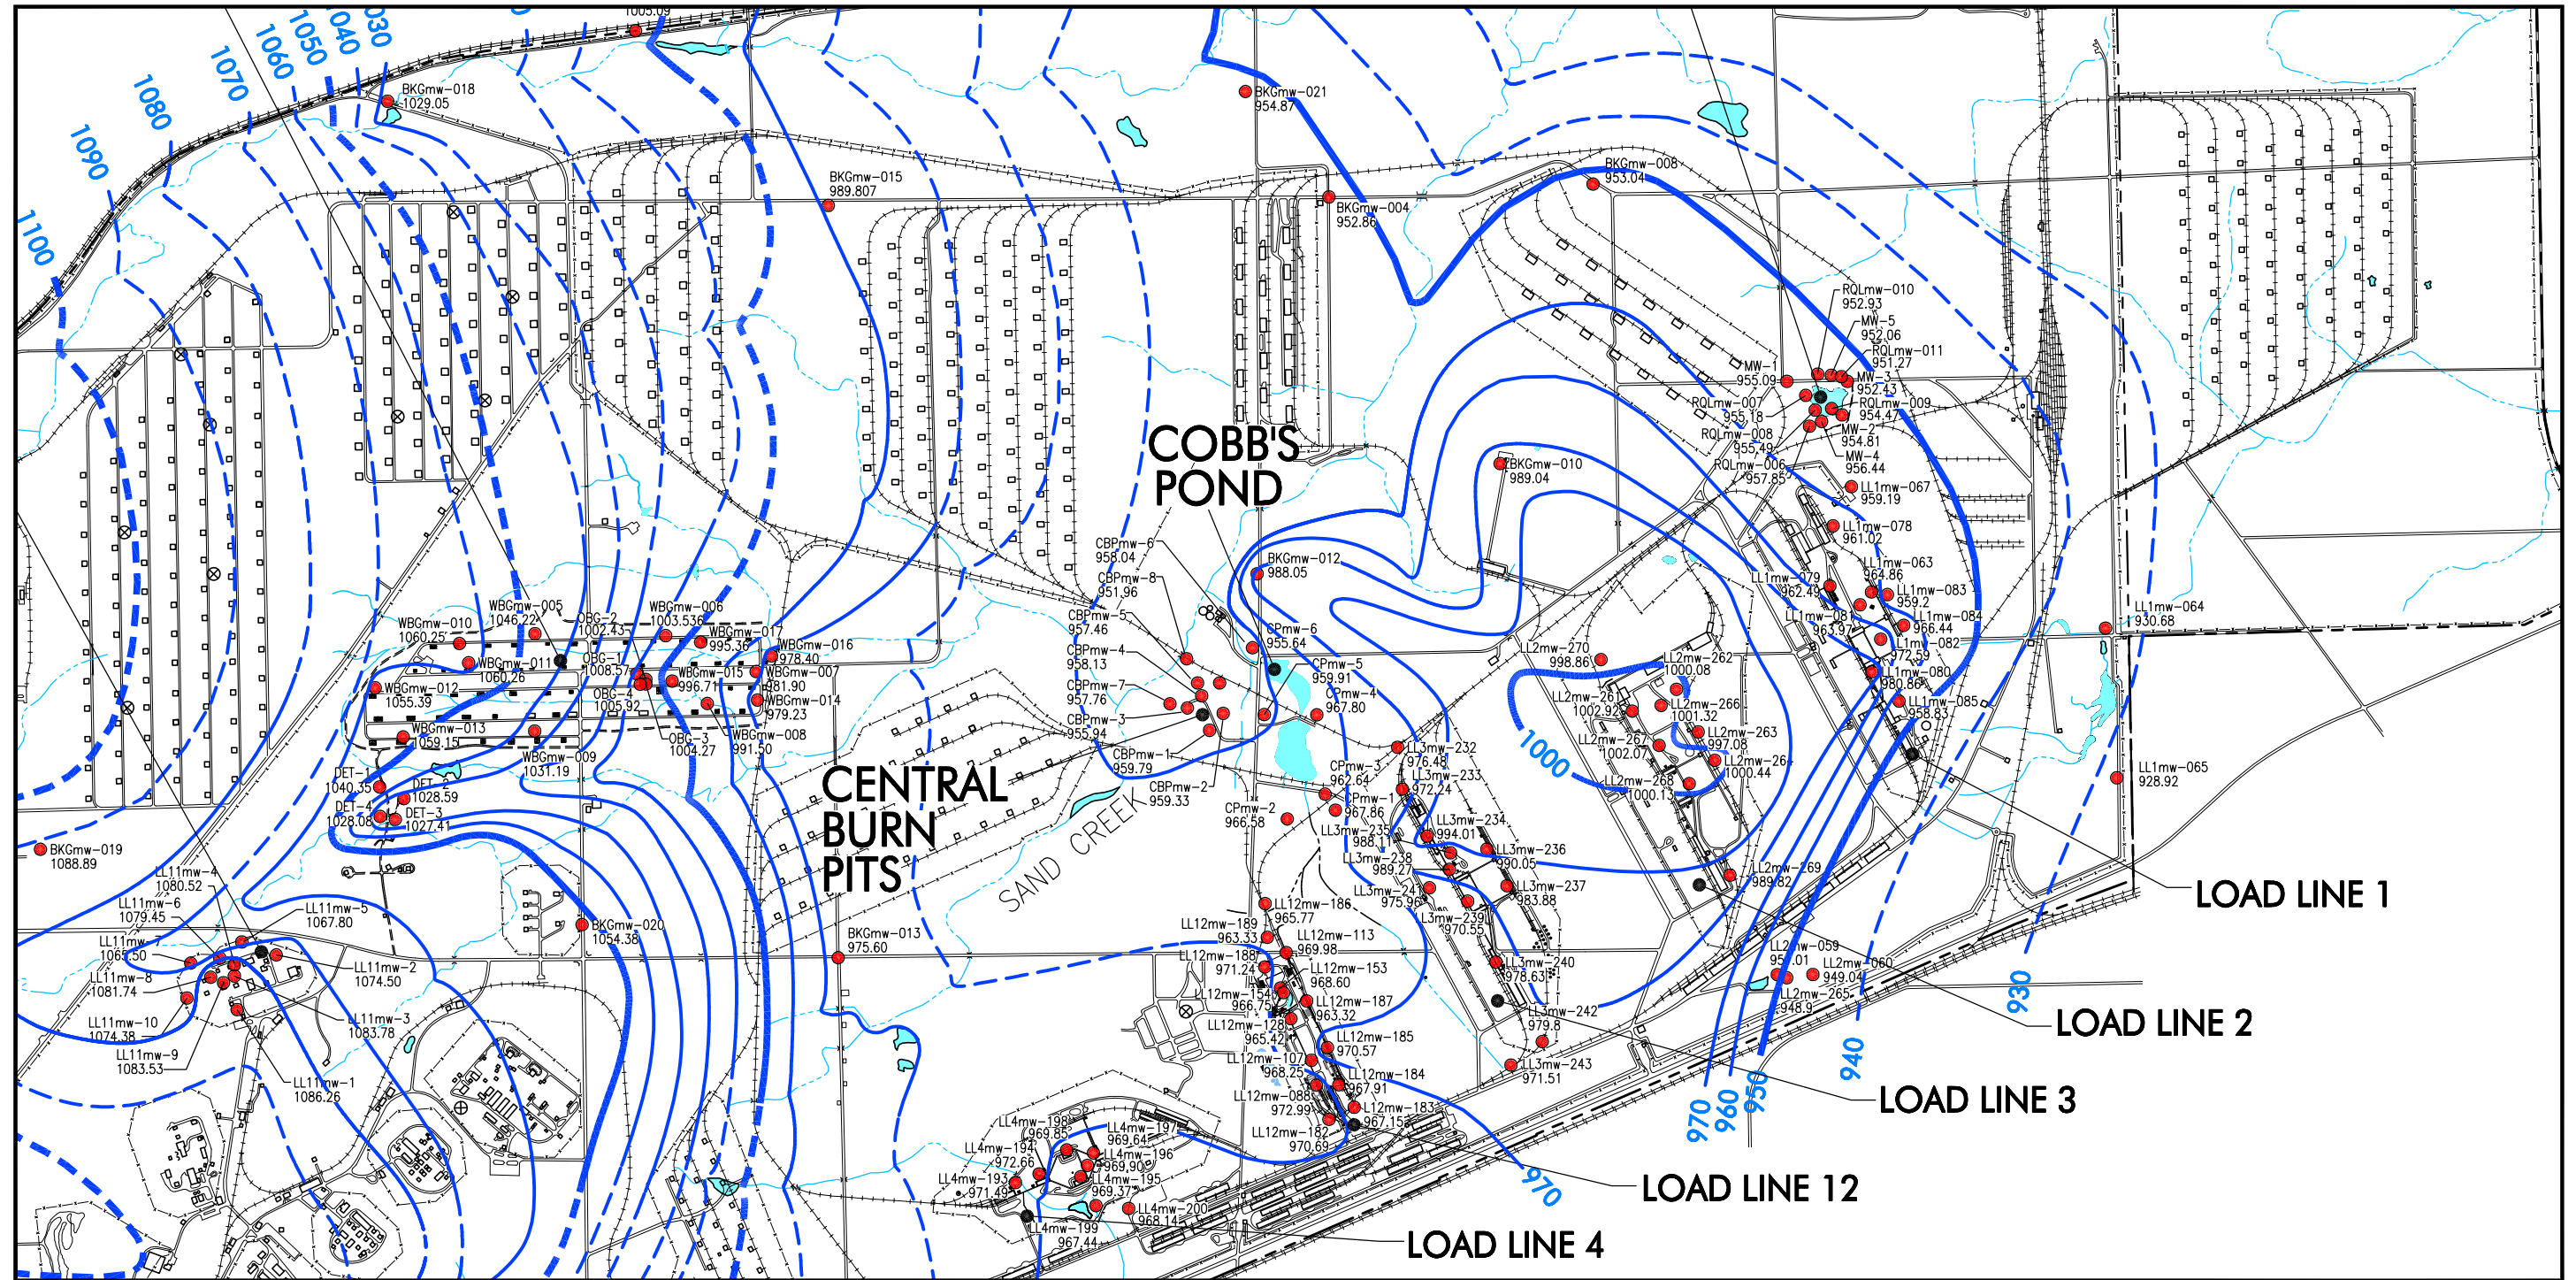
Figure 2-4. Facility-wide Potentiometric Map, August 2001

- 1.) POTENTIOMETRIC MAP BASED ON FACILITY-WIDE WATER LEVEL MEASUREMENTS COLLECTED AUGUST 27/28, 2001. CONTOUR INTERVAL IS 10 FT.
- 2.) POTENTIOMETRIC SURFACE ELEVATIONS ARE IN FEET ABOVE MEAN SEA LEVEL.

The facility-wide potentiometric map shows that the water table surface is a subdued representation of the topography of the region. The predominant groundwater flow direction is to the east, with water table elevations decreasing from a high of about 346 m (1,136 ft) amsl at well BKGmw-063 in the northwest portion of the facility to a low of about 283 m (928 ft) amsl southeast of Load Line 1 (well LL1mw-065). A potentiometric high centered around Load Line 2 is indicated in the southeastern portion of RVAAP. This potentiometric high results in localized radial flow vectors in this portion of the facility. A groundwater divide is inferred in the western portion of the facility based on surface stream and topographic elevations, although little potentiometric data exist in this region to confirm its presence.

At the watershed scale (i.e., Sand Creek, Hinkley Creek, South Fork of Eagle Creek), groundwater flow generally mirrors surface drainage patterns. Regional drainage patterns along Sand Creek in the northeast portion of RVAAP result in a localized perturbation in the overall flow direction to the north-northeast. In several locations along the southern boundary of RVAAP, south-southeast perturbations in the overall observed groundwater flow patterns are observed as follows:

- a localized south-southeasterly flow component from the potentiometric high area centered around Load Lines 1, 2, and 3 toward the facility boundary;
- a localized southerly flow component toward the facility boundary from the southernmost portion of Load Line 12;
- a localized southerly flow component toward the facility boundary from Load Line 4, which mirrors the direction of surface water flow in the unnamed tributary that drains this load line; and
- groundwater flow to the south in association with Hinkley Creek in the southwest portion of the site (i.e., NACA Test Area and Demolition Area 1 vicinity).

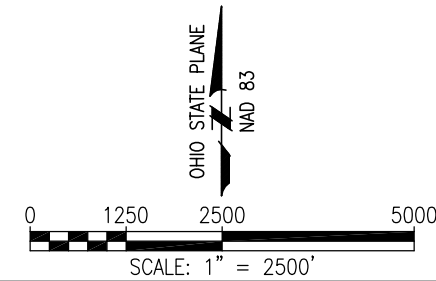
A facility-wide water table map was constructed using water-level measurements taken during a 2-day period (August 27 and 28, 2001) as part of the Phase II RI field investigation (Figure 2-4). Monitoring wells from which data were obtained are all screened within the uppermost groundwater interval at RVAAP, either at the water table or immediately below it. Both unconsolidated and bedrock zone wells are represented in the water level data set; thus, the potentiometric map presents a generalized representation of the water table surface. Perennial streams and ponds present at RVAAP were considered as expressions of the water table surface. Thus, to augment water level data in areas that did not have adequate well coverage, elevations of perennial streams and ponds, estimated from topographic base map files, were used to infer water table elevations. Topographic surface controls from base map files were also used to guide placement of water table isopleths.
