Evaluation, Identification, and Management of Potential Solid Waste Sites at the Former Ravenna Army Ammunition Plant/ Camp James A. Garfield

Restoration Advisory Board Meeting

22 May 2019

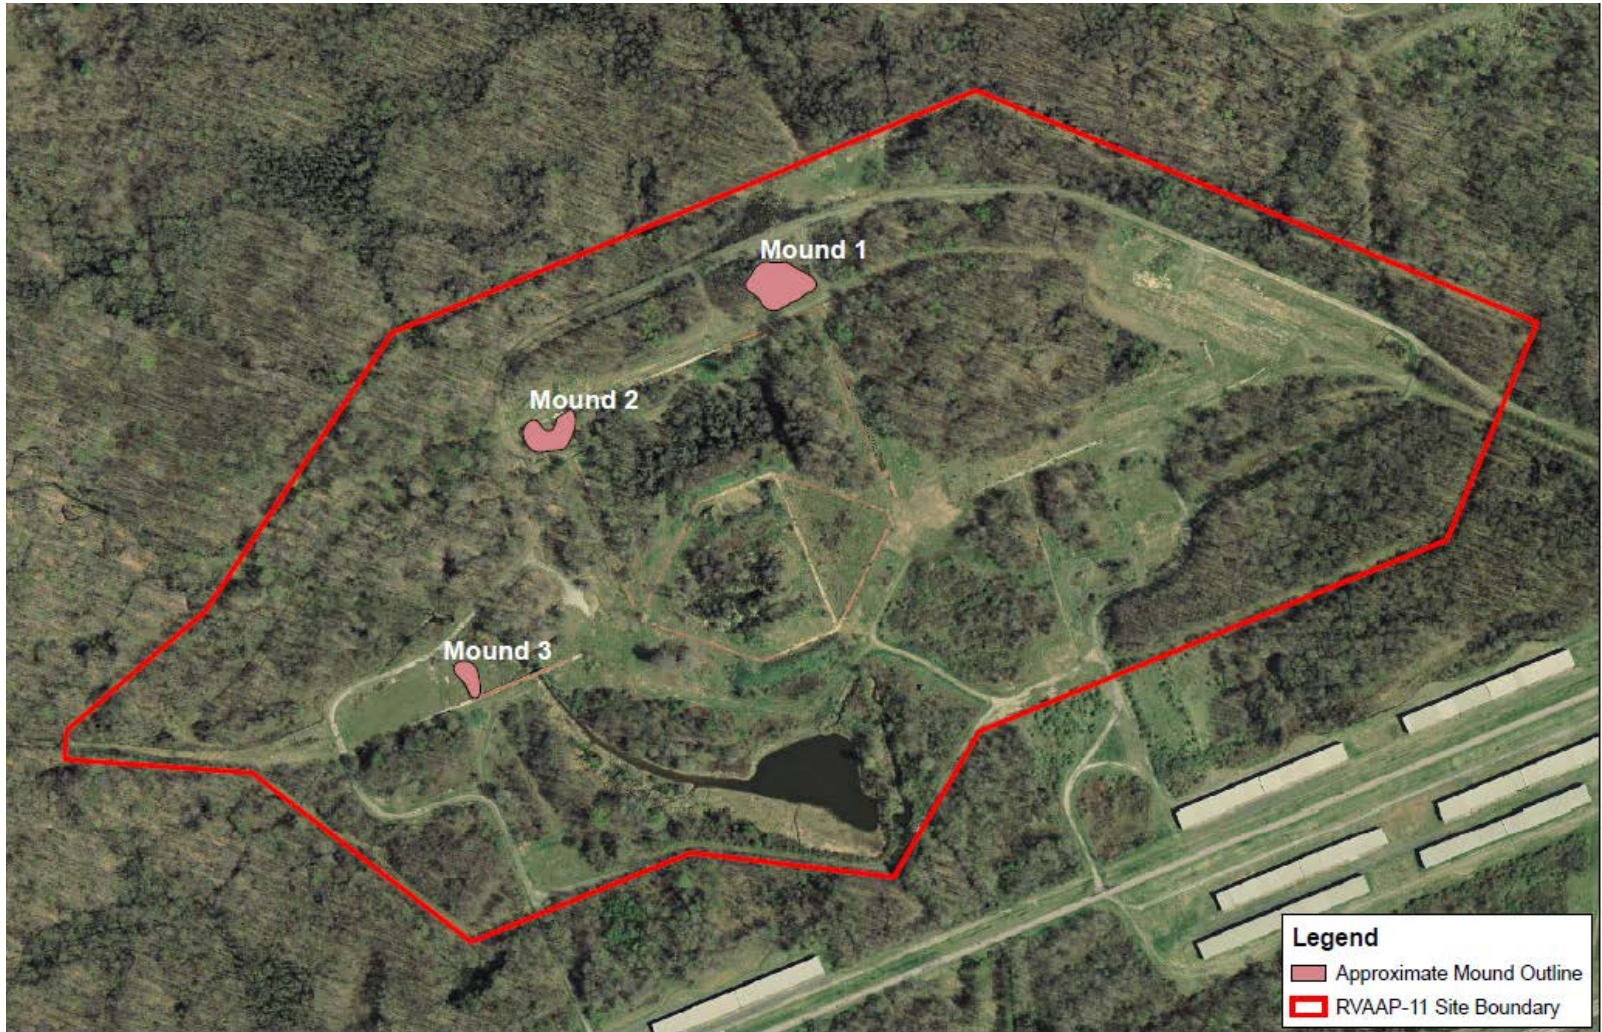
Mounded Areas (RVAAP-11)

- Field team documented the work with detailed notes and photographs.
- Each test pit was photographed and GPS locations were collected
- A photoionization detector (PID) was used to monitor for volatile organic compounds (VOCs) during excavation activities
- Five test pits were excavated at each mound
- Test pits were approximately 4 feet deep and 6 feet long and the width of the excavator bucket
- Rebar, compacted fill crushed stone
- Historical specifications maps depicted as engineered barricades
- Intrusive investigation confirmed no solid waste present

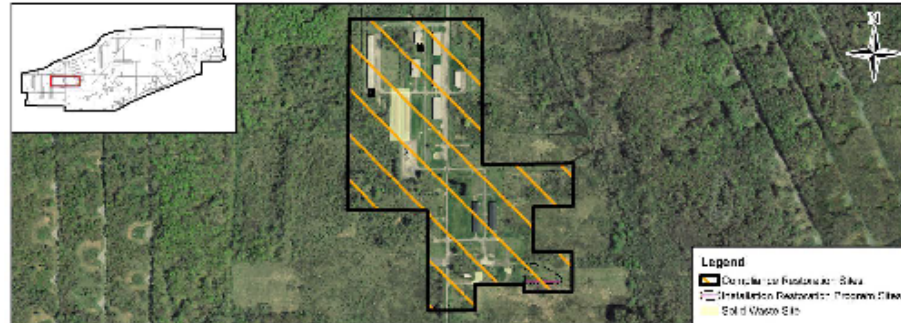
Fact Sheet 4-5: Depot Sewage Treatment Plant (RVAAP-21) and Depot Area (CC RVAAP-76) Solid Waste Site

A 234 ft long, 24 ft pile, 10 ft high pile of wooden pallets under a covered awning exists at the site (AECOM, 2017). A large pile of concrete footers from fence posts are also at the site.

Surficial solid waste at the Depot Sewage Treatment Plant (RVAAP-21) is categorized as Open Dumping (OAC 3745-27-01).

- Disposal of surficial solid waste in a disposal facility as defined by OAC 3745-27-01 and licensed in accordance with OAC Chapter 3745-37.

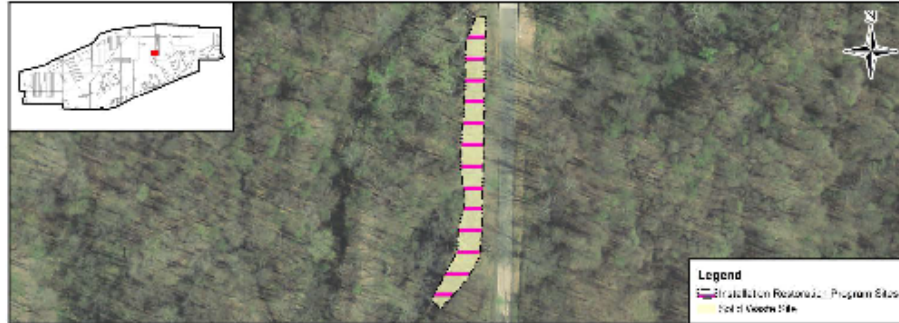
Fact Sheet 4-4: Dump along Paris-Windham Road (RVAAP-51) Solid Waste Site

The cap over buried materials was observed during the 2016 AECOM Visual Assessment Survey. No evidence of solid waste was observed. The area is marked as off-limits with Siebert stakes, and the extent of the remaining subsurface solid waste is delineated.

The remaining solid waste at the Dump along Paris-Windham Road is buried waste that is considered a solid waste management unit. No surficial waste exists at the site.

- Buried solid waste is a solid waste management unit that will remain in place. If disturbance is required then an OAC 3745-27-13(C)(2)(c) exemption applies.

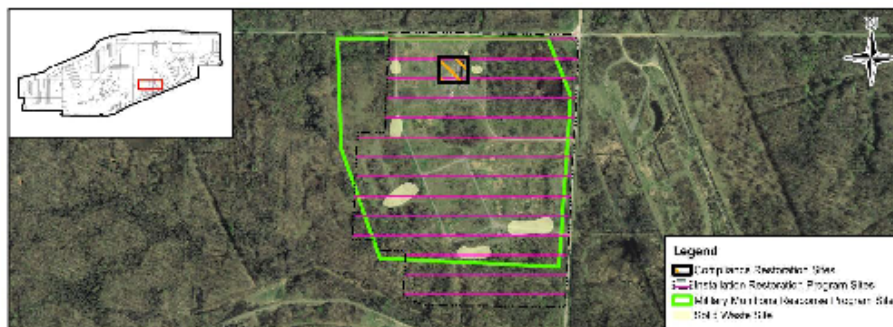
Fact Sheet 4-17: Atlas Scrap Yard IRP Site and MRS (RVAAP-50, RVAAP-050-R-01) and Atlas Scrap Yard Coal Storage CRS (CC RVAAP-73) Solid Waste Site

Large piles of concrete and metal, railroad ties, insulators, and asphalt observed during the AECOM 2016 Visual Assessment Survey have since been removed. Smaller piles of metal, wood, and concrete surface debris remain scattered throughout the site.

Surficial solid waste at the Atlas Scrap Yard is considered Open Dumping. Buried scrap metal and debris encountered during 2014 MMRP activities that was returned to the ground is now considered a solid waste management unit.

- Surficial waste qualifies as Open Dumping (OAC 3745-27-01) and will be removed and disposed of properly as funds become available.
- Buried solid waste is a solid waste management unit, which will remain in place. If disturbance is required then an OAC 3745-27-13(C)(2)(c) exemption applies.
