No Further Action Proposed Plans for

Load Line #1A, Firestone Test Facility, Sand Creek Dump, and Water Works #4 Dump Munitions Response Sites

David Crispo, P.E.—CB&I Federal Services LLC

June 3, 2015

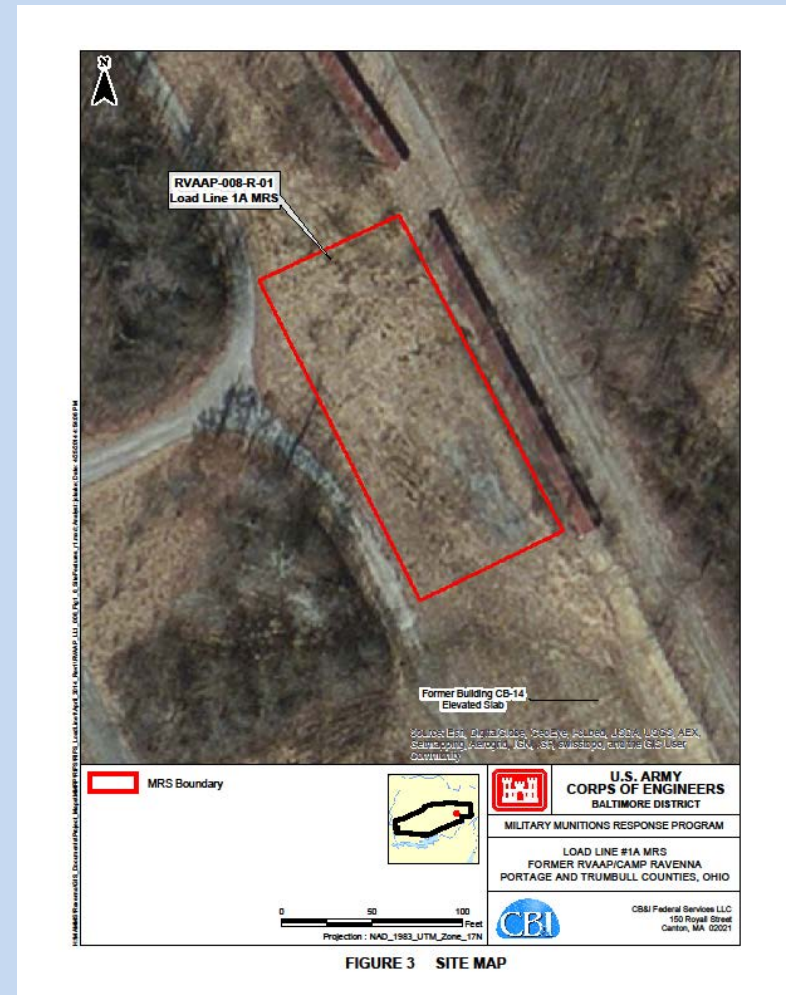
FIGURE 3 SITE MAP

- LL1A MRS is 0.41 acres in area.
- The MRS is co-located with an IRP AOC (Load Line #1)
- No significant cultural features.
- Topography is flat with little change in elevation.
- No surface water features or nearby drainage ways.
- Vegetation consists mostly of shrub species.
- Current activities - maintenance and natural resource management.

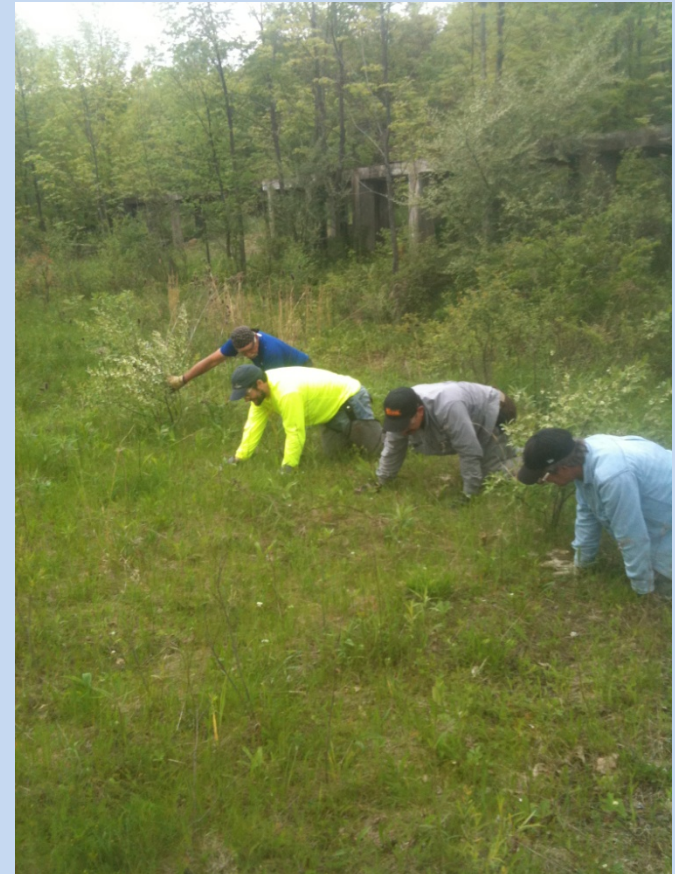
- MMRP RI was conducted at LL1A between April and August 2011.
- LL1A RI field work:
 - Instrument-assisted visual surveys over 100% of the MRS.
 - Collect for MC samples as pre-determined in the Work Plan.
 - 2 ISM samples for MC over 100% of the MRS.
 - Analyze MC samples for lead, explosives, and propellants.

- No MEC was found during visual surveys.
- MC results for lead and nitroguanidine were below the risk-based screening levels for human and environmental receptors.
- Conclusions: No risks associated with exposures to MEC or MC at the LL1A MRS.
- Final RI Report issued/approved by Ohio EPA in August 2014.

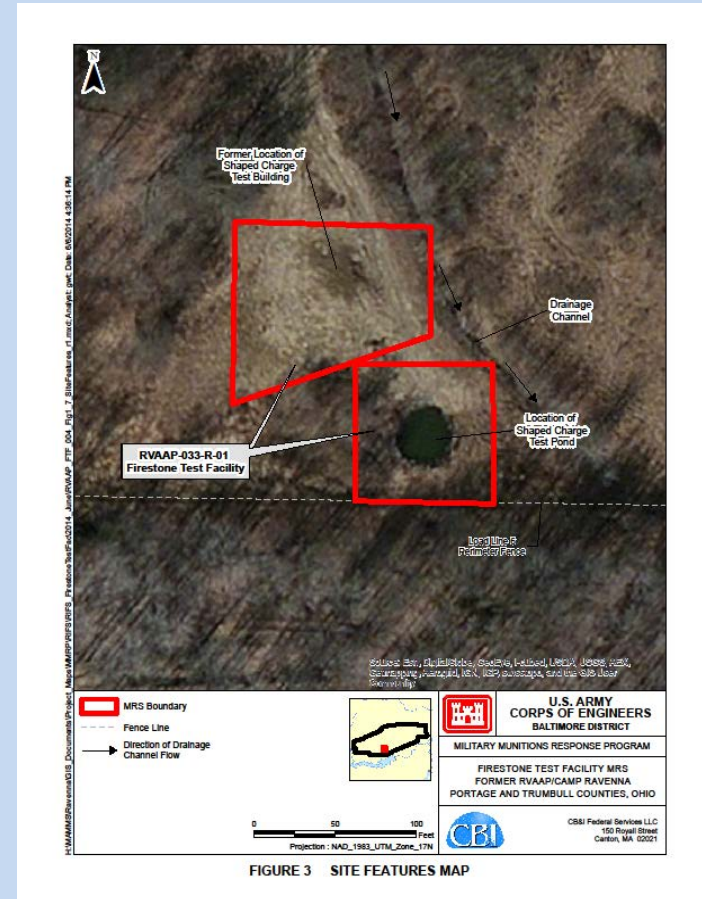
- The MRS is 0.41 acres in size and is the location of the former building and area around the former test pond.
- MRS is co-located with an IRP AOC (Load Line #6).
- No significant cultural features remain.
- Topography gently slopes to east.
- Drainage is towards ditch and pond.
- Vegetation consists mostly of grass and shrub species.
- Current activities - maintenance and natural resource management

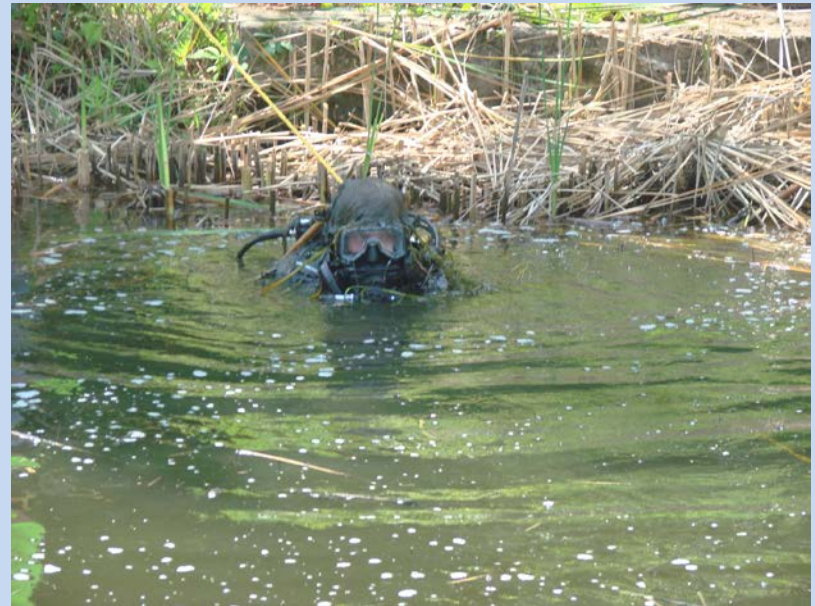
- MMRP RI was conducted at FTF from May to August 2011
- FTF RI field work:
 - DGM over 100% of accessible areas at the MRS.
 - Intrusive subsurface anomaly investigation at selected targets.
 - 100% underwater investigation.
 - Collect MC samples as pre-determined locations in the Work Plan:
 - 1 ISM surface soil sample around pond,
 - 2 grab sediment samples within pond,
 - 1 surface water sample from pond.

- 105 of 423 anomalies identified from DGM selected for intrusive investigation (25% of anomalies).
- No MEC was found during the land-based intrusive investigation or underwater tactile investigation.
- MC results in surface soil, surface water, and sediment were below the risk-based screening levels for human and environmental receptors.
- Conclusions: No risks associated with exposures to MEC or MC at the FTF MRS.
- Final RI Report issued/approved by Ohio EPA in August 2014.

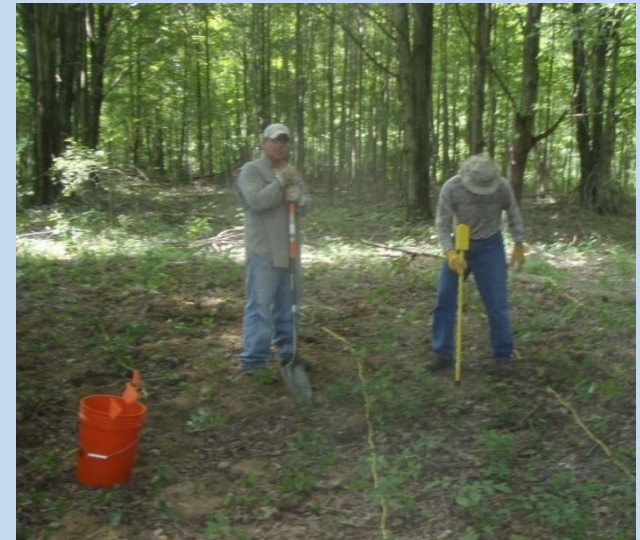
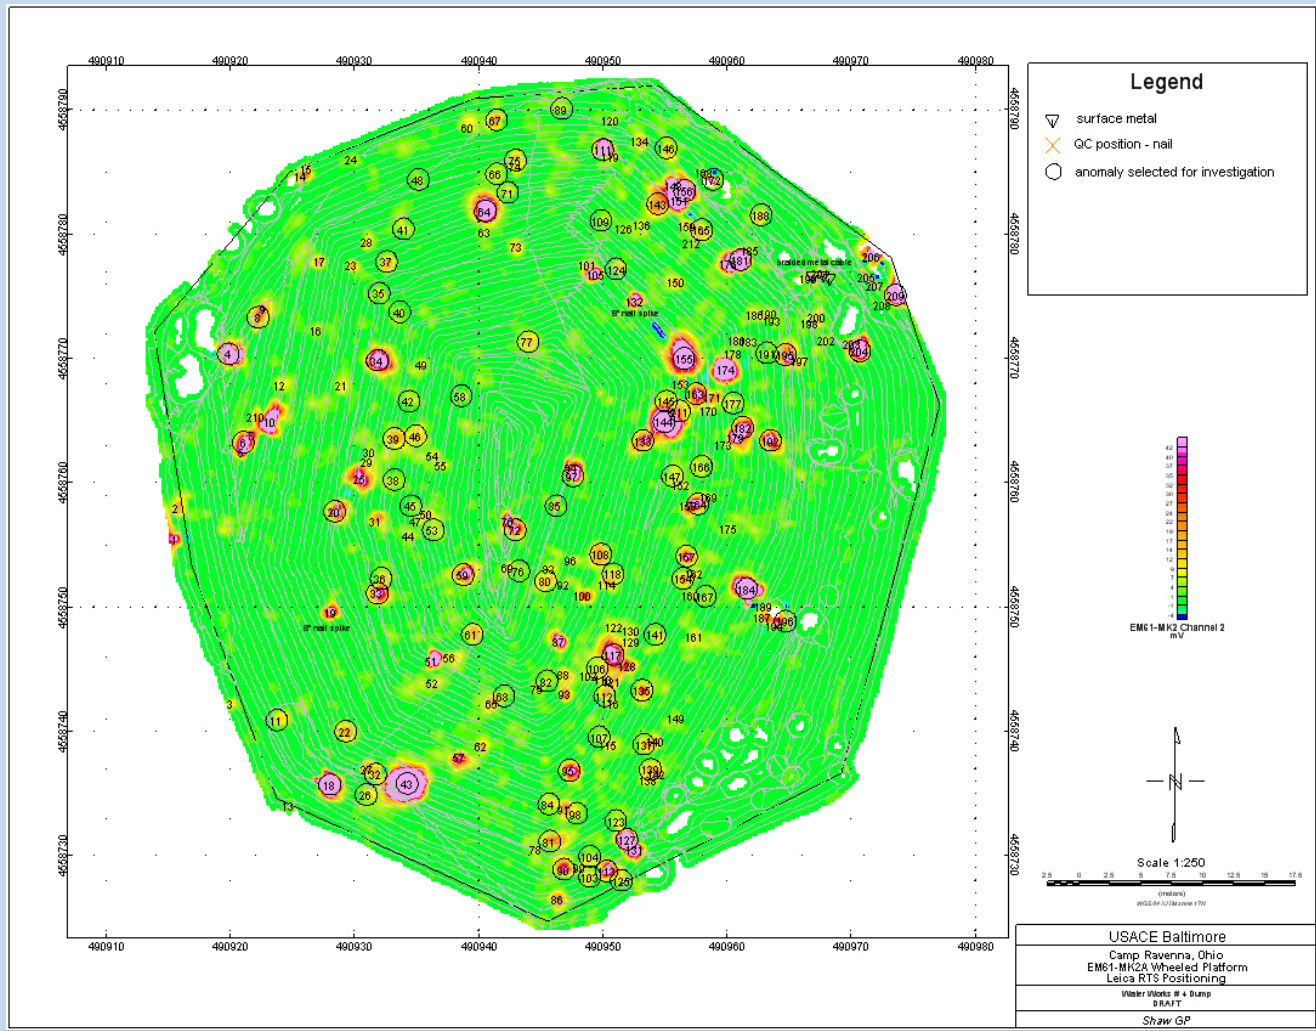
- Expanded investigation area to include the wooded area where ogives were found during the SI Report (original 6.15 acres).
- Instrument-assisted visual survey at the combined MRS and wooded area.
- Full DGM coverage of the 0.77 acre MRS.
- Intrusive investigation of subsurface anomalies identified during DGM survey.
- Sample for MC if MEC or concentrated areas of MD found.

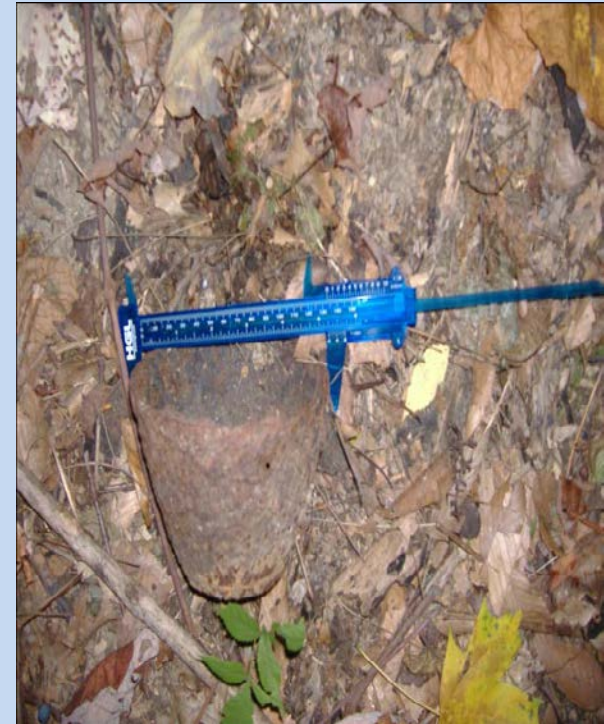
- Instrument-assisted visual survey:
 - Five ogives found at isolated locations in wooded area (all MDAS).
- Intrusive activities at MRS dump area:
 - 93 of 205 anomalies identified from DGM selected for investigation (45% of anomalies)
 - Two ogives found just below ground surface (both MDAS).
- No MEC found.
- Conclusions: No risks associated with exposure to MEC at the MRS.
- Final RI Report issued/approved by Ohio EPA in March 2015.

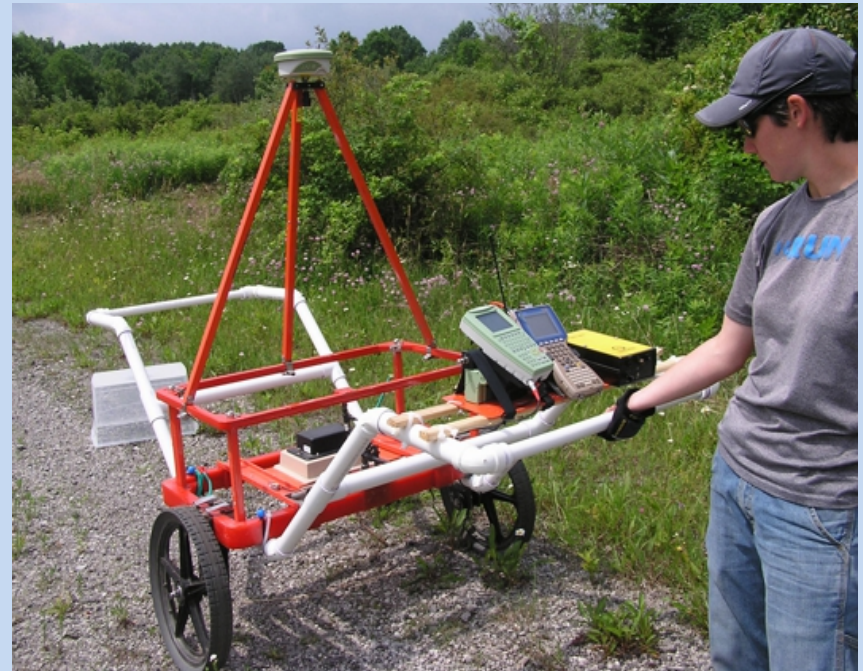
- MMRP RI was conducted at SCD MRS in December 2011.
- SCD RI field work:
 - DGM survey to cover areas not covered during the IRP investigation.
 - Intrusive investigation of subsurface anomalies identified during DGM survey.
 - Visual survey of creek where 105mm projectile was seen during the SI field work.
 - Sample for MC if MEC or concentrated areas of MD found.

- Intrusive investigation activities:
 - 8 trenches to maximum depth of 2.5 feet bgs.
 - Hand dug at 167 individual anomaly locations.
- No MEC was found during the intrusive investigation activities or visual survey of the creek.
- Conclusions: No risks associated with exposures to MEC at the MRS.
- Final RI Report issued/approved by Ohio EPA in March 2015.
