# **QUARTERLY EFFECTIVENESS EVALUATION REPORT (#1)**

Quarterly Effectiveness Evaluation Report  
Sand Creek Barrier System  
Time Critical Response Action (TCRA) for the Rocket Ridge Area of  
Open Demolition Area #2

<b>Project No:</b>	W912QR-09-C-0084	<b>QEE Report No:</b>	Vista 01
<b>Date of QEE Site Visit:</b>	1-28-10		
<b>Time Period Covered by QEE Report:</b>	<b>From: Oct. 09</b>	11-24-09	
	<b>To: Jan. 10</b>	1-28-10	
<b>Dates of O&amp;M Trip During Period Covered by QEE Report:</b>		11-24-09	
		12-21-09	
		1-28-10

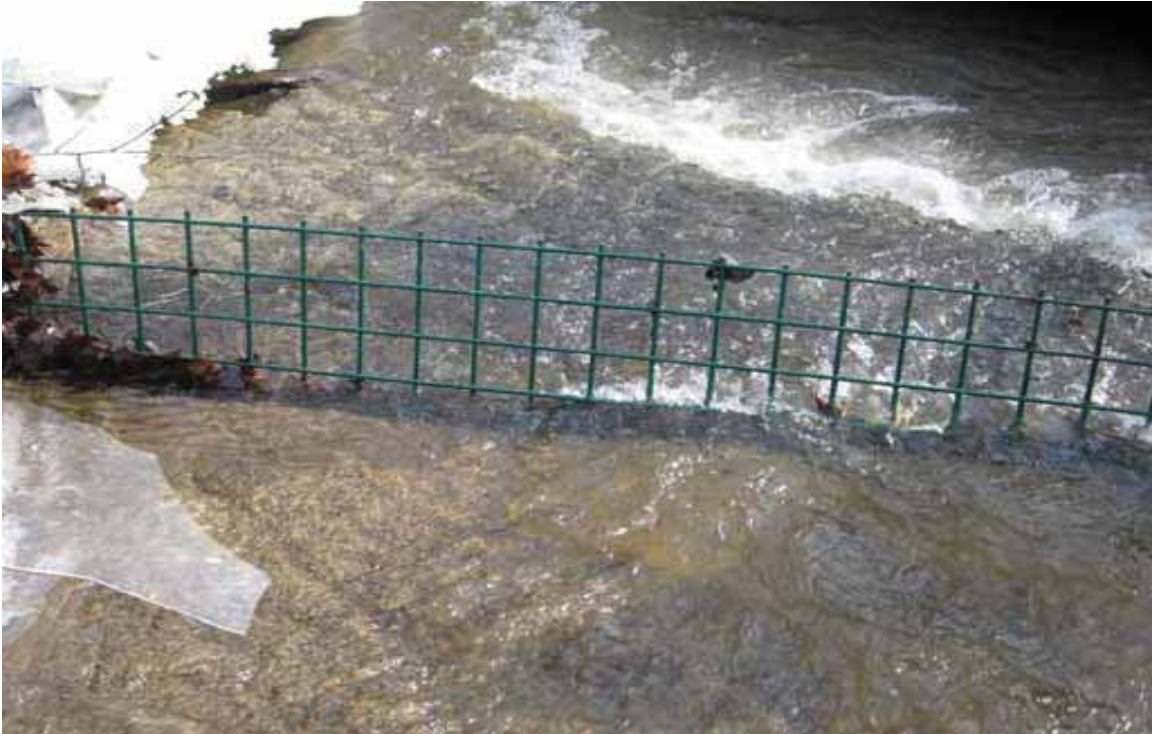
CLOSEUP OF UPSTREAM BARRIER FOLLOWING CLEANUP.

Maintenance performed: Removed all materials from screens.

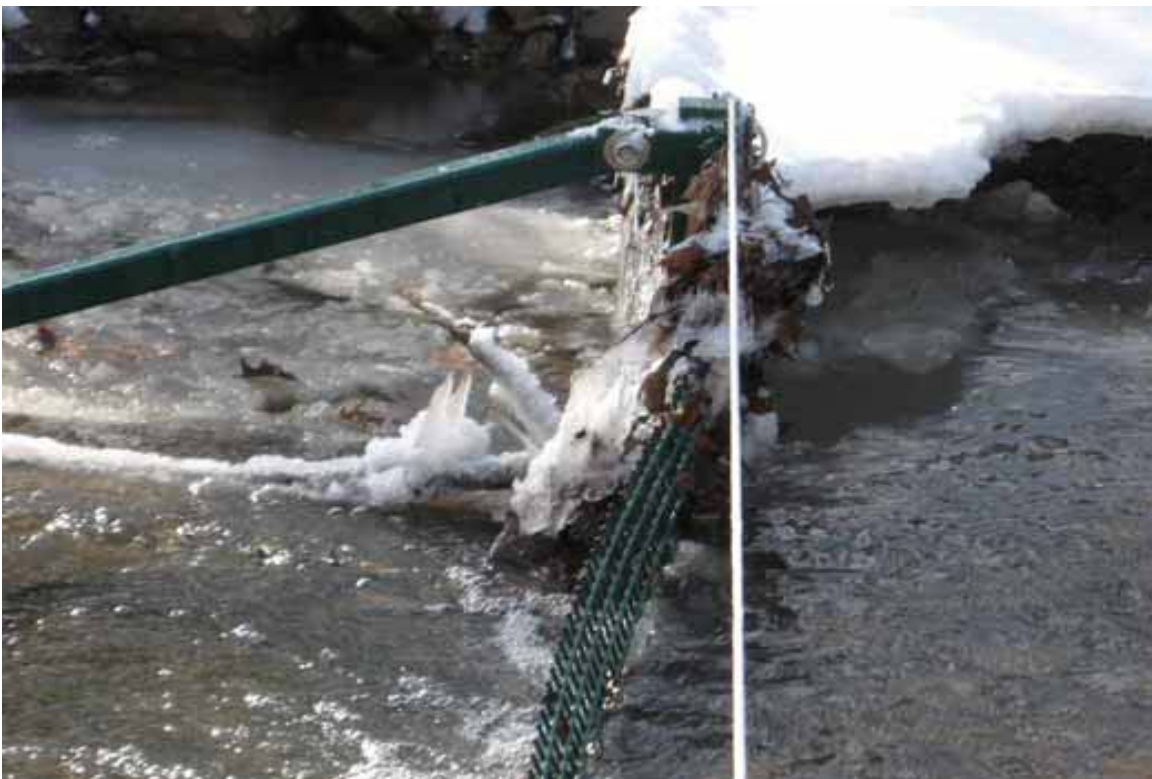
All barrier components are intact and solidly anchored. Most screen panels are bowed due to water pressure building up when water flow is limited because of debris build up. See photos.

The deflection in the screen panels does not limit the effective performance of the barrier system.

PICTURE SHOWING EXTENT OF BEND IN DOWNSTREAM BARRIER TO DATE.
