QUARTERLY EFFECTIVENESS EVALUATION REPORT (#2)

MARCH 23, 2011

Quarterly Effectiveness Evaluation Report
Sand Creek Barrier System
Time Critical Response Action (TCRA) for the Rocket Ridge Area of
Open Demolition Area #2

Project No:	W912QR-09-C-0084	QEE Report No:	Vista 02
Date of QEE Site Visit:	3-28-11		
Time Period Covered by QEE Report:	From: 1-20-11		
	To: 3-23-11		
Dates of O&M Trip During Period Covered by QEE Report:		1-20-11	
		2-17-11	
		3-23-11

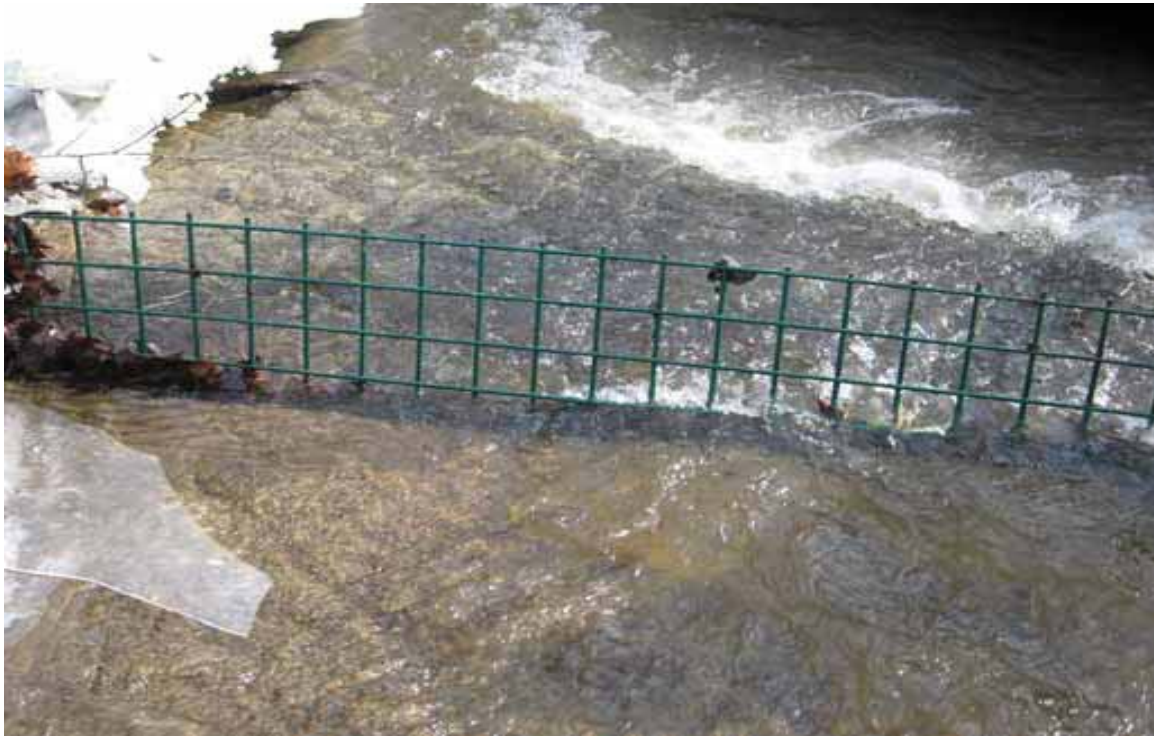
CLOSEUP OF UPSTREAM BARRIER FOLLOWING CLEANUP.

Maintenance performed: Removed all materials from screens.

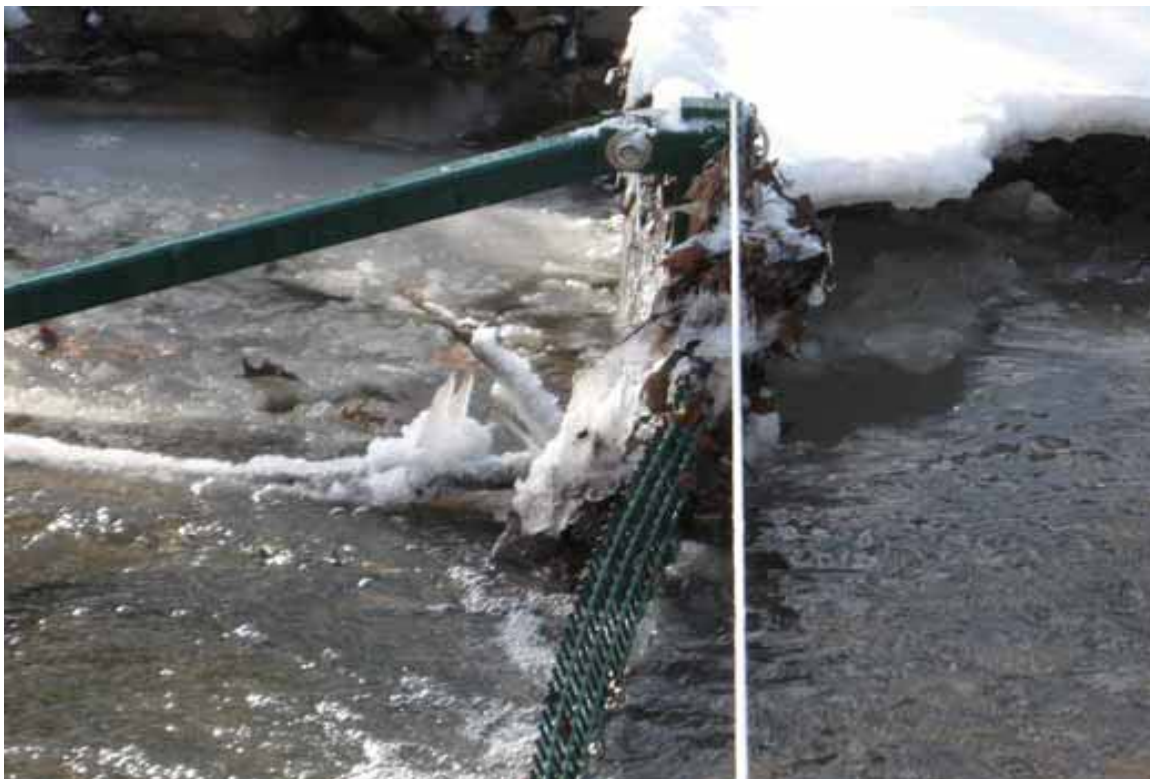
All barrier components are intact and solidly anchored. Most screen panels are bowed due to water pressure building up when water flow is limited because of debris build up. (See photos)

The deflection in the screen panels does not limit the effective performance of the barrier system.

PICTURE SHOWING EXTENT OF BEND IN DOWNSTREAM BARRIER TO DATE.
