**FY 2014 Annual Report for the  
Quarterly Land Use Control Inspections,  
RVAAP-05 Winklepeck Burning Grounds**

**Camp Ravenna Joint Military Training Center  
Former Ravenna Army Ammunition Plant  
Portage and Trumbull Counties, Ohio**

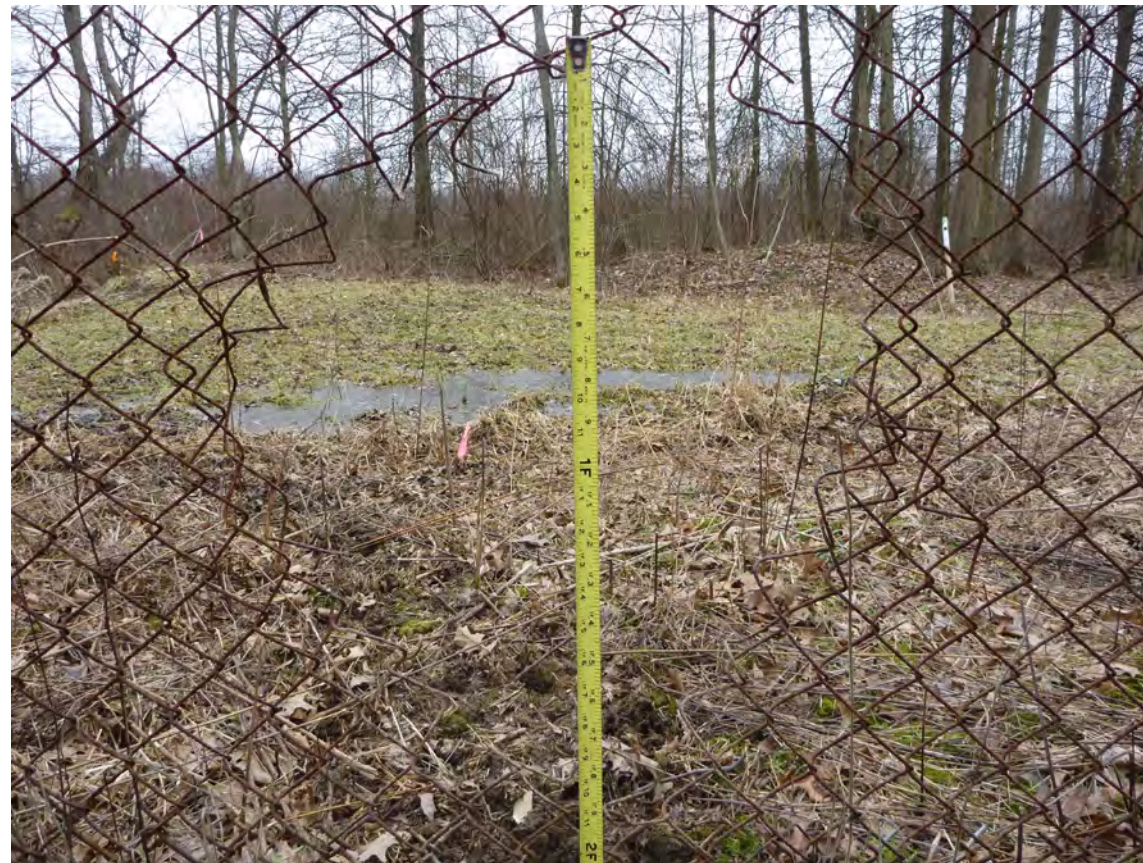
## DETAIL SHEET FOR NE5

PHOTO NE5 discovered 02/13/2013

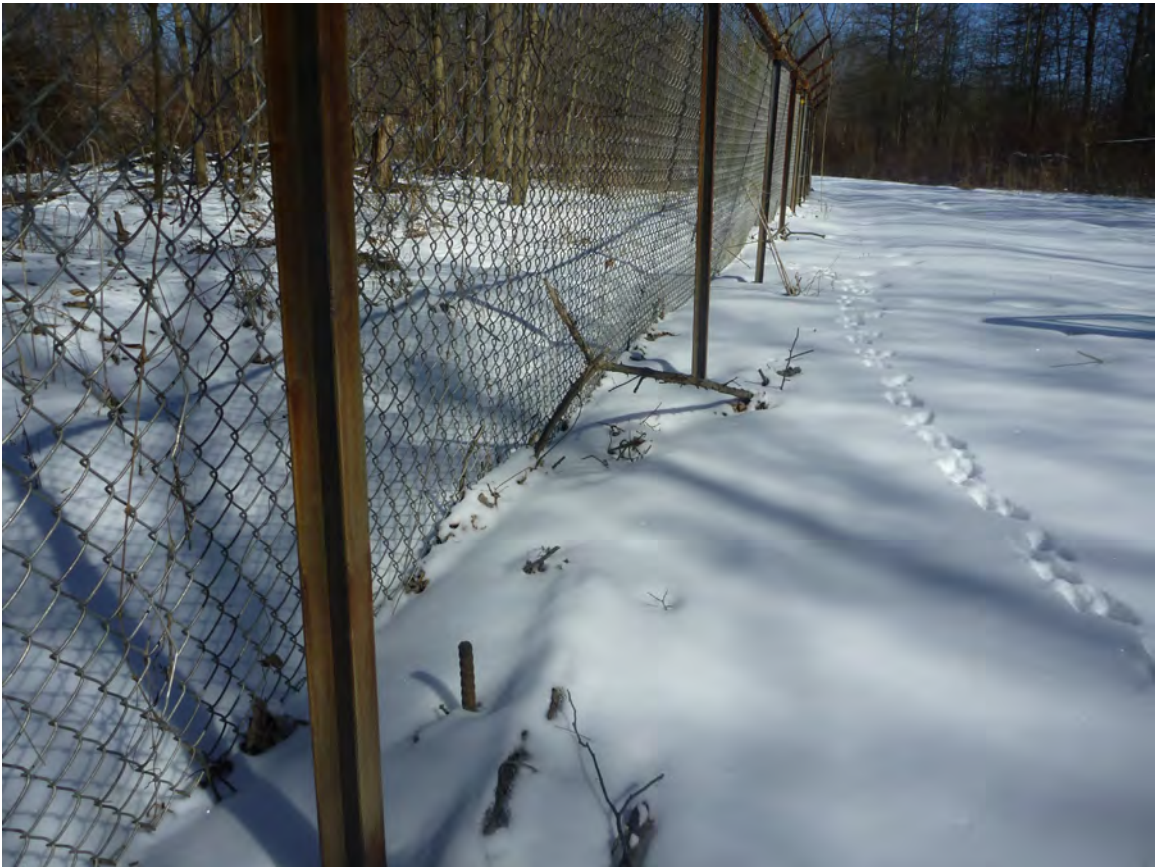
DETAIL SHEET FOR NE18

| Detail Sheet | | Camp Ravenna Joint Military Training Center 1st Qtr. FY 2014 LUC Inspection | | Summary Table | US Survey Feet | | |
|---|---|---|--|---|---|---|---|
| NE18 | 7/17/2013 | c:\My Documents\My ArcPad\P1010219.JPG | | apx. 10 sections of fence fabric needs reattached at base due to storm damage | 573035 | 2372897 | |

PHOTO NE18 discovered 07/17/2013

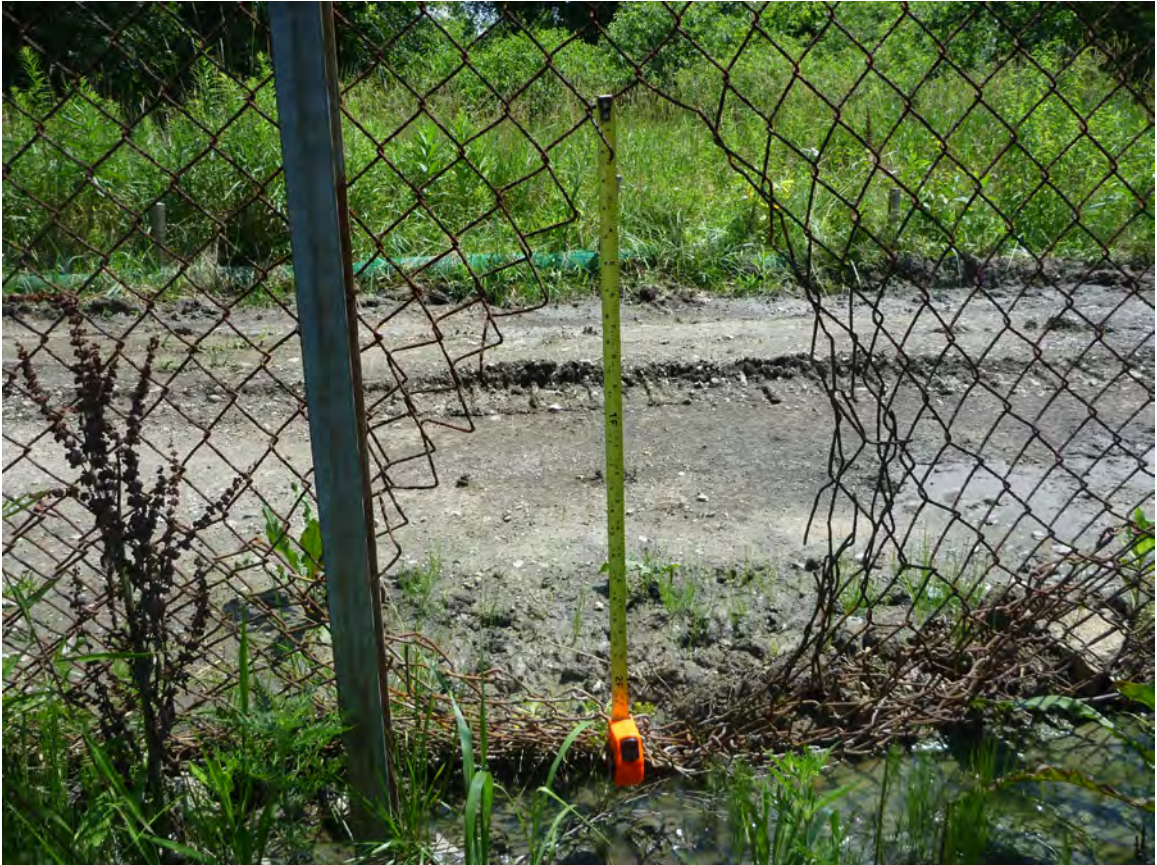
DETAIL SHEET FOR NE19

PHOTO NE19 discovered 07/17/2013

REPAIR  
CALLOUT

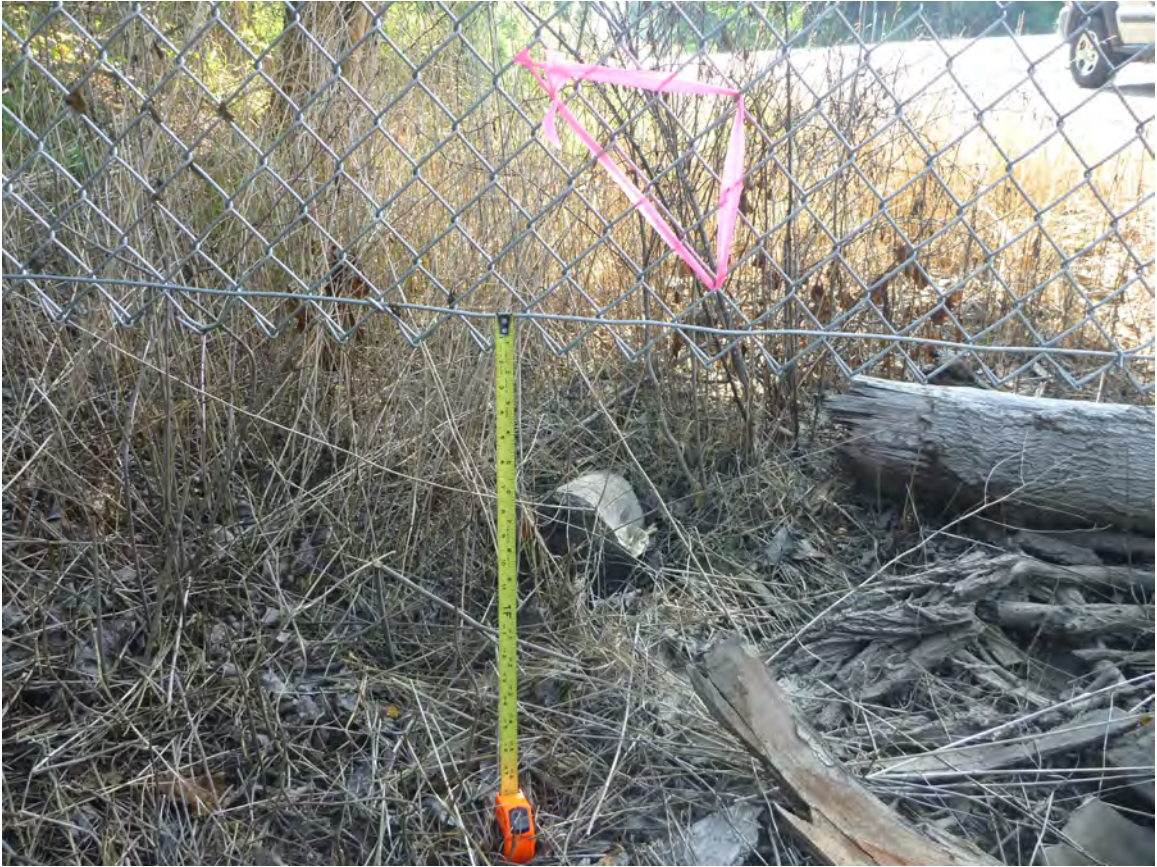
DETAIL SHEET FOR NE20

PHOTO NE20 discovered 07/18/2013

REPAIR  
CALLOUT

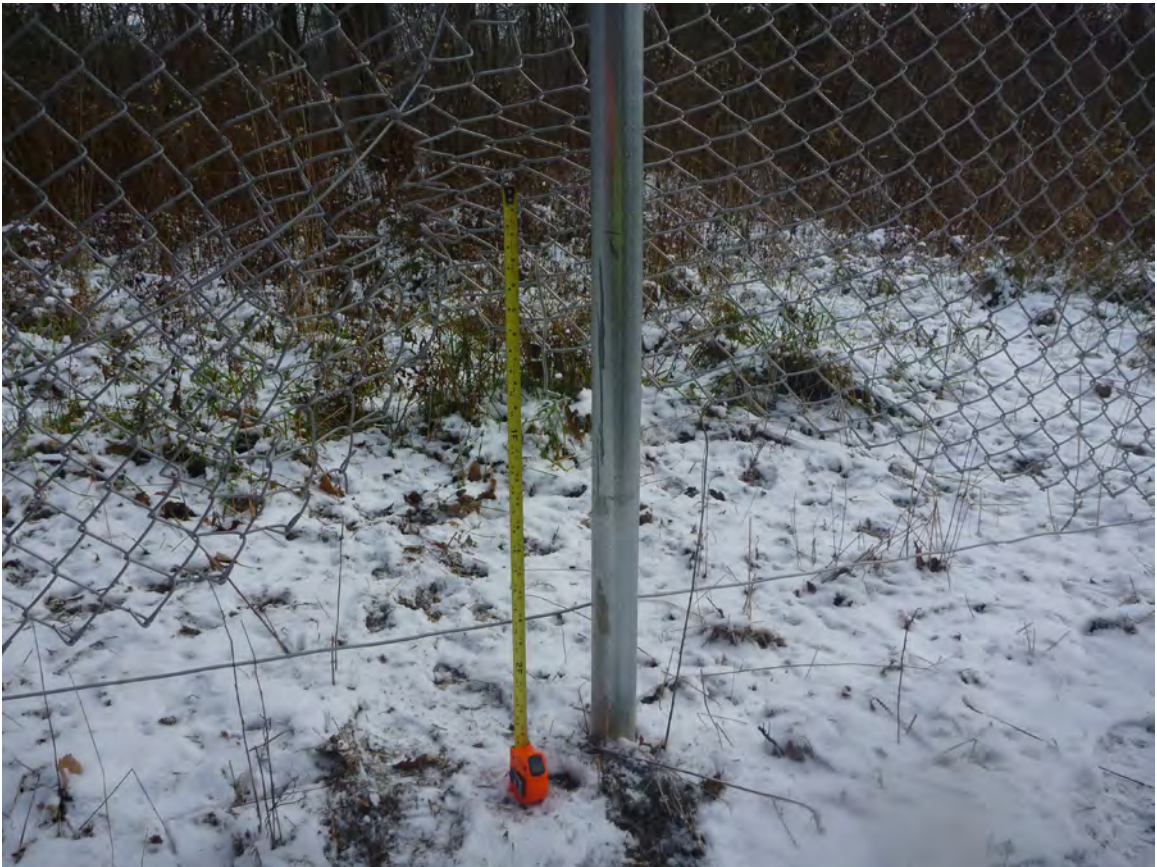
DETAIL SHEET FOR NE22

PHOTO NE22 discovered 11/25/2013

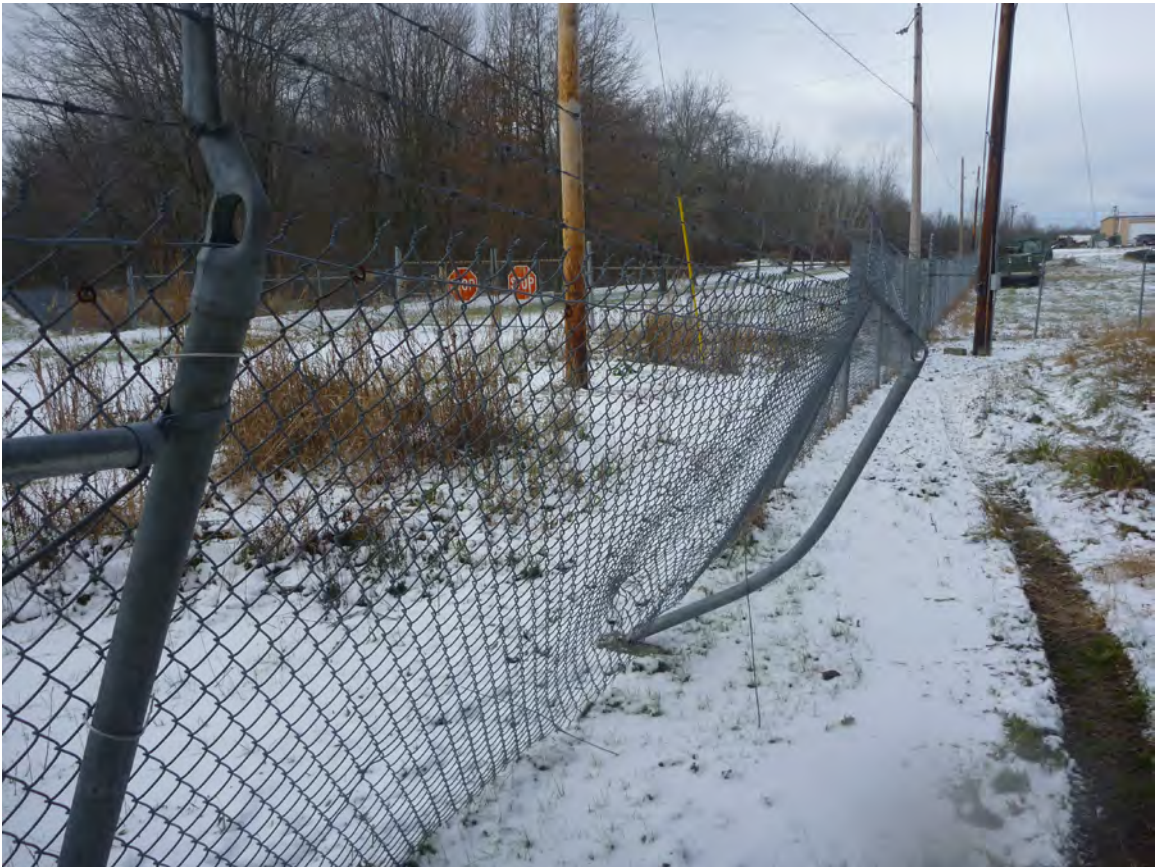
DETAIL SHEET FOR NE23

| Callout | Comments | US Survey Ft | | Fiscal Year and Quarter Identified | Fiscal Year and Quarter Repaired |
|---|---|---|---|---|---|
| NE23 | 3 sections badly damaged | 563209 | 2383312 | FY 2014 - 1 Qtr. | FY 2014 - 2 Qtr. |

| Detail Sheet | | Camp Ravenna Joint Military Training Center 1st Qtr. FY 2014 LUC Inspection | | Summary Table | US Survey Feet | | |
|---|---|---|--|---|---|---|---|
| NE23 | 11/25/2013 | c:\My Documents\My ArcPad\P1010269.JPG | | 3 sections badly damaged | 563209 | 2383312 | |

PHOTO NE23 discovered 11/25/2013

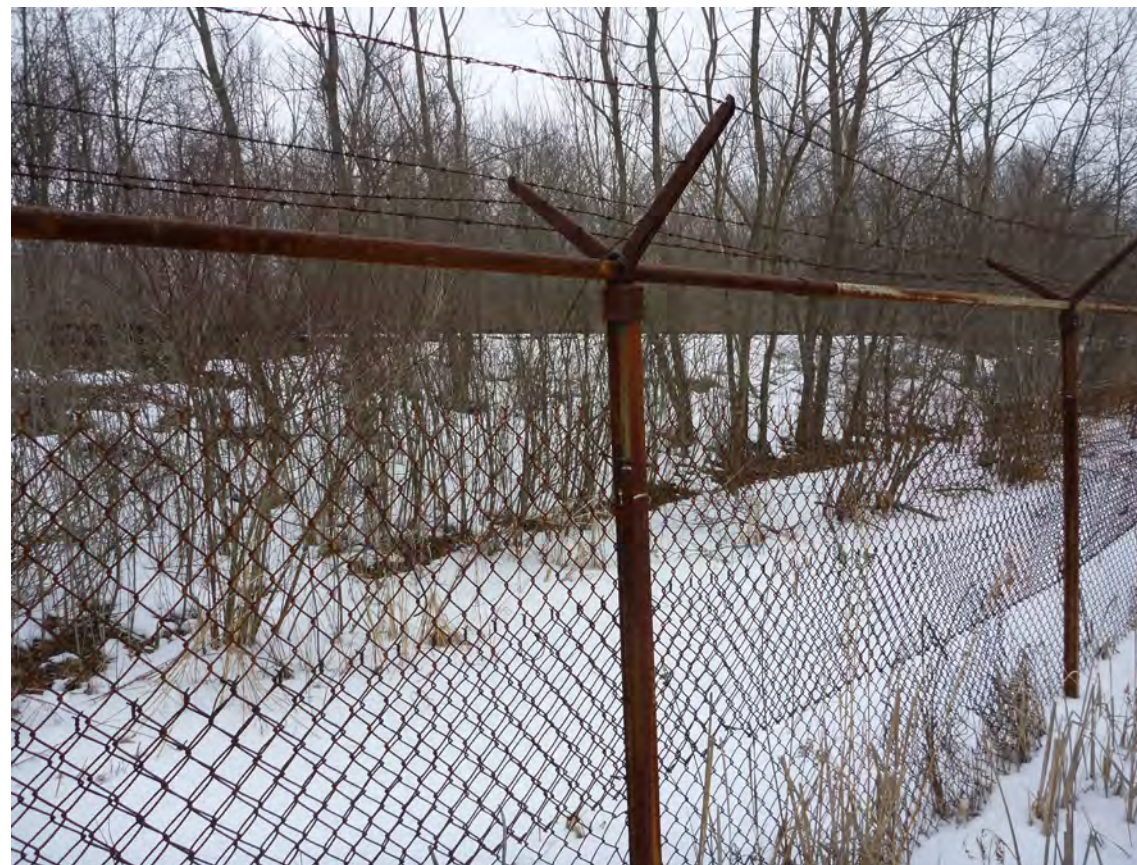
## DETAIL SHEET FOR NW8

PHOTO NW8 discovered 07/16/2013

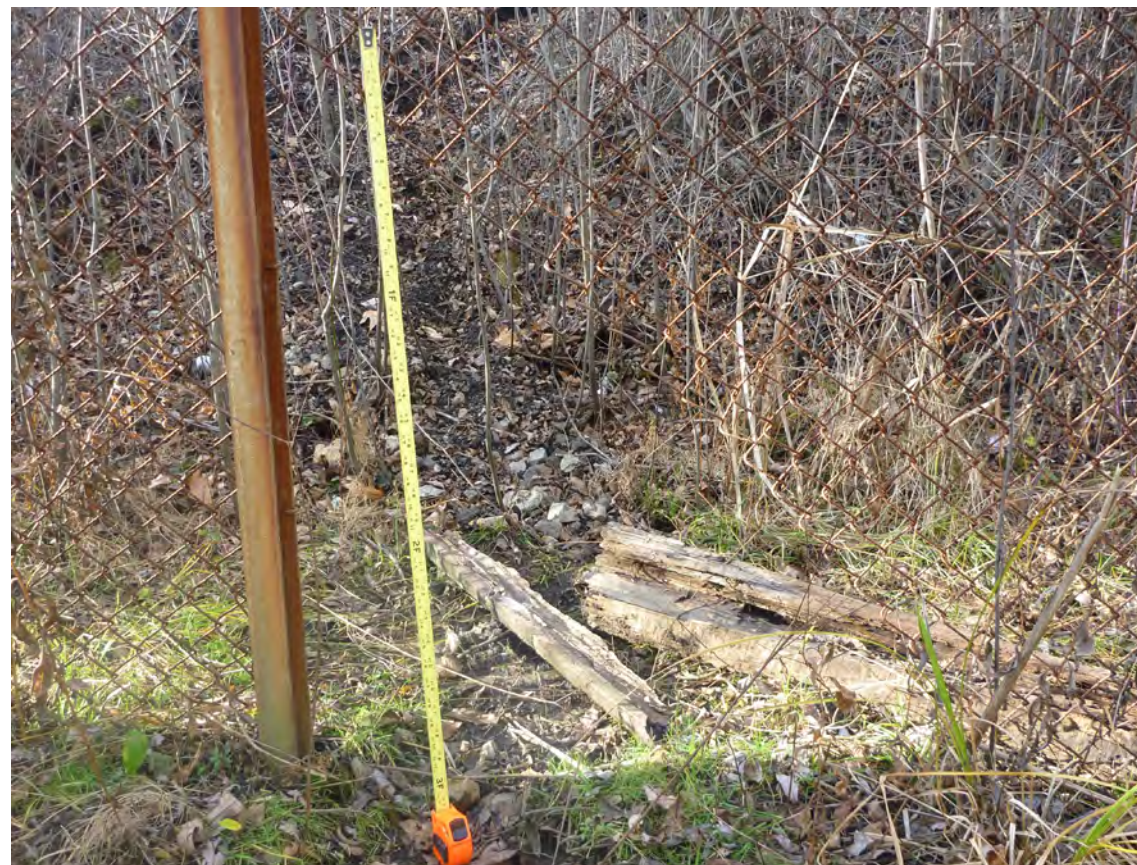
## DETAIL SHEET FOR NW9

PHOTO NW9 discovered 11/19/2013

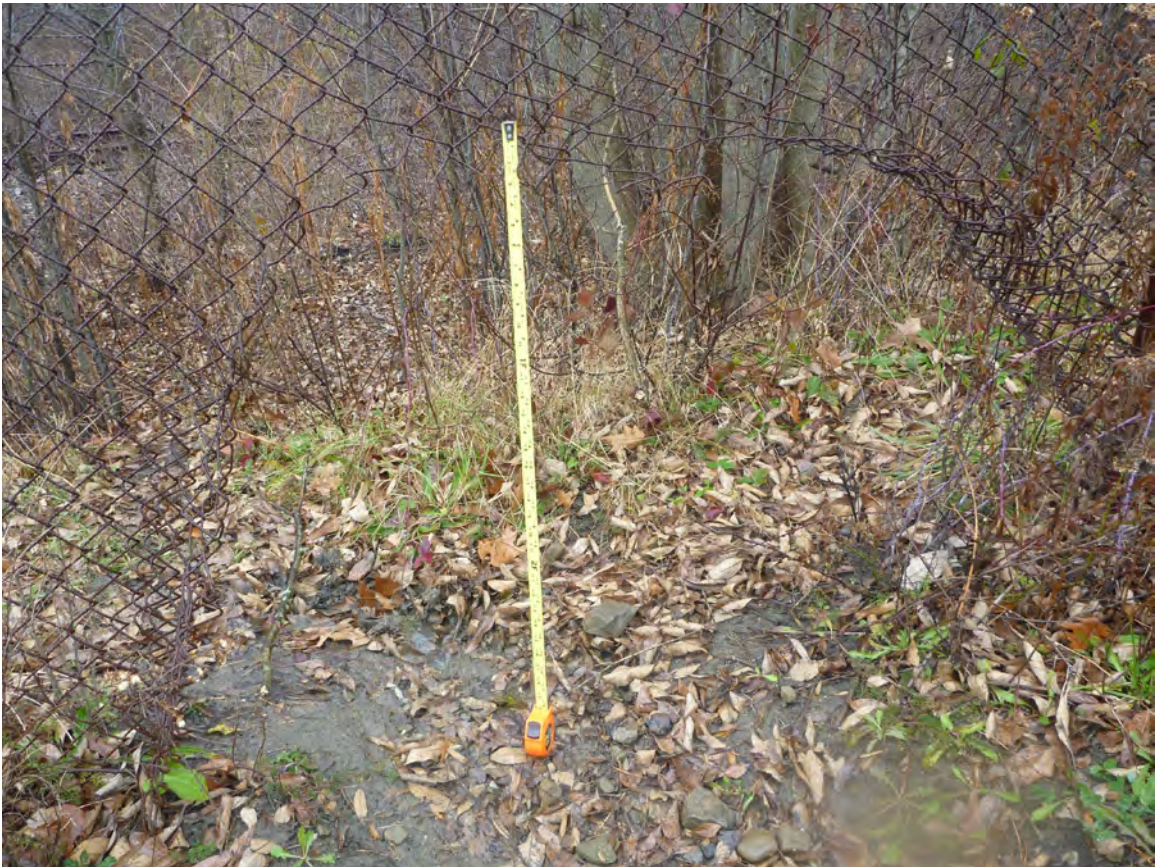
DETAIL SHEET FOR NW10

PHOTO NW10 discovered 11/21/2013

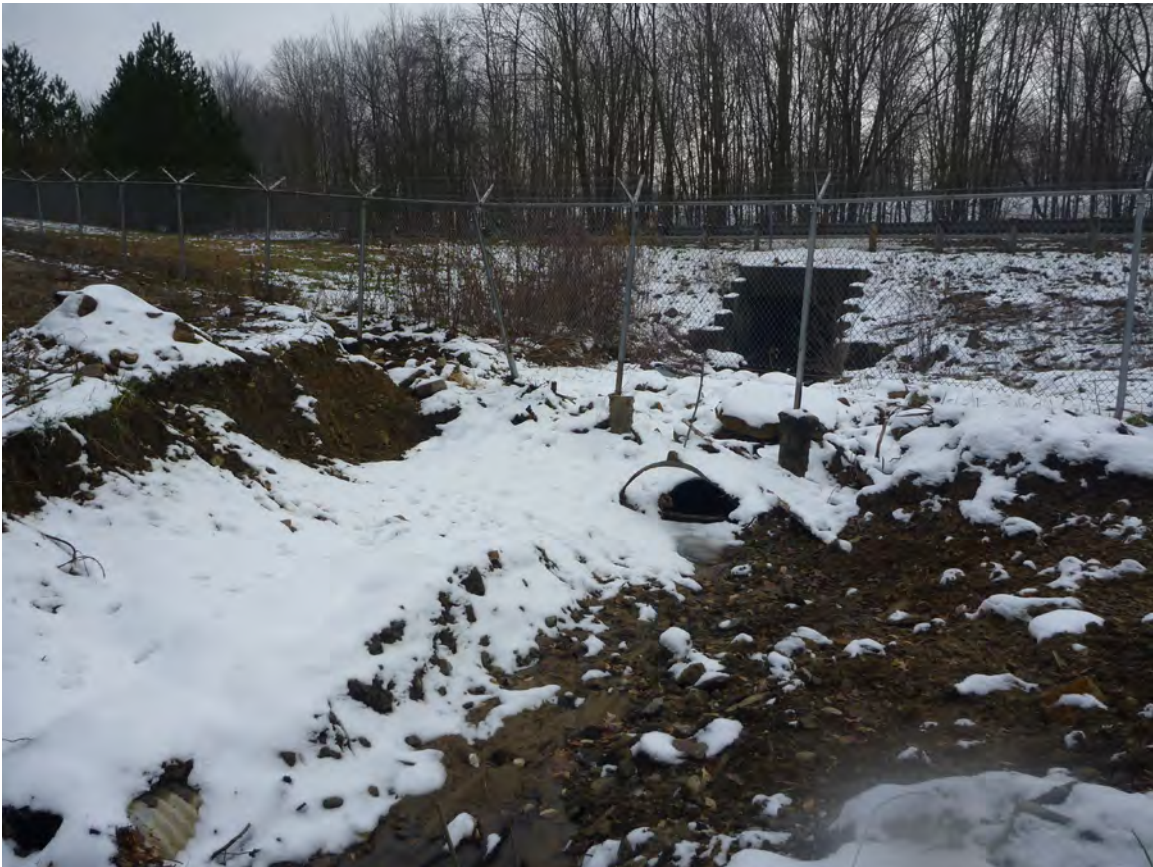
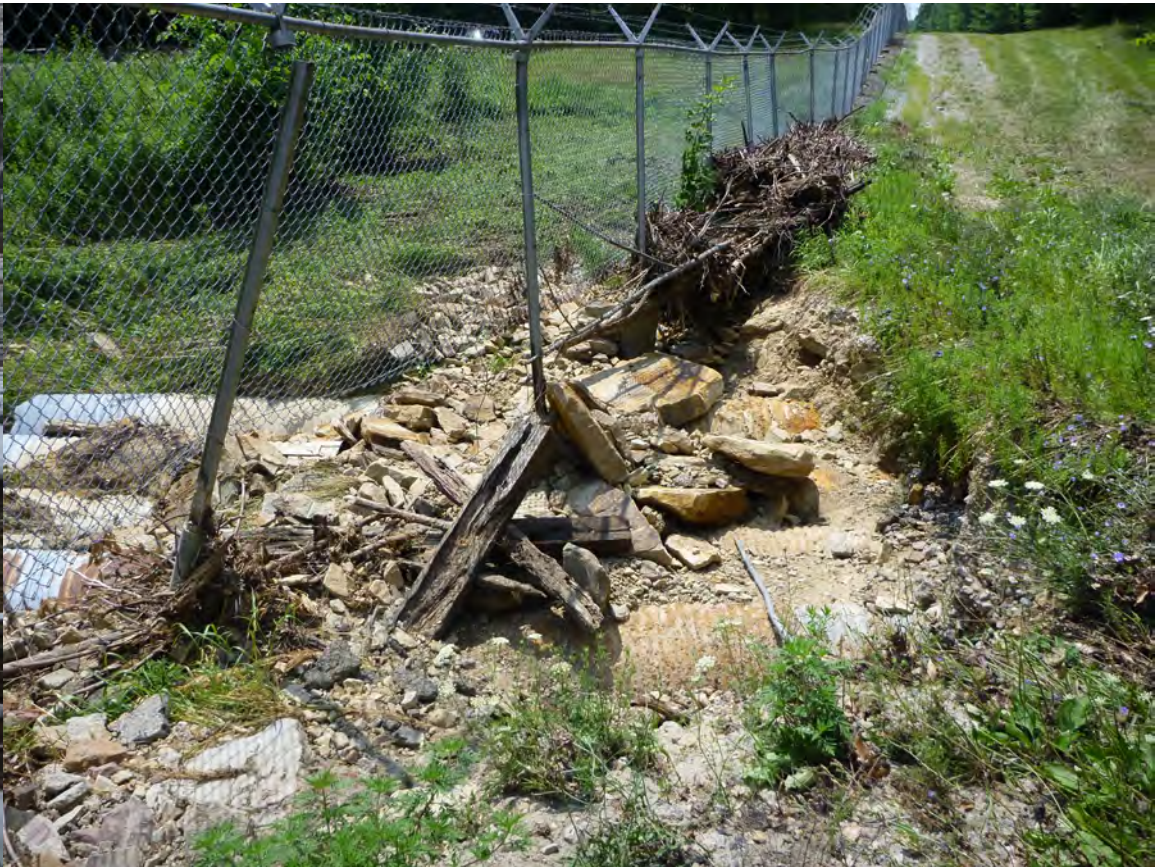
DETAIL SHEET FOR SE2

PHOTO SE2 on 2 Dec 2013

PHOTO SE2 discovered 07/18/2013

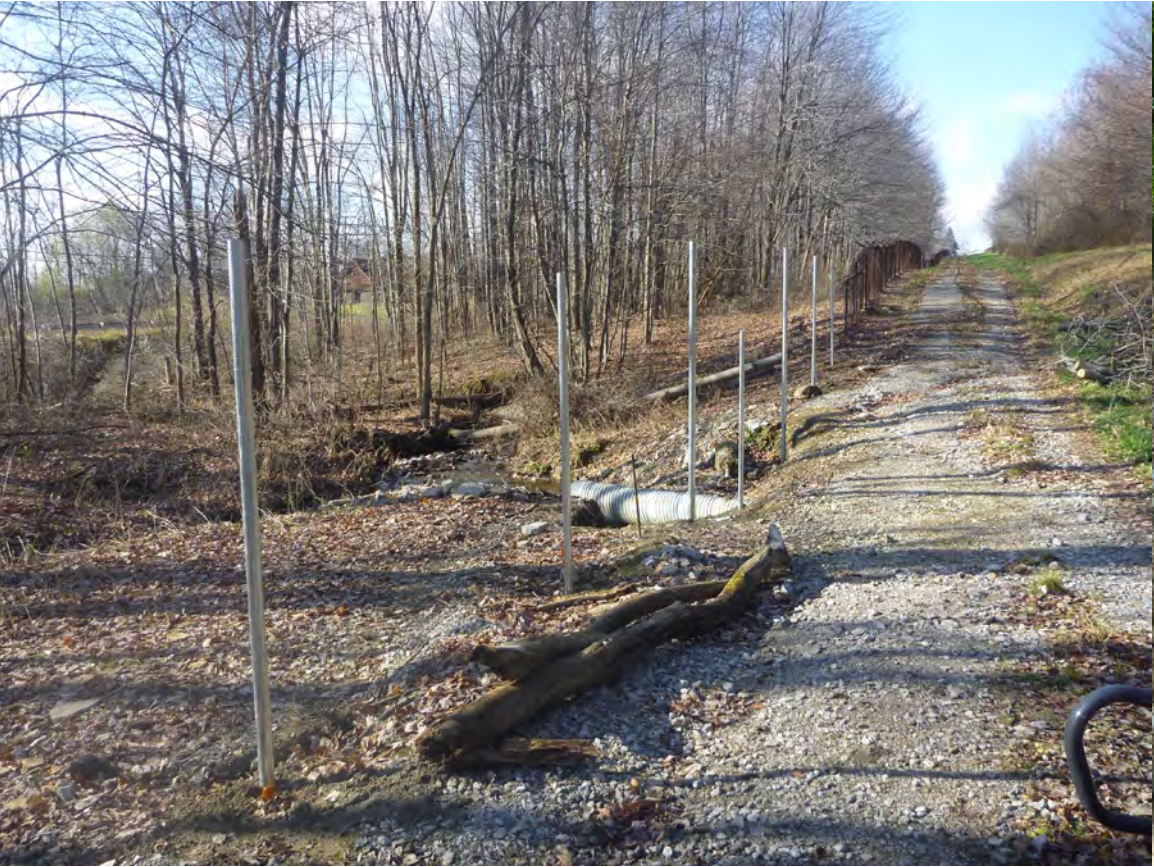
PHOTO SW11 DEPICTING REPAIRS IN PROGRESS  
photo taken 11/18/2013

| <b>Camp Ravenna Fence Repair Log - 2013</b> | | | | |
|---|---|---|---|---|
| SW10 and SW11 | Replaced fabric and fixed wash out under fence | RT Fence (contracted) | November 2013 | |

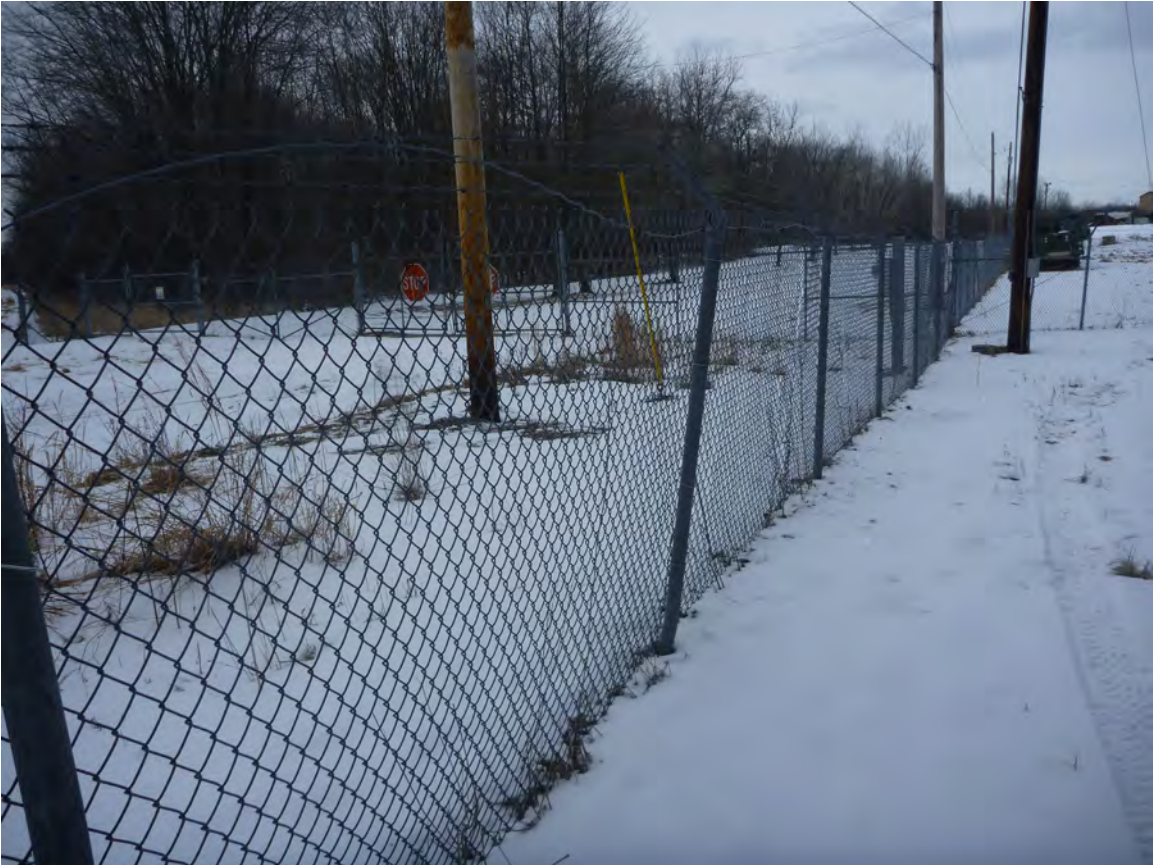
PHOTO NE23 repair 03/05/2014

| Camp Ravenna Joint Military Training Center 2nd Qtr FY2014 LUC Inspection Summary Table | | | | US Survey Ft | | | |
|---|---|--|---|---|---|--|---|
| NE23 | 11/25/2013 | c:\My Documents\My ArcPad\P1010269.JPG | 3 sections badly damaged | 563209 | 2383312 | c:\My Documents\My ArcPad\P1010375.JPG | NE23 |

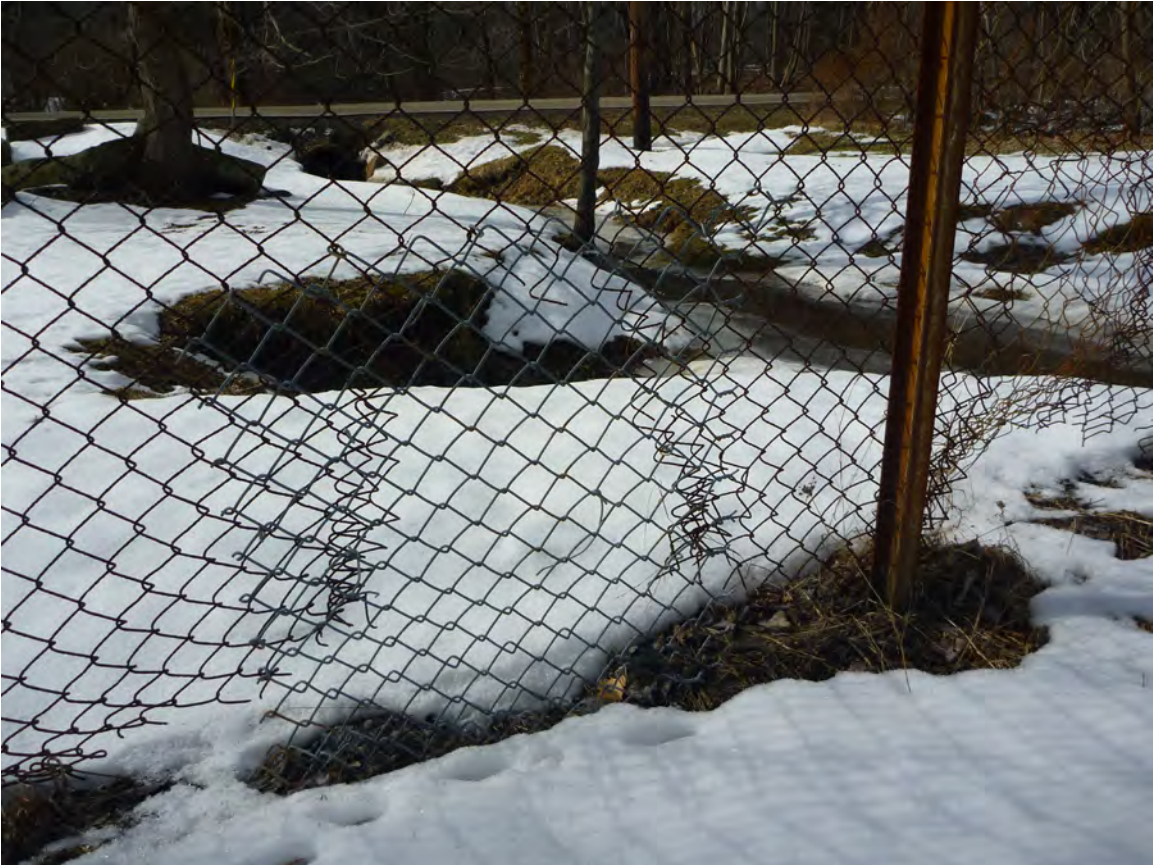
PHOTO SW13 repair 02/24/2014

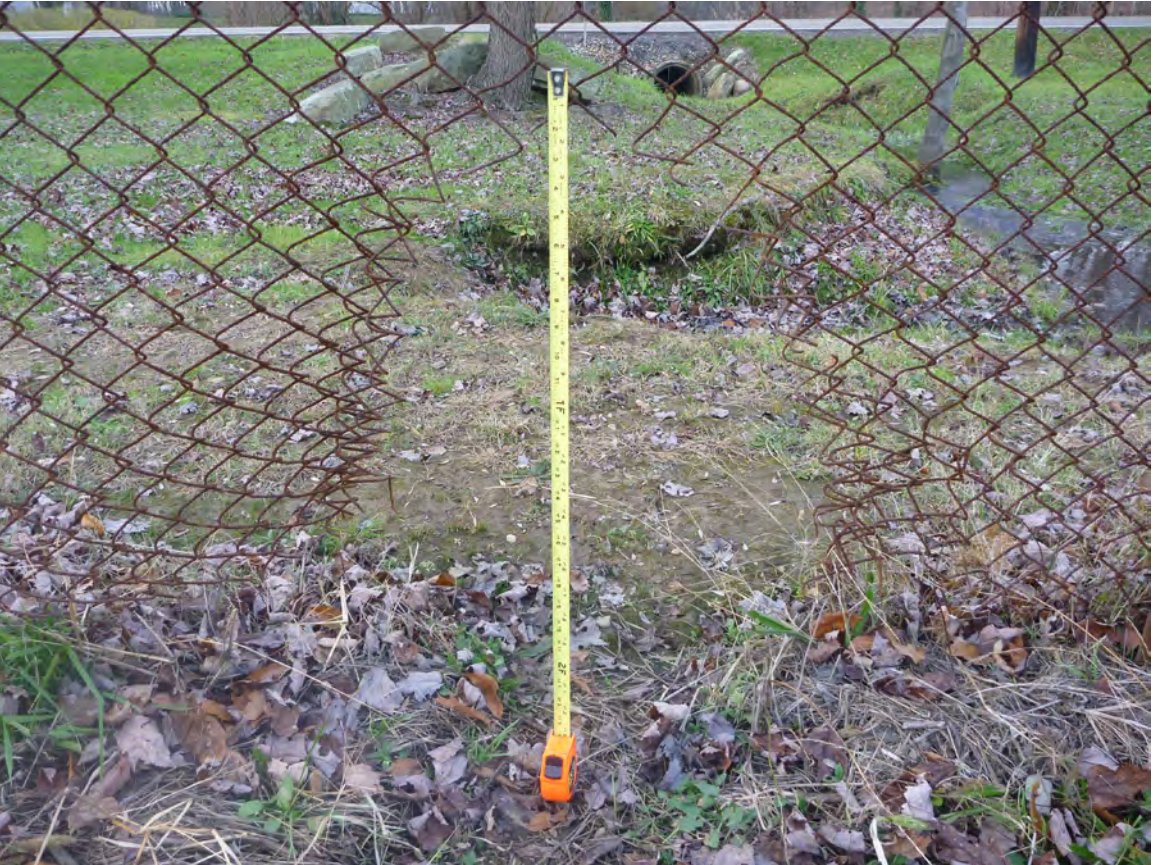
PHOTO SW13 discovered 11/18/2013

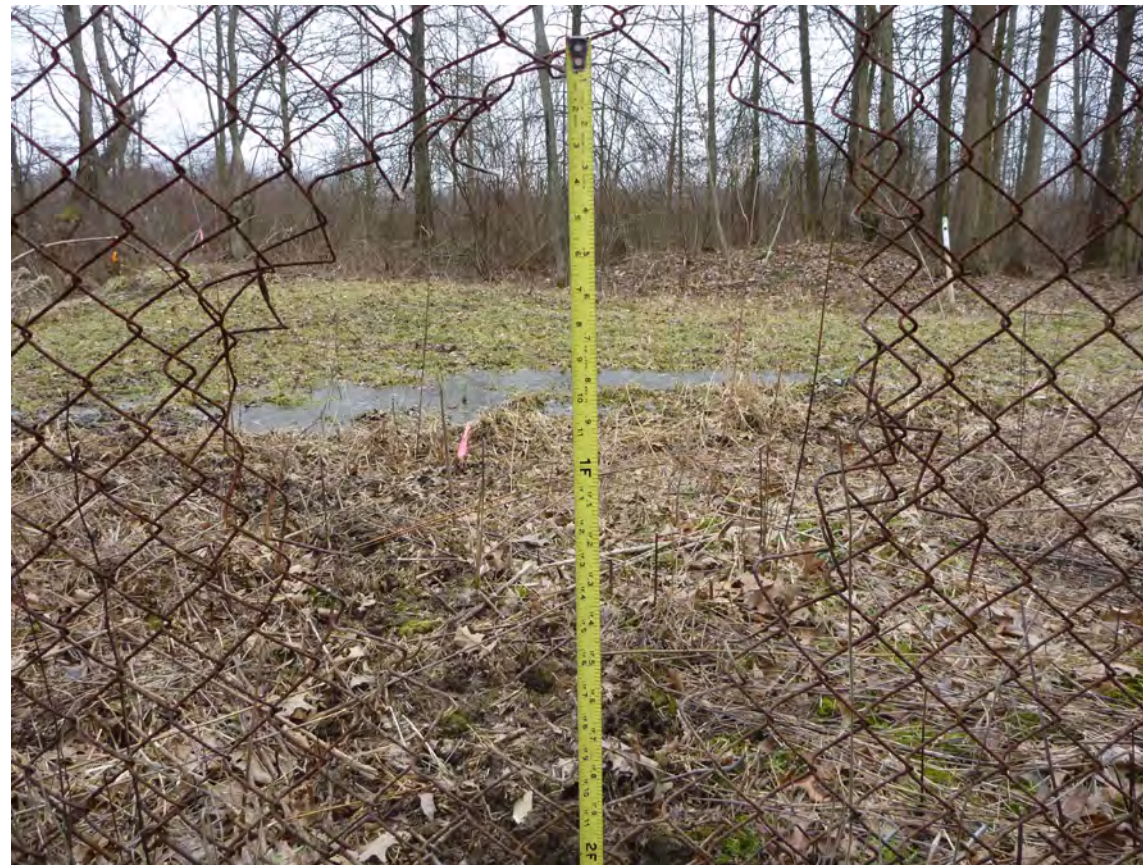
PHOTO NE5 discovered 02/13/2013

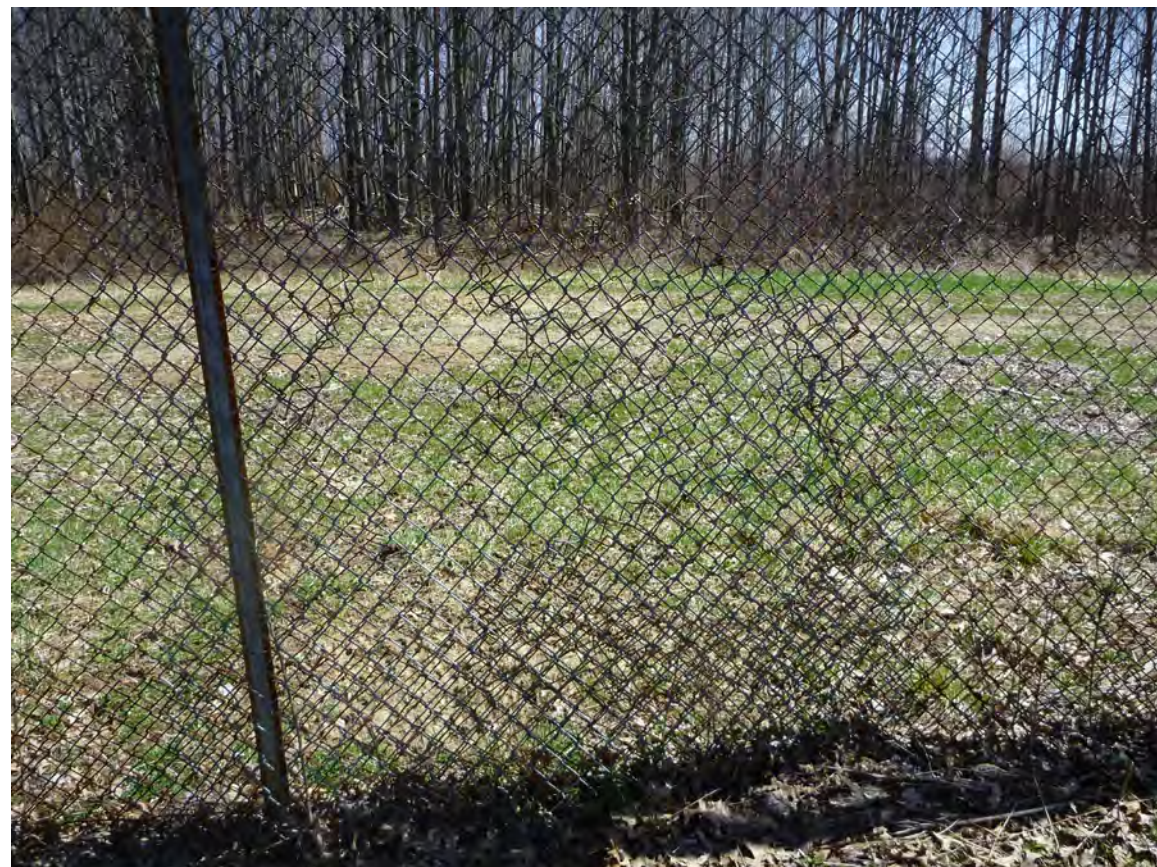
PHOTO NE6 repaired 04/17/2014

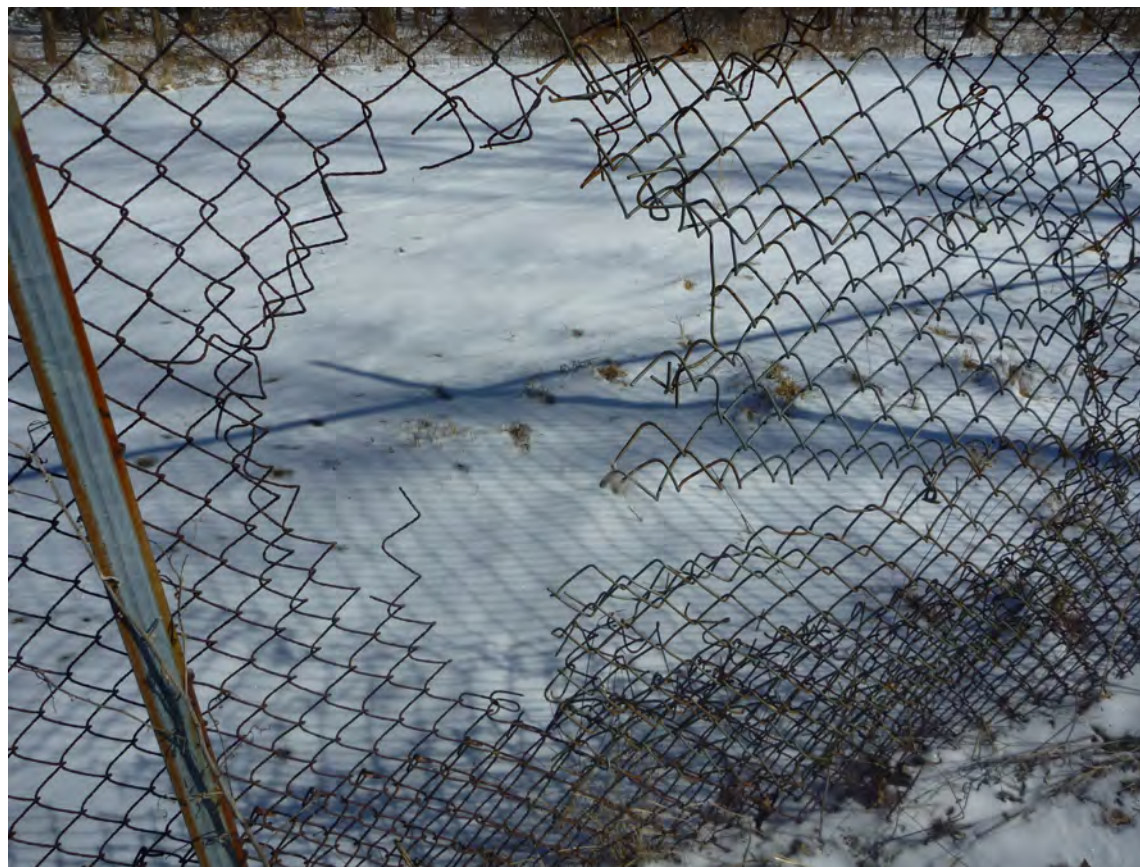
PHOTO NE6 discovered 03/03/2014

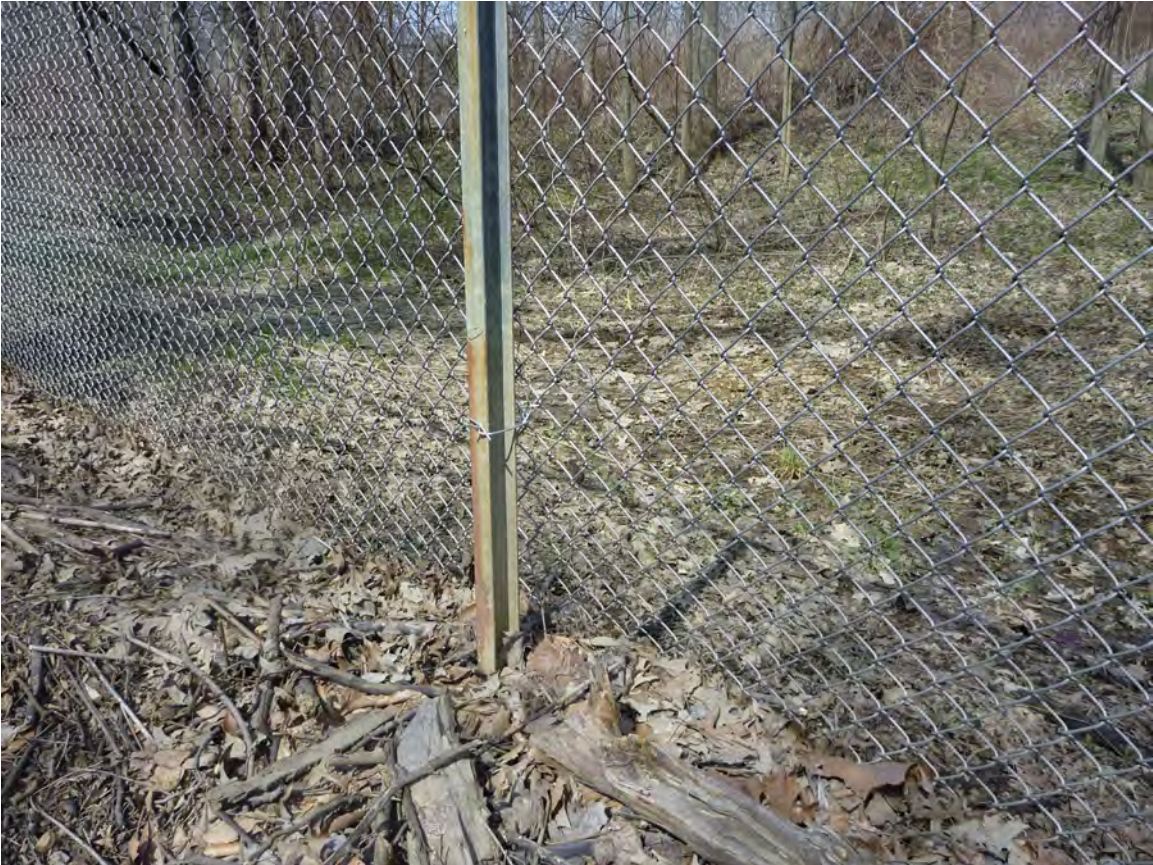
PHOTO NE18 repaired 04/17/2014

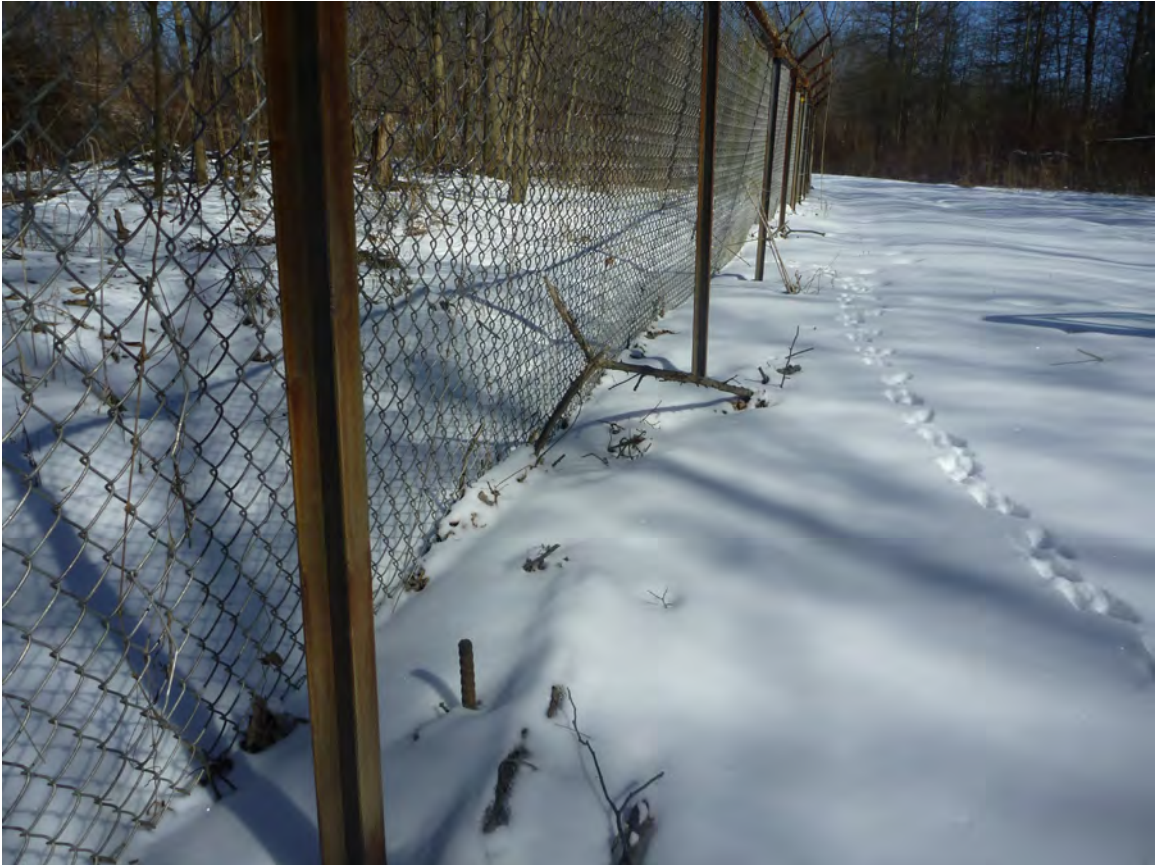
PHOTO NE18 discovered 07/17/2013

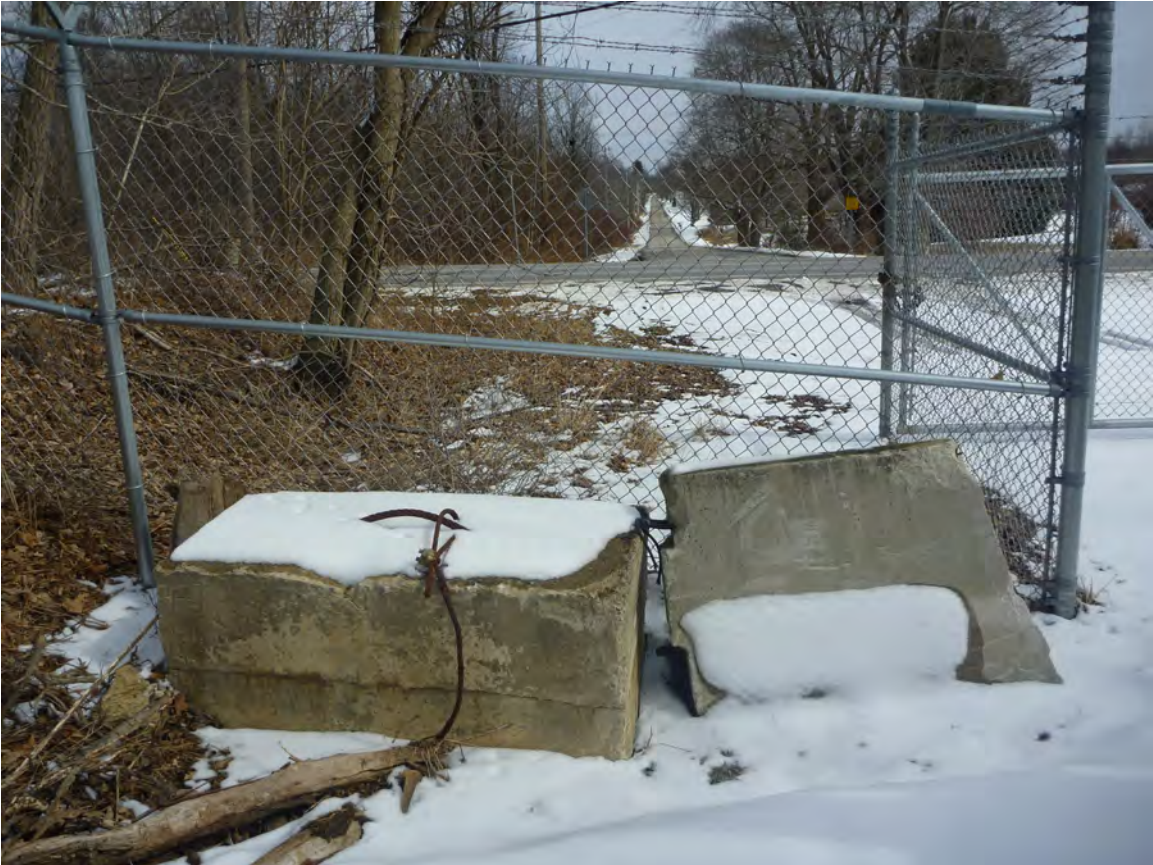
PHOTO NE20 repair 03/05/2014

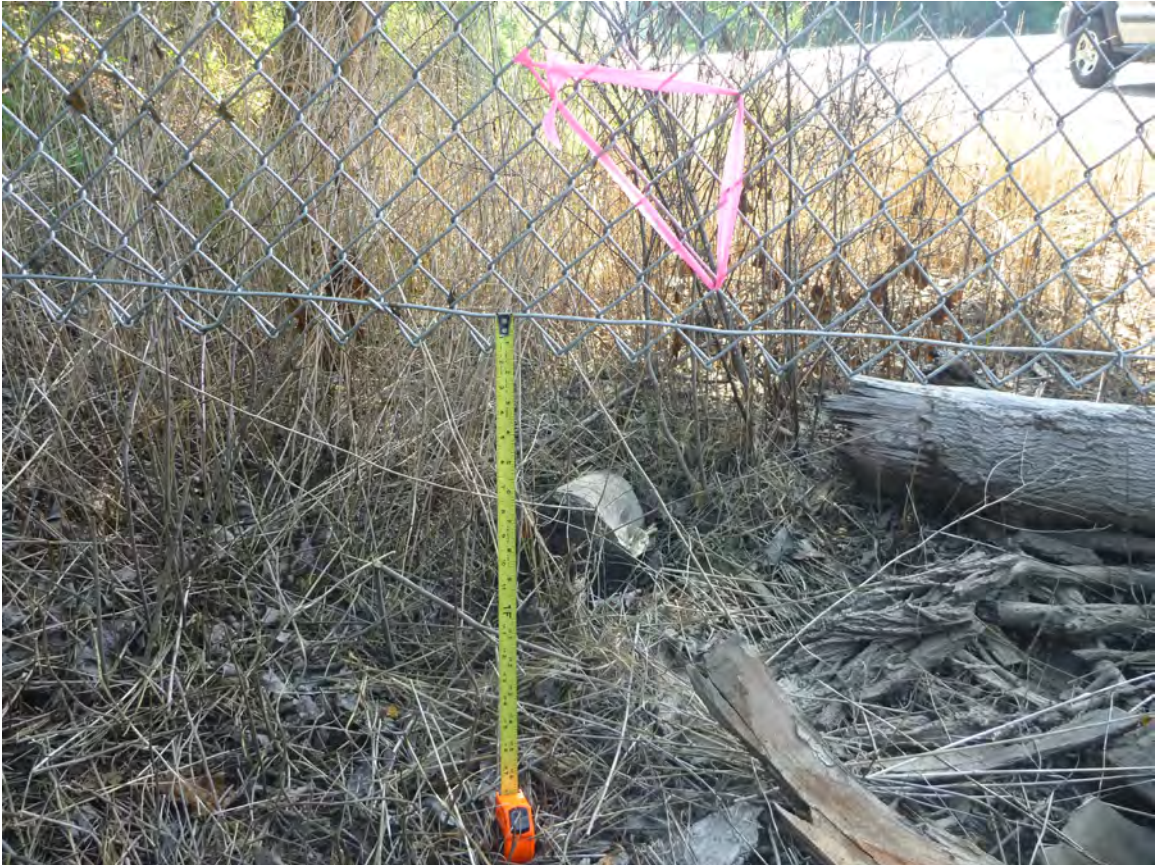
PHOTO NE20 discovered 07/18/2013
