**FY 2014 Annual Report for the  
Quarterly Land Use Control Inspections,  
RVAAP-05 Winklepeck Burning Grounds**

**Camp Ravenna Joint Military Training Center  
Former Ravenna Army Ammunition Plant  
Portage and Trumbull Counties, Ohio**

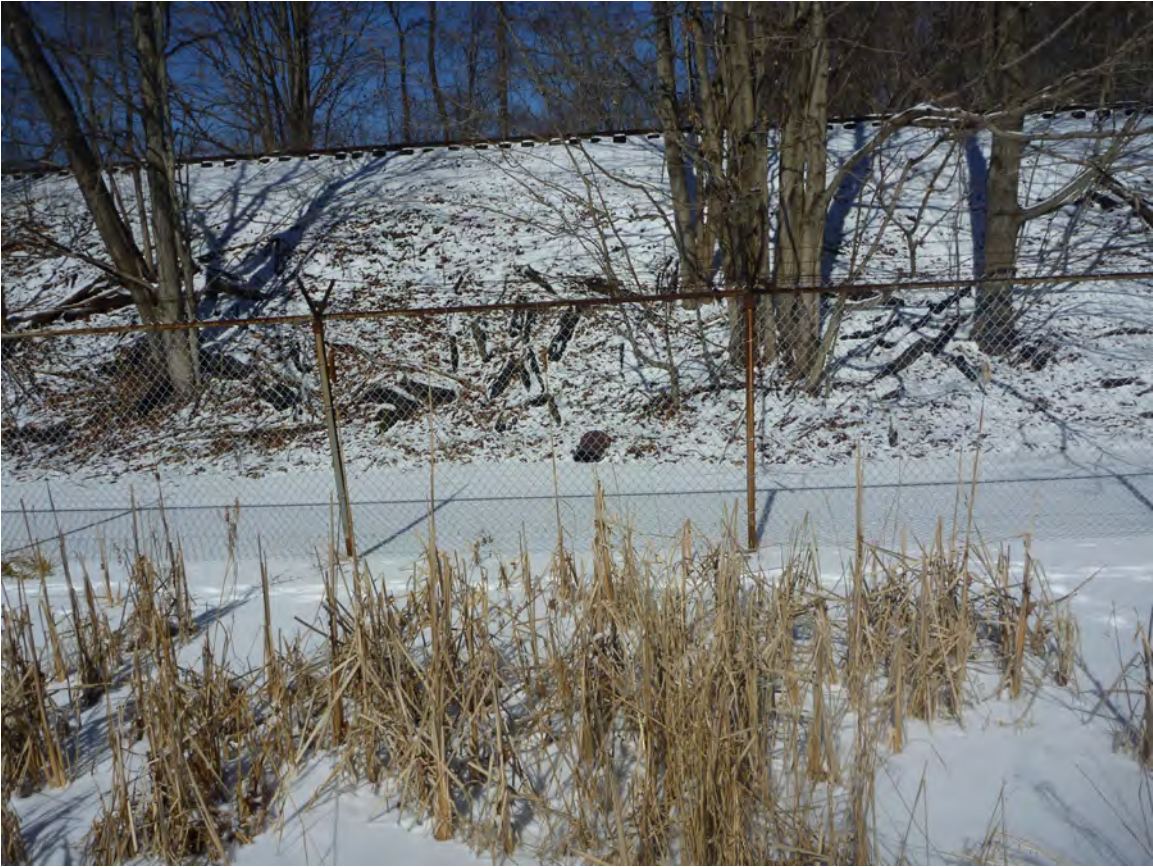
PHOTO NE21 repair 03/03/2014

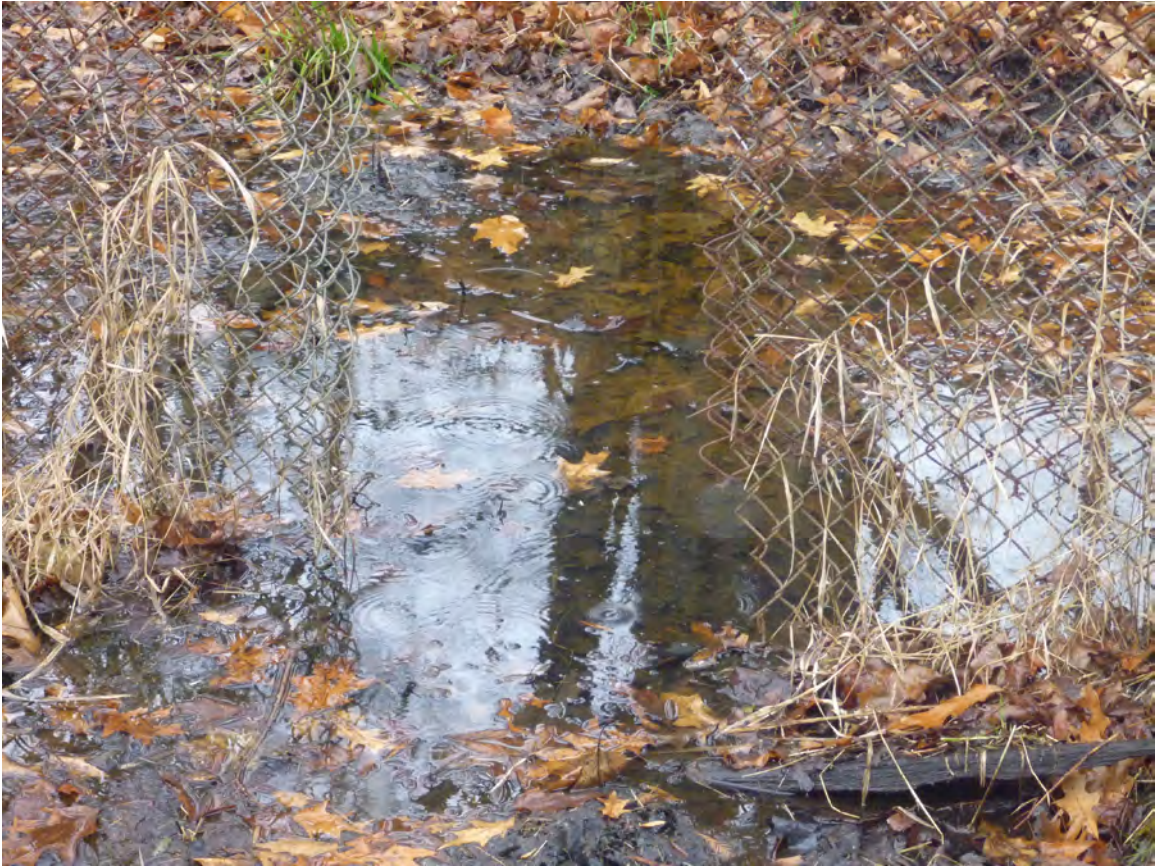
PHOTO NE21 discovered 11/21/2013

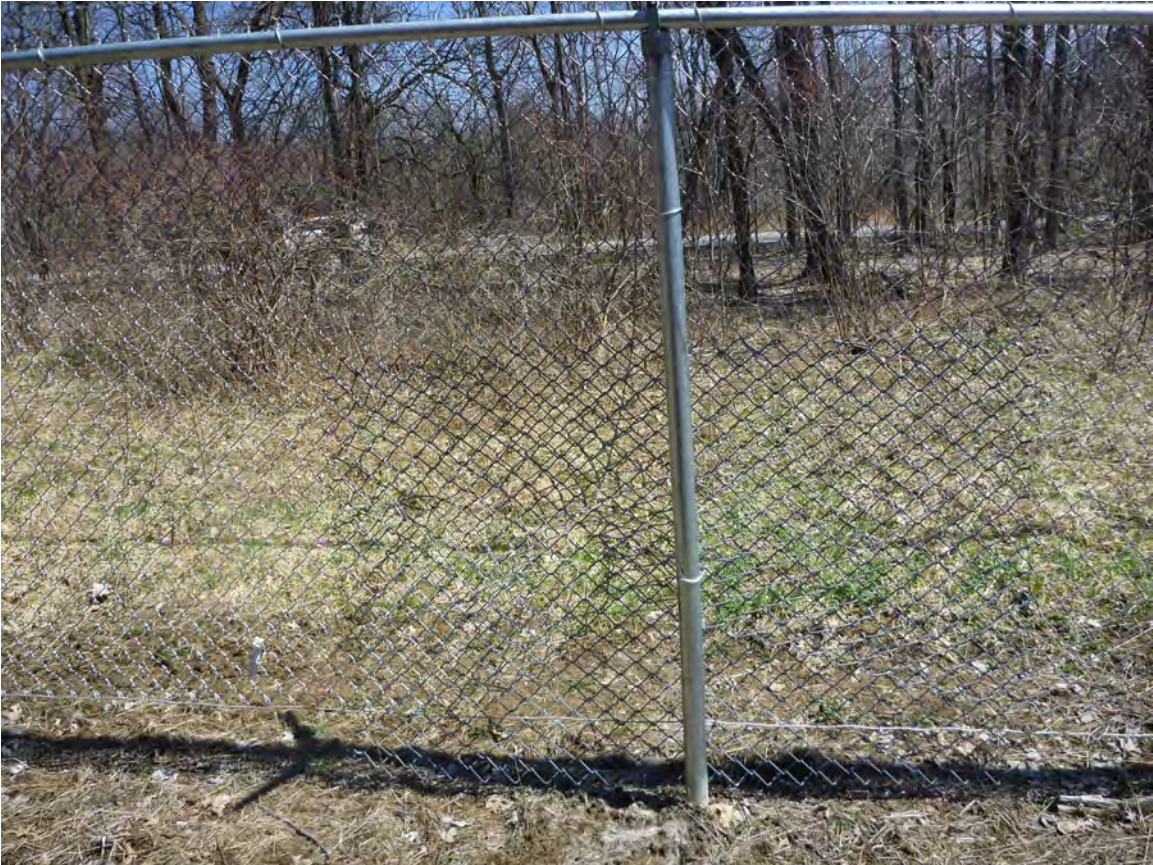
PHOTO NE22 repaired 04/17/2014

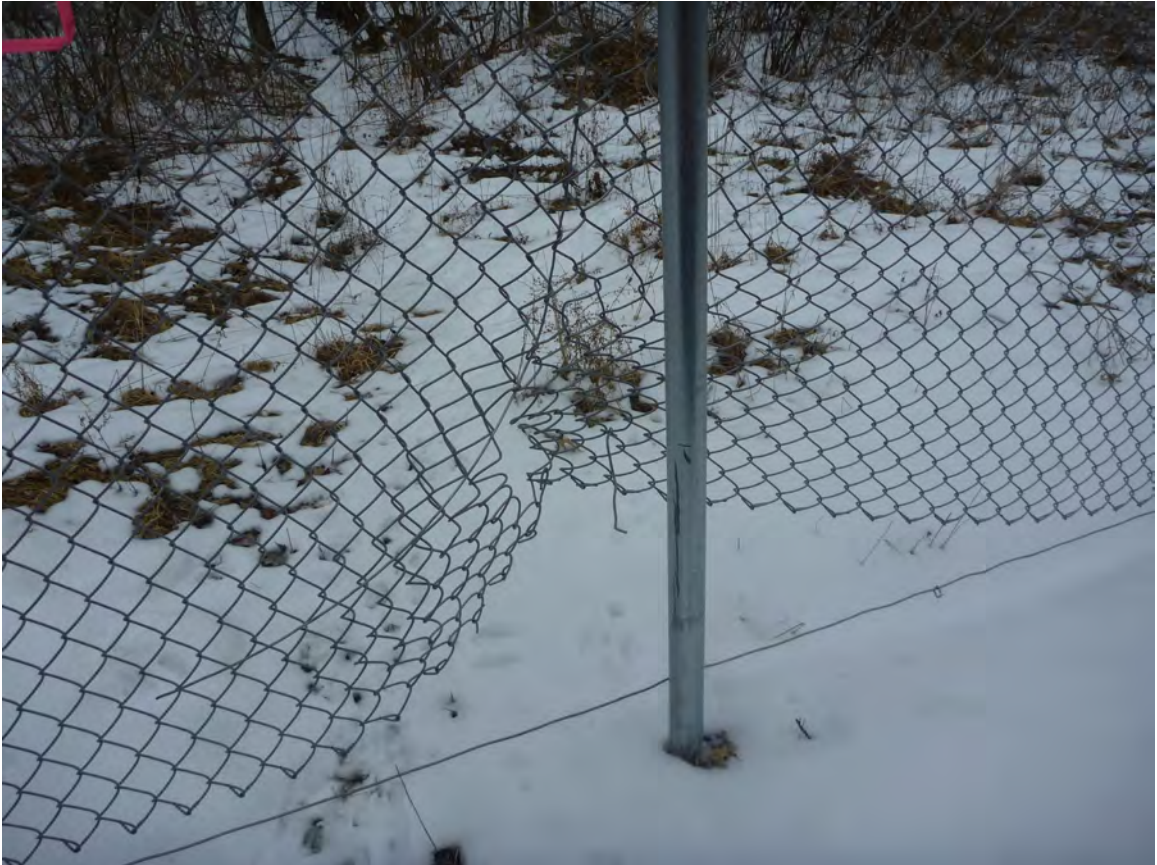
PHOTO NE22 discovered 11/25/2013

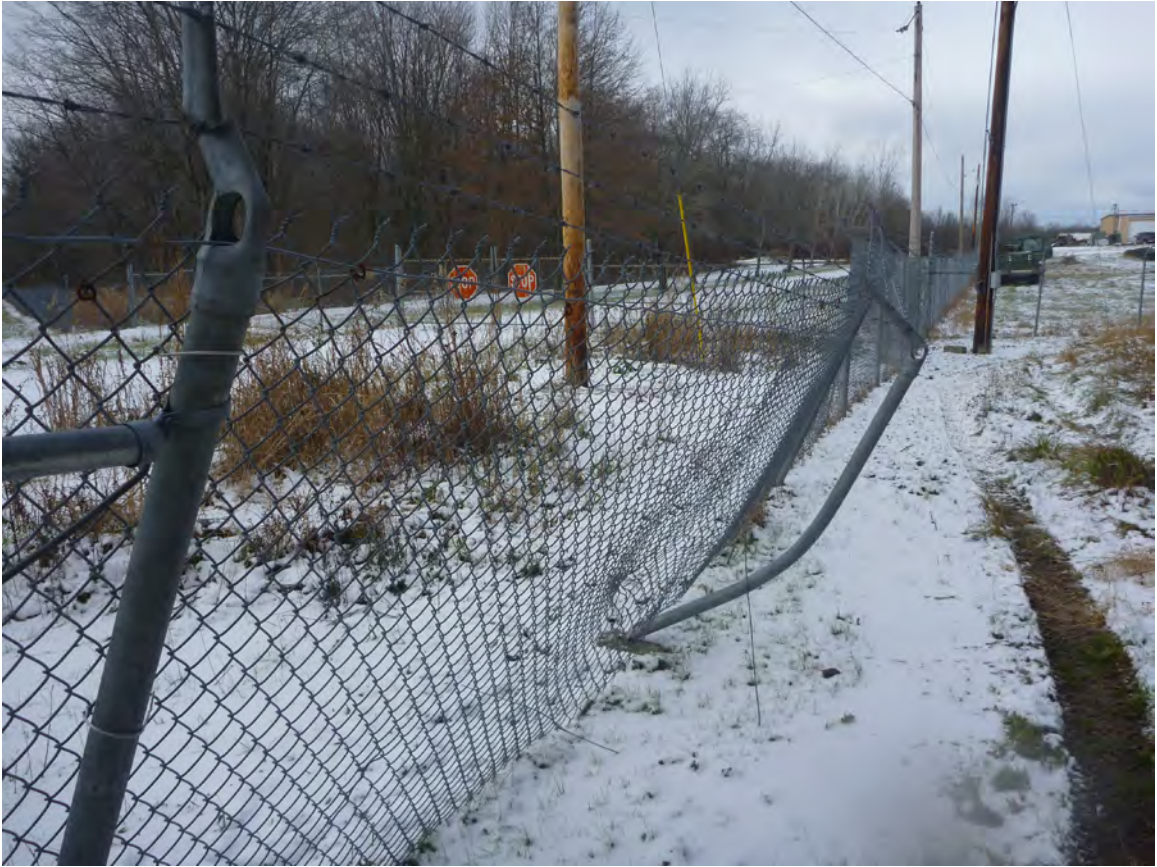
PHOTO NE23 discovered 11/25/2013

| Callout | Date | Path to Photo Location | Comments | Nothing | Eastwing | Path to Repair Photo | Callout |
|---|---|--|---|---|---|--|---|
| NE23 | 11/25/2013 | c:\My Documents\My ArcPad\P1010269.JPG | 3 sections badly damaged | 563209 | 2385312 | c:\My Documents\My ArcPad\P1010375.JPG | NE23 |

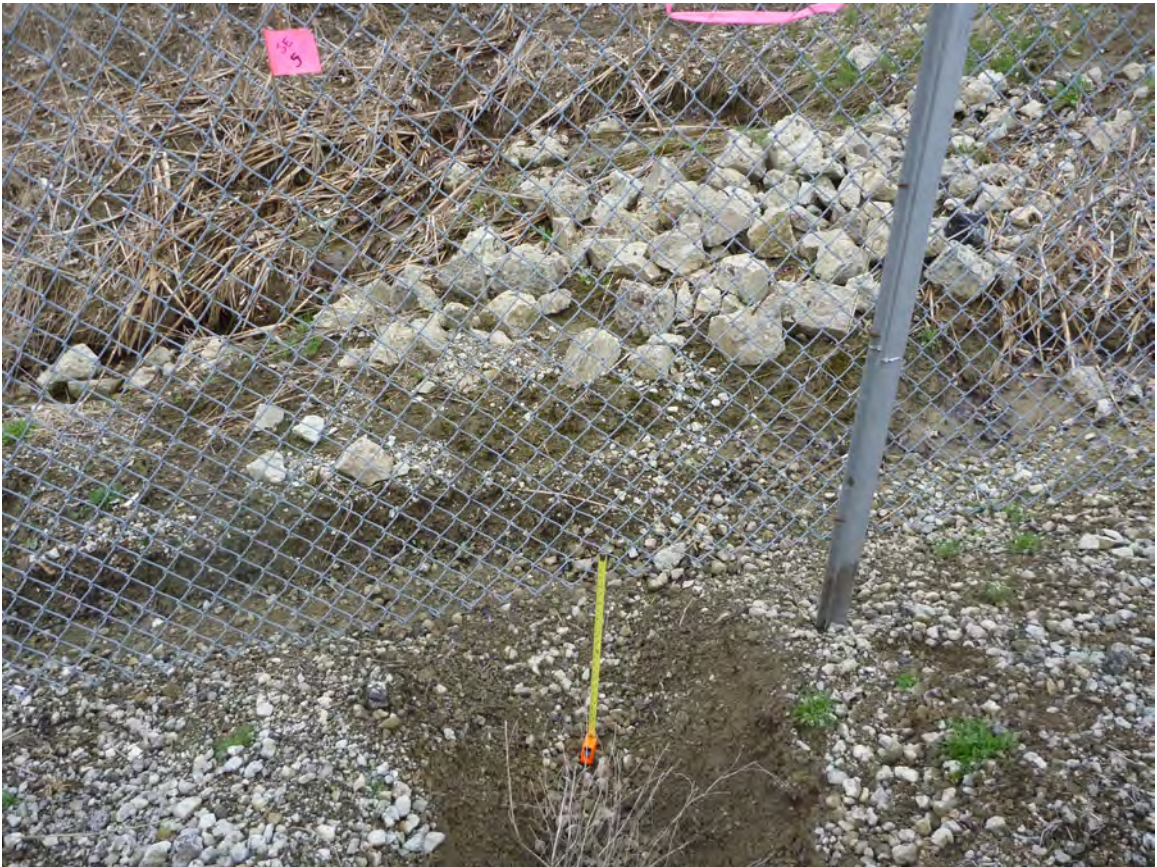
DETAIL SHEET FOR SE5

PHOTO SE5 discovered 04/22/2014

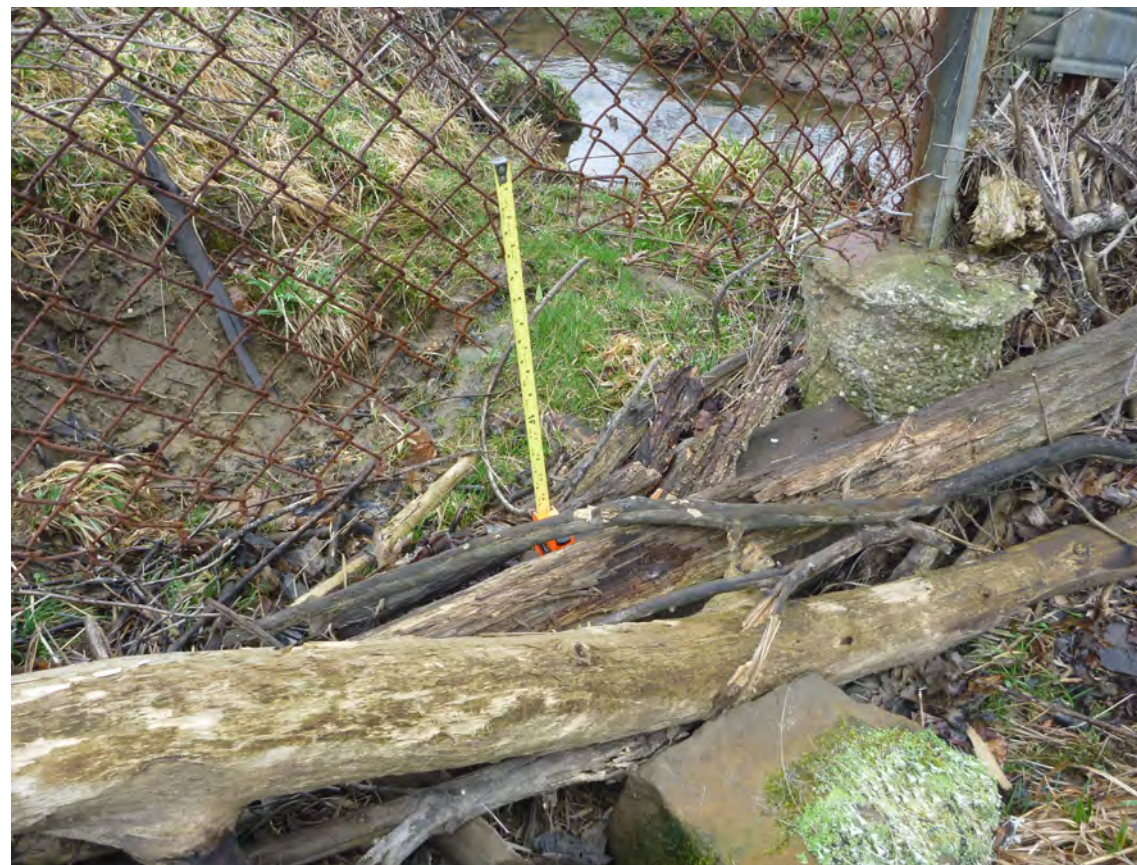
## DETAIL SHEET FOR SW1

PHOTO SW1 discovered 02/07/2013

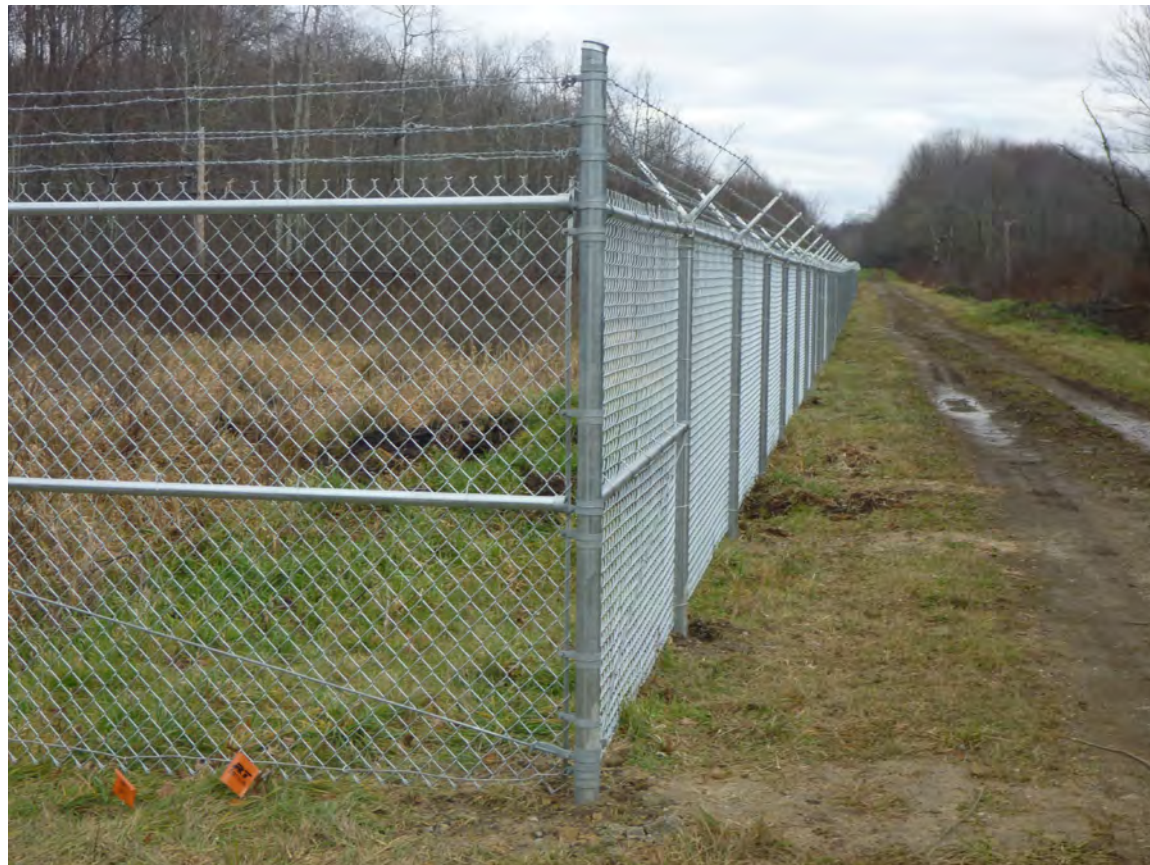
REPAIR PHOTO SW5 DEPICTING NEW RELOCATED FENCE  
dated 11/19/2013

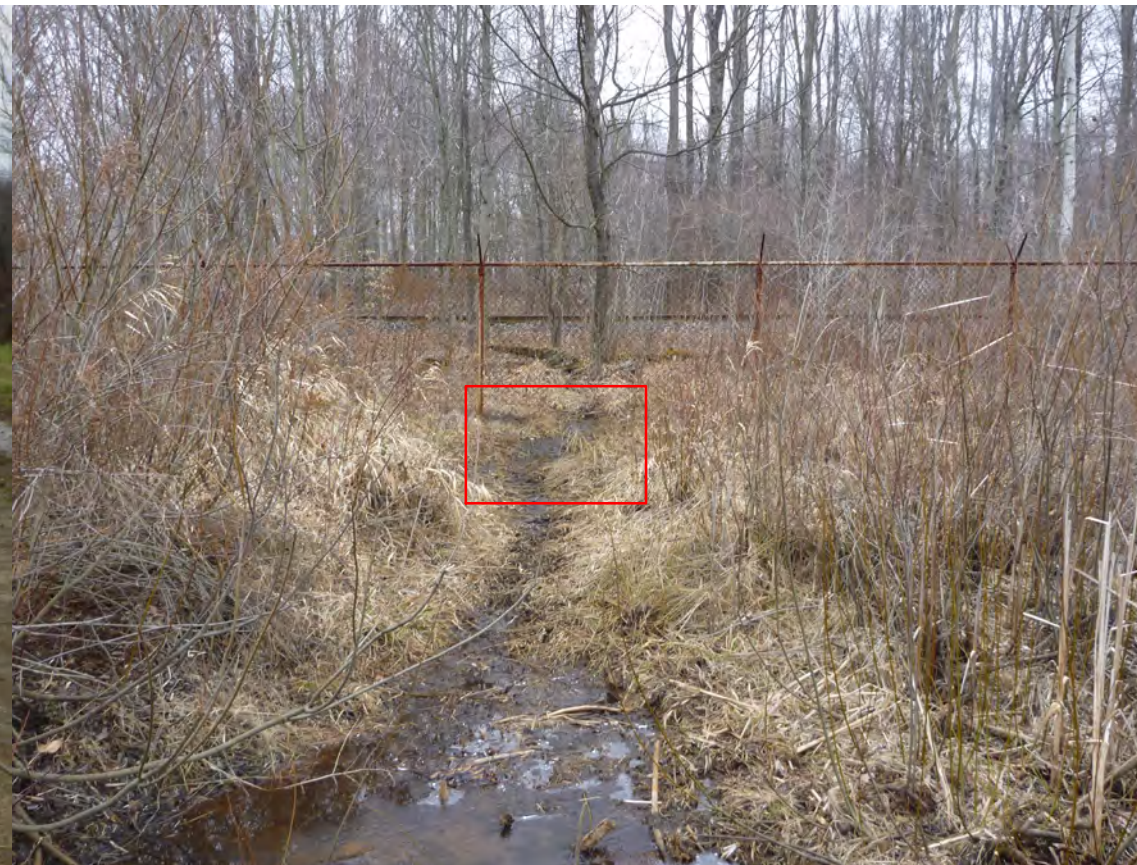
## DETAIL SHEET FOR SW5

PHOTO SW5 discovered 02/12/2013

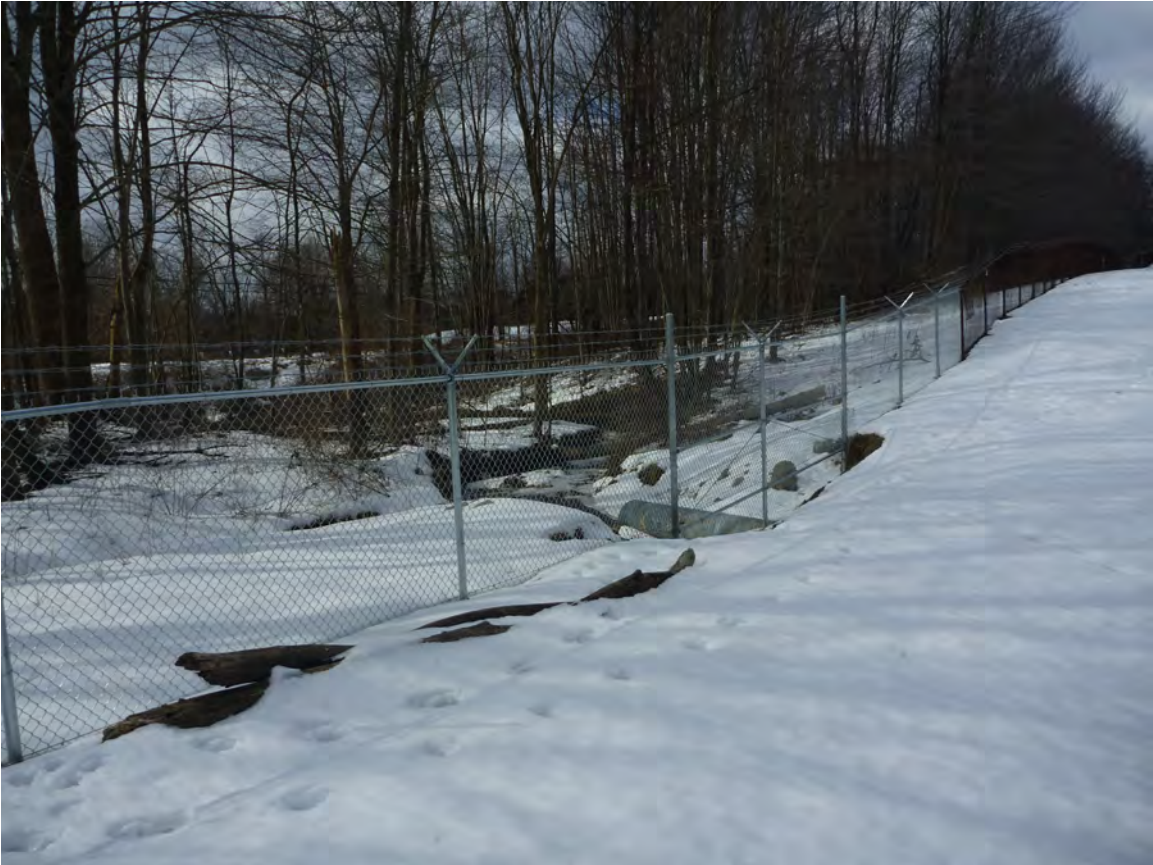
PHOTO SW11 repair 02/24/2014

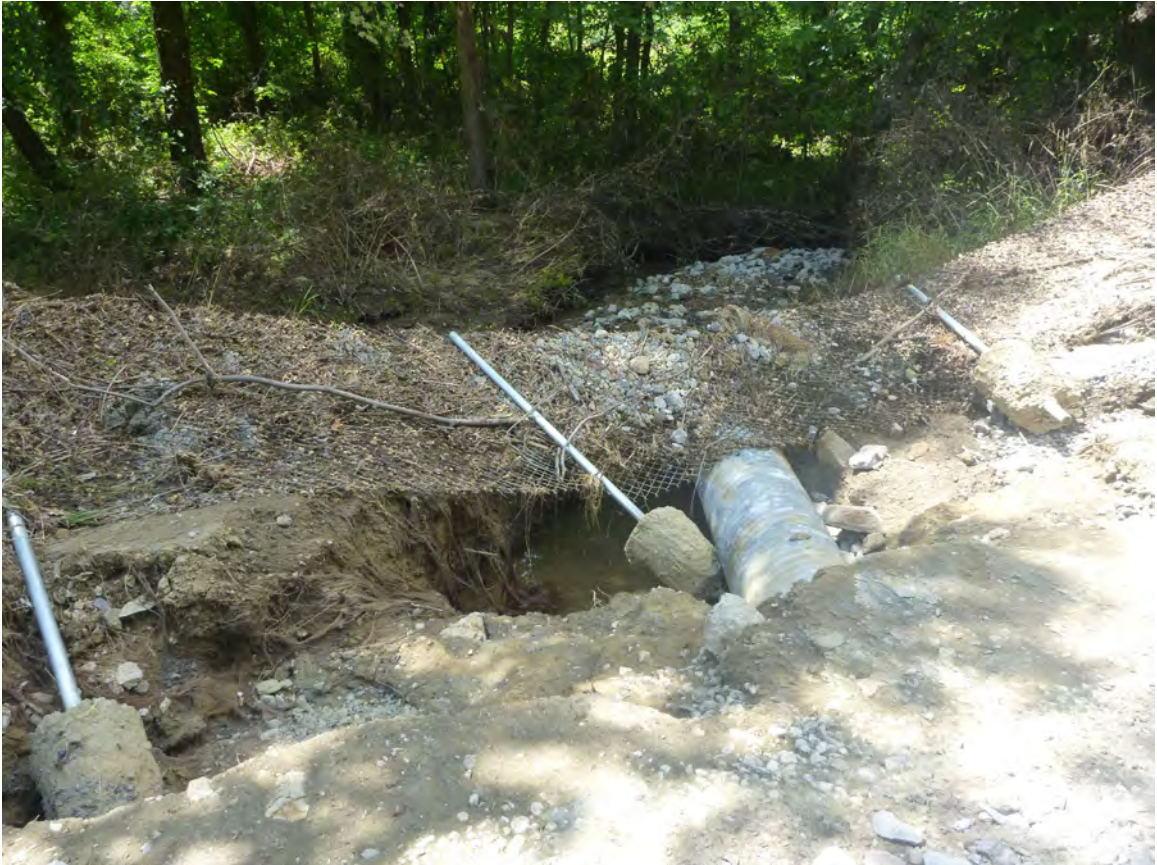
DETAIL SHEET FOR SW11

PHOTO SW11 discovered 07/15/2013

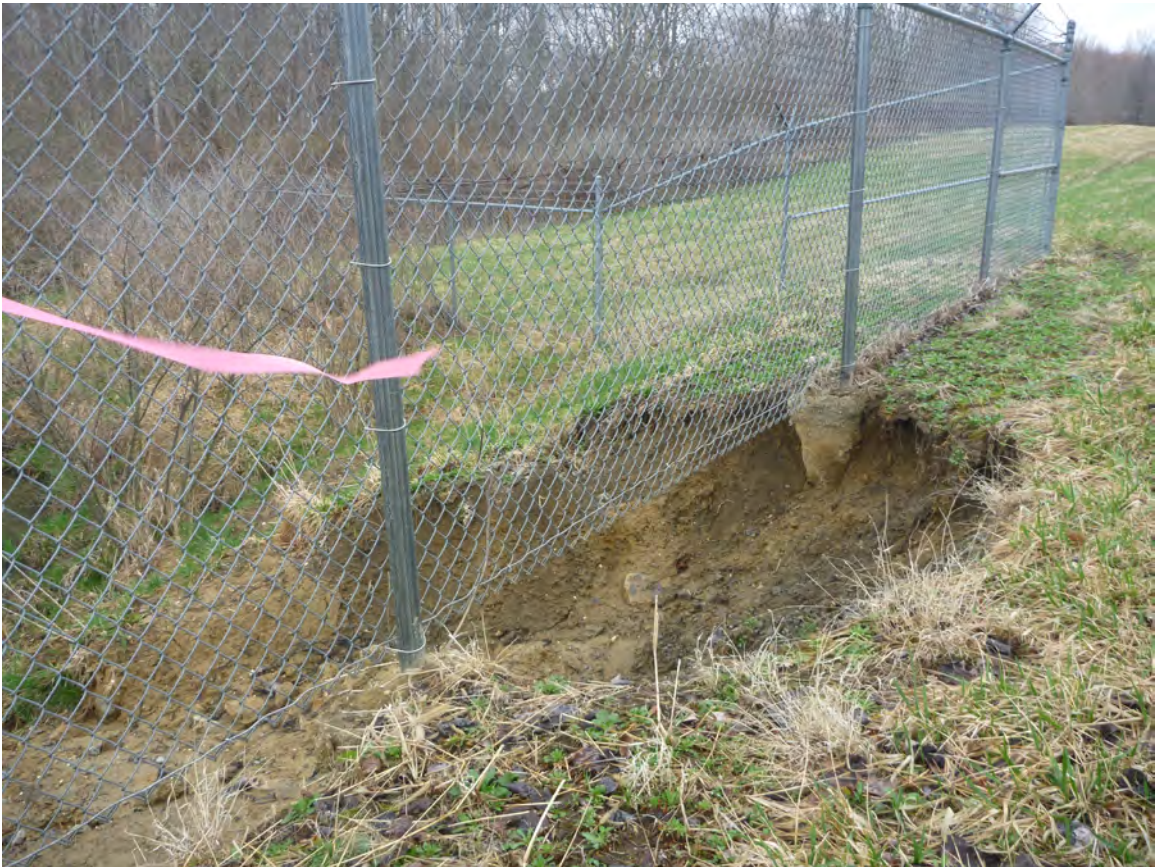
DETAIL SHEET FOR SW12

PHOTO SW12 discovered 11/18/2013

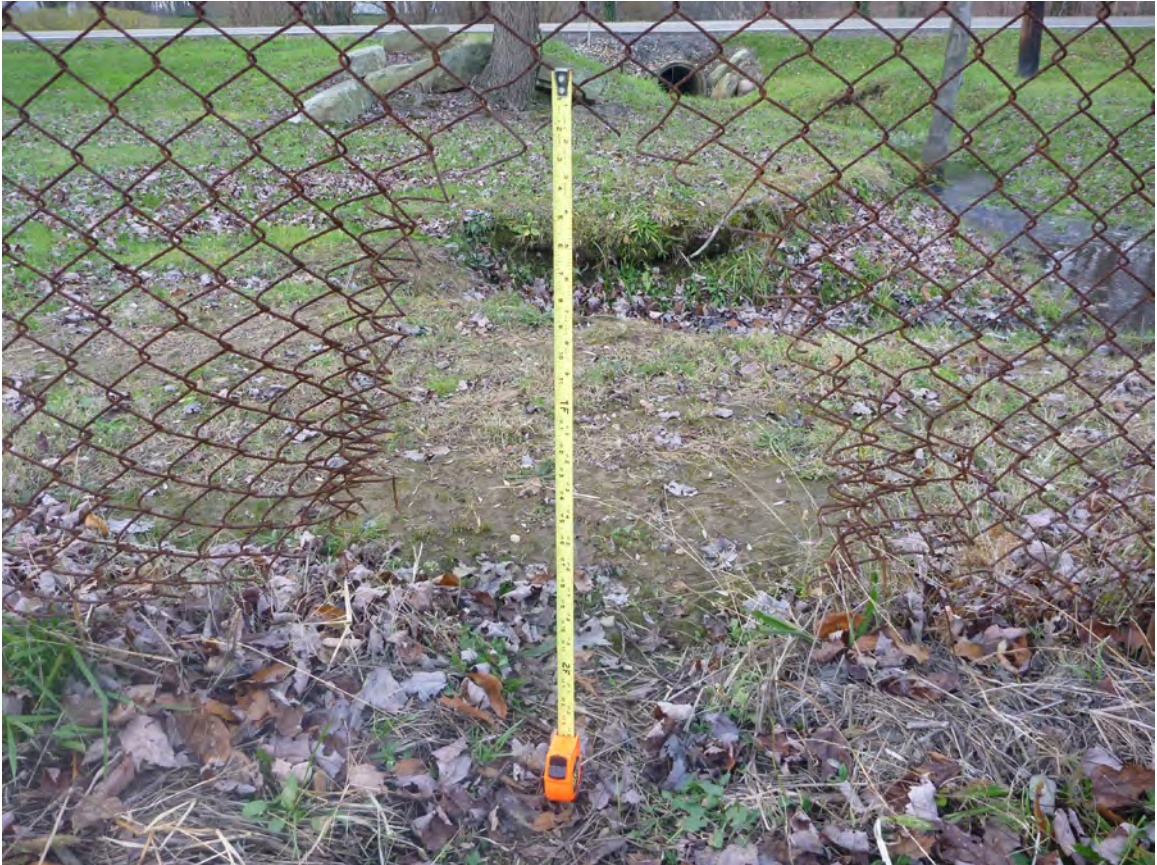
DETAIL SHEET FOR SW13

PHOTO SW13 discovered 11/18/2013

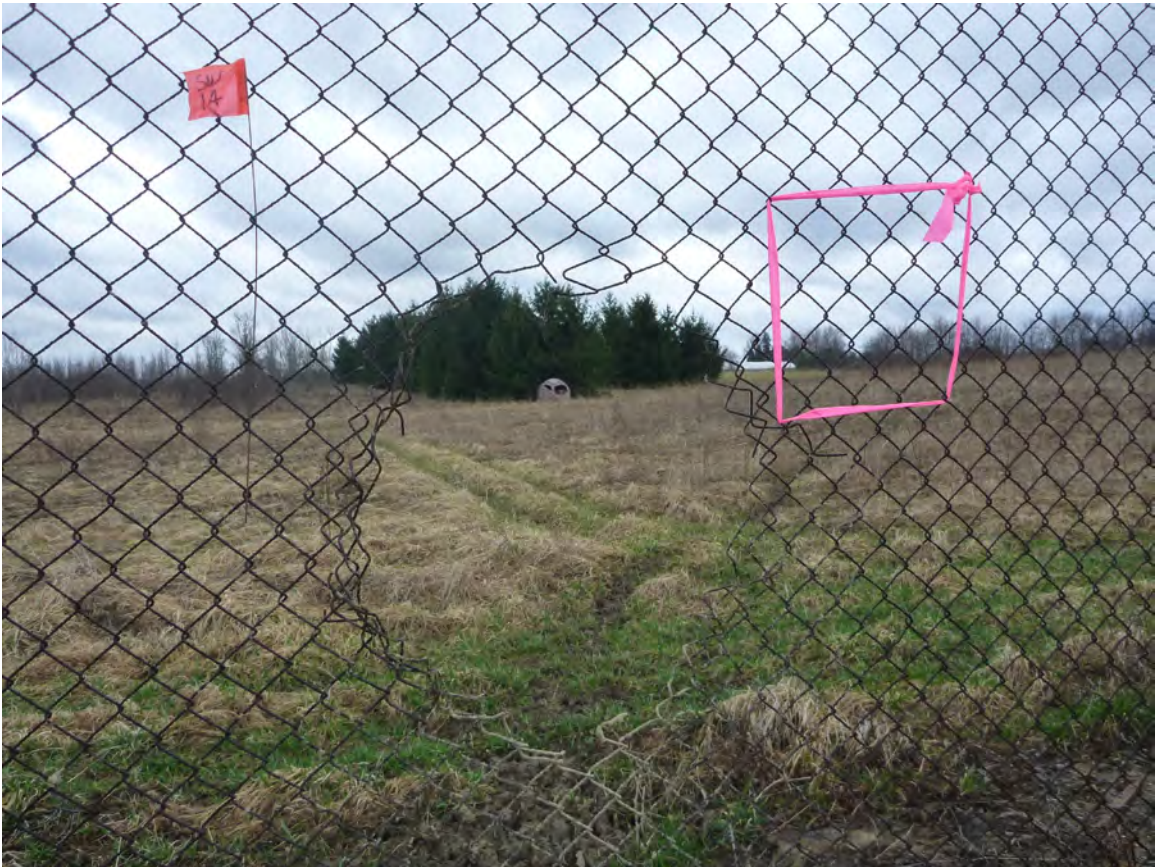
DETAIL SHEET FOR SW14

PHOTO SW14 discovered 04/14/2014

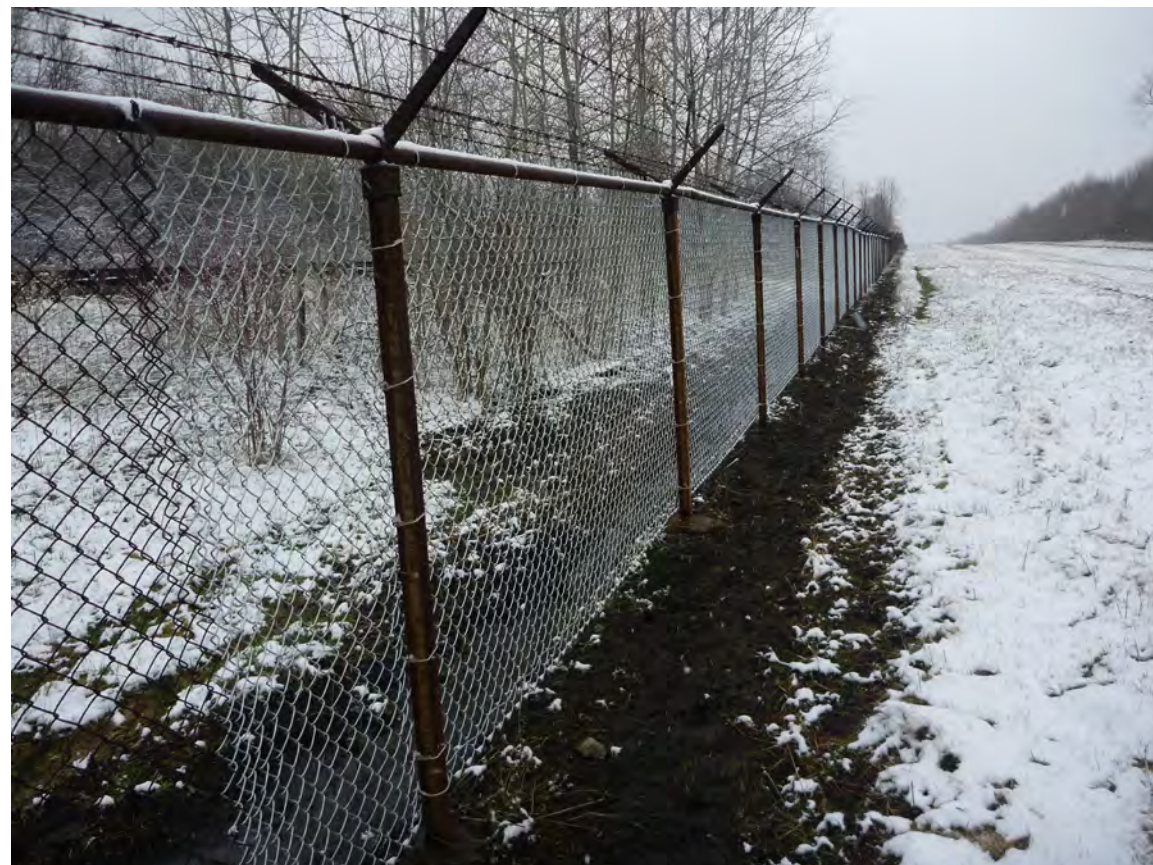
## SUPPLEMENTAL DETAIL SHEET NO.1

PHOTO NO.1 04/15/2014 (Begin new fence fabric clockwise from here)

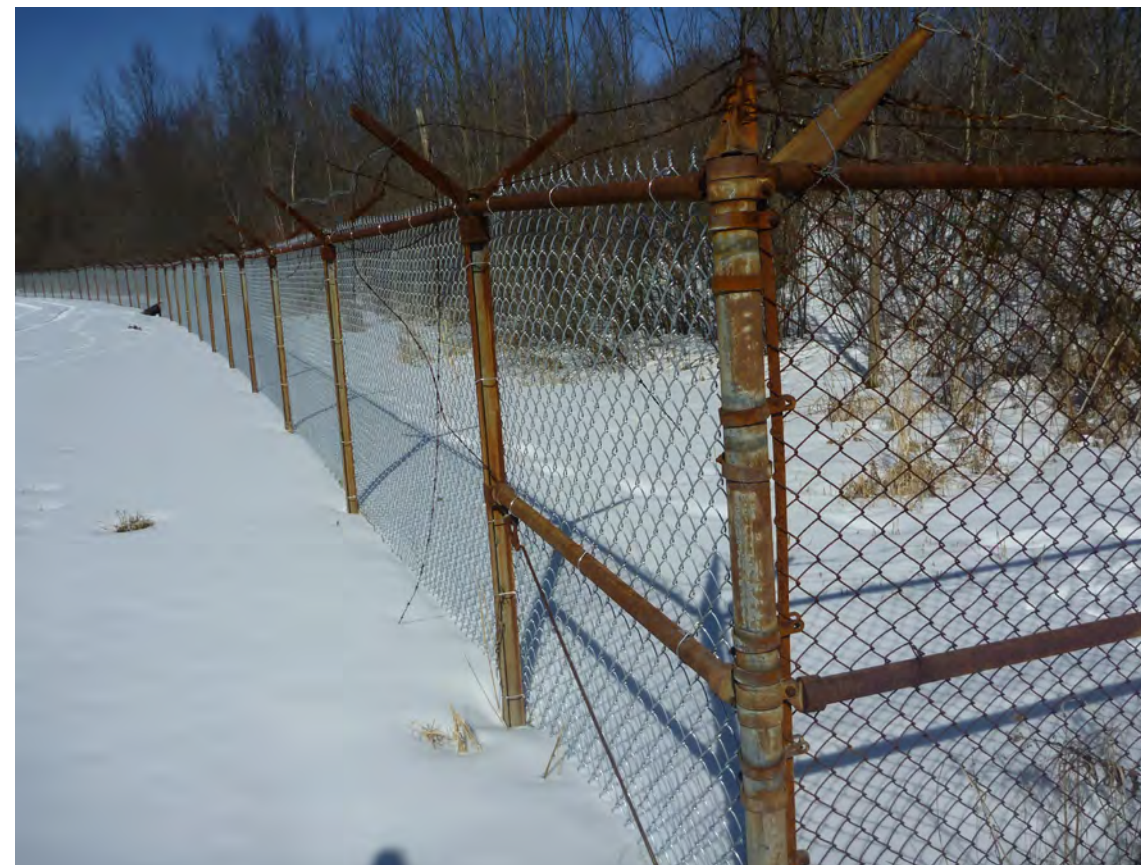
PHOTO No.2 (End new fence fabric here) 04/17/2014

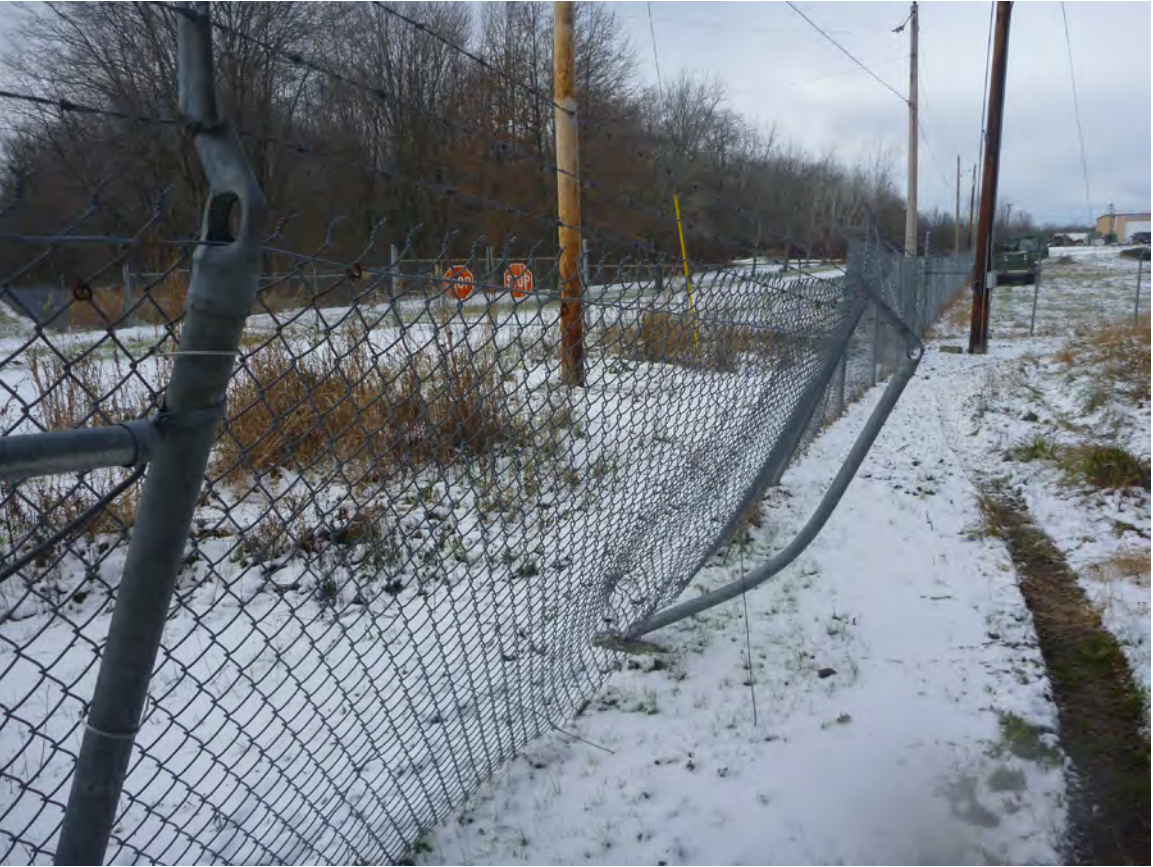
PHOTO NE23 discovered 11/25/2013

| Callout | Date | Comments | US Survey Ft | | Callout |
|---|---|---|---|---|---|
| NE23 | 11/25/2013 | 3 sections badly damaged | 563209 | 2383312 | NE23 |

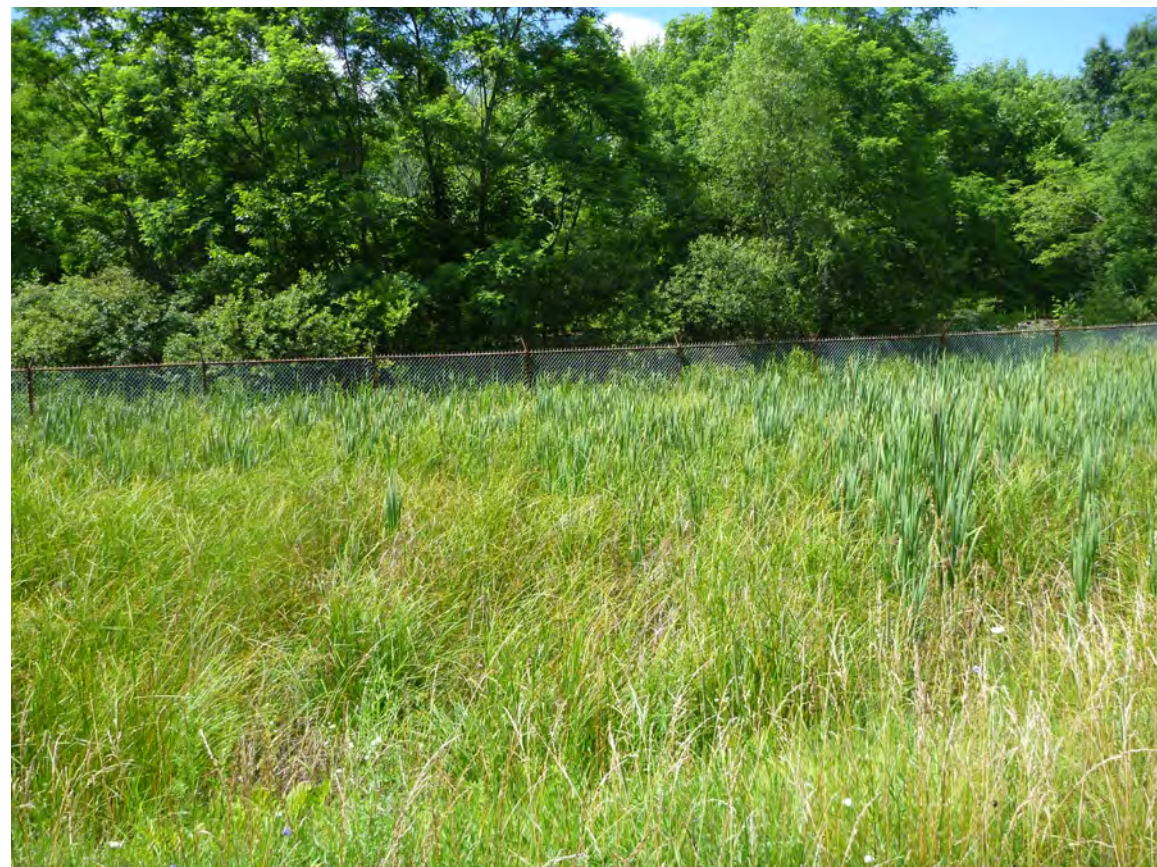
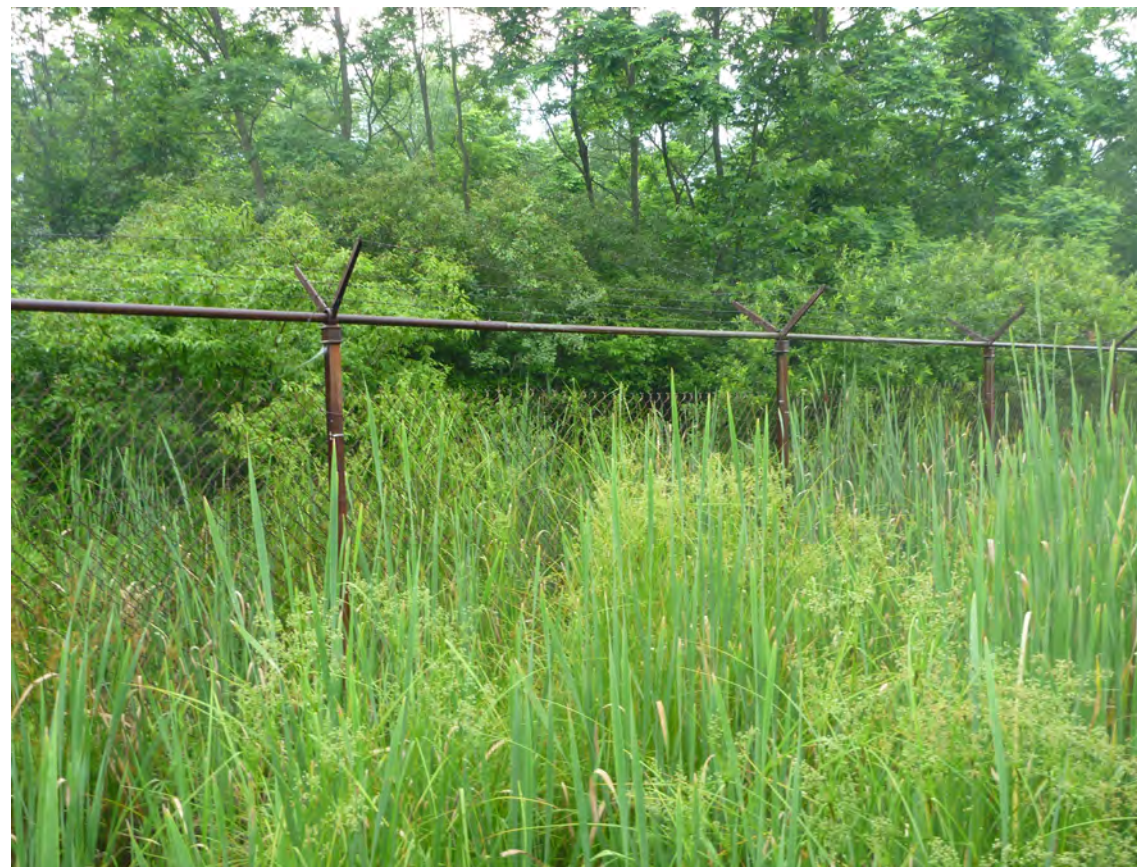
Repair PHOTO NW8 dated 07/16/2014

PHOTO NW8 discovered 07/16/2013

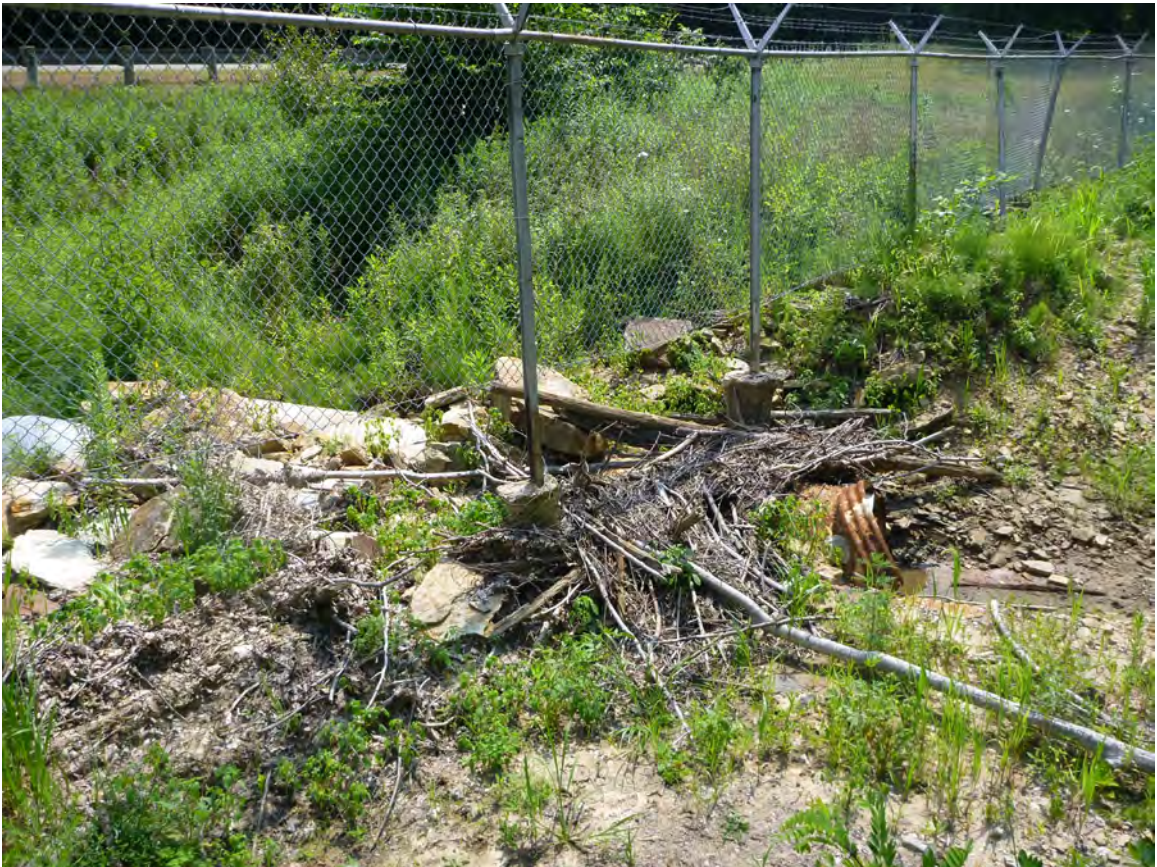
PHOTO SE2 discovered 07/18/2013

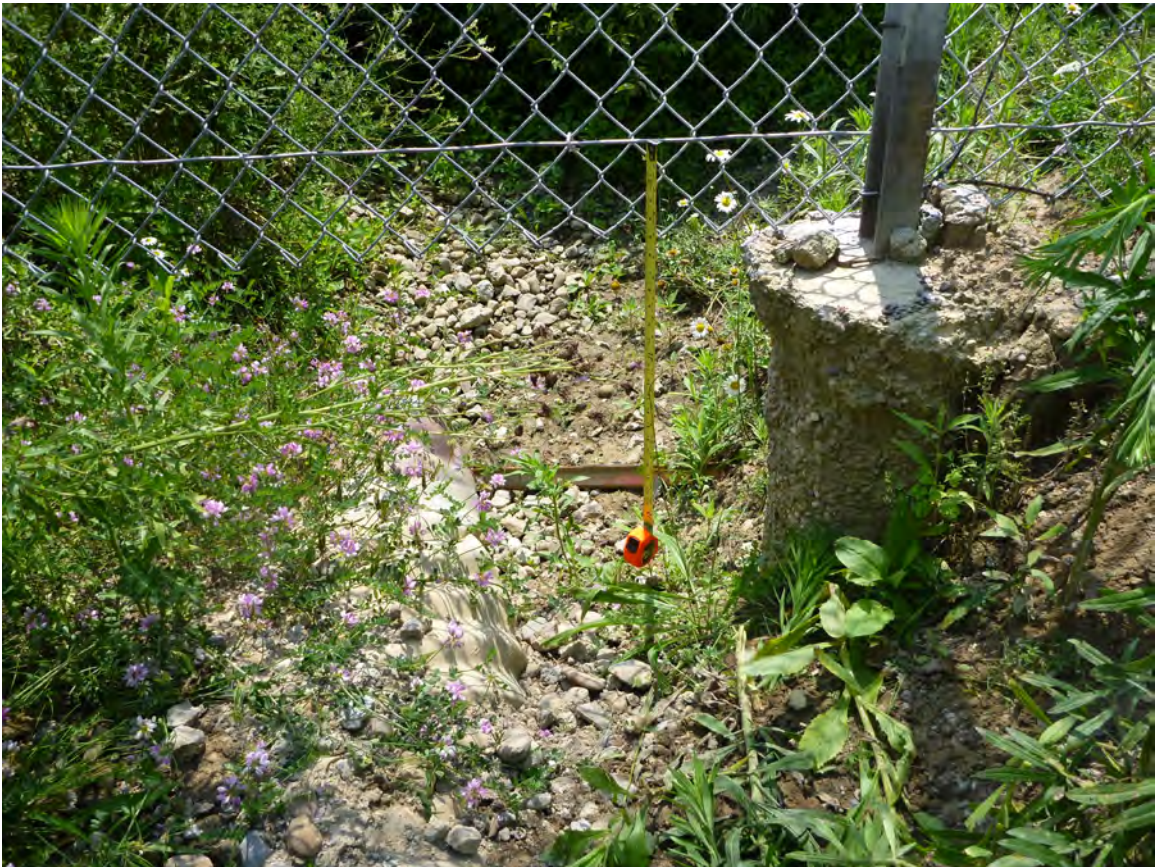
PHOTO SE4 discovered 02/27/2014

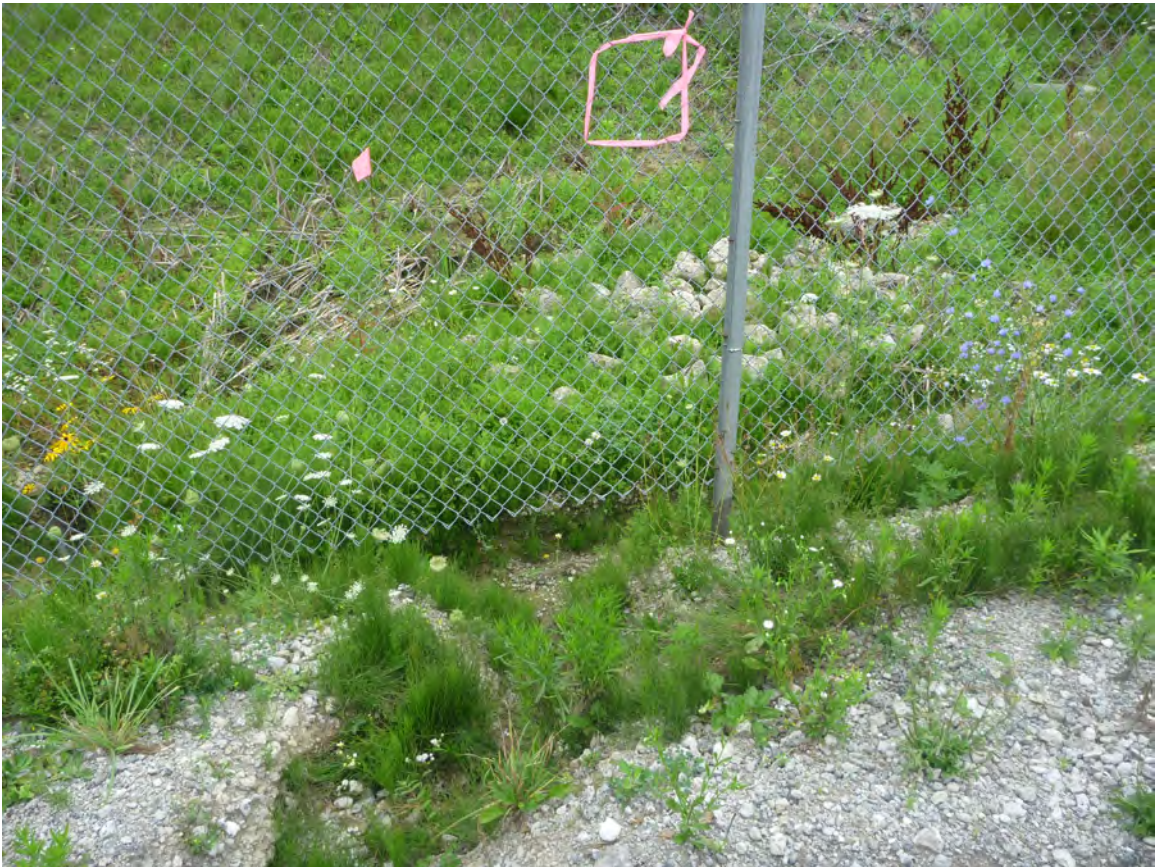
PHOTO SE5 discovered 04/22/2014

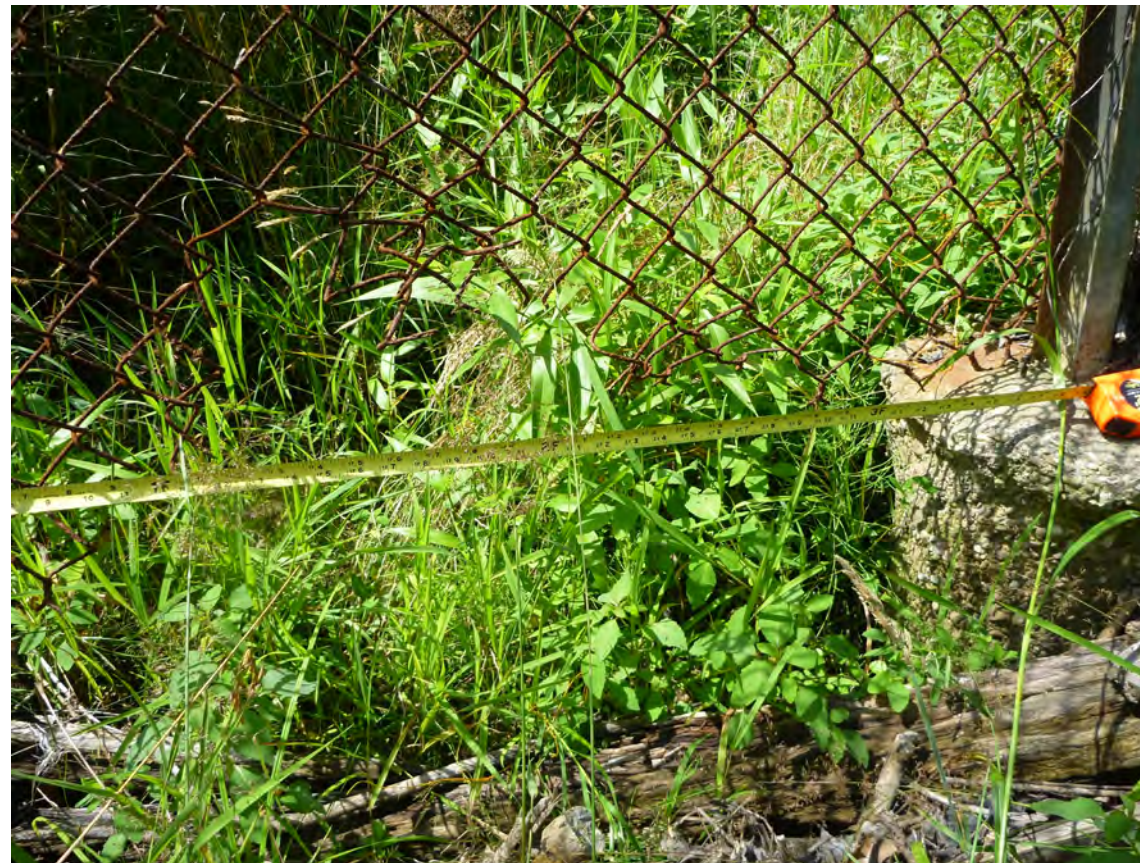
PHOTO SW1 discovered 02/07/2013
