**FY 2014 Annual Report for the  
Quarterly Land Use Control Inspections,  
RVAAP-05 Winklepeck Burning Grounds**

**Camp Ravenna Joint Military Training Center  
Former Ravenna Army Ammunition Plant  
Portage and Trumbull Counties, Ohio**

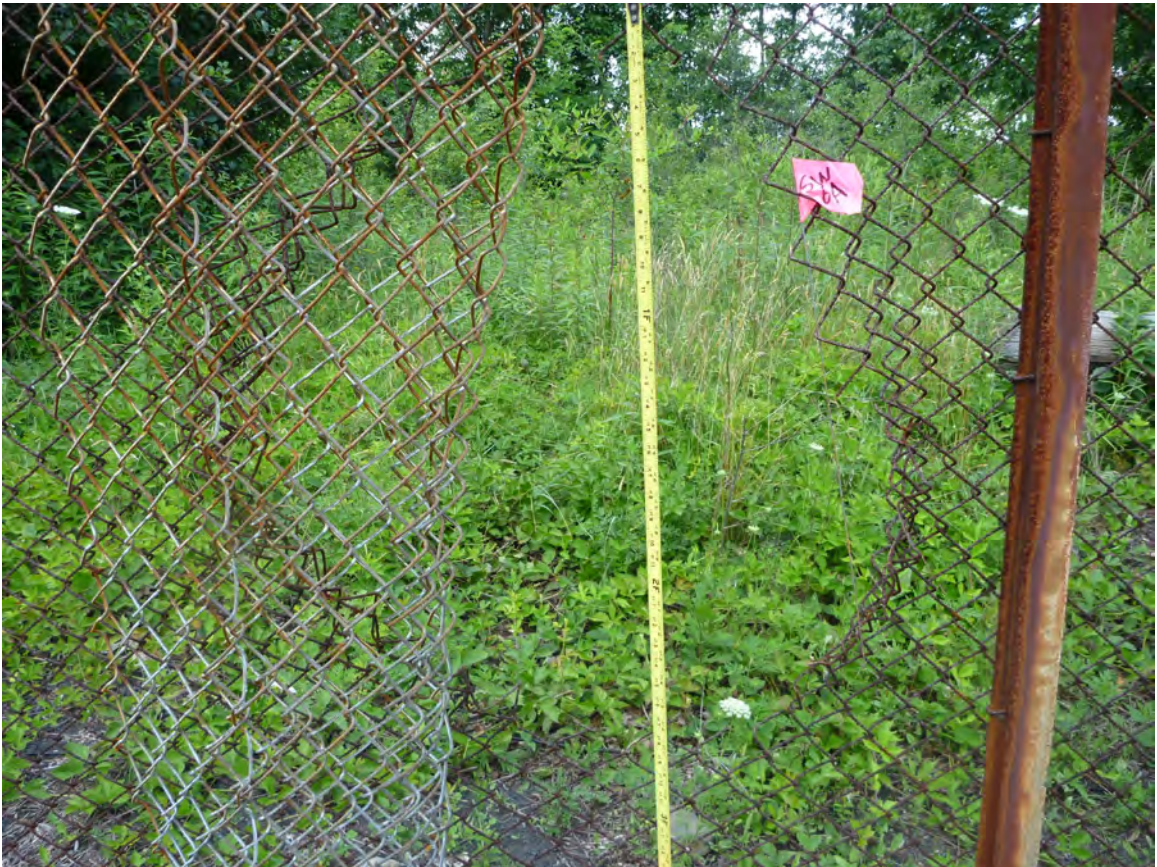
PHOTO SW6A discovered 07/16/2014

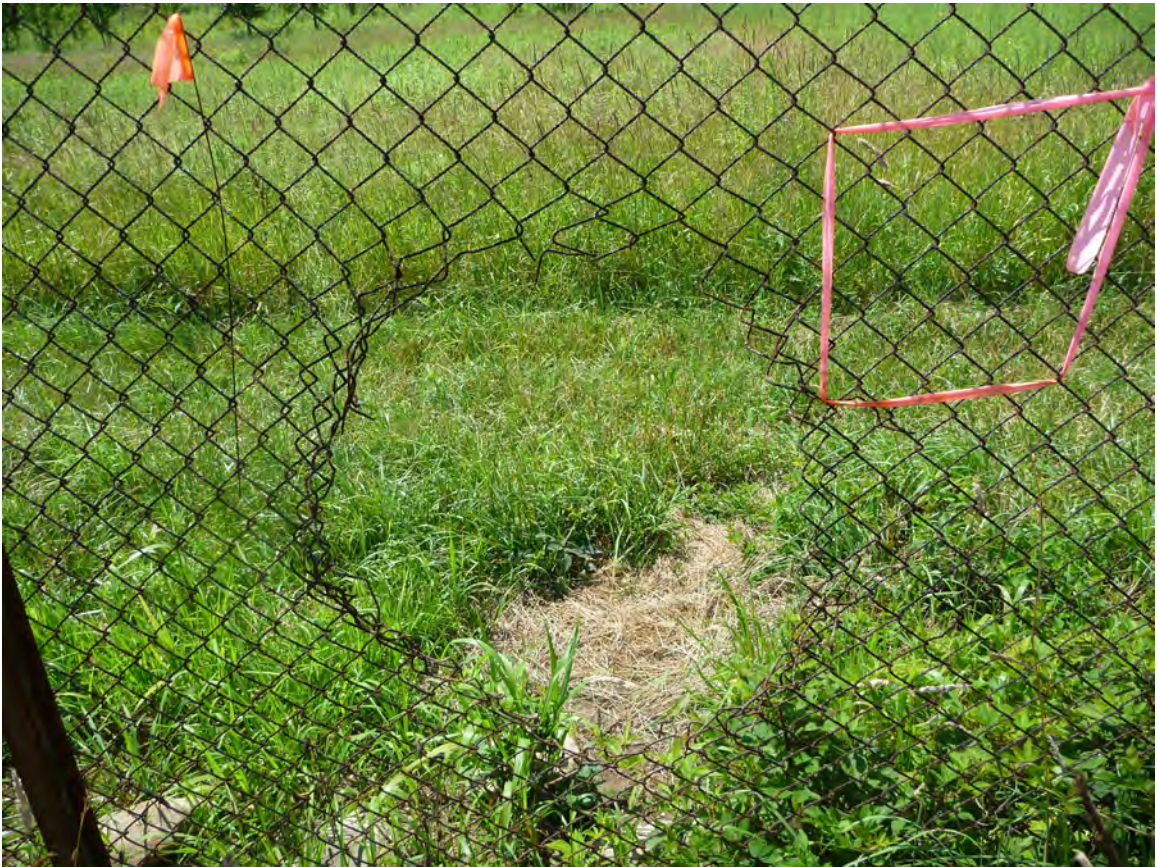
PHOTO SW14 discovered 04/14/2014

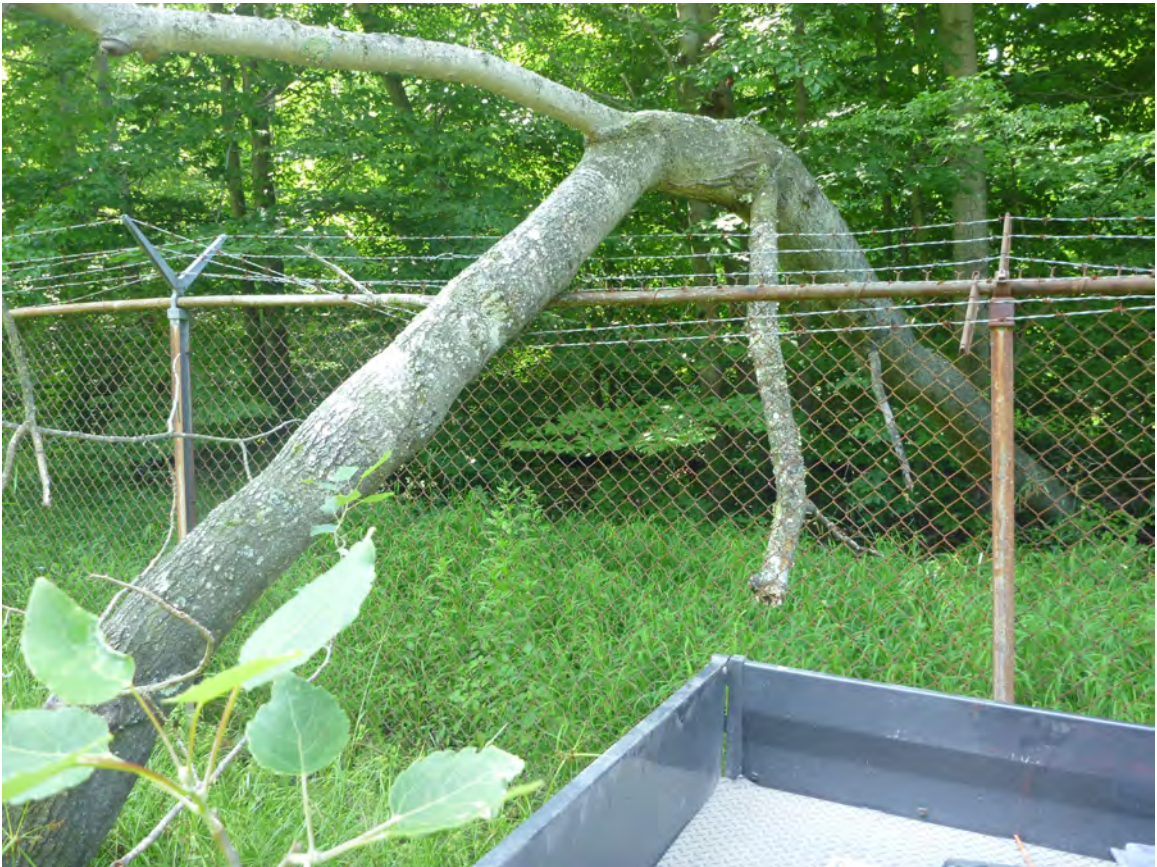
PHOTO SW15 discovered 07/15/2014

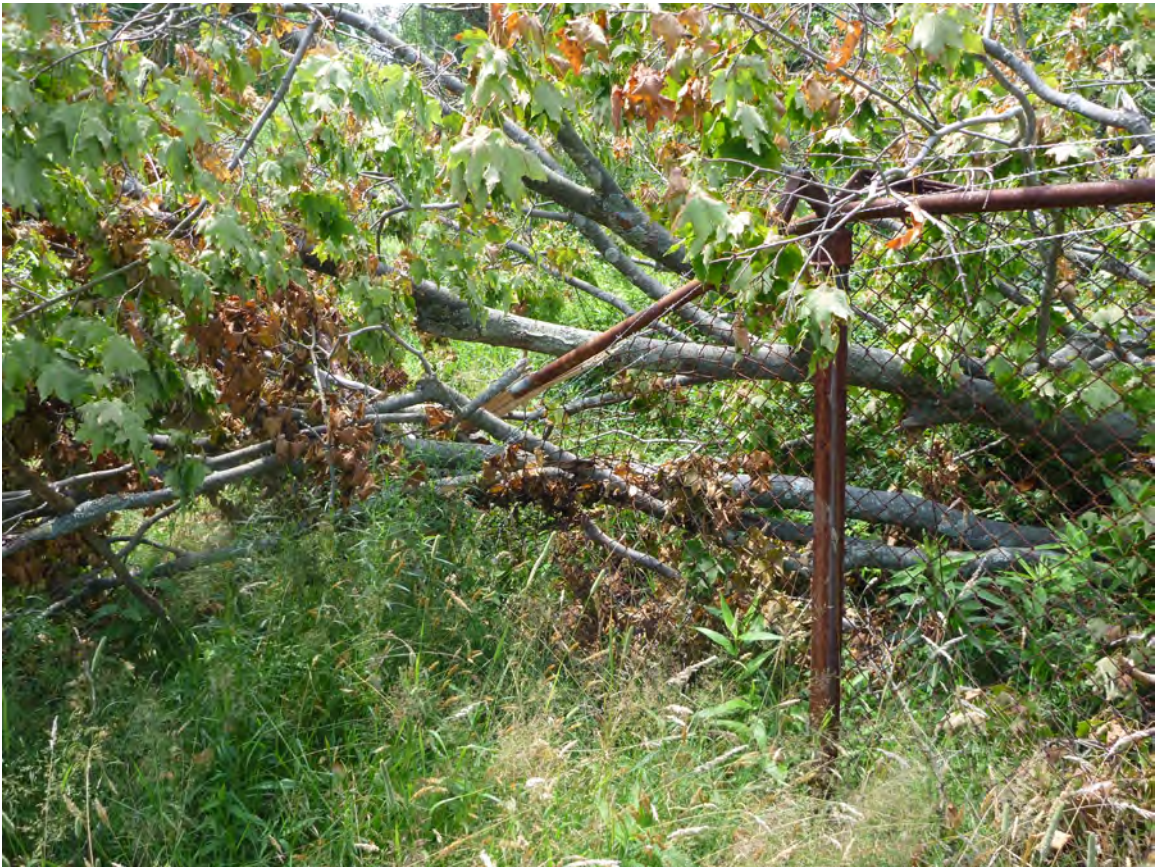
| Camp Ravenna Joint Military Training Center 4th Qtr FY2014 LUC Inspection | | | | US Survey Fc | | | |
|---|---|--|---|---|---|--|---|
| SW16 | 7/15/2014 | c:\My Documents\My ArcPad\P1010408.JPG | tree blow down/damaged fence | 554267 | 2328362 | | SW16 |

| Callout | Date | Comments | US Survey Ft | | Callout |
|---|---|---|---|---|---|
| SW16 | 07/15/2014 | tree blow down/damaged fence | 554267 | 2328362 | SW16 |

PHOTO SW16 discovered 07/15/2014

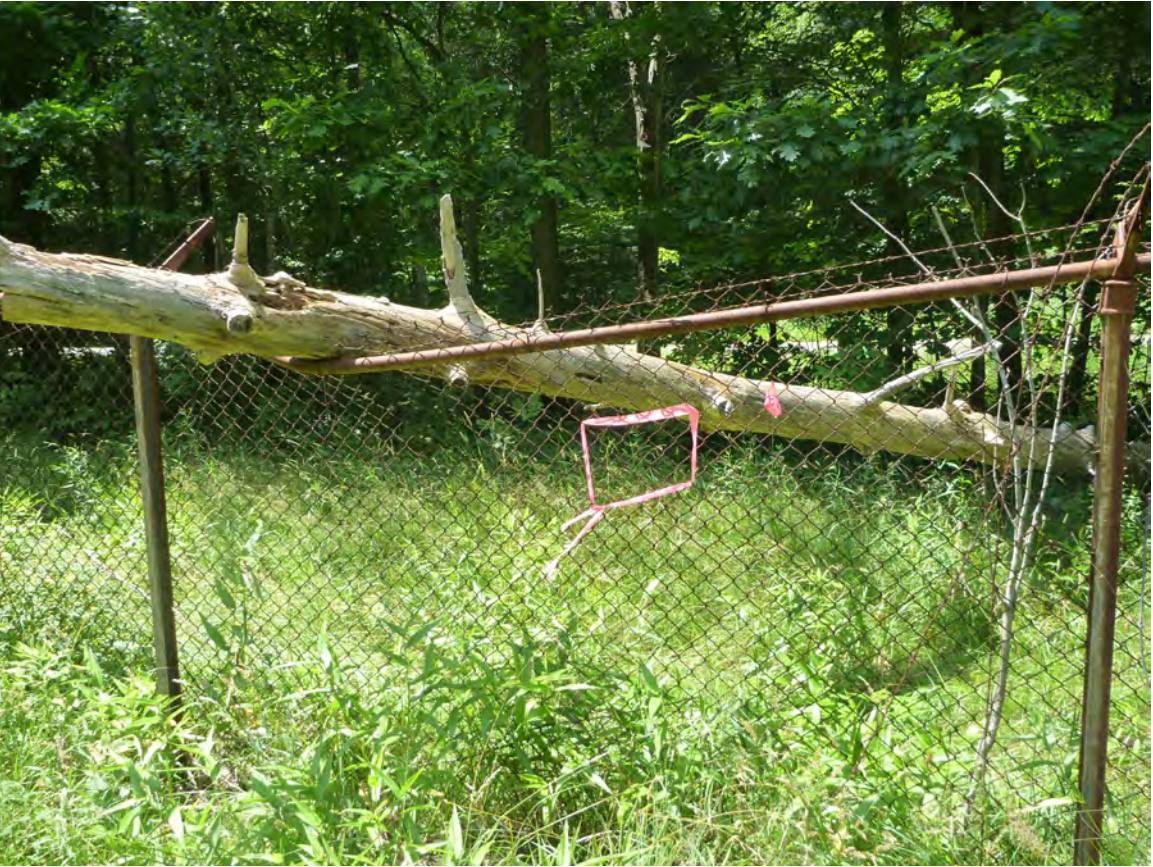
DETAIL SHEET FOR SW17

| Callout | Date | Comments | US Survey Ft | | Callout |
|---|---|---|---|---|---|
| SW17 | 07/15/2014 | tree blow down/fence top damaged | 556228 | 2328345 | SW17 |

PHOTO SW17 discovered 07/15/2014

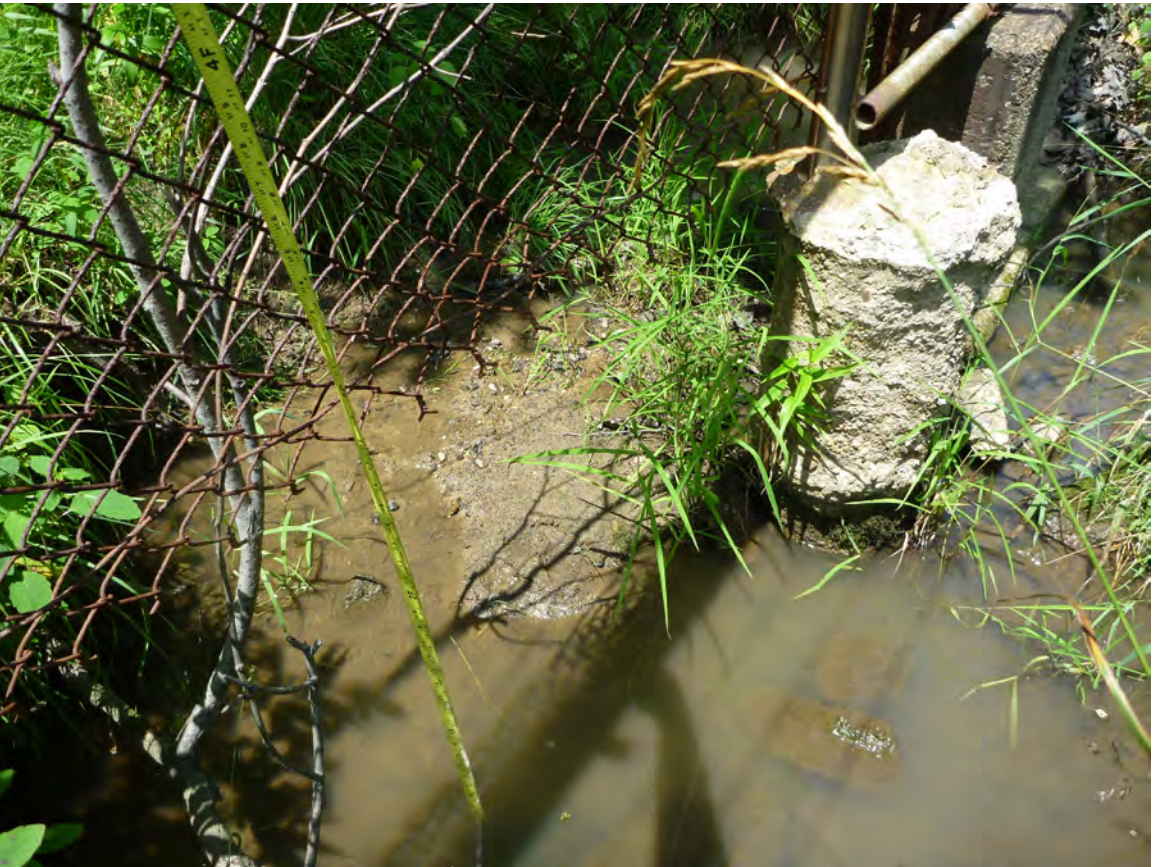
DETAIL SHEET FOR SW18

PHOTO SW18 discovered 07/15/2014

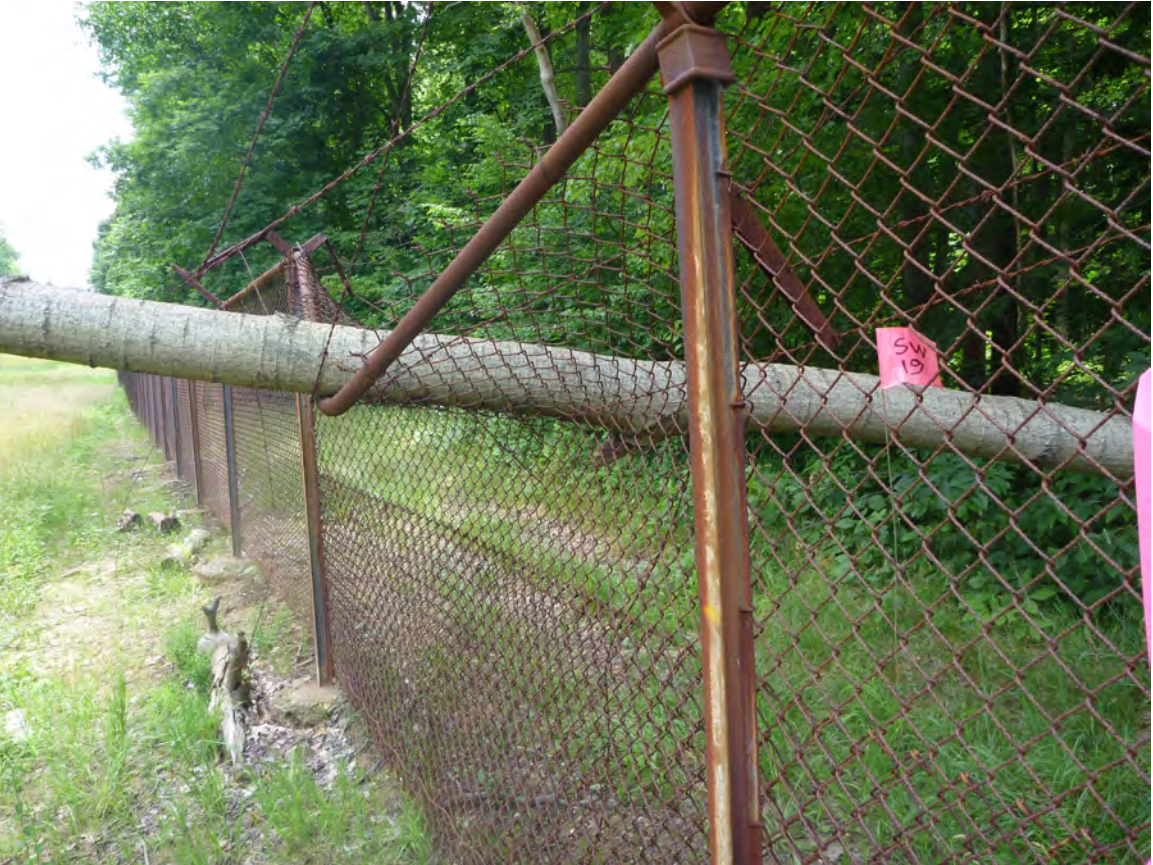
DETAIL SHEET FOR SW19

| Callout | Date | Comments | US Survey Ft | | Callout |
|---|---|---|---|---|---|
| SW19 | 07/15/2014 | tree blow down/top fence damaged | 556581 | 2328342 | SW19 |

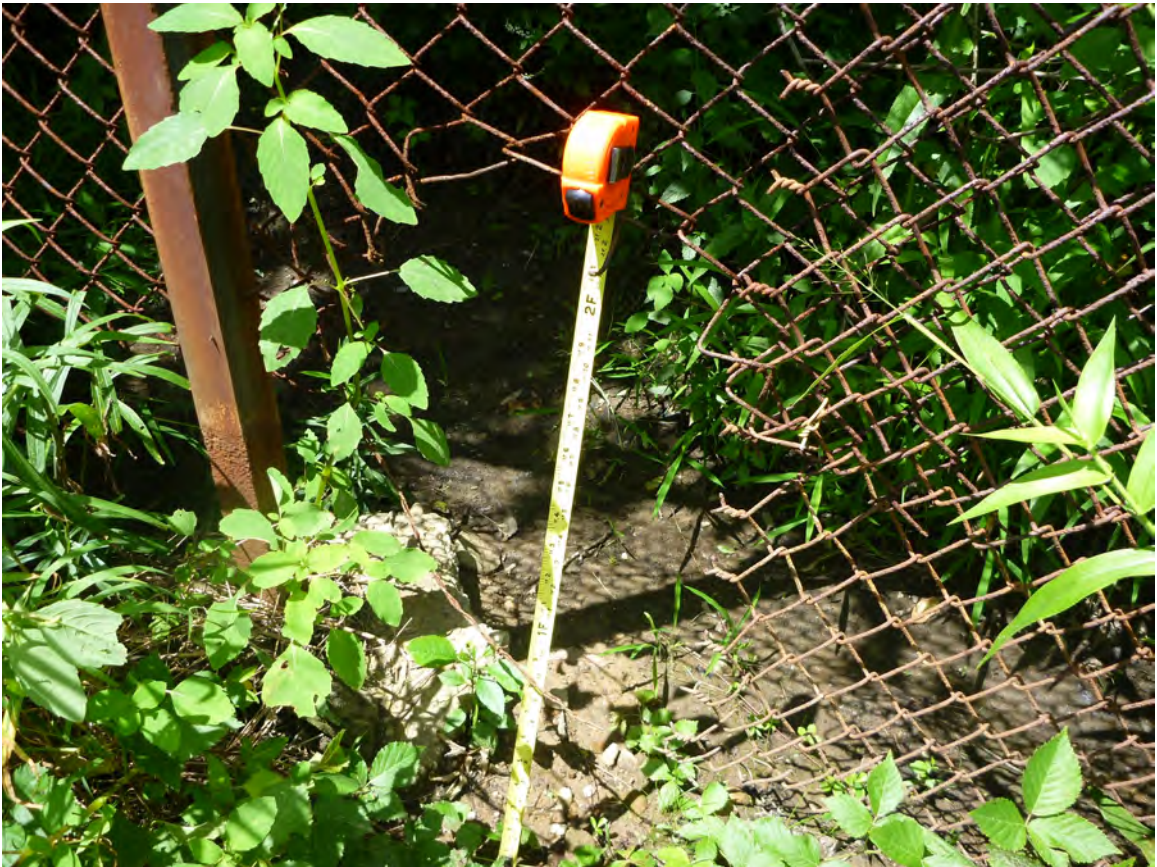
DETAIL SHEET FOR SW20

PHOTO SW20 discovered 07/15/2014

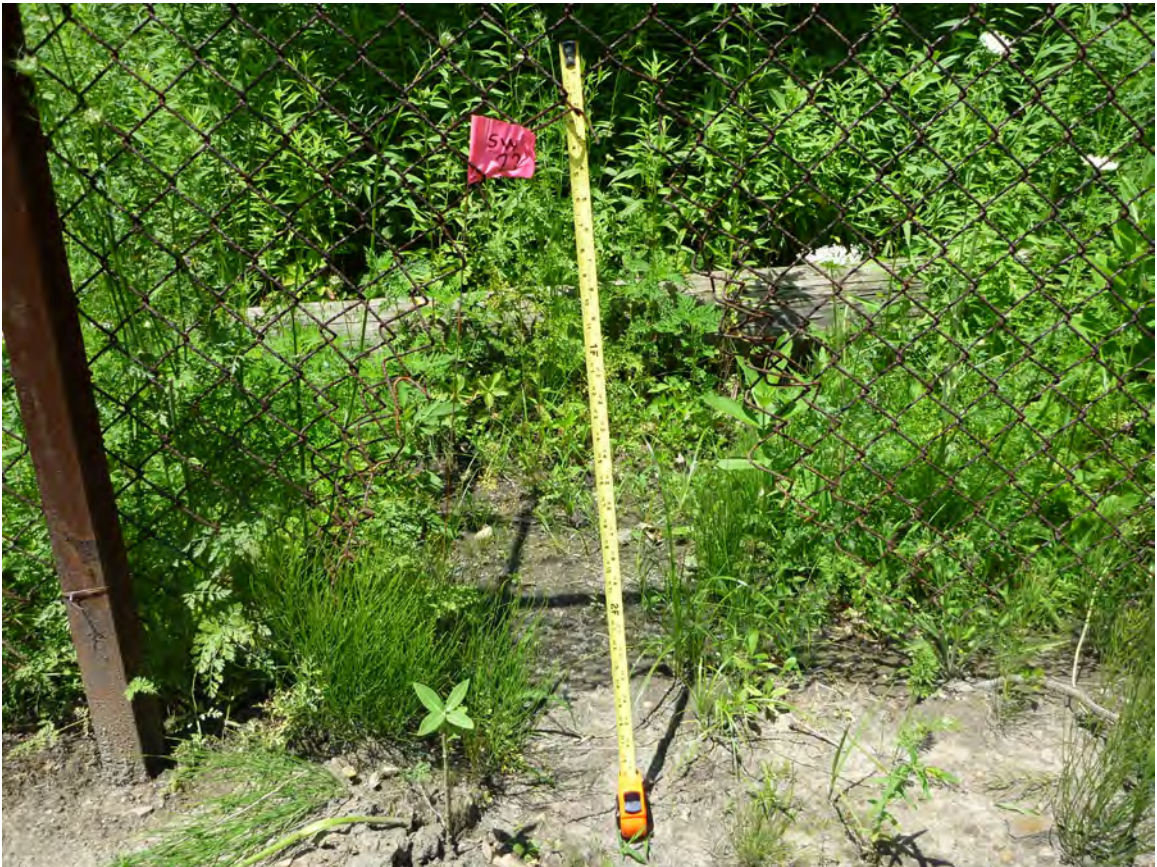
DETAIL SHEET FOR SW22

PHOTO SW22 discovered 07/16/2014
