**Final**  
**2020 Annual Land Use Control Monitoring Report,**  
**RVAAP-01 Ramsdell Quarry Landfill,**  
**RVAAP-05 Winklepeck Burning Grounds,**  
**RVAAP-08 through RVAAP-11 (Load Lines 1 through 4),**  
**RVAAP-12 (Load Line 12) and RVAAP-51 (Dump Along Paris-Windham**  
**Road)**

**Camp James A. Garfield Joint Military Training Center**  
**Former Ravenna Army Ammunition Plant**  
**Portage and Trumbull Counties, Ohio**

**May 24, 2021**

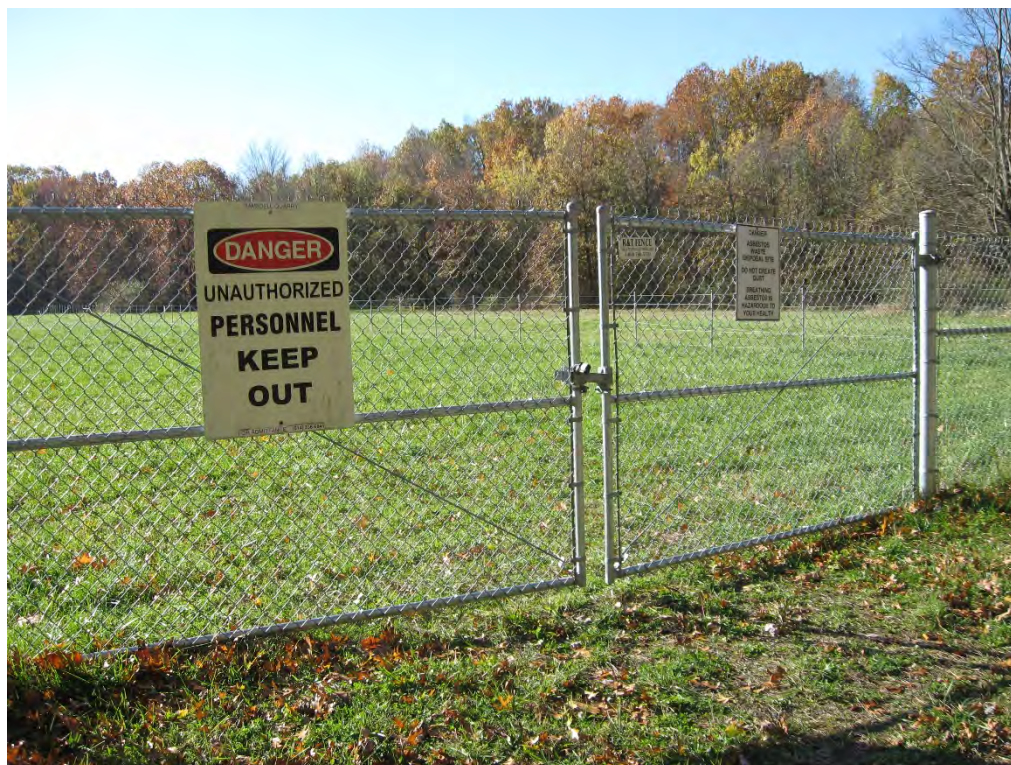
Main gate at Ramsdell Quarry Landfill.

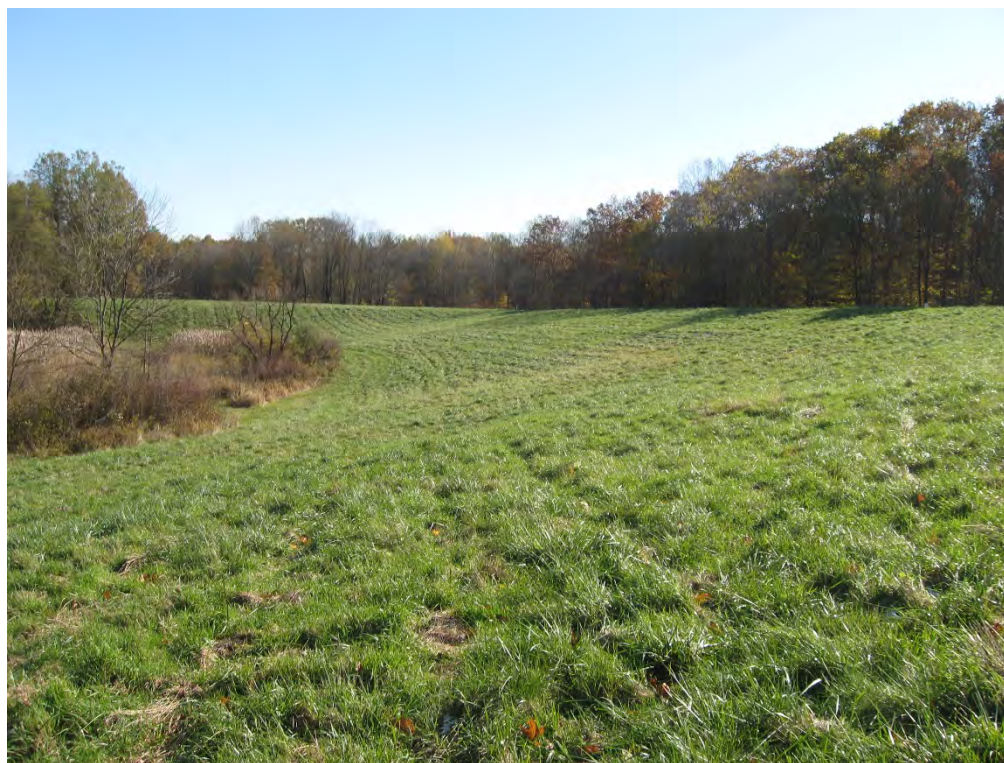
Southern portion of Ramsdell Quarry Landfill, looking east from the southwest portion of the site.

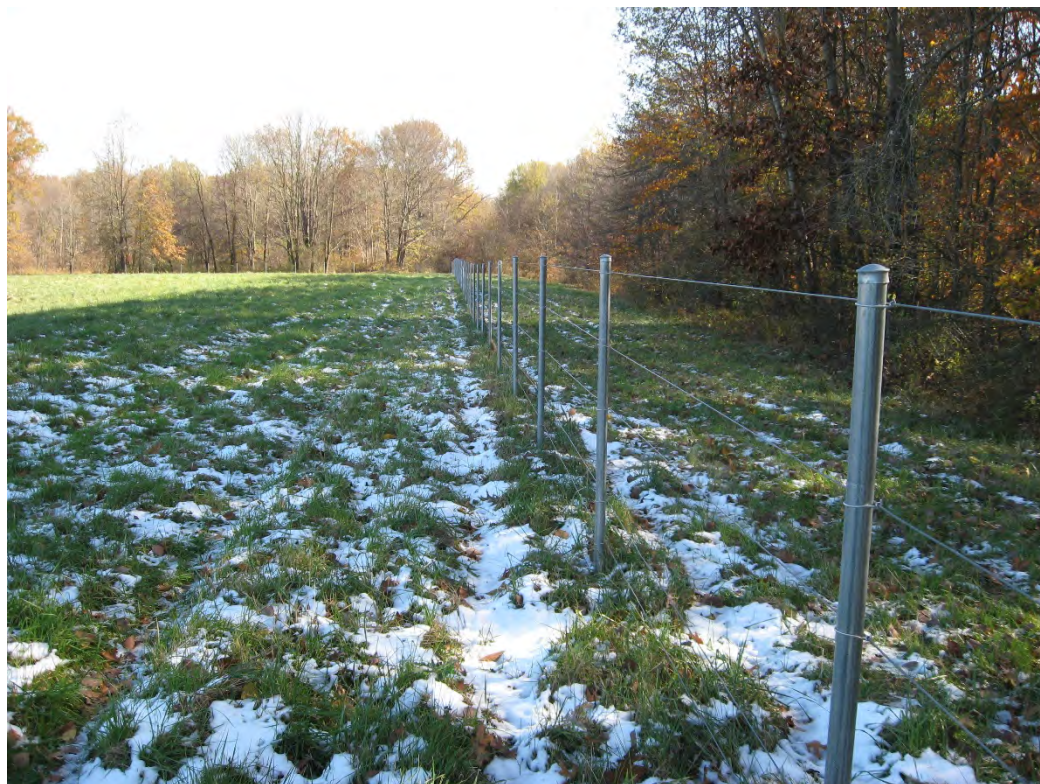
Southern 5-wire tensile fence at Ramsdell Quarry Landfill, looking east.

Several wire connectors that attached several of the 5-wire tensile fence strands to fence posts at various points along were broken, which allowed several of the tensile wire fence strands to sag. Additionally, several of the 5-wire strands were broken and needed to be spliced. These repairs were made in October 2020. A large oak tree fell across the chain-link fence bordering Ramsdell Road and took out about 30 feet of fence in November 2020. The tree was removed and the fence repaired November 18-23, 2020.

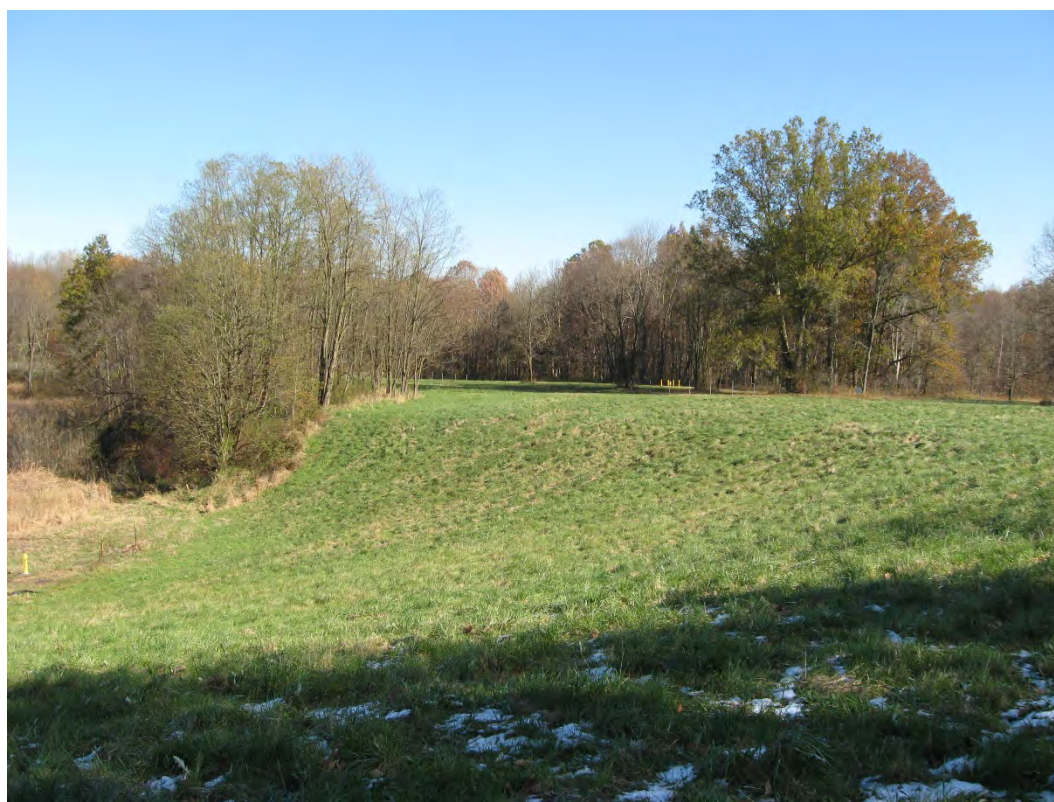
Eastern portion of Ramsdell Quarry Landfill as seen from the southeastern portion of the site.

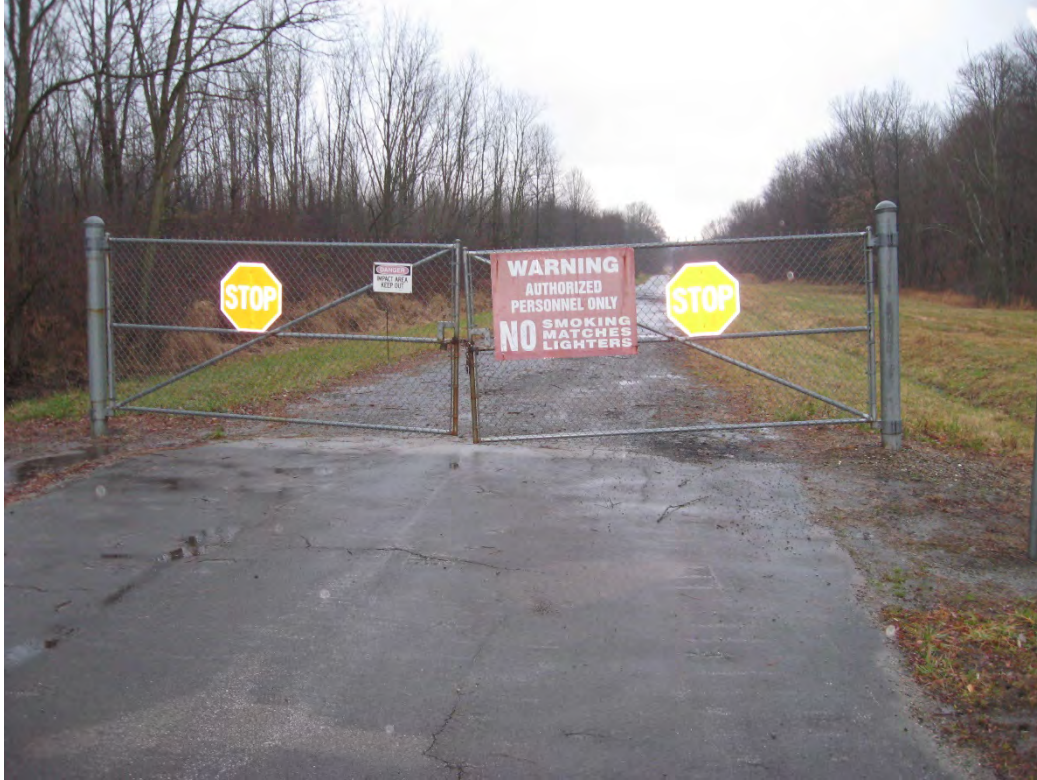
Winklepeck Burning Grounds George Road (south) gate.

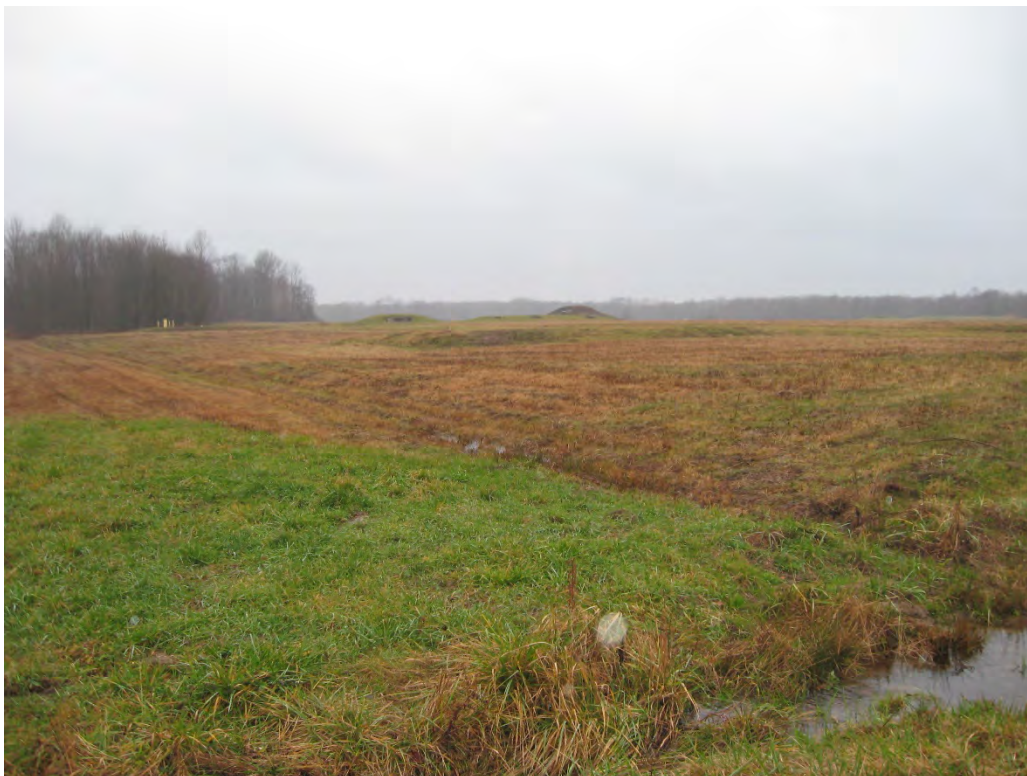
Winklepeck Burning Grounds field, looking west from south-central portion of the site.

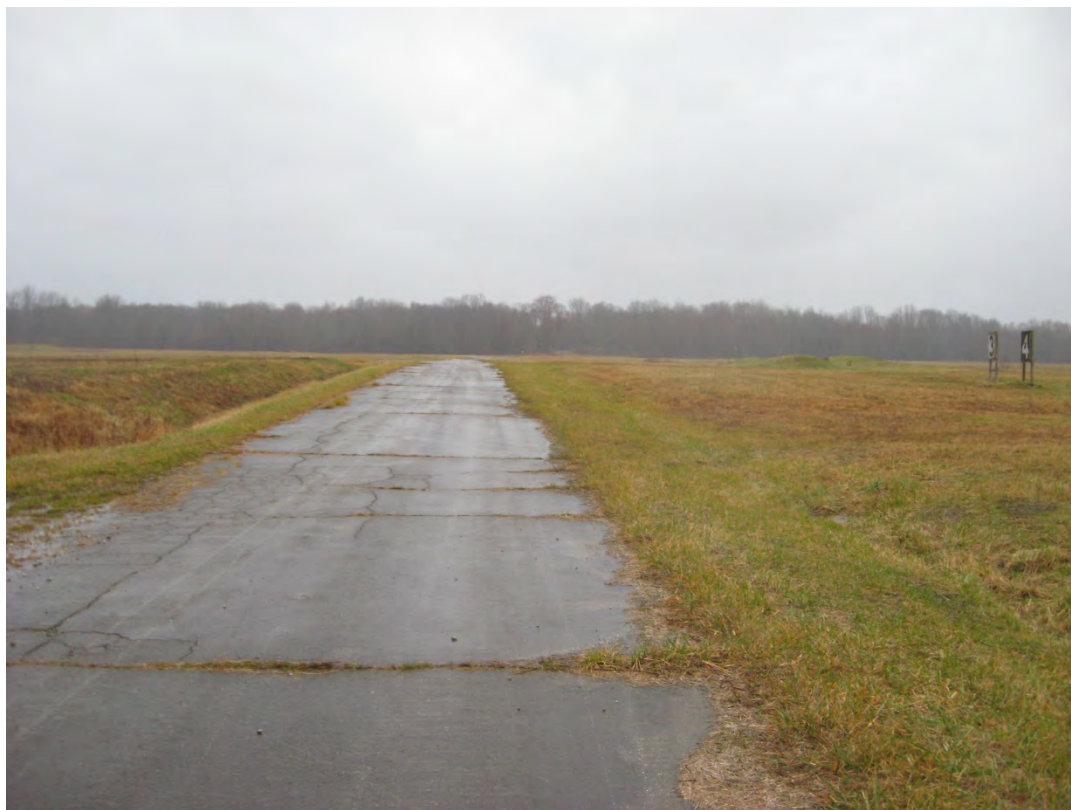
Winklepeck Burning Grounds field, looking north from the central portion of the site.

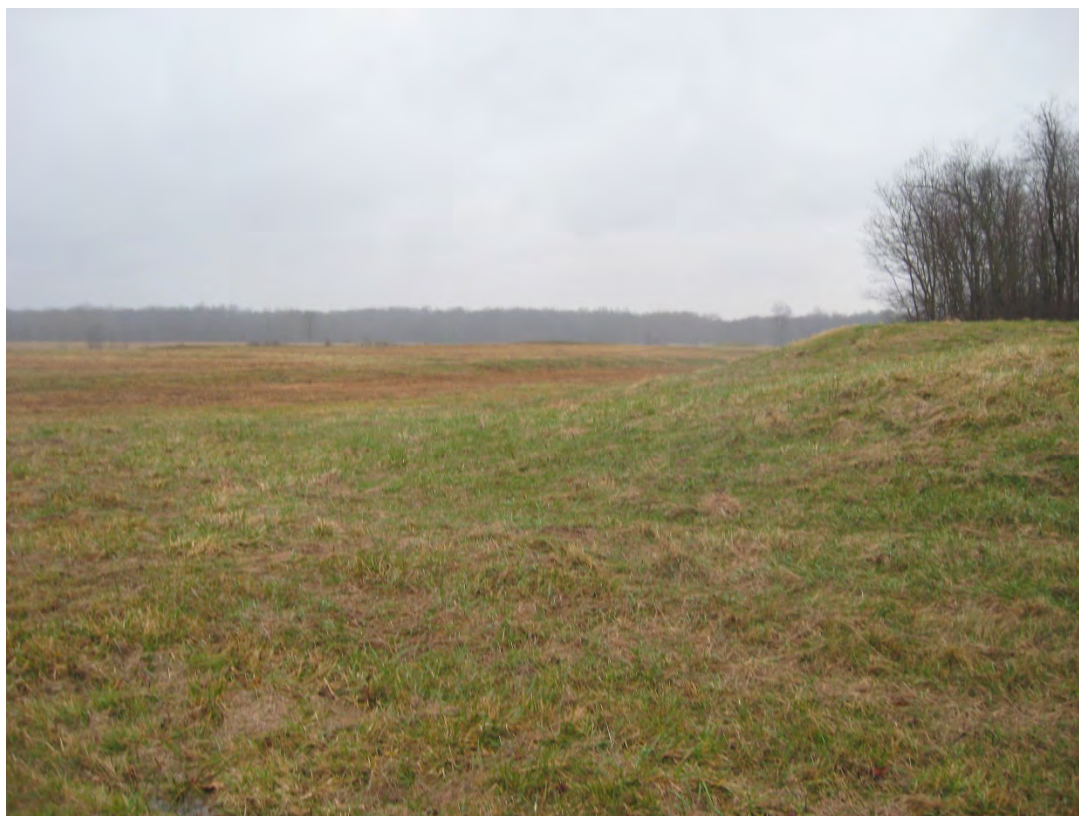
Winklepeck Burning Grounds field, looking east from the south-central portion of the site.

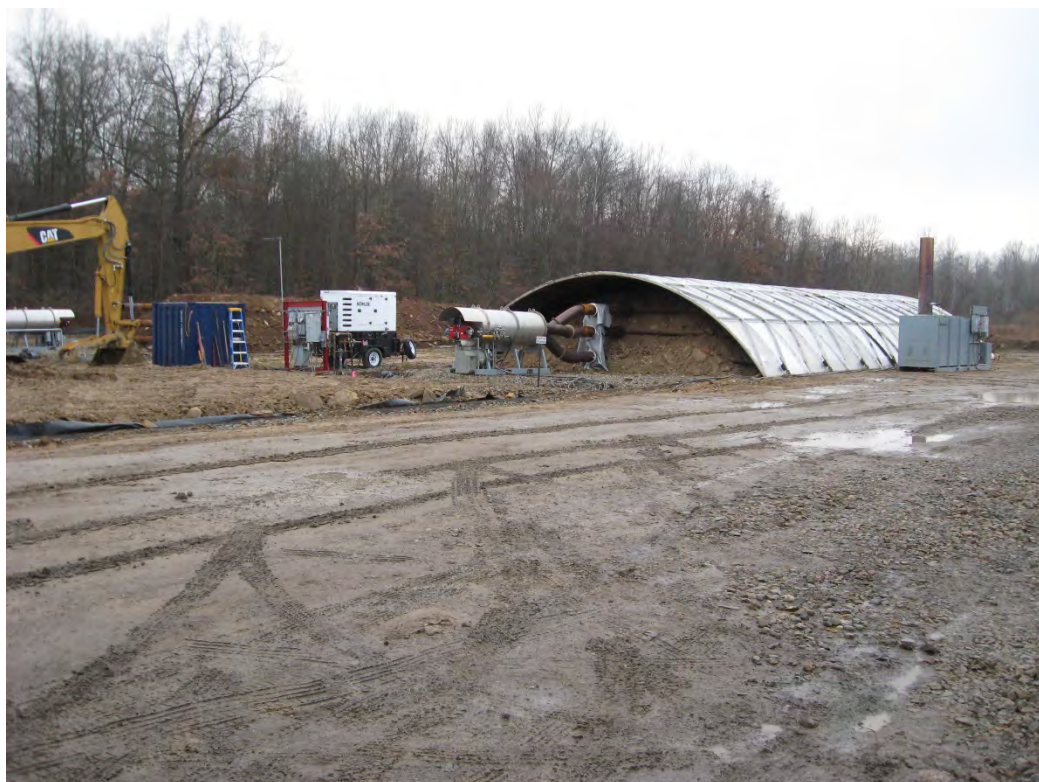
Load Line 1 soil remediation structures.

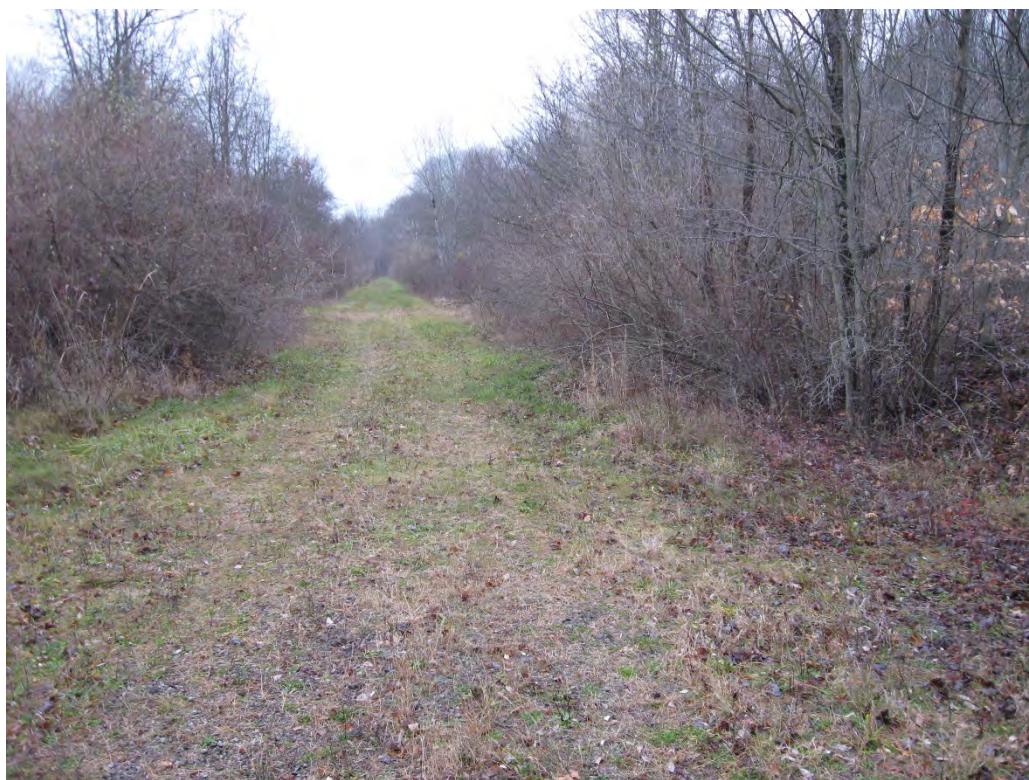
Load Line 1 field, from central western portion of the site looking north.

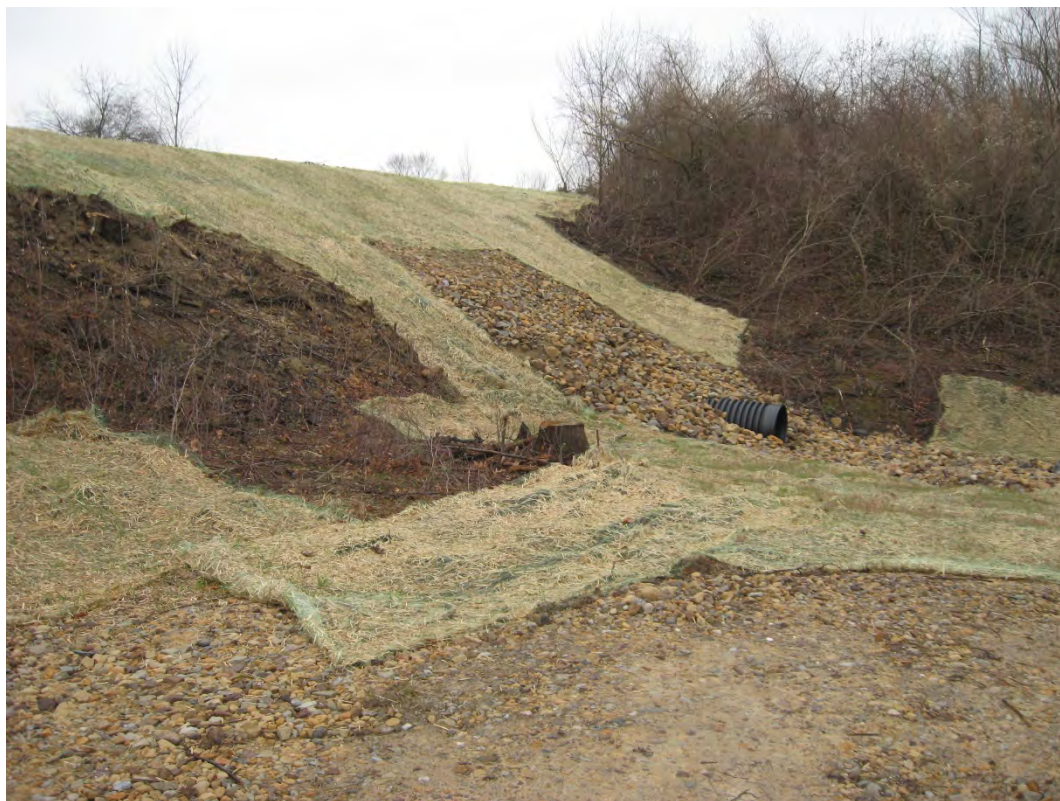
Load Line 2 field, replaced culvert on southern access road.

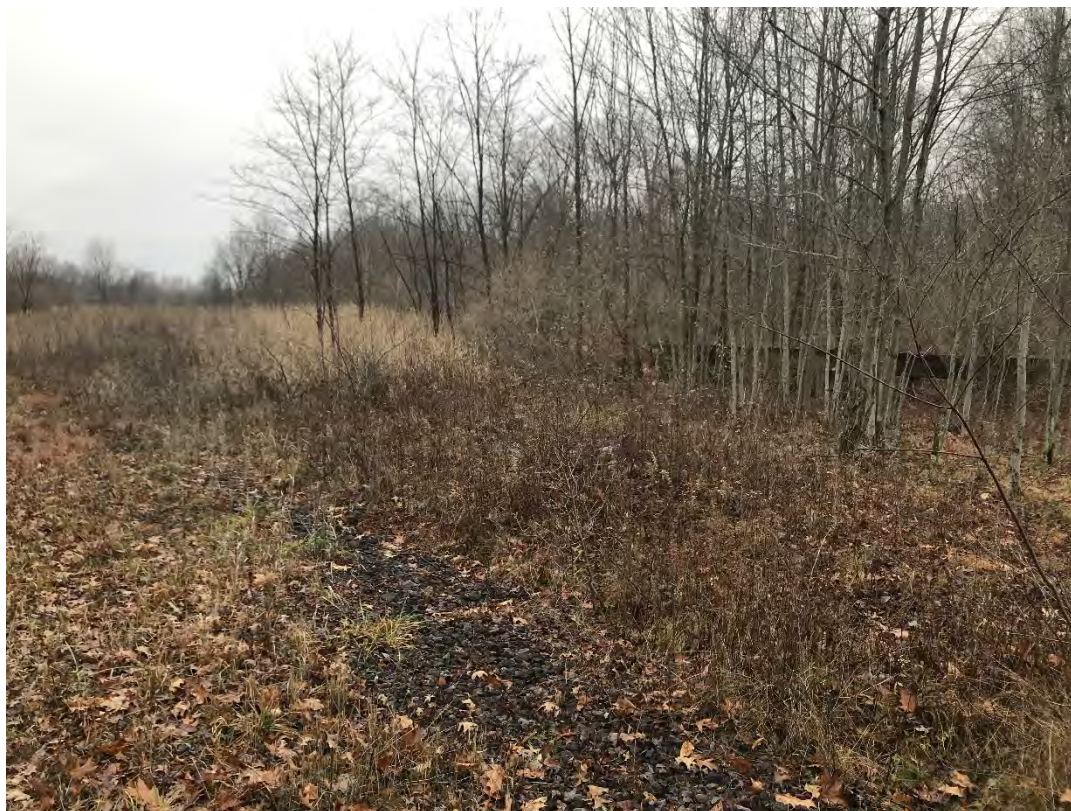
Load Line 2 field, from central portion of the site looking north.

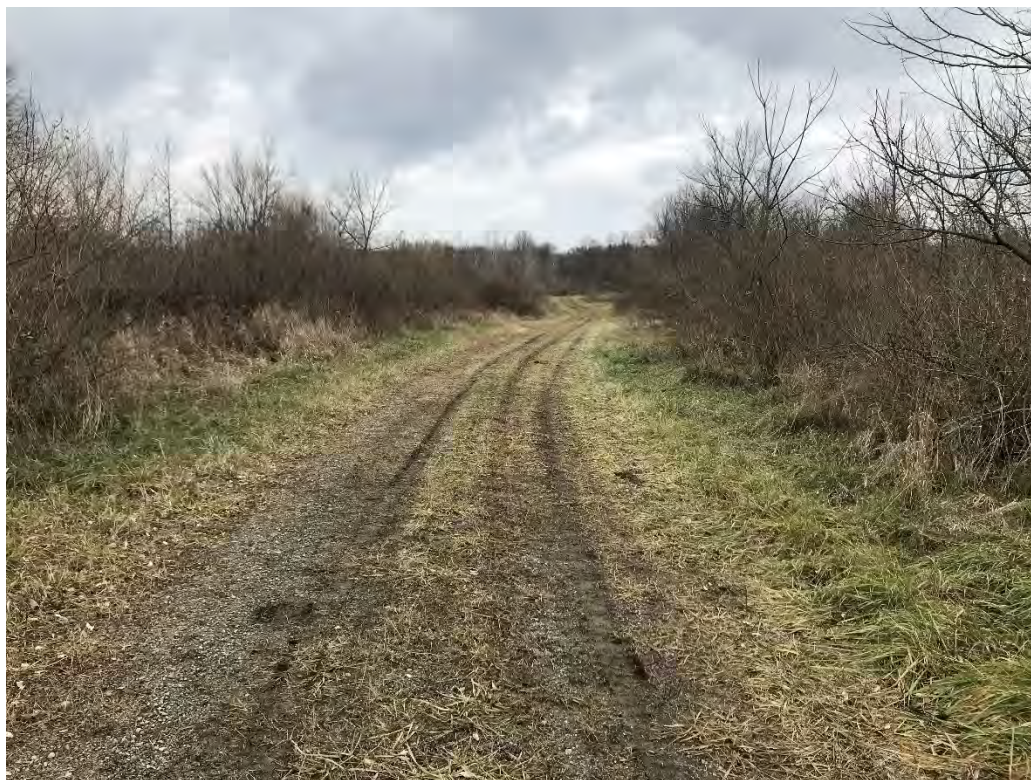
Load Line 3 field, from southeast portion of the site looking north.

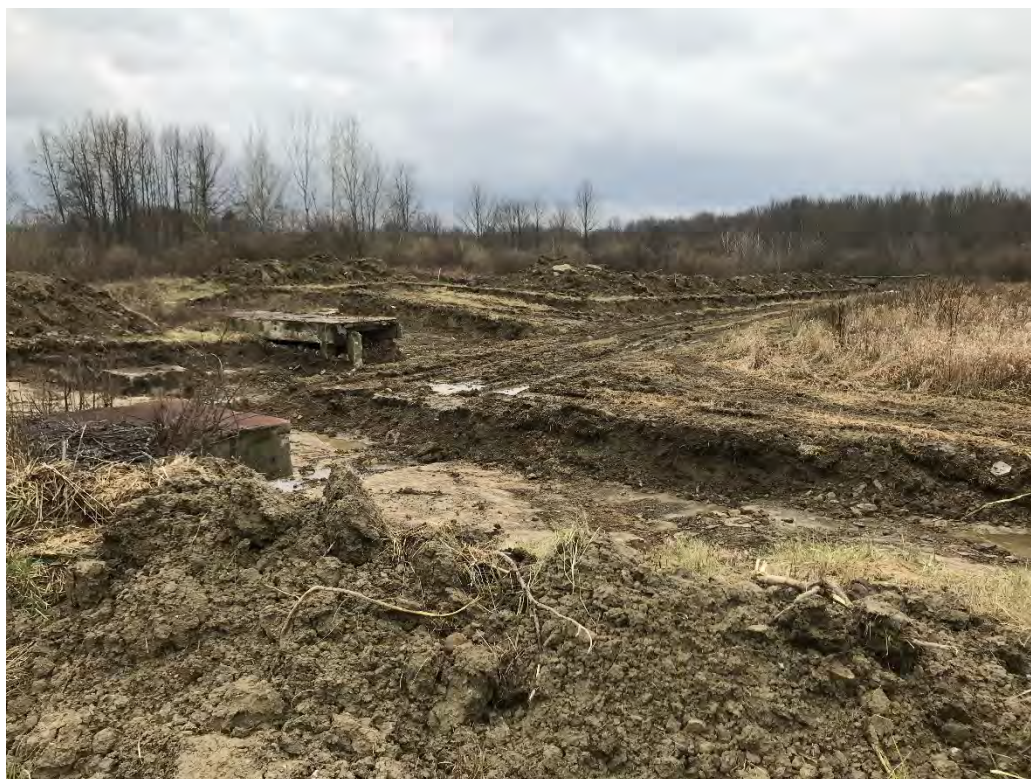
Load Line 3 field, area excavated for ongoing soil remediation in the central portion of the site.

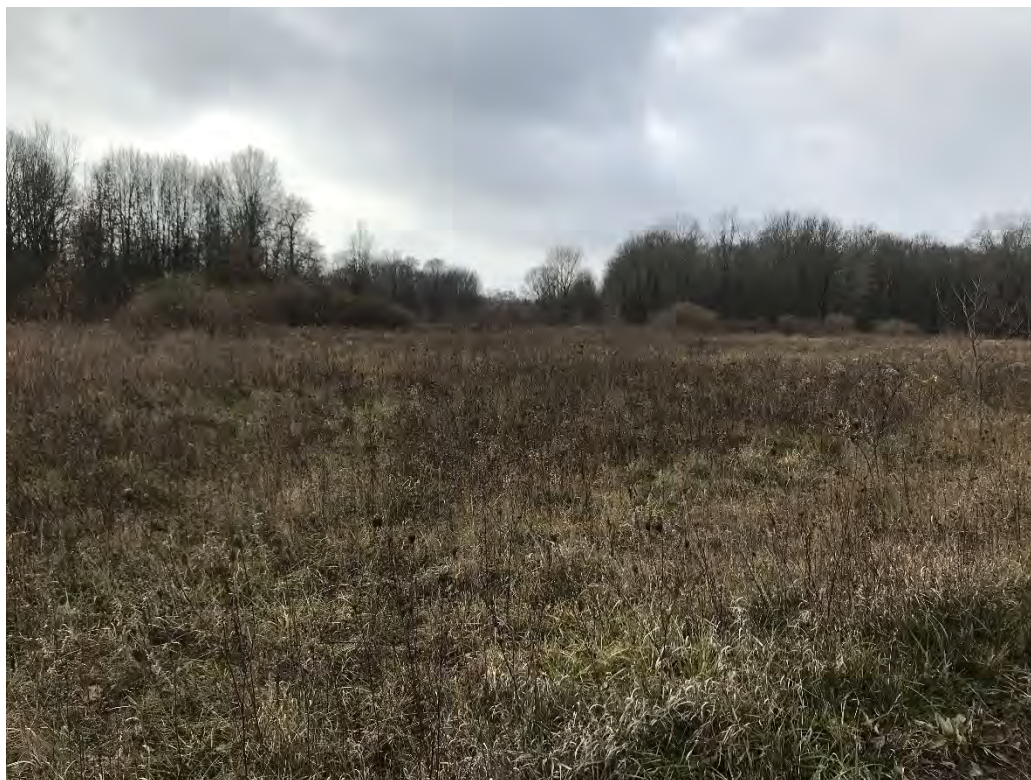
Load Line 4 field, from northern access road looking south.

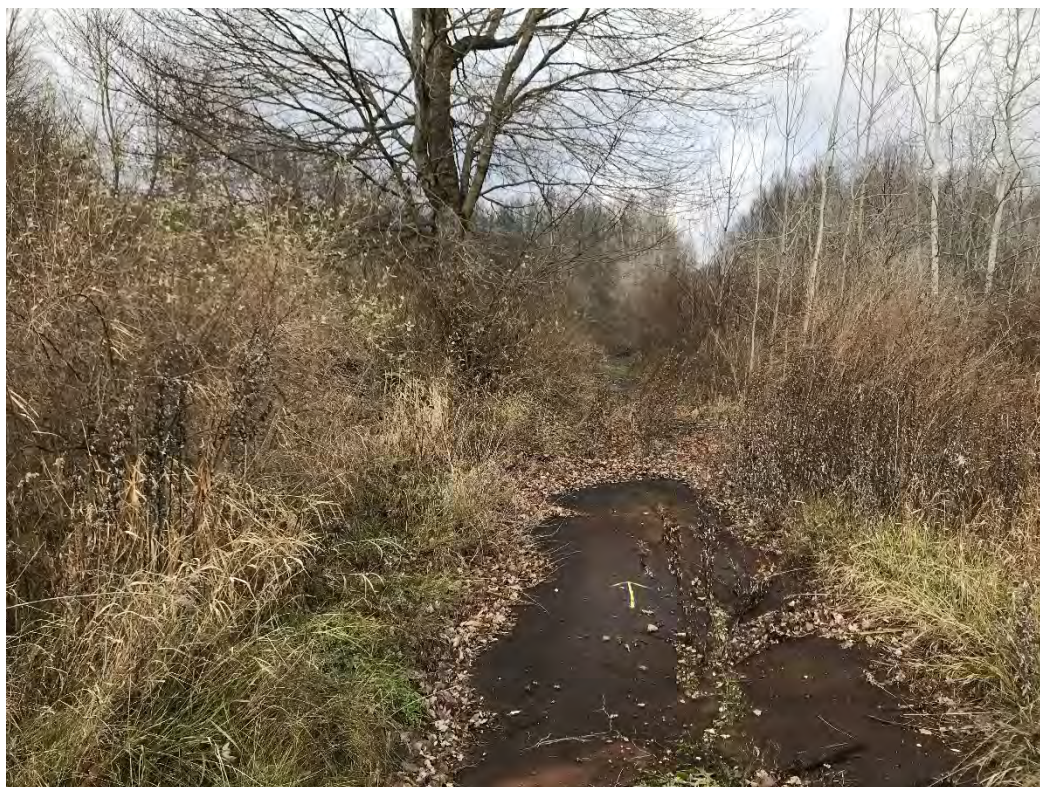
Load Line 4 field, from the central portion of the site looking north.

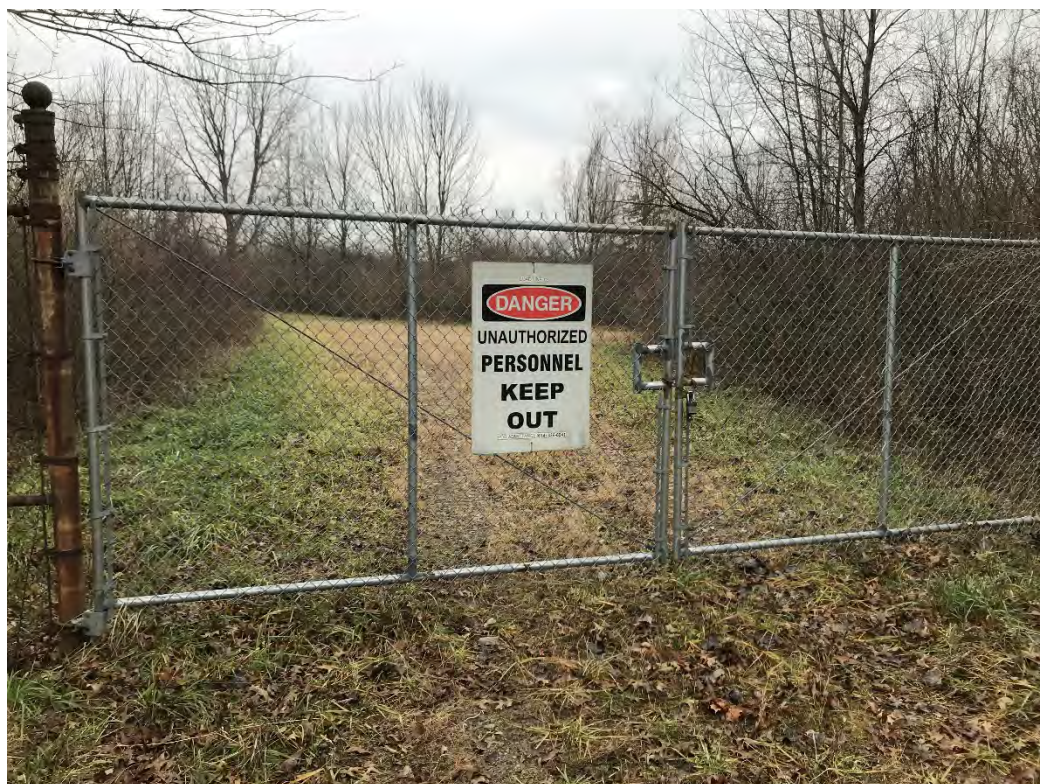
Load Line 12, looking south from the north gate.

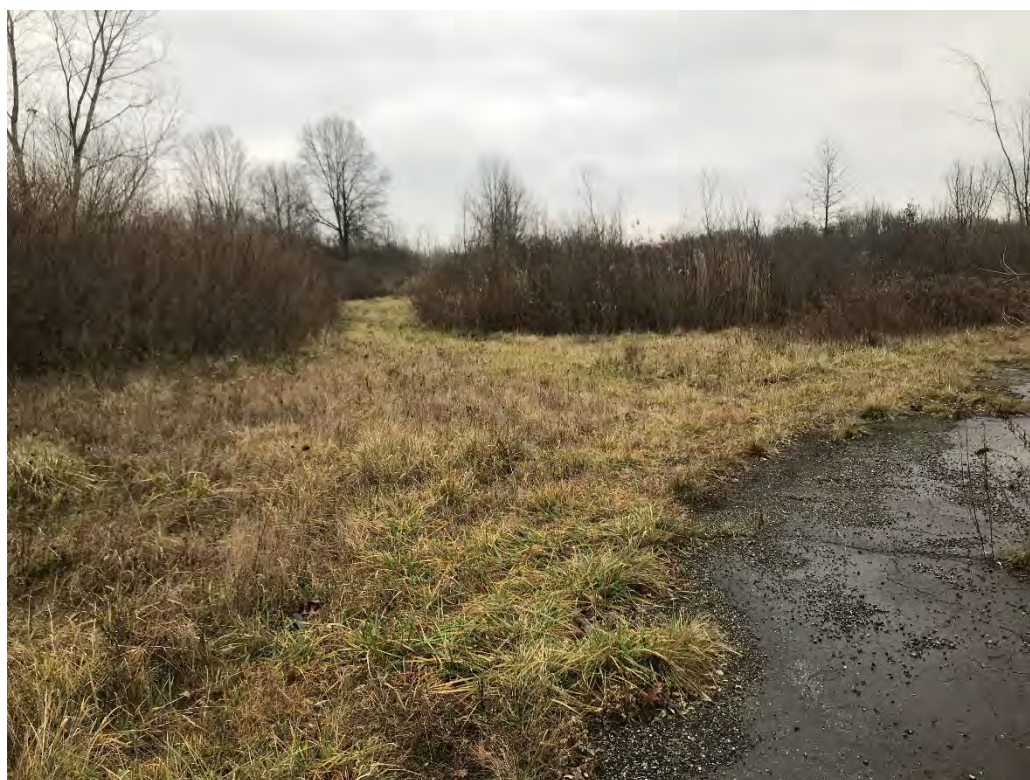
Load Line 12, from the north-central portion of the site looking south.

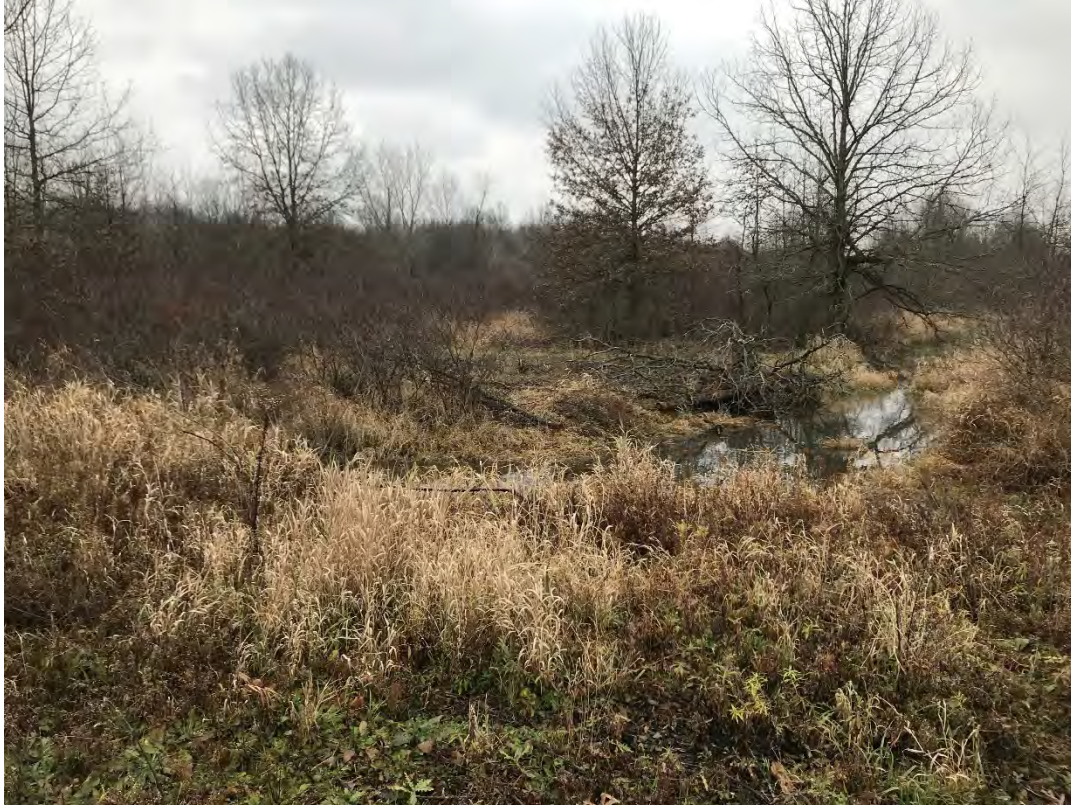
Load Line 12, from the central portion of the site looking south.

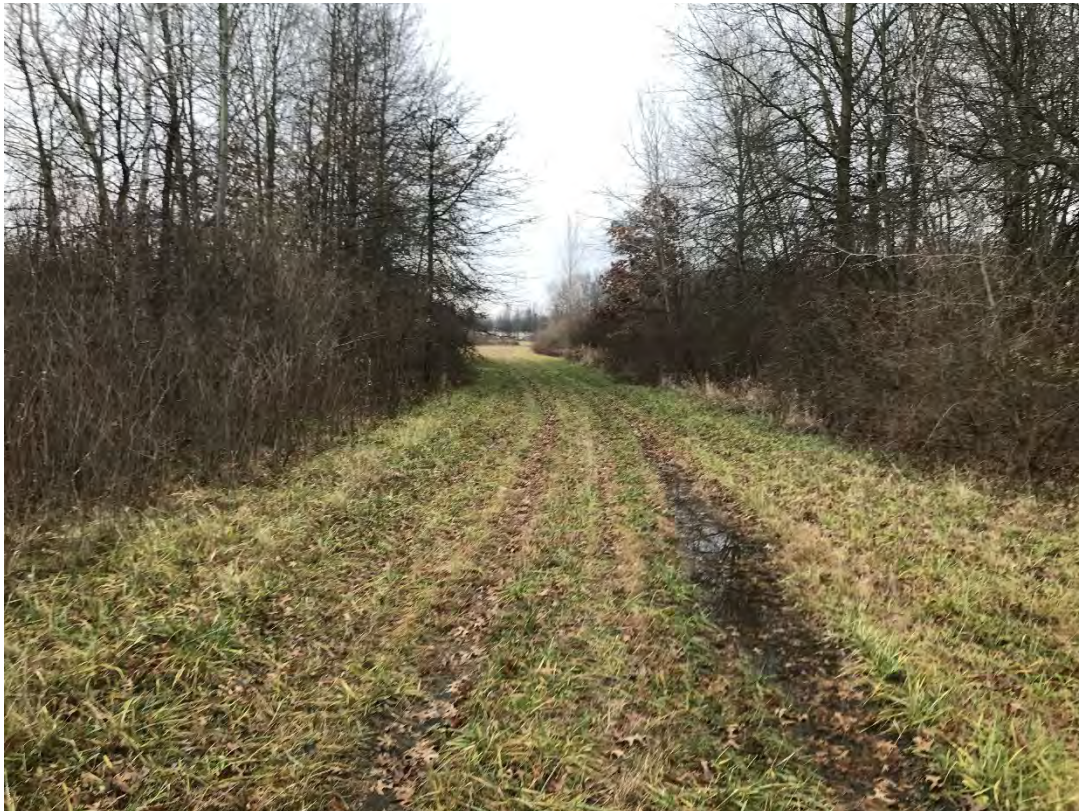
Load Line 12, from the south-central portion of the site looking towards the southern gate.

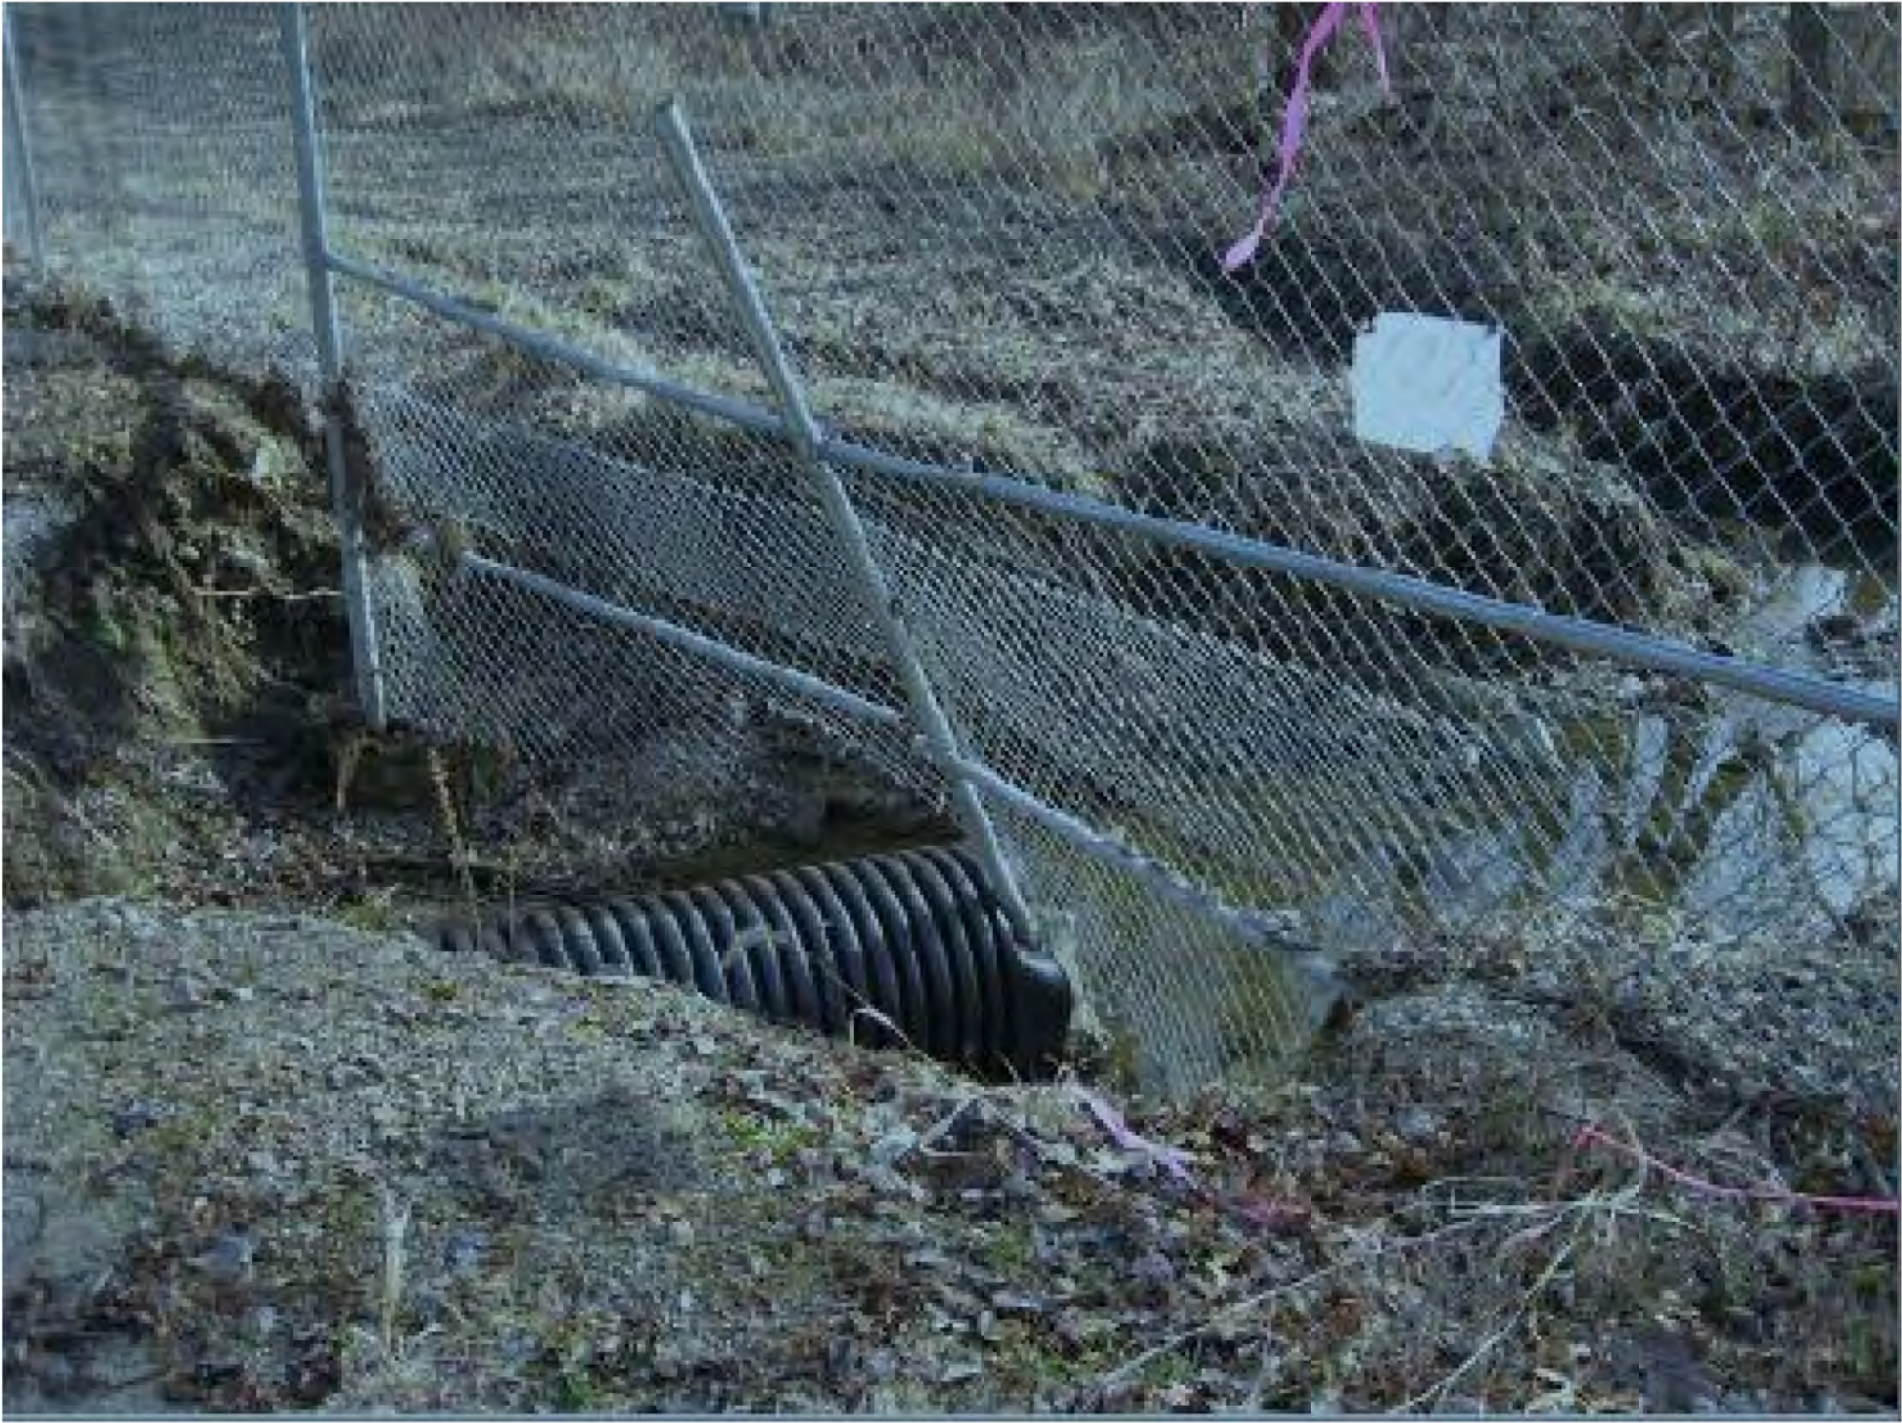
Photo Taken December 26, 2019

Washout at Culvert Mile 0.86

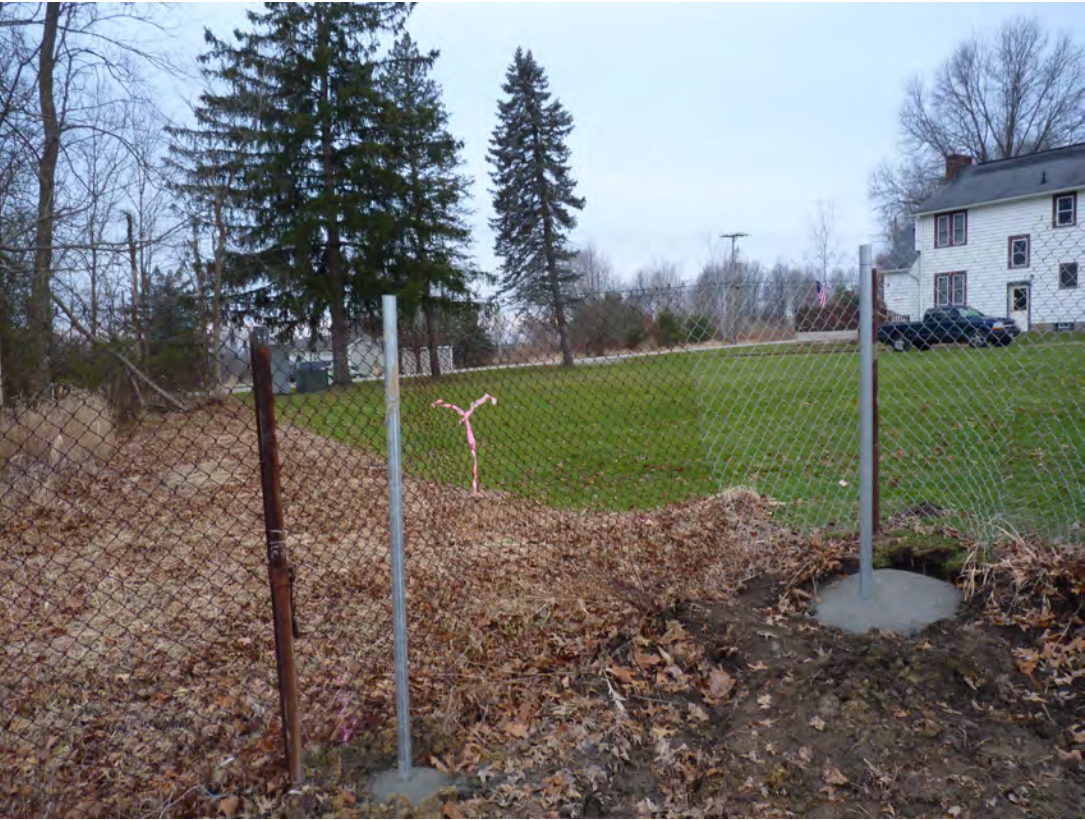
FENCE UNDERGOING TOTAL REPLACEMENT AS OF 1/14/2021

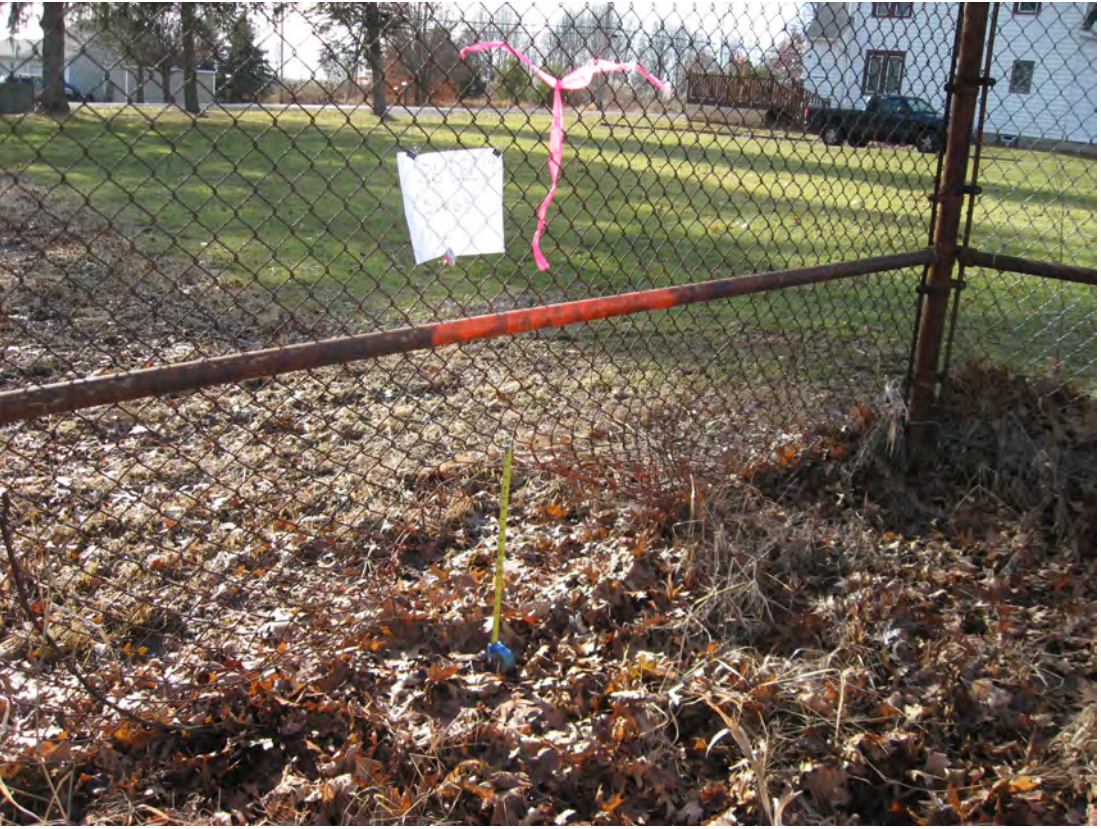
PHOTO SW63 discovered 12/26/2019
