**Final**  
**2020 Annual Land Use Control Monitoring Report,**  
**RVAAP-01 Ramsdell Quarry Landfill,**  
**RVAAP-05 Winklepeck Burning Grounds,**  
**RVAAP-08 through RVAAP-11 (Load Lines 1 through 4),**  
**RVAAP-12 (Load Line 12) and RVAAP-51 (Dump Along Paris-Windham**  
**Road)**

**Camp James A. Garfield Joint Military Training Center**  
**Former Ravenna Army Ammunition Plant**  
**Portage and Trumbull Counties, Ohio**

**May 24, 2021**

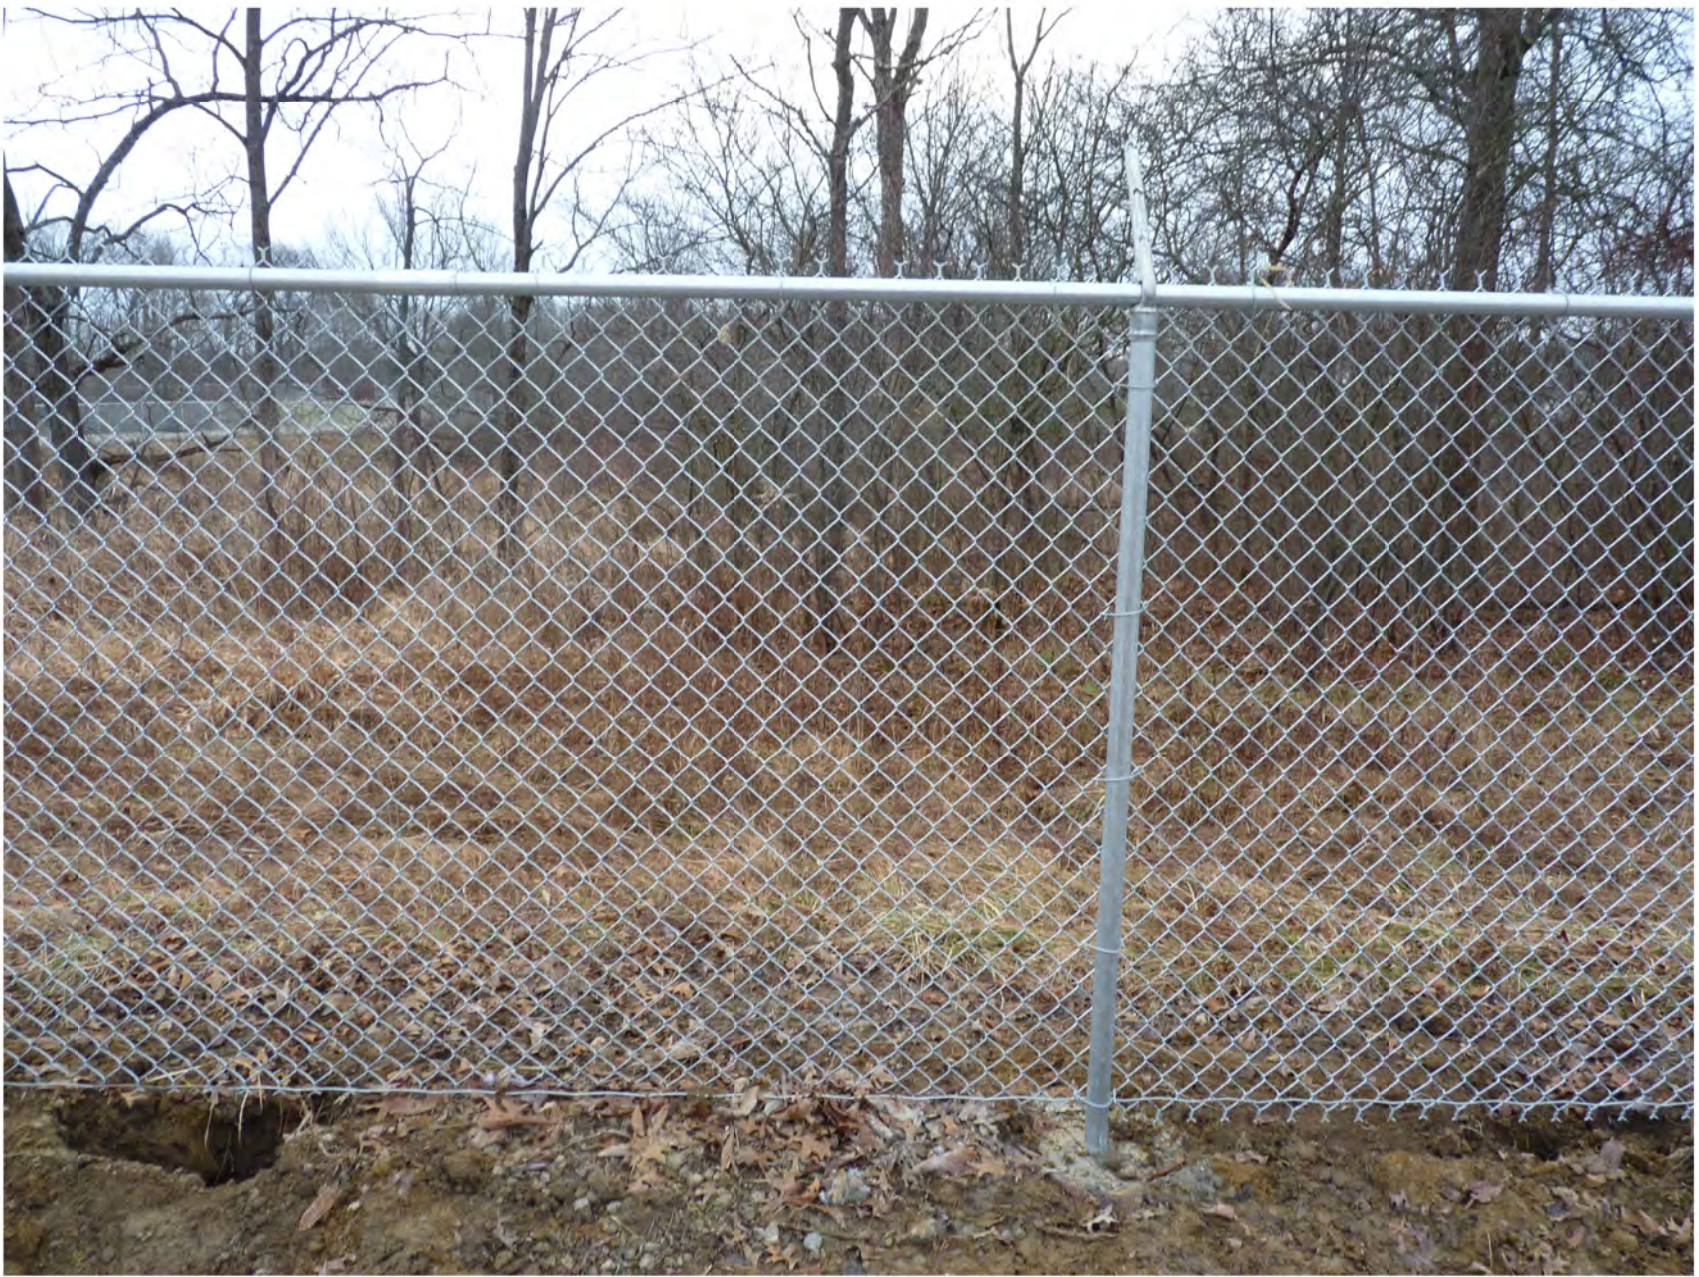
Poacher Hole at Mile 2.80

Repaired: Status Photo January 14, 2021

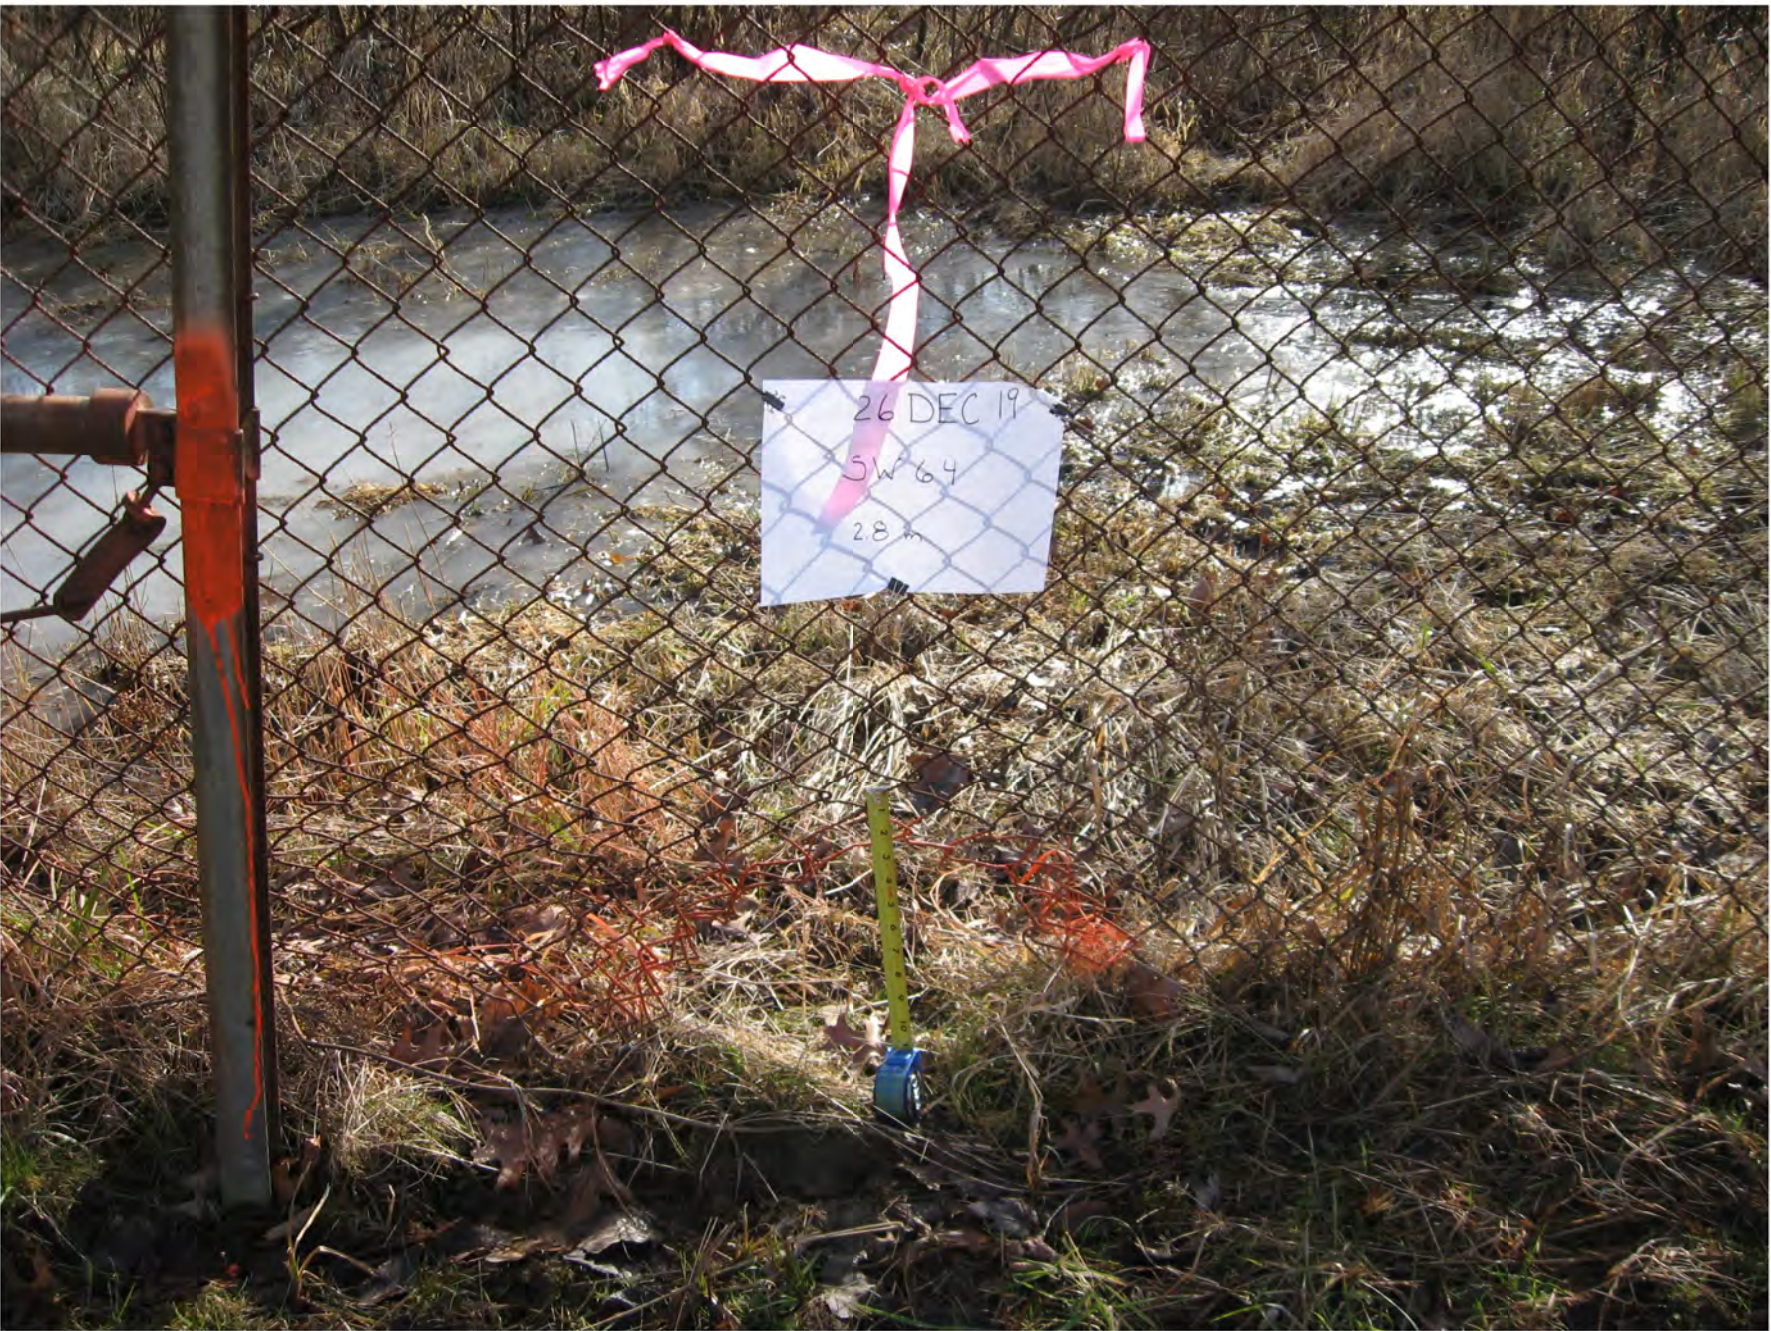
Discovered December 26, 2019

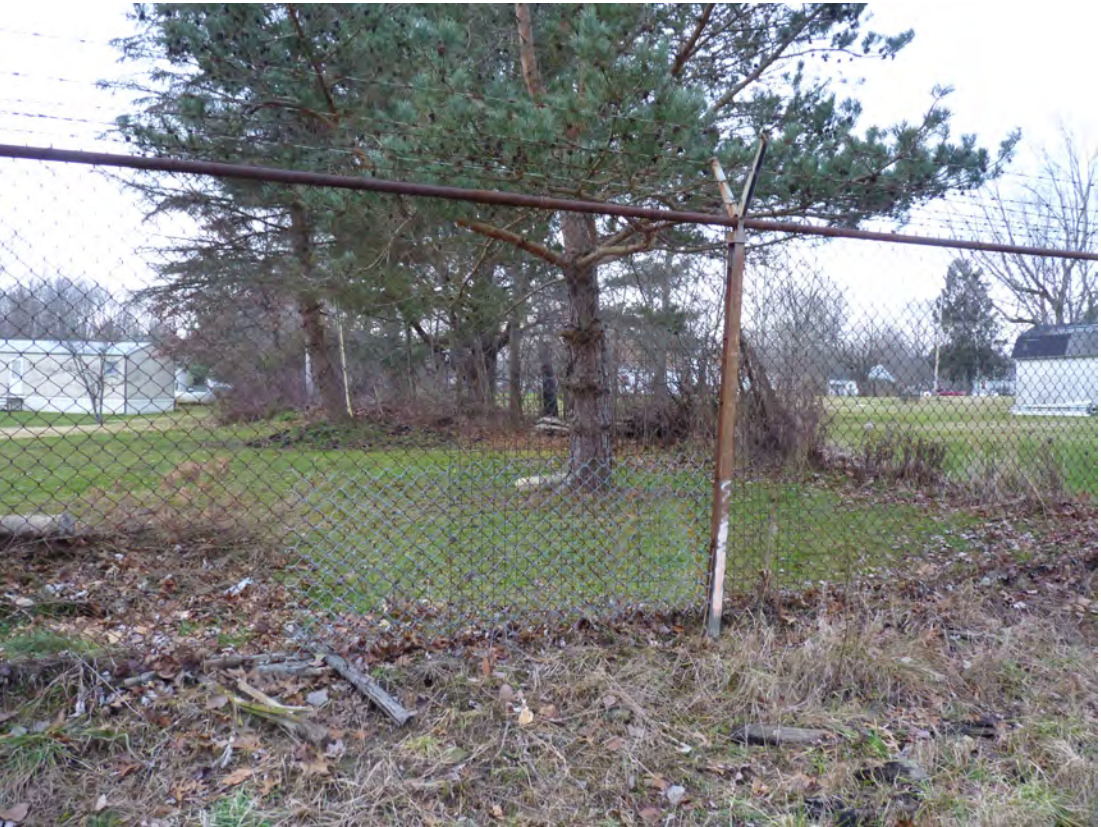
REPAIRED: STATUS PHOTO on 1/14/2021

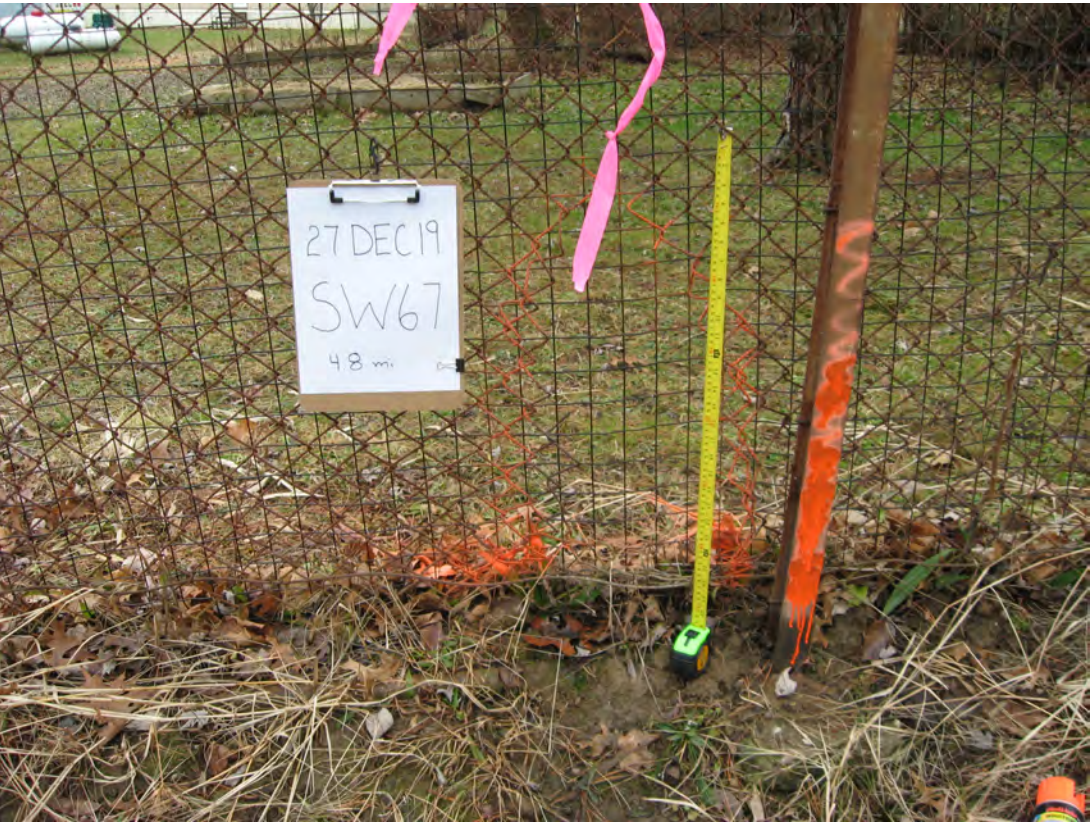
PHOTO SW67 discovered 12/27/2019

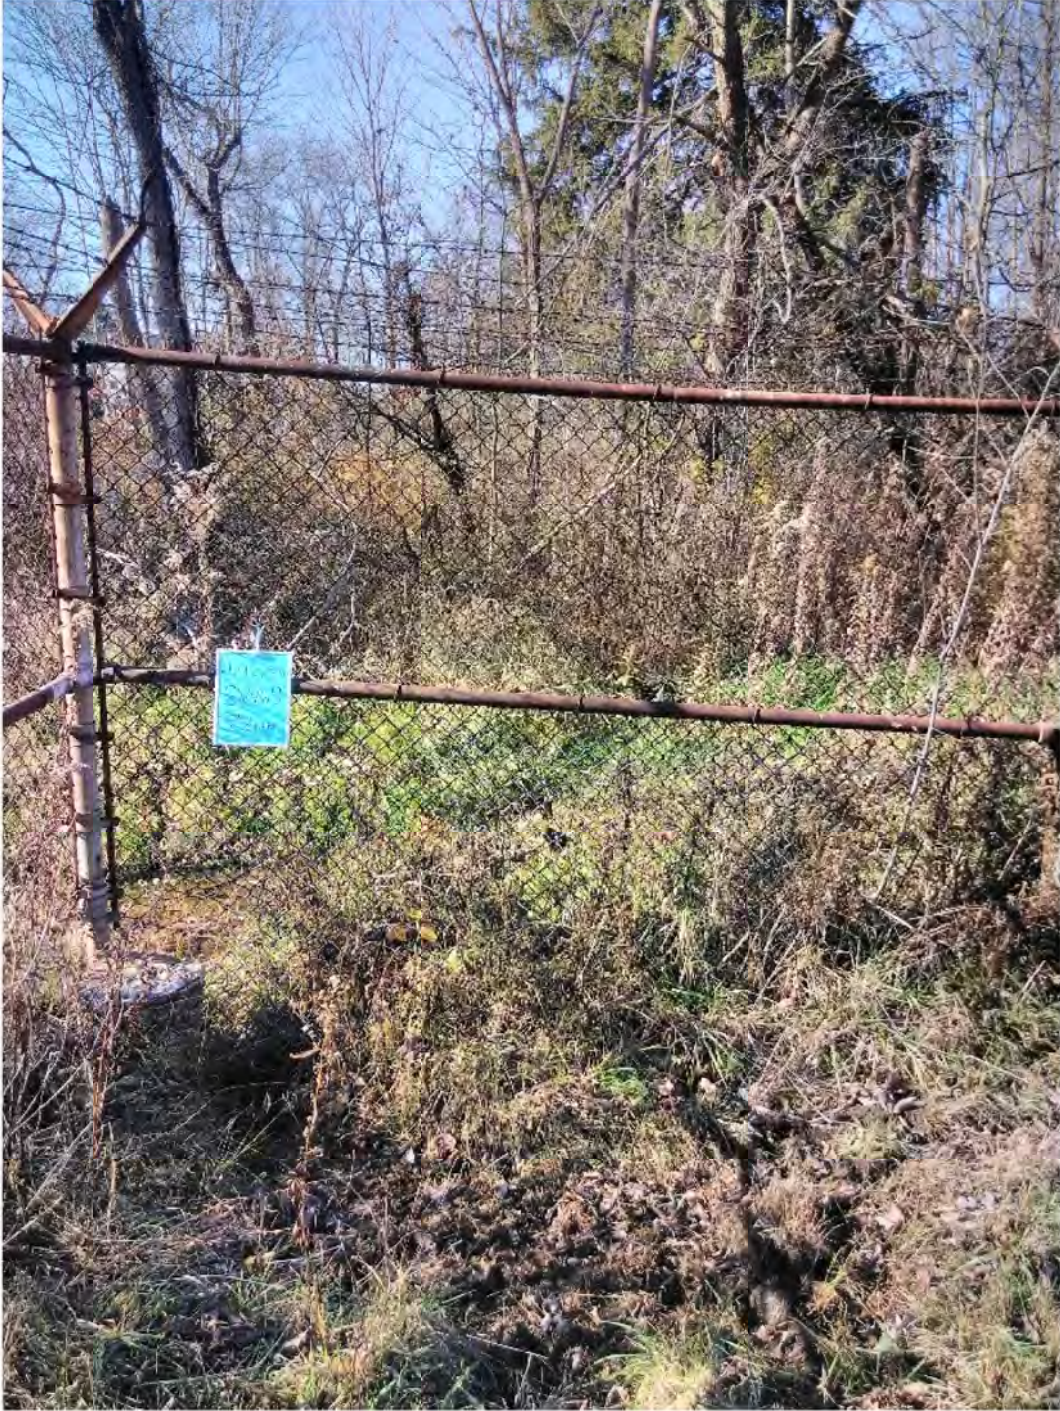
Fence Damage/Poacher Hole at Mile 7.14 (7.2)  
Repair Verified November 12, 2020

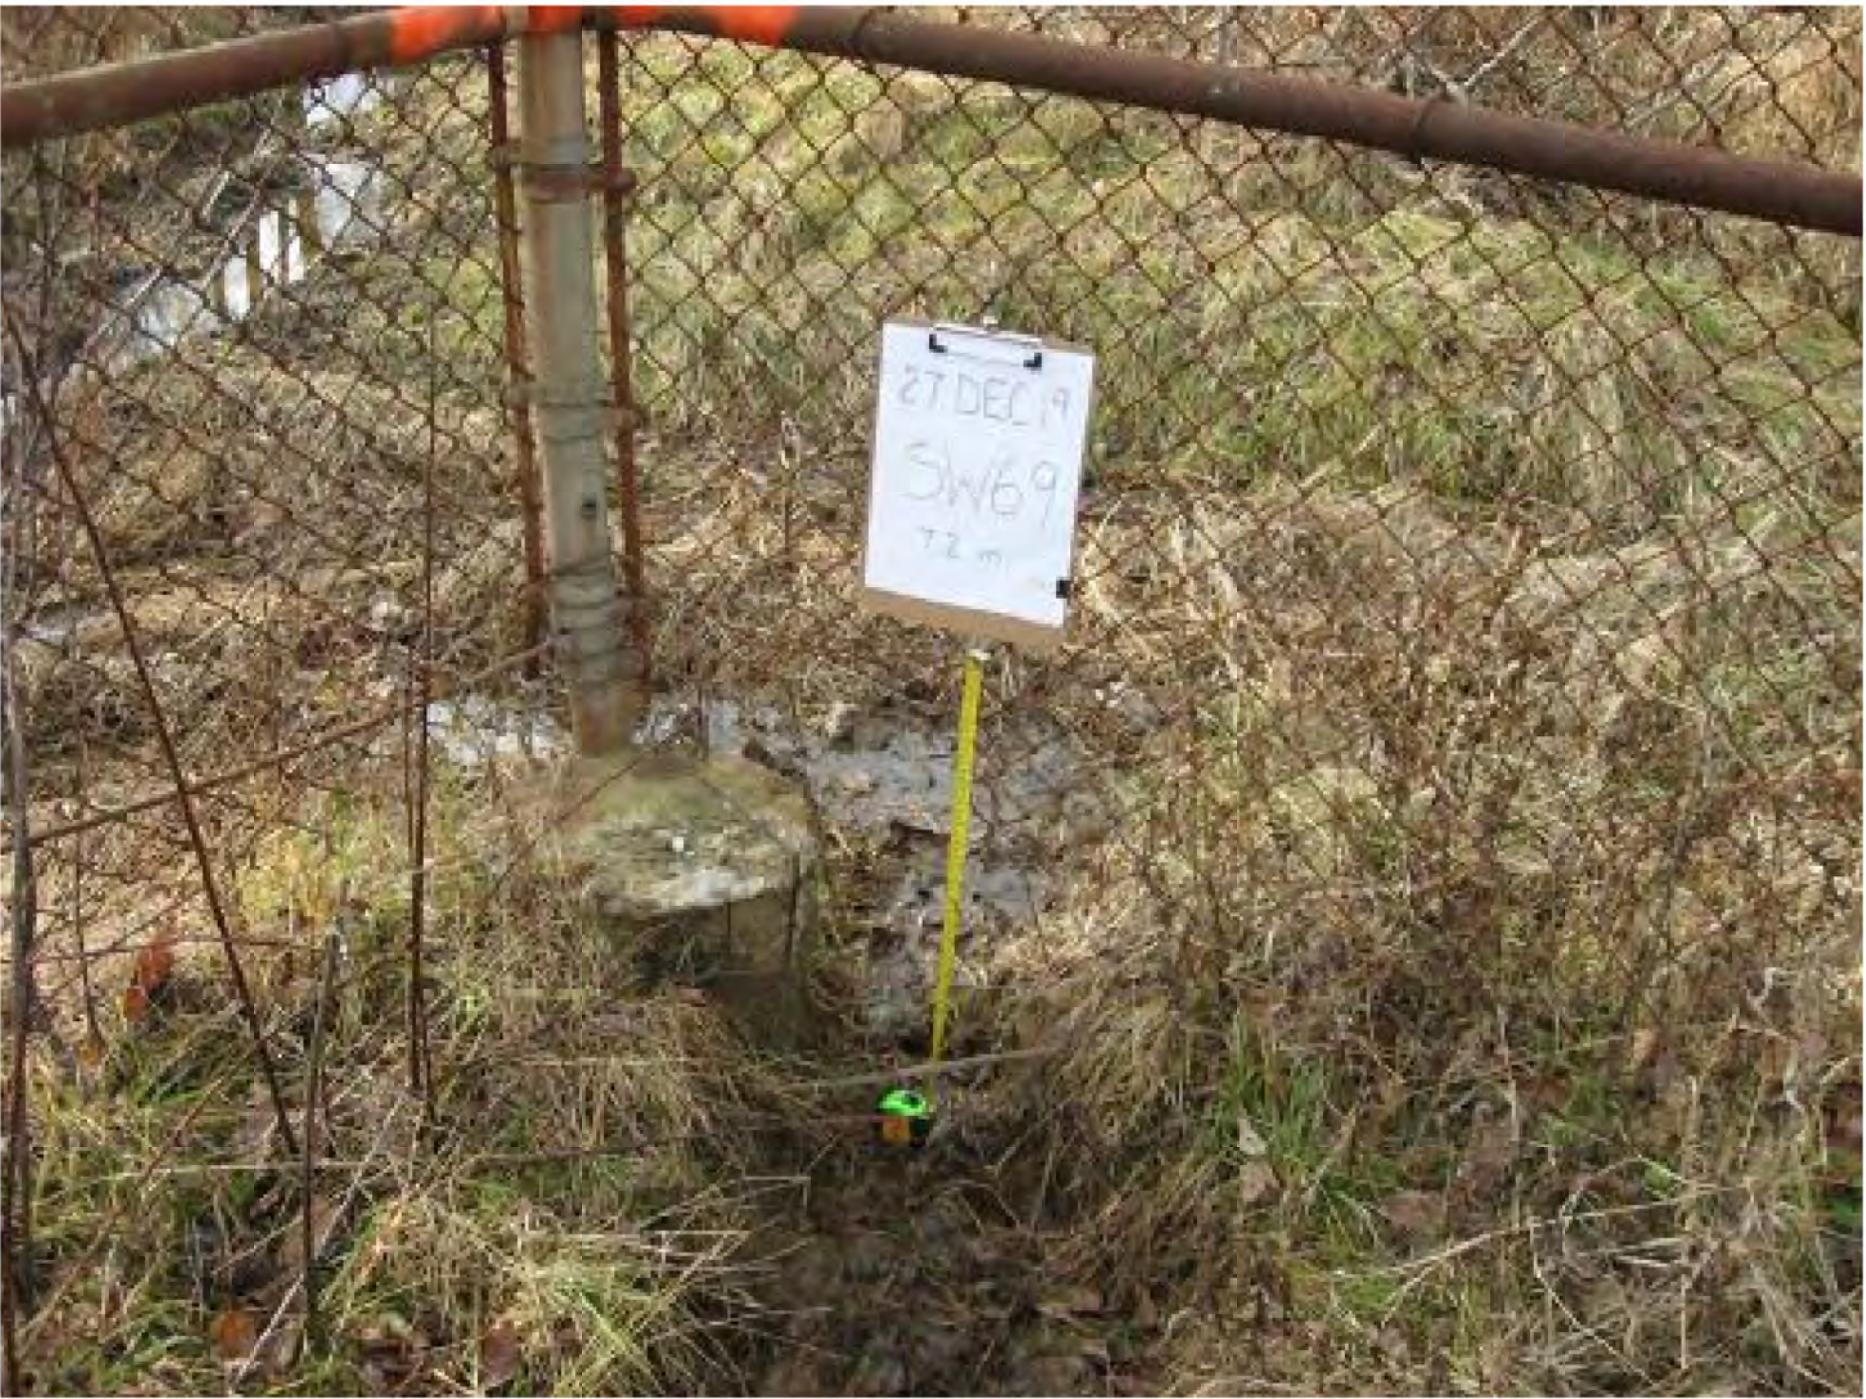
Discovered December 27, 2019

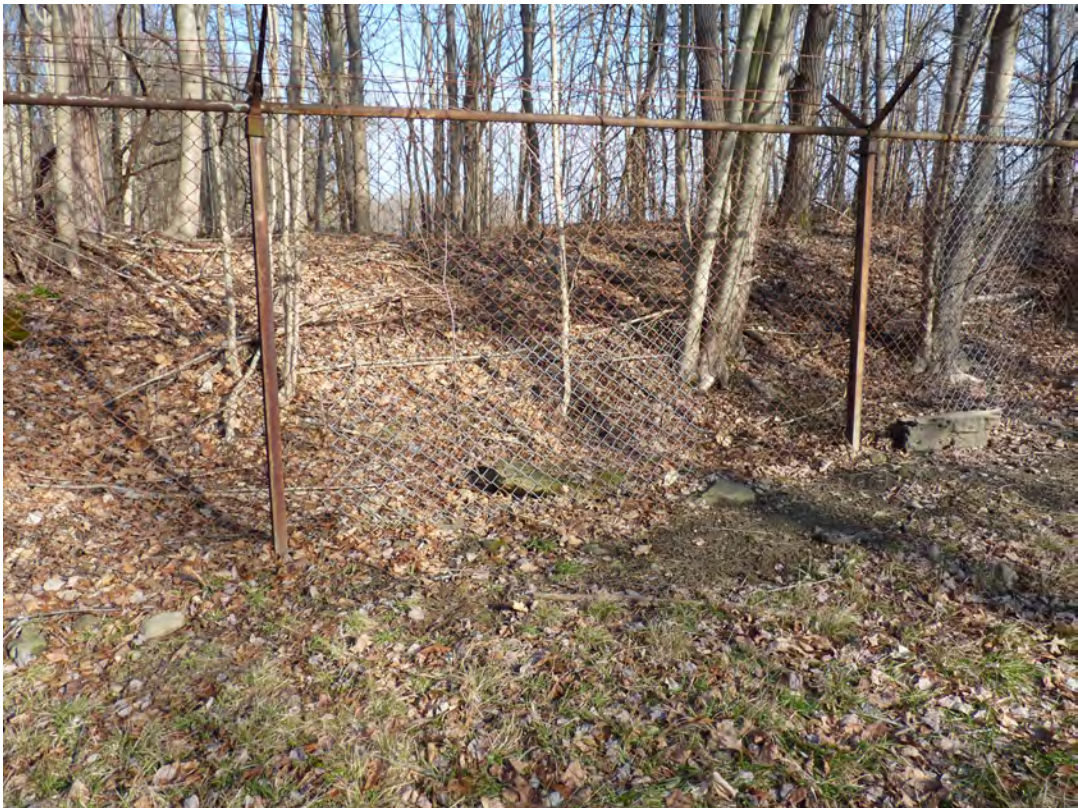
REPAIRED: STATUS PHOTO on 1/14/2021

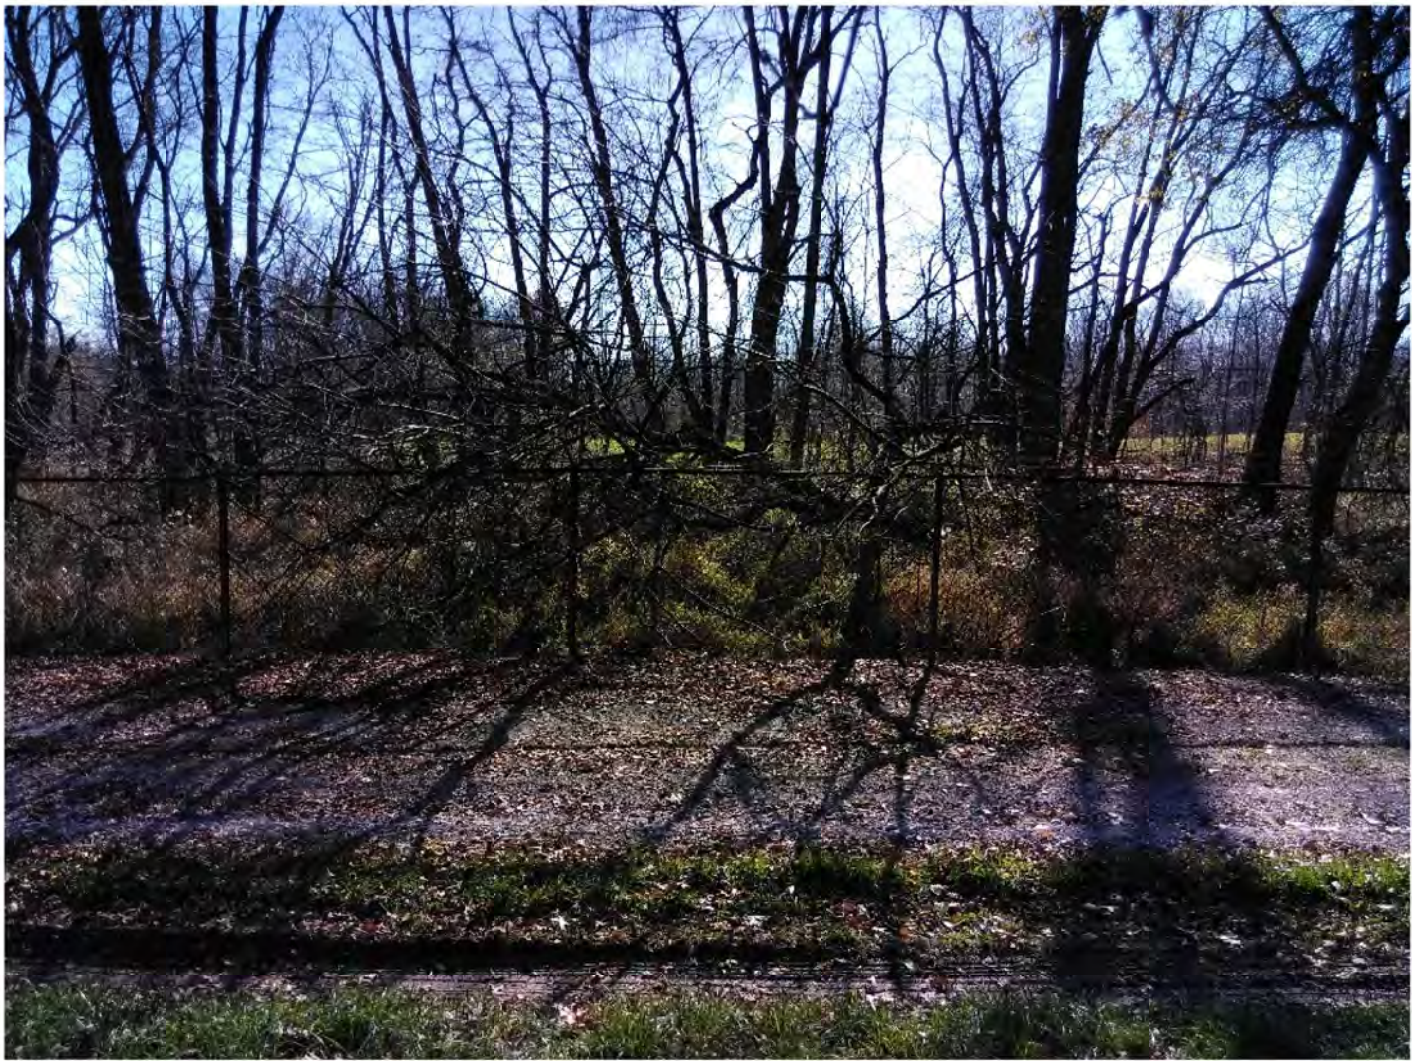
# DETAIL SHEET FOR SW76

Tree on Fence at Mile 2.98

Photo Taken November 10, 2020

Repaired. New fencing, posts and post foundations were installed between December 2020 and January 2021 between mile markers 0.9 and 5.0. Photo not available.

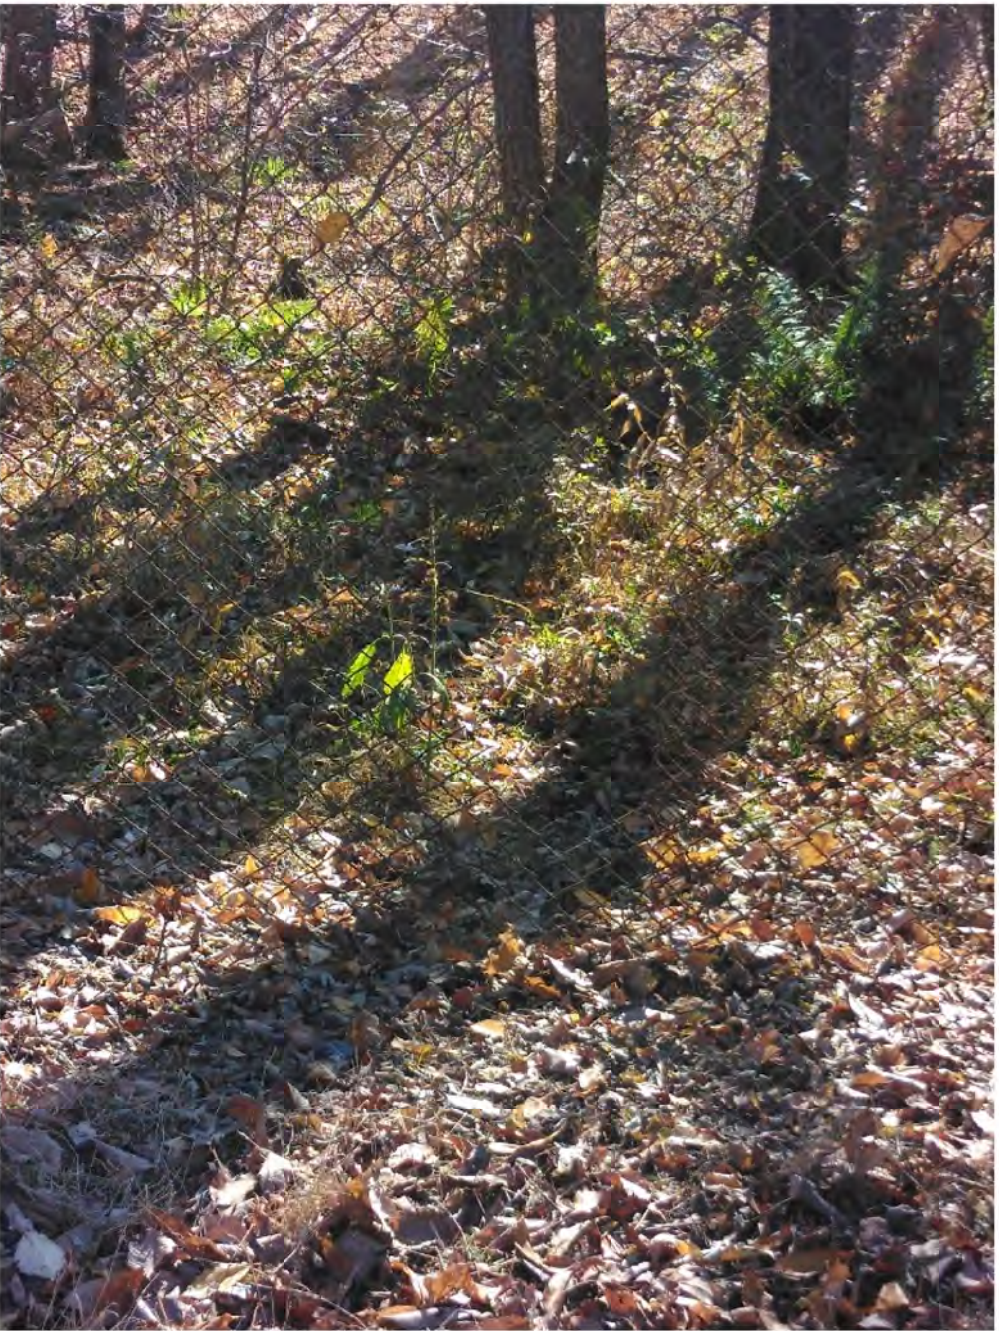
# DETAIL SHEET FOR SW77

Poacher Hole at Mile 3.20

Discovered November 10, 2020

Repaired. New fencing, posts and post foundations were installed between December 2020 and January 2021 between mile markers 0.9 and 5.0. Photo not available.

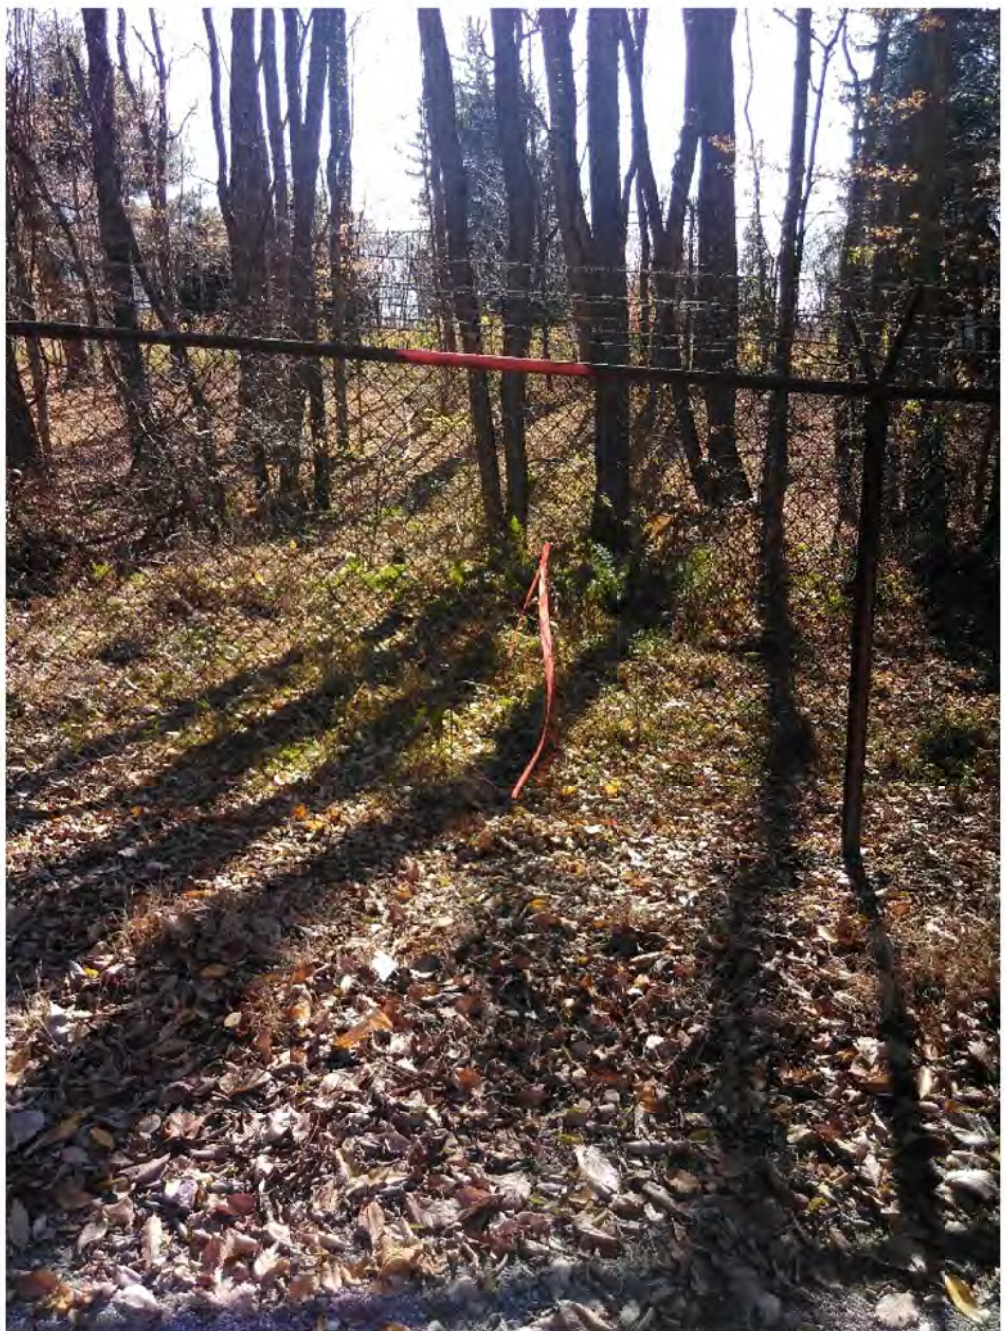
# DETAIL SHEET FOR SW78

Poacher Hole at Mile 3.20

Discovered November 10, 2020

Repaired. New fencing, posts and post foundations were installed between December 2020 and January 2021 between mile markers 0.9 and 5.0.  
Photo not available.

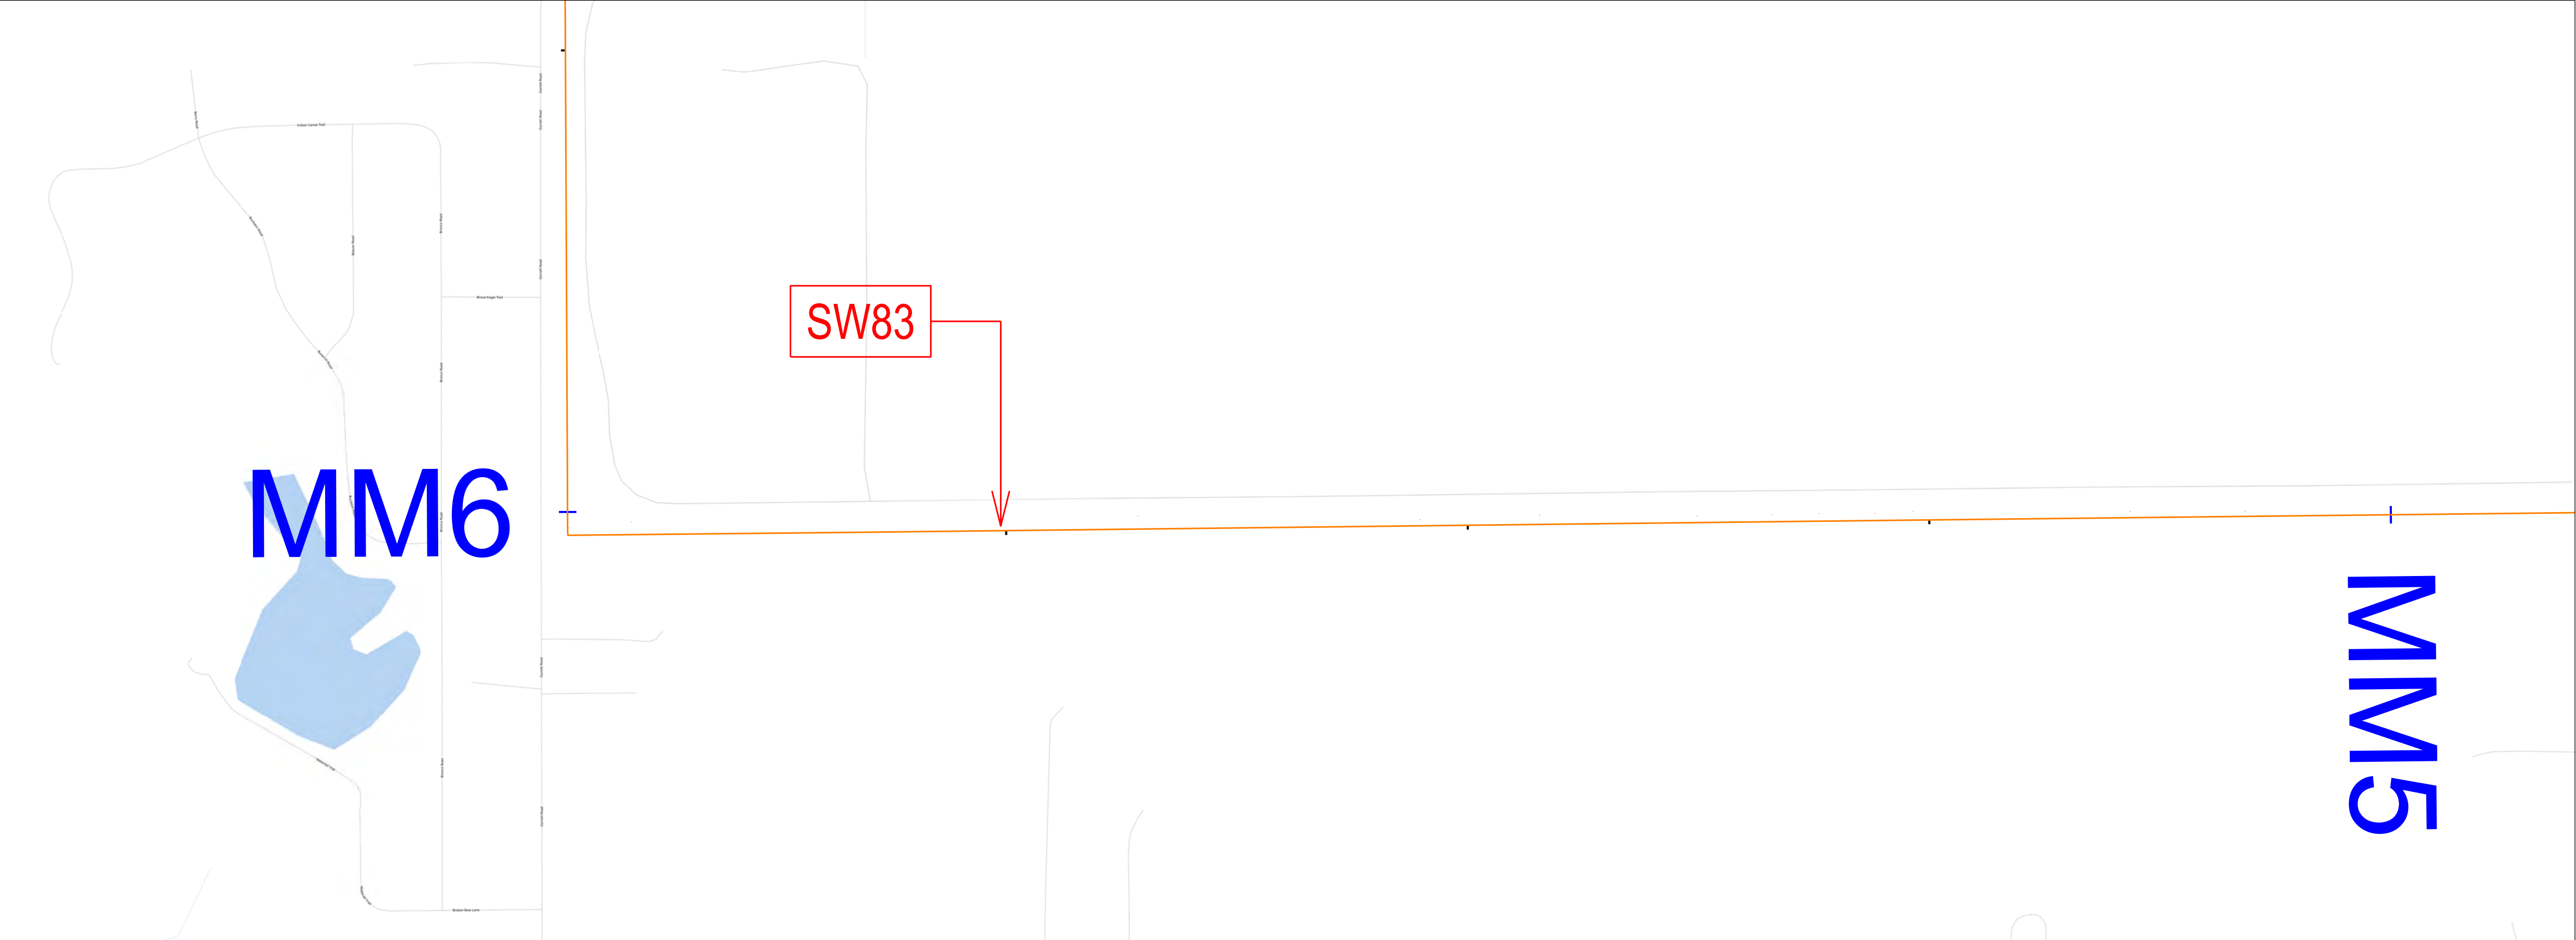
# DETAIL SHEET FOR SW83

Fence Damage / Pocaher Hole at Mile 5.75

Discovered November 10, 2020

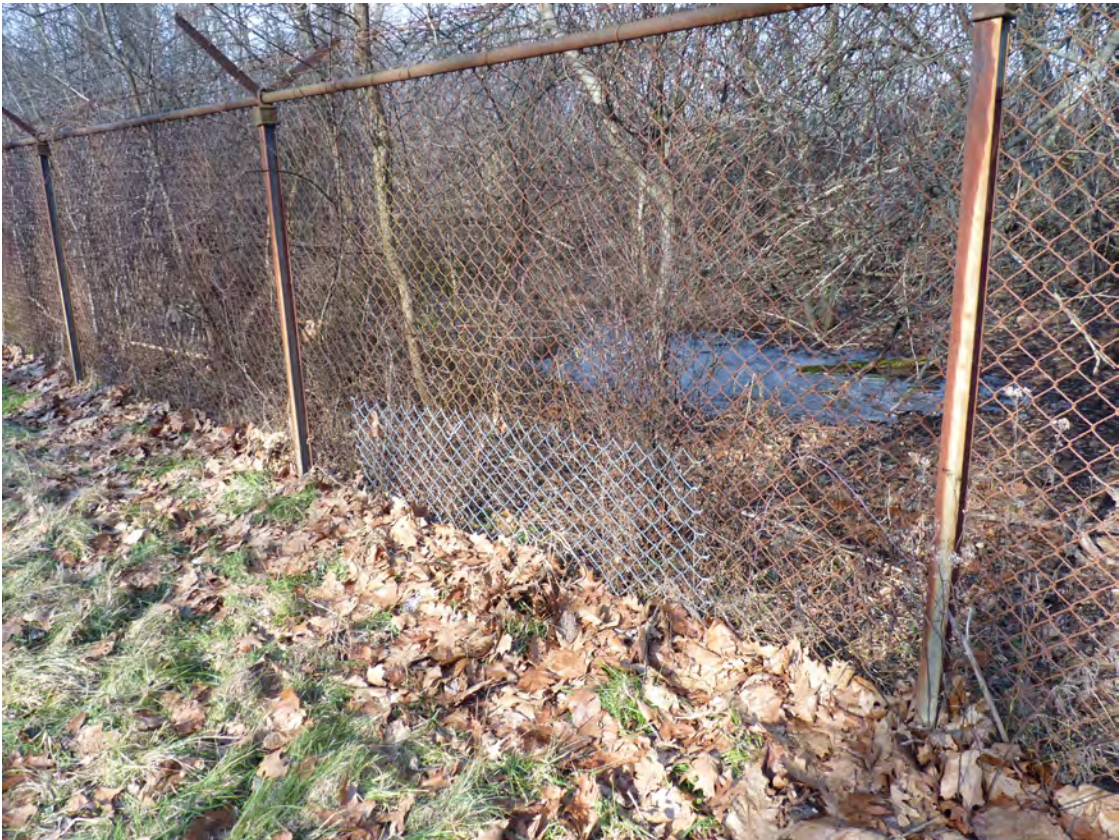
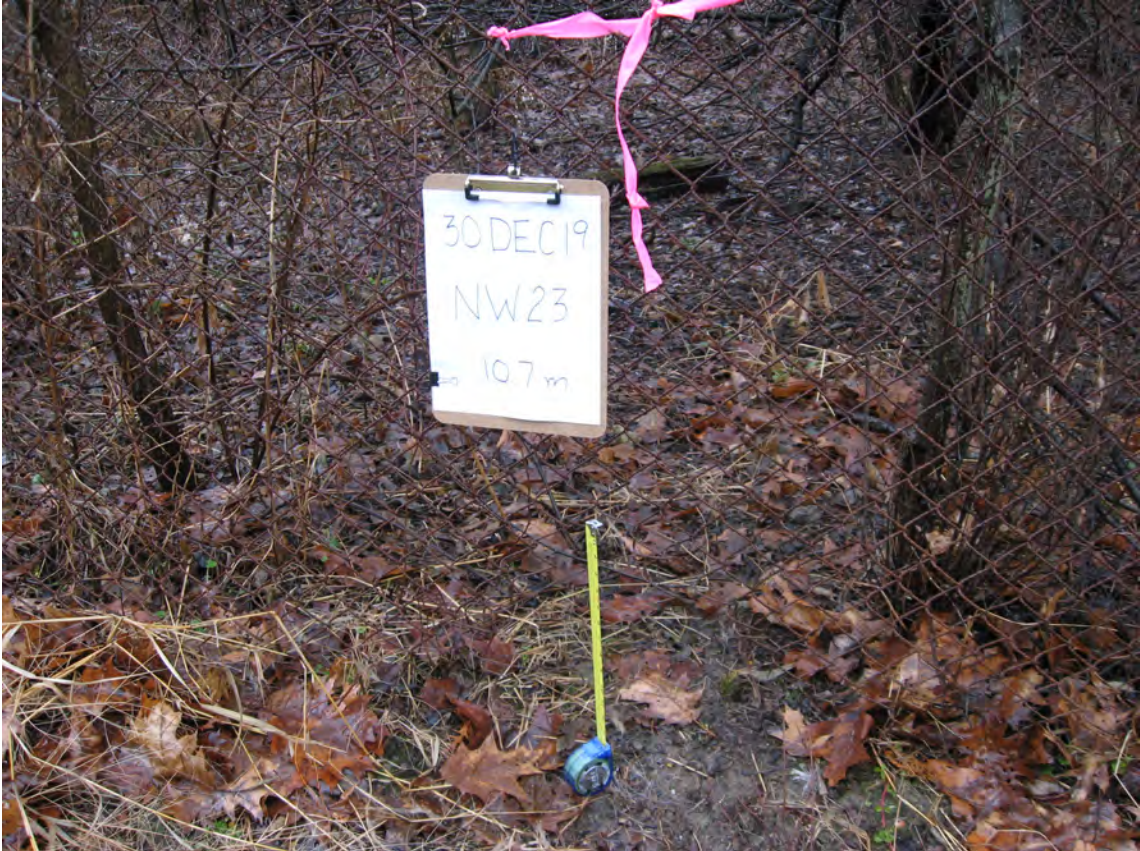
DETAIL SHEET FOR NW23

REPAIRED; STATUS PHOTO on 1-14-2021

PHOTO NW23 discovered 12/30/2019

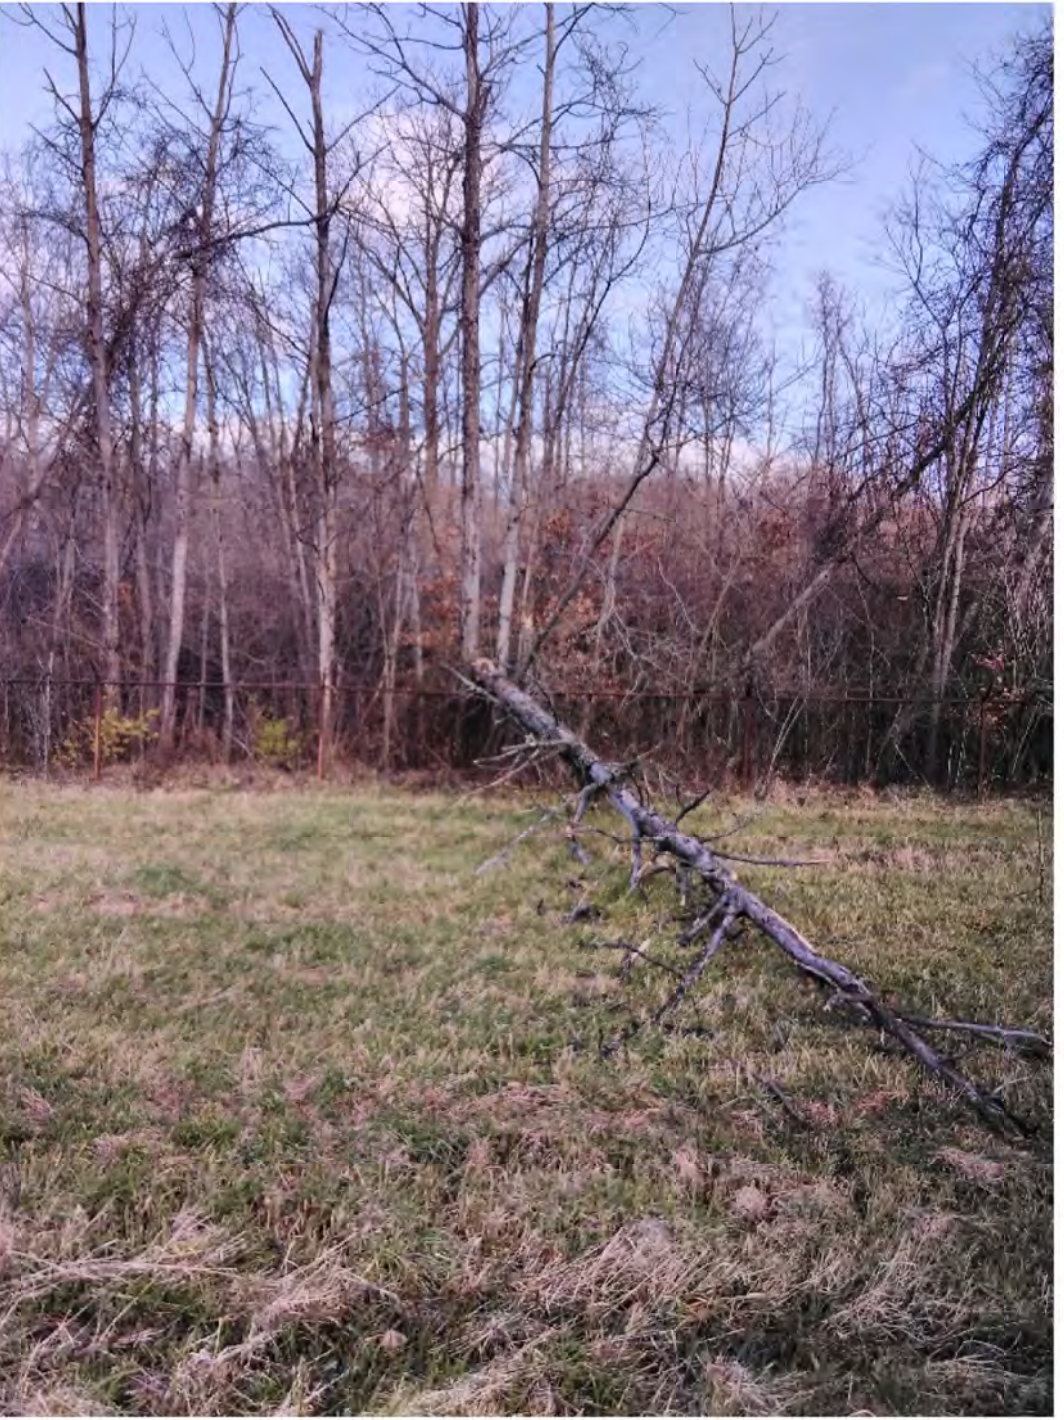
DETAIL SHEET FOR NW24

Tree on Fence at Mile 8.58

Discovered November 16, 2020

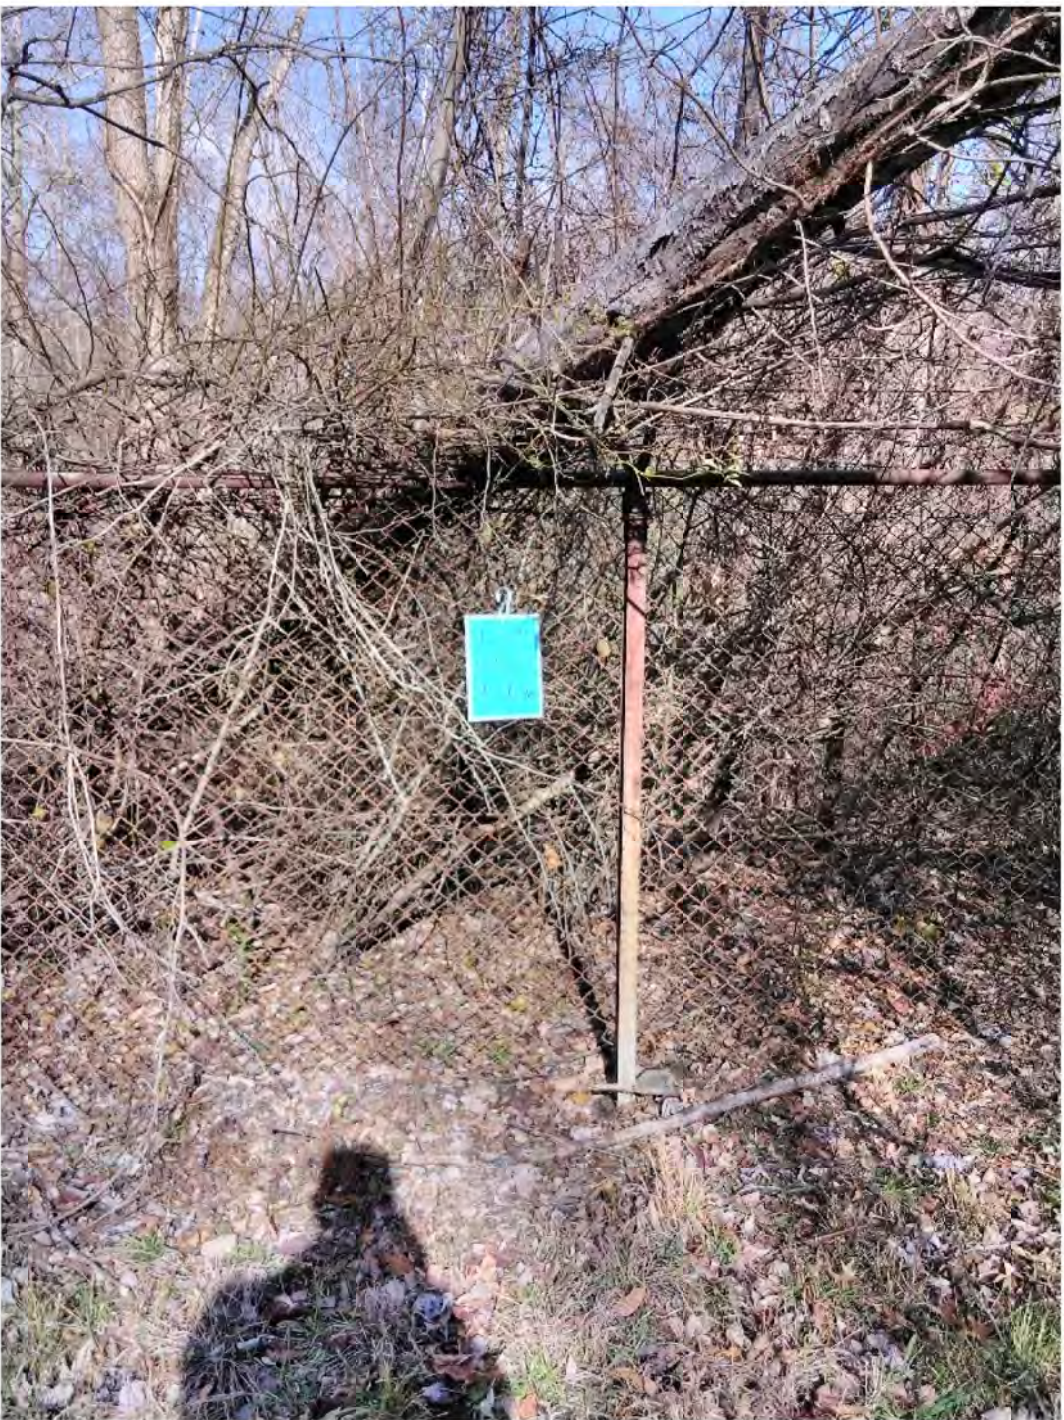
DETAIL SHEET FOR NW25

Tree on Fence at Mile 8.96

Discovered November 16, 2020
