**Final**  
**2020 Annual Land Use Control Monitoring Report,**  
**RVAAP-01 Ramsdell Quarry Landfill,**  
**RVAAP-05 Winklepeck Burning Grounds,**  
**RVAAP-08 through RVAAP-11 (Load Lines 1 through 4),**  
**RVAAP-12 (Load Line 12) and RVAAP-51 (Dump Along Paris-Windham**  
**Road)**

**Camp James A. Garfield Joint Military Training Center**  
**Former Ravenna Army Ammunition Plant**  
**Portage and Trumbull Counties, Ohio**

**May 24, 2021**

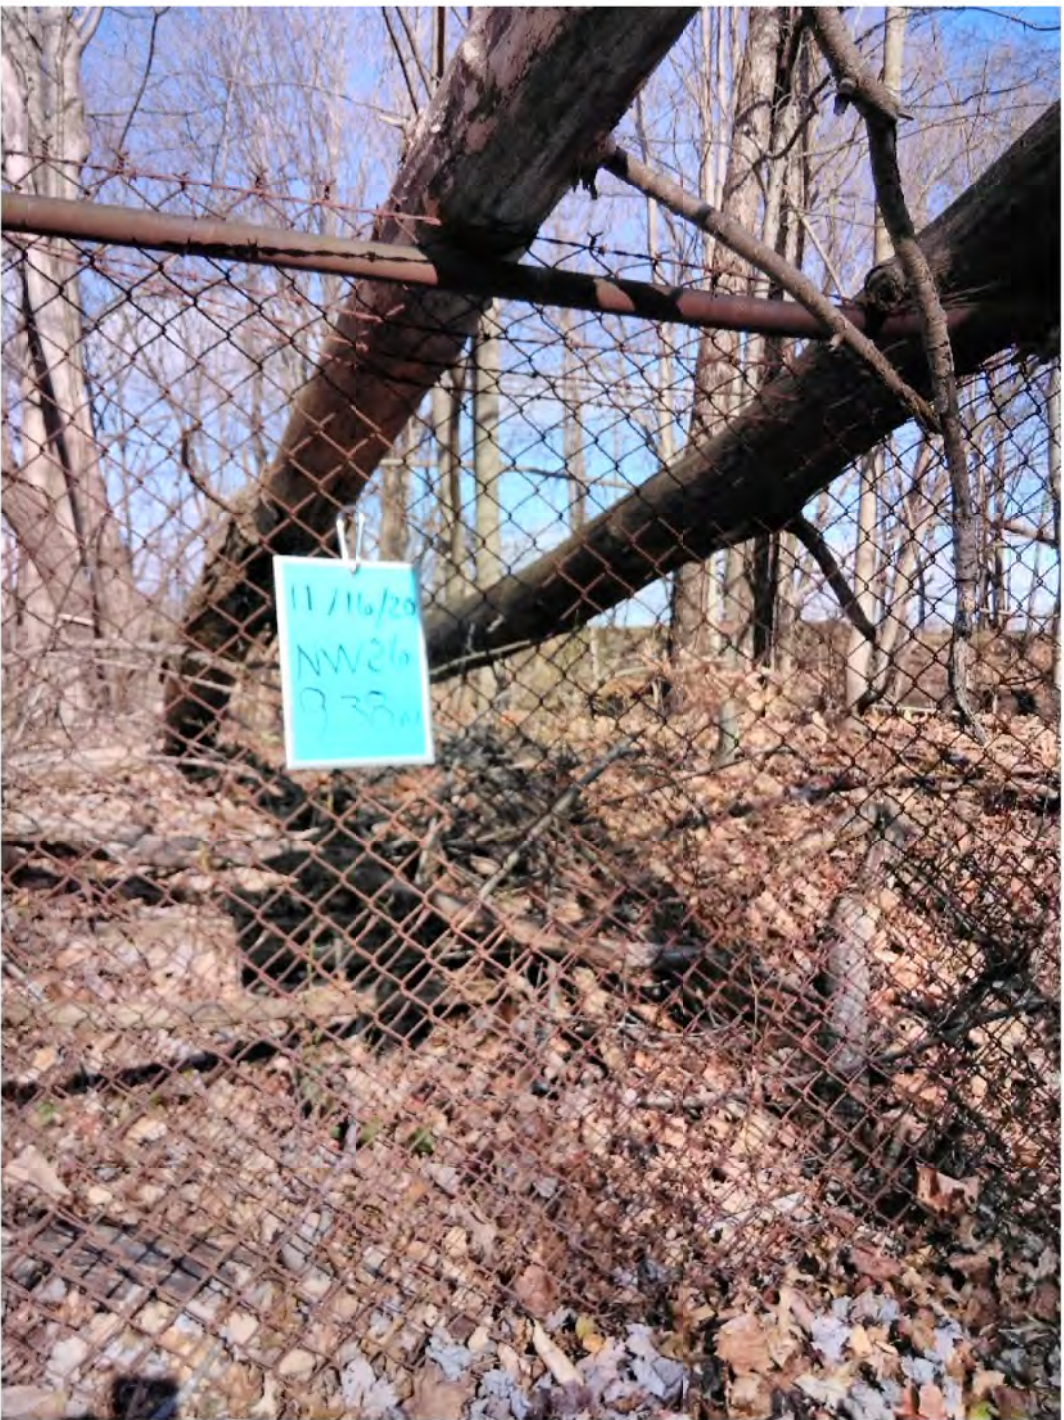
DETAIL SHEET FOR NW26

Tree on Fence at Mile 9.37

Discovered November 16, 2020

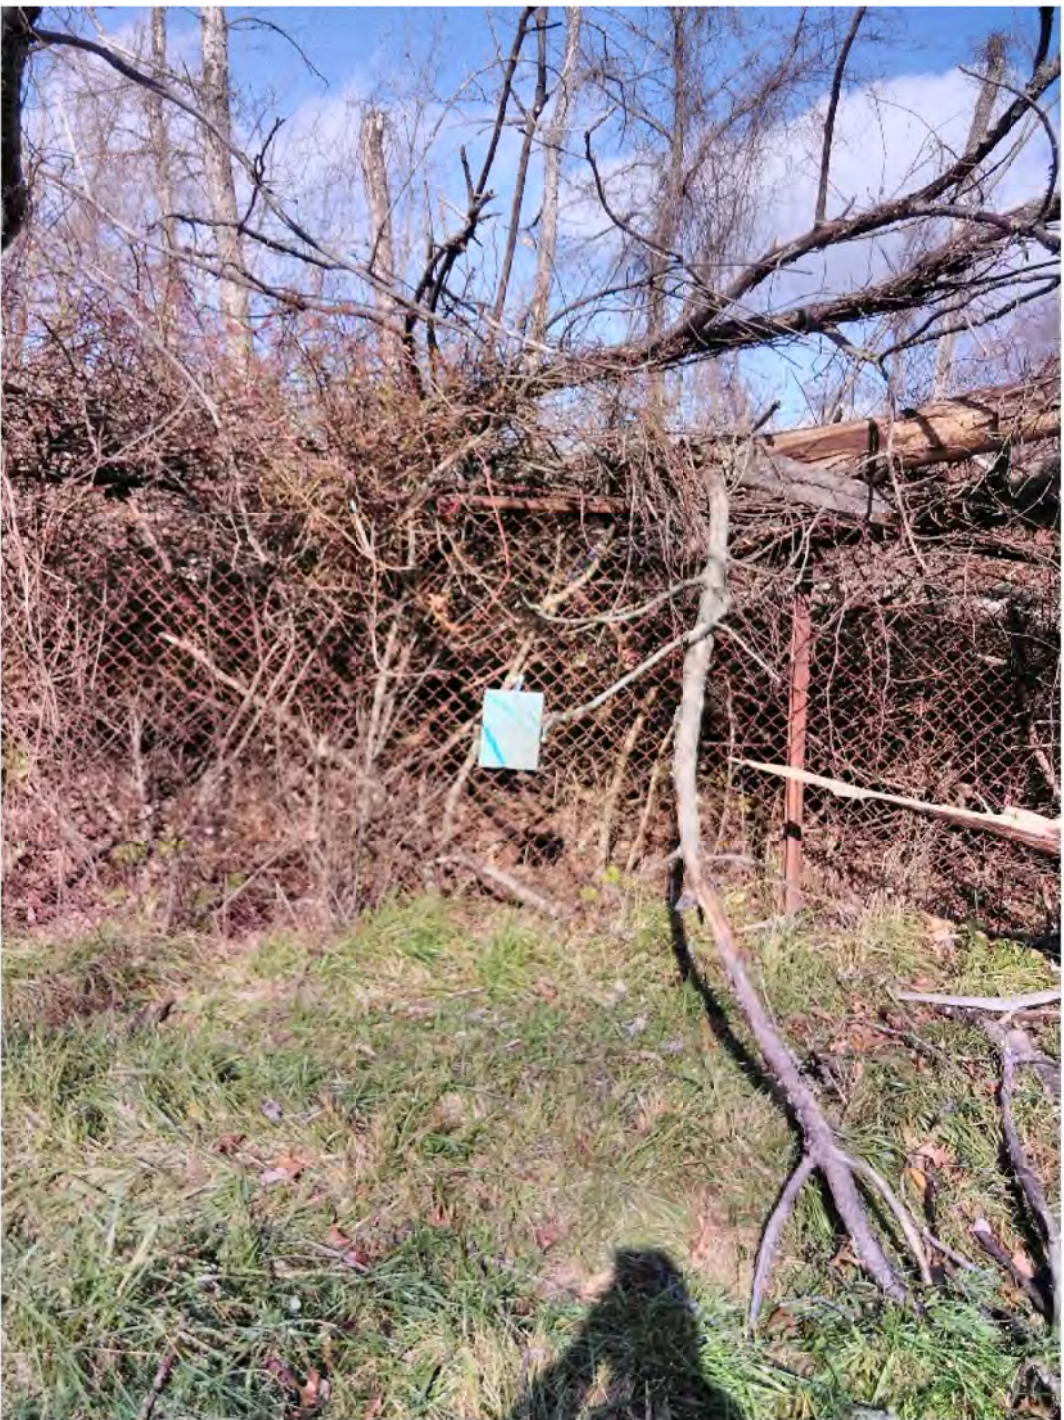
DETAIL SHEET FOR NW27

Tree on Fence at Mile 9.62

Discovered November 16, 2020

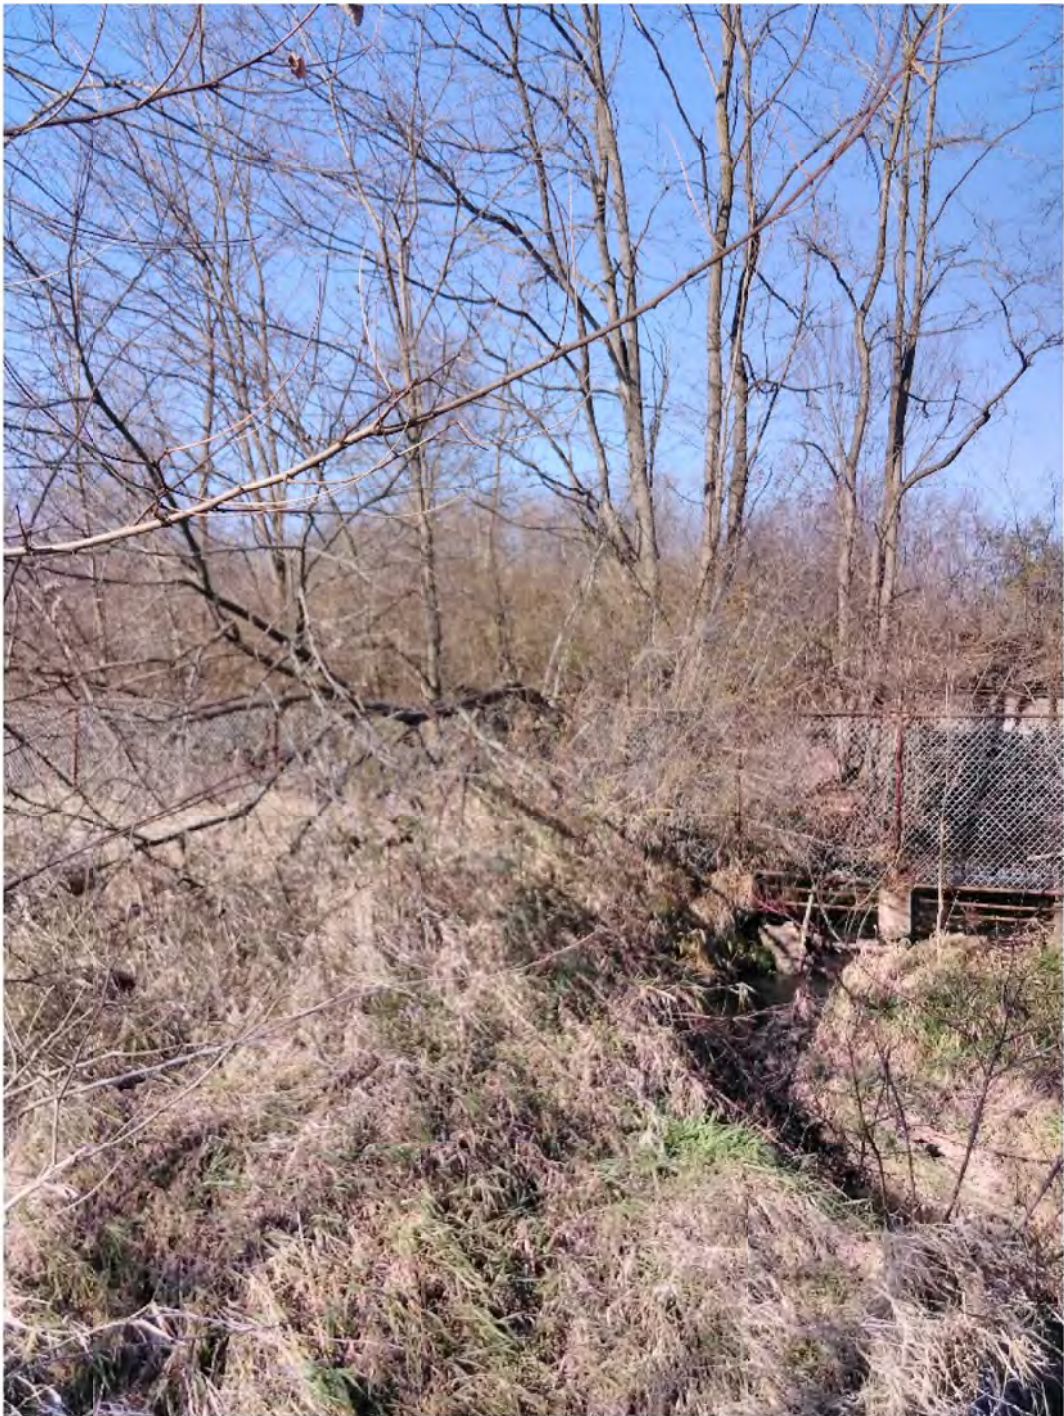
DETAIL SHEET FOR NW28

Tree on Fence at Mile 11.45

Discovered November 16, 2020

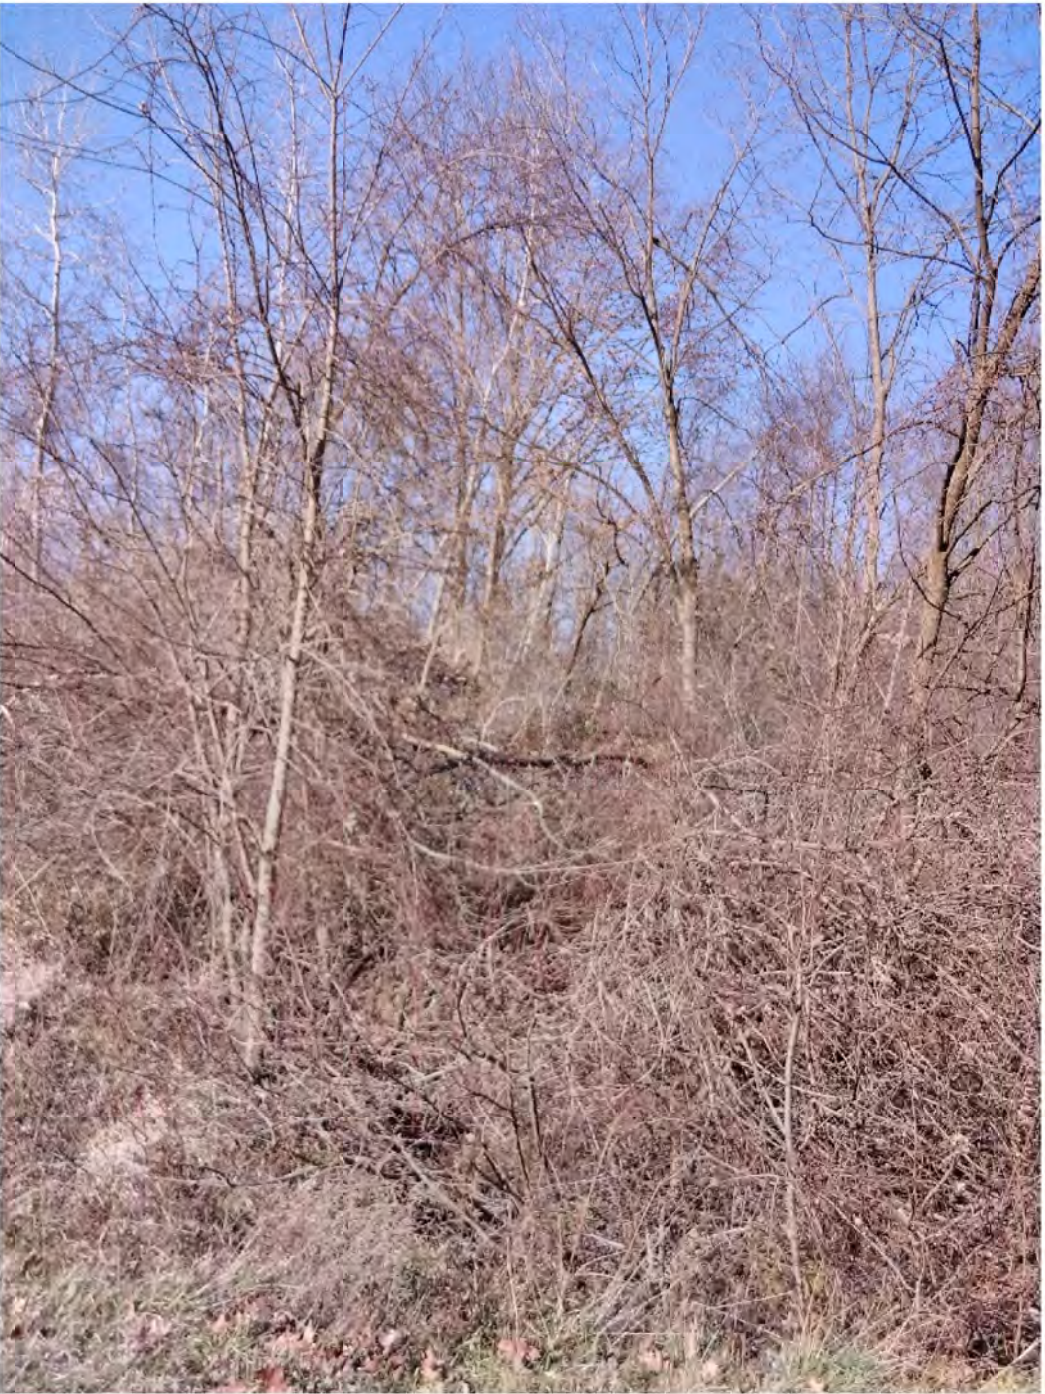
DETAIL SHEET FOR NW29

Tree on Fence at Mile 13.25

Discovered November 16, 2020

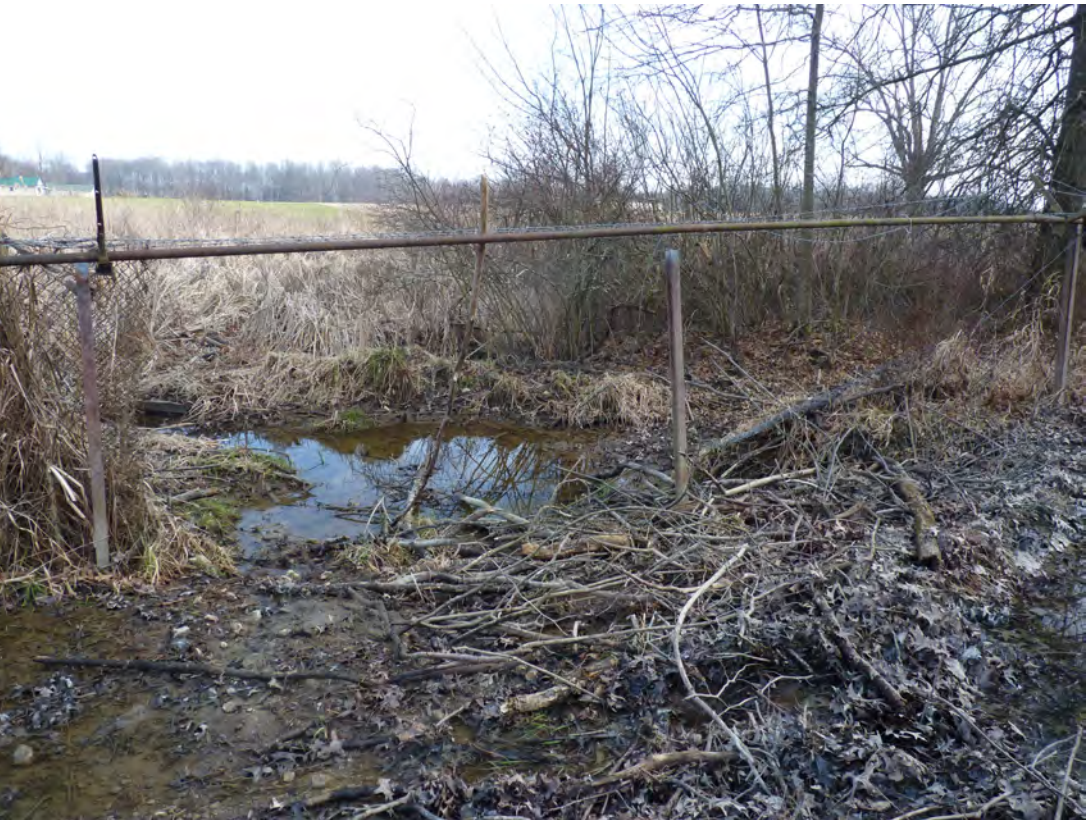
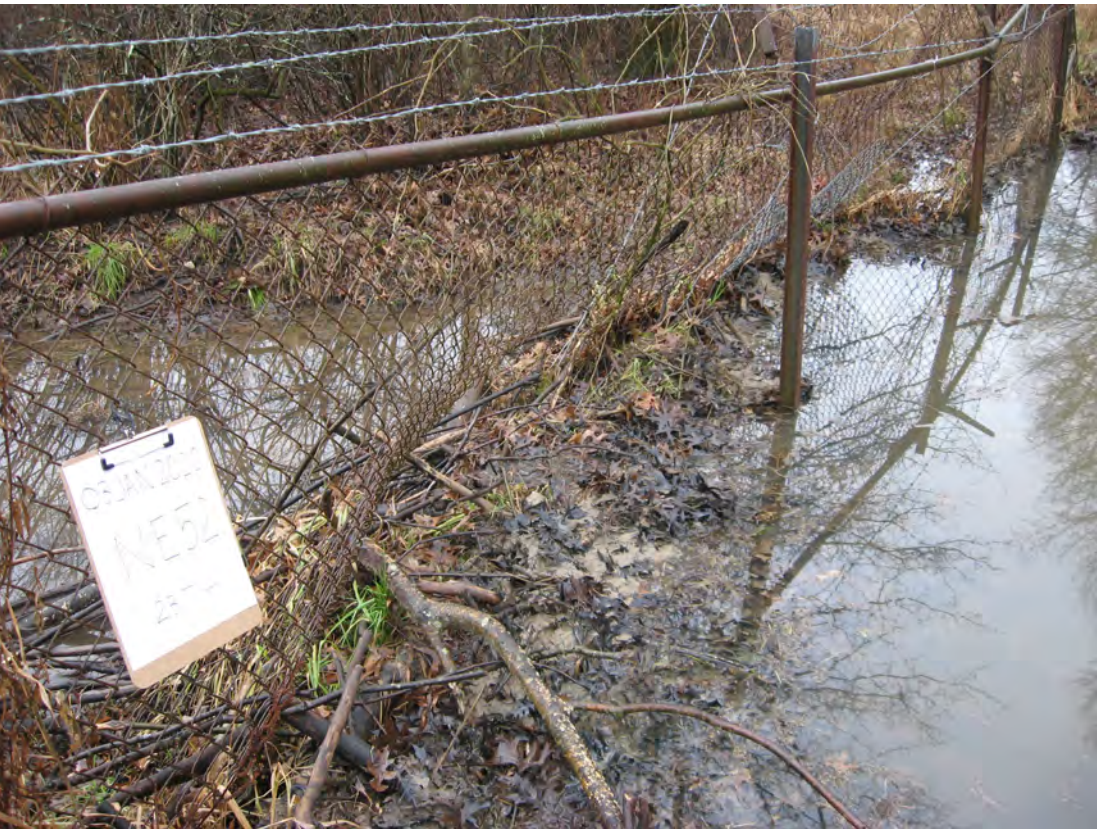
DETAIL SHEET FOR NE52

UPDATE PHOTO on 1/14/2021

PHOTO NE52 discovered 1/03/2020

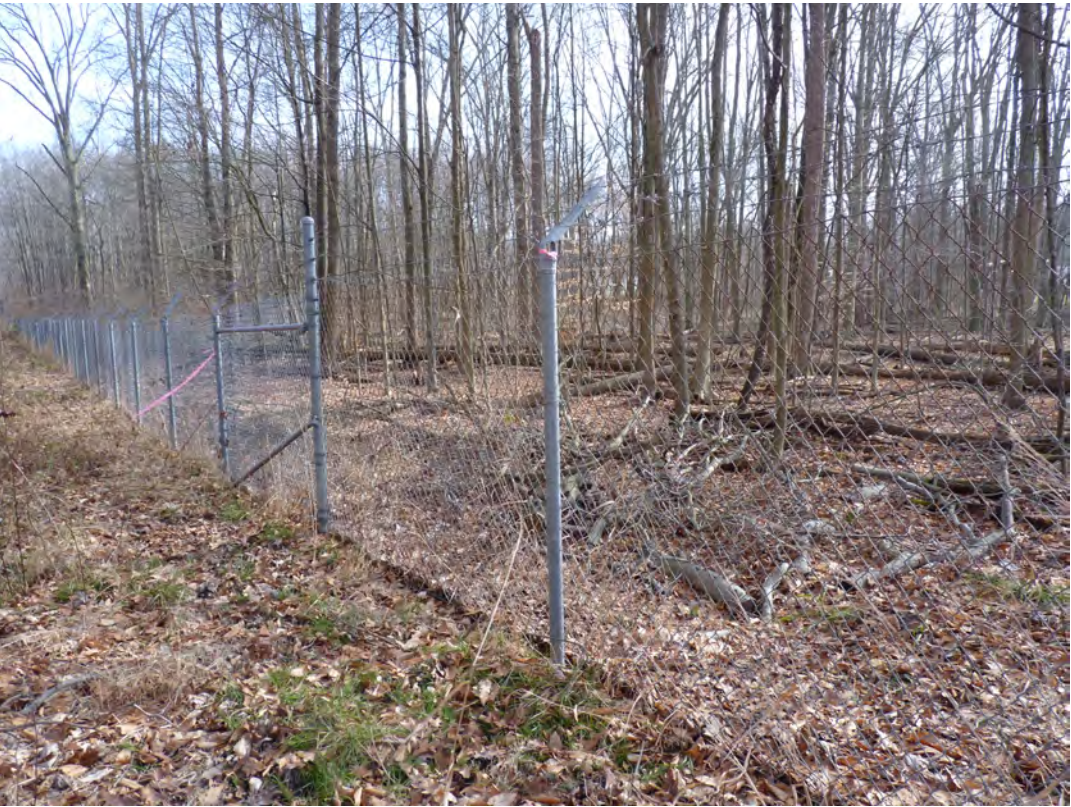
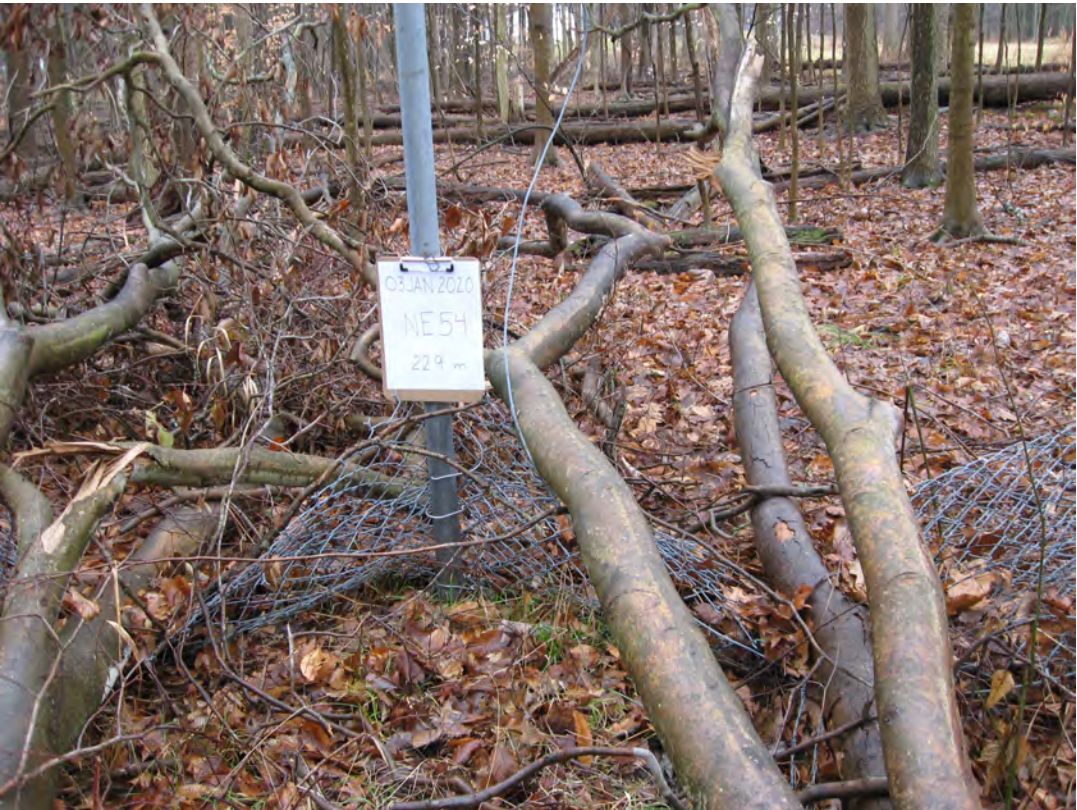
DETAIL SHEET FOR NE54

REPAIRED: STATUS PHOTO on 1/14/2021

PHOTO NE54 discovered 1/03/2020

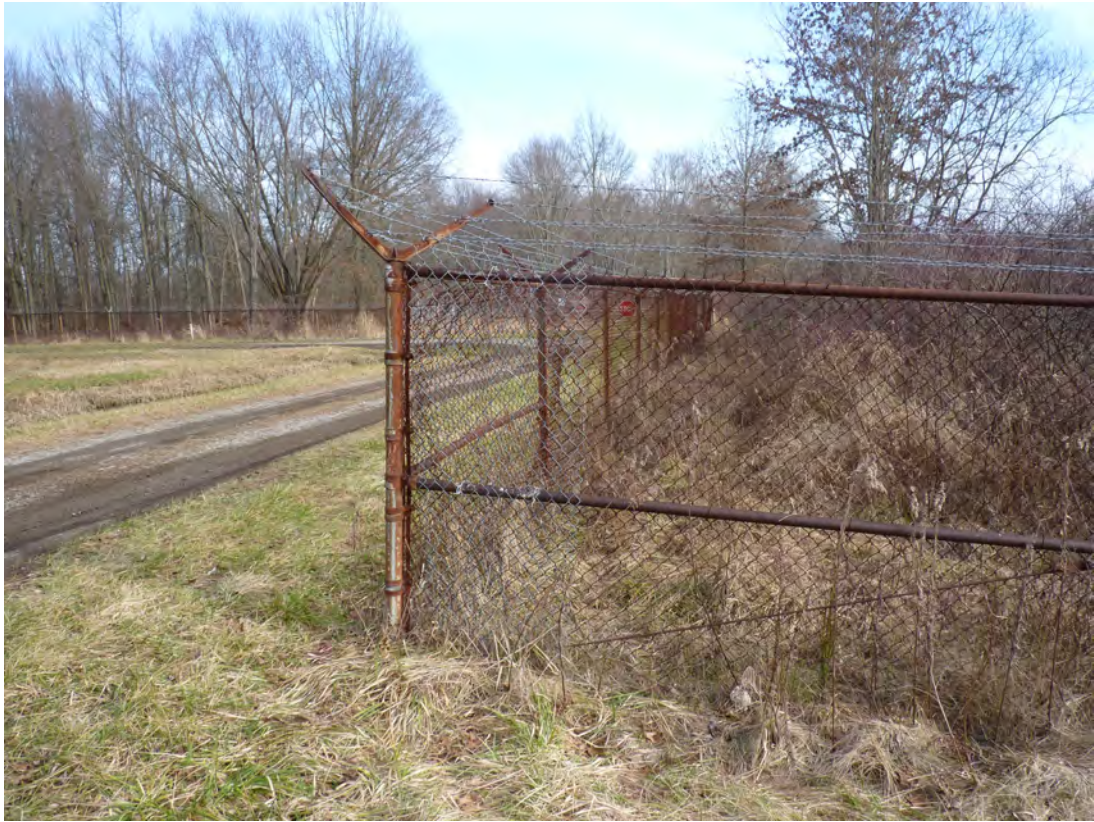
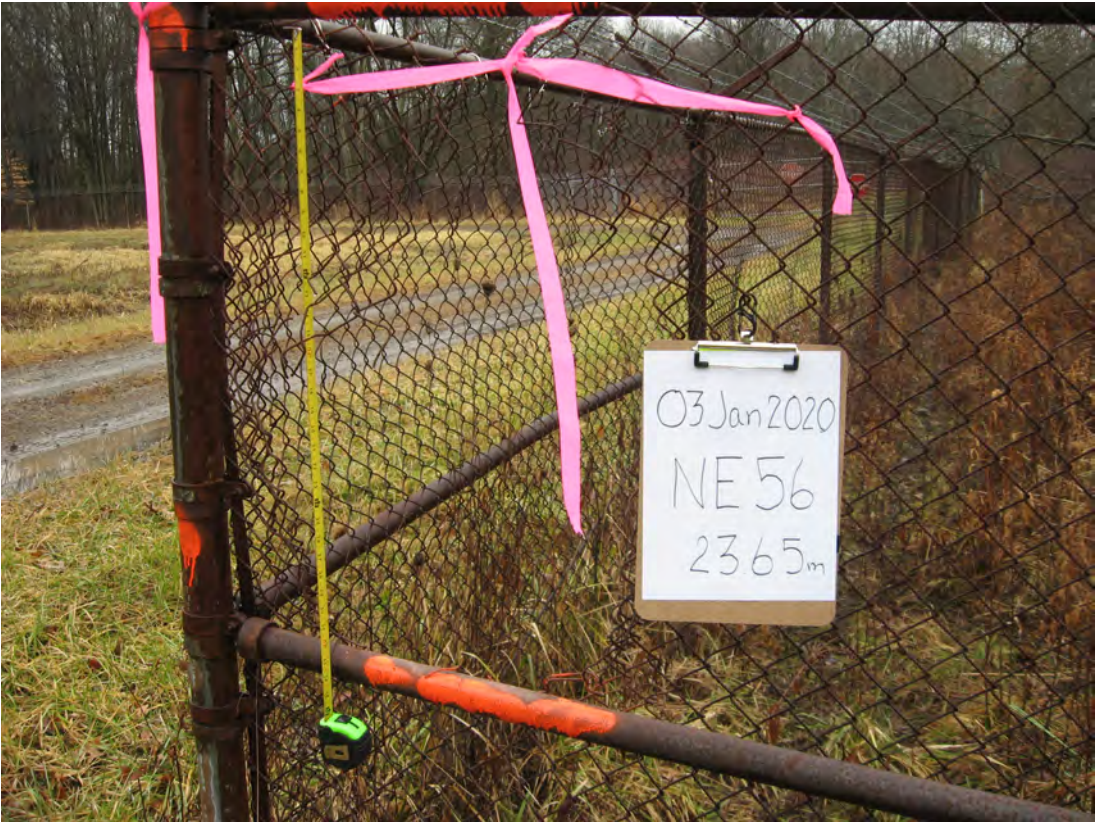
DETAIL SHEET FOR NE56

REPAIRED: STATUS PHOTO on 1-14-2021

PHOTO NE56 discovered 1/03/2020

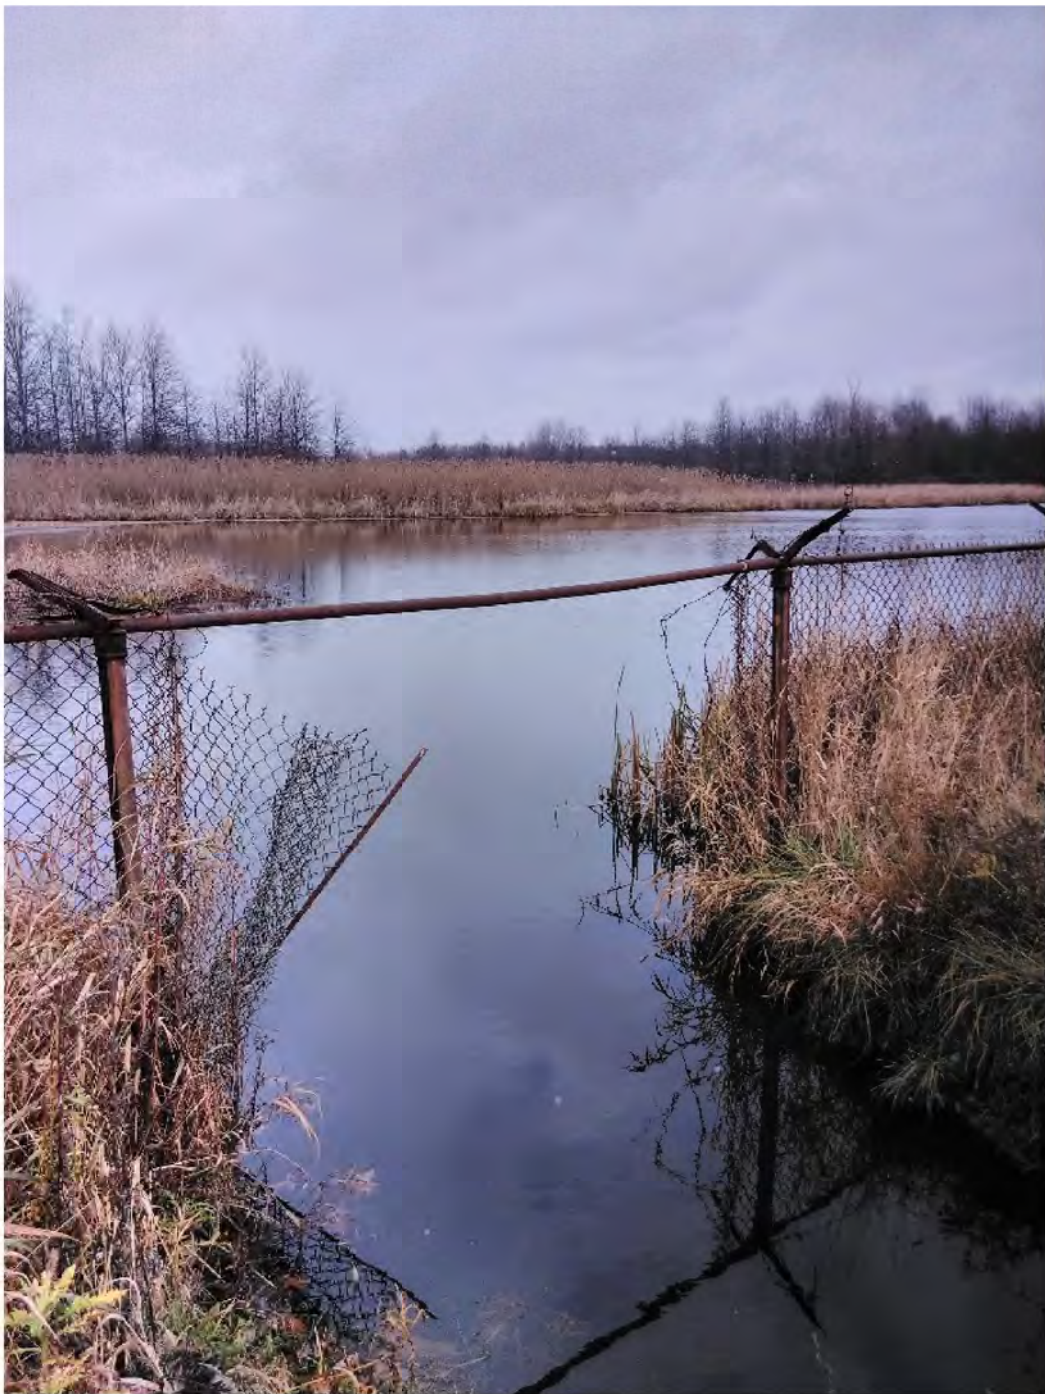
DETAIL SHEET FOR NE57

Fence down / culvert breached at Mile 18.78

Discovered November 17, 2020

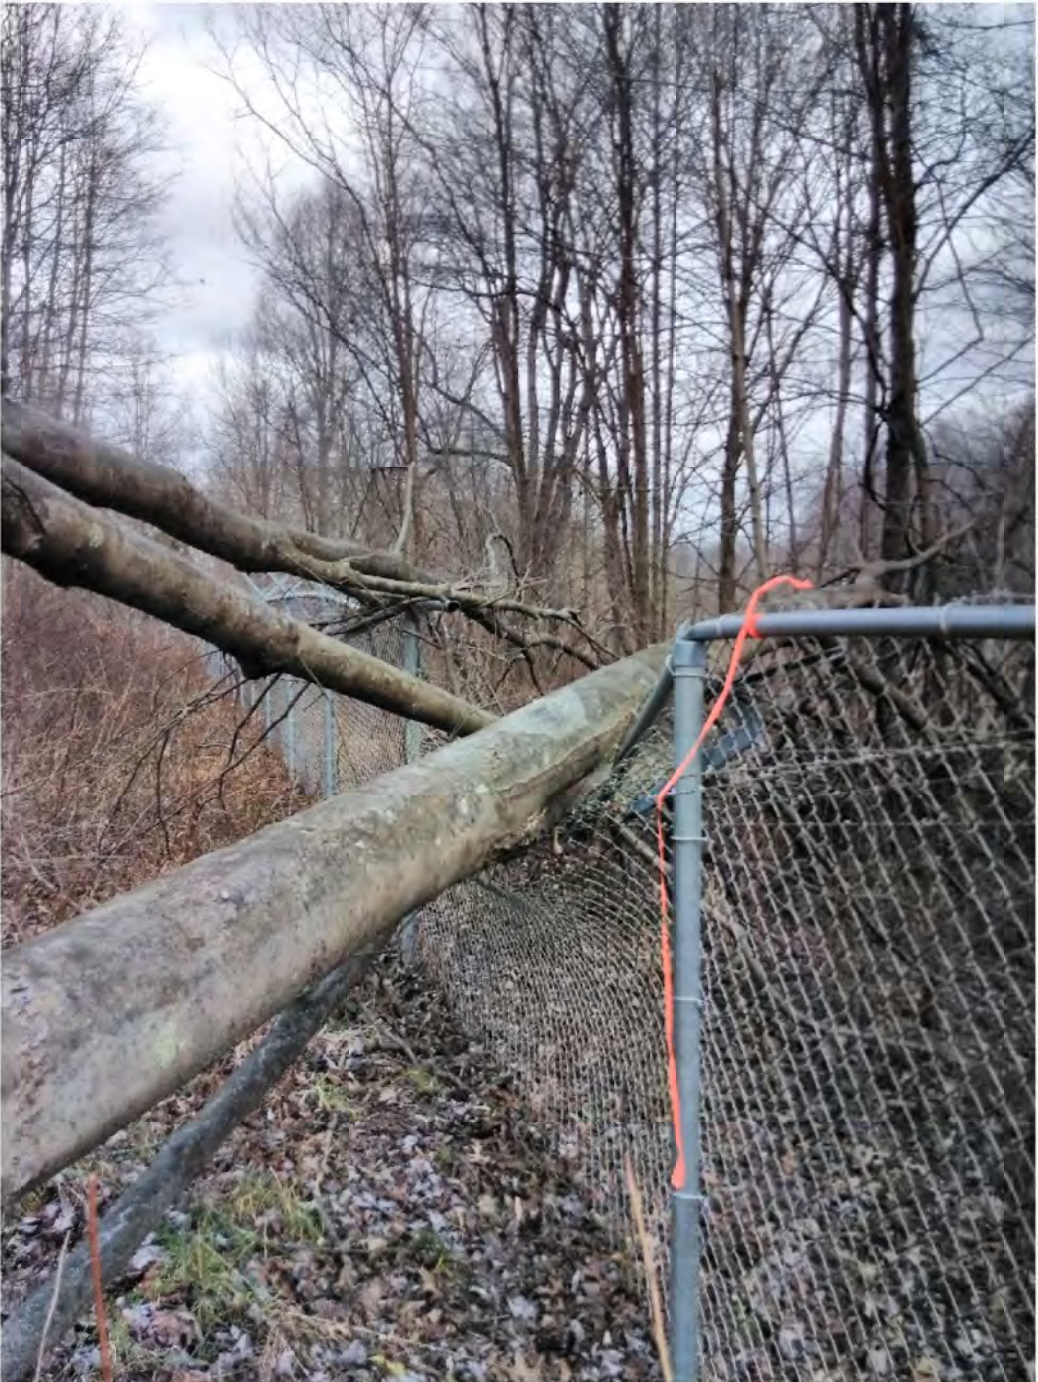
# DETAIL SHEET FOR NE60

Tree on Fence at Mile 21.76

Discovered December 15, 2020

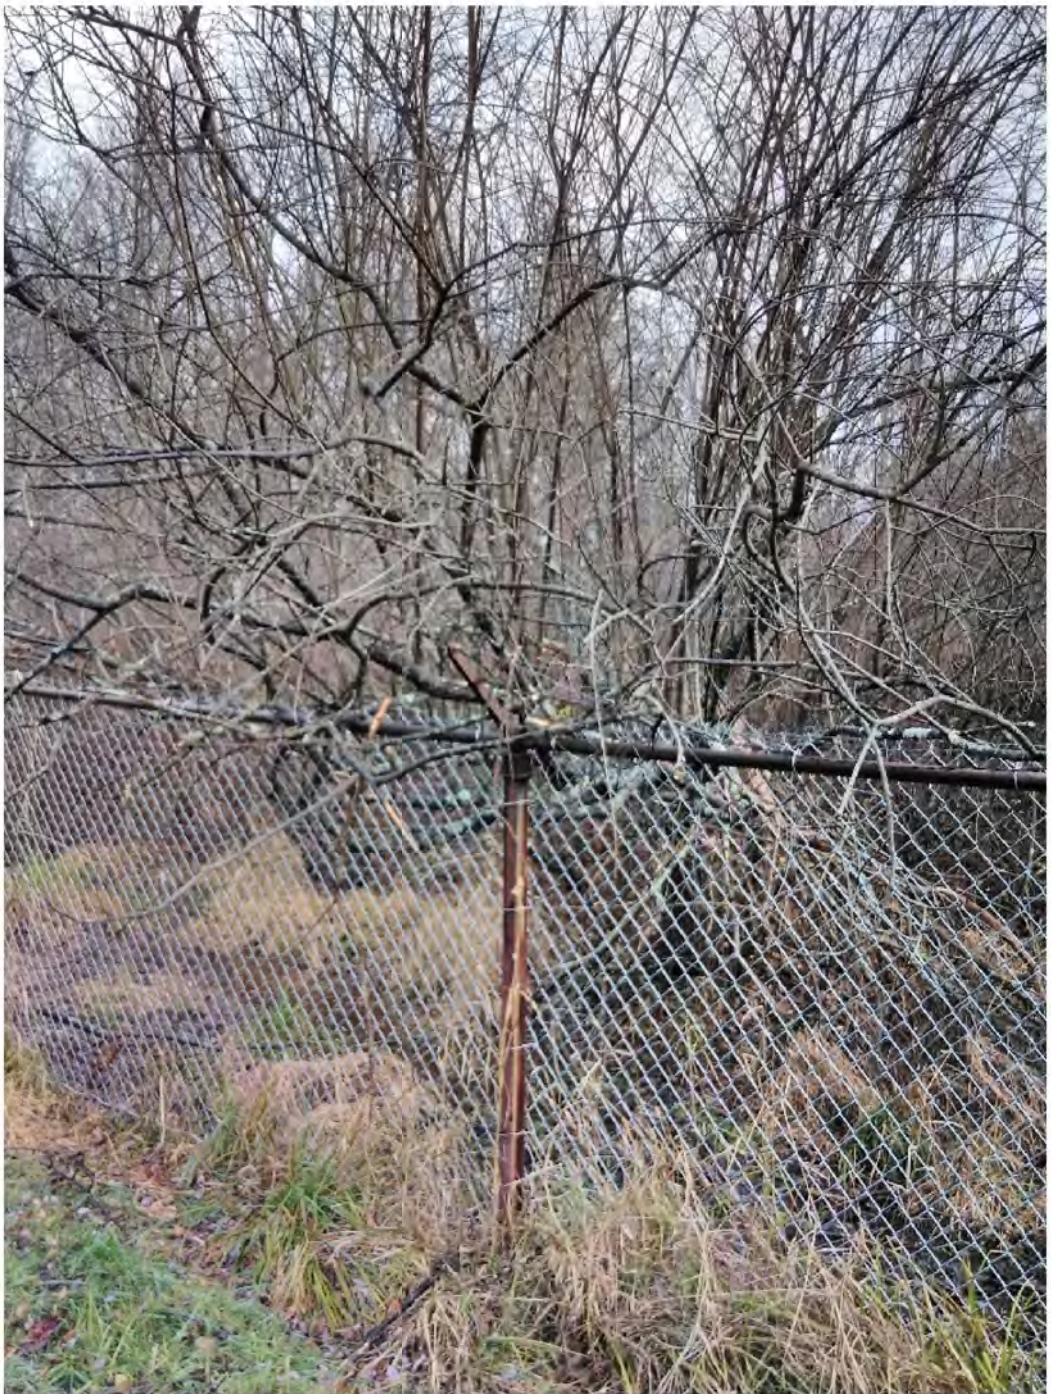
# DETAIL SHEET FOR NE62a

Tree on Fence at Mile 18.64

Discovered November 17, 2020

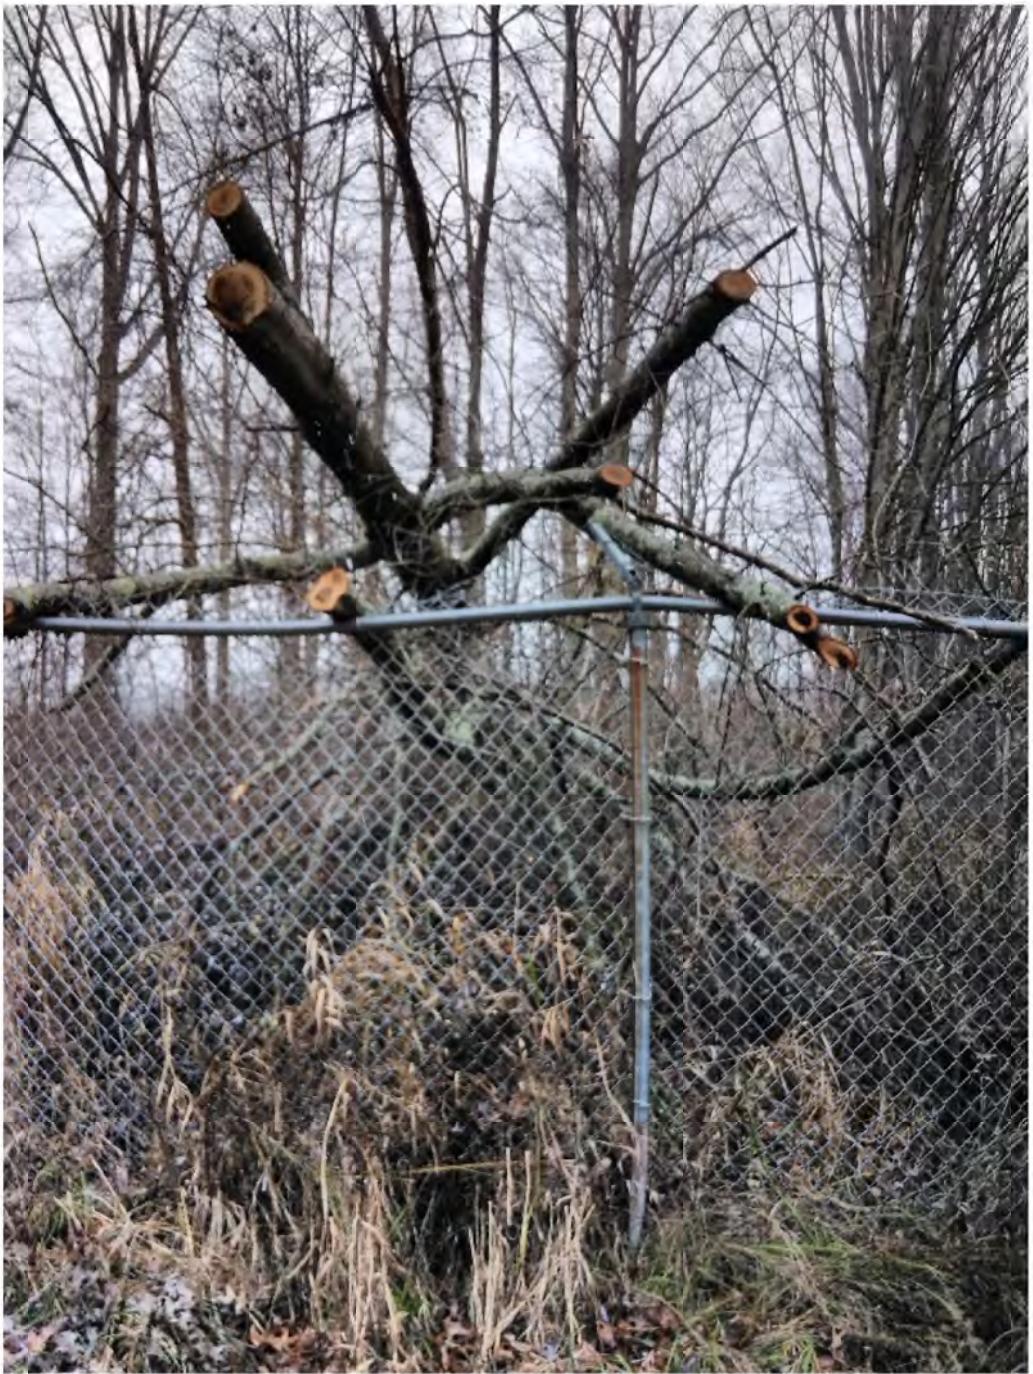
DETAIL SHEET FOR NE65

Tree on Fence at Mile 19.35

Discovered November 17, 2020

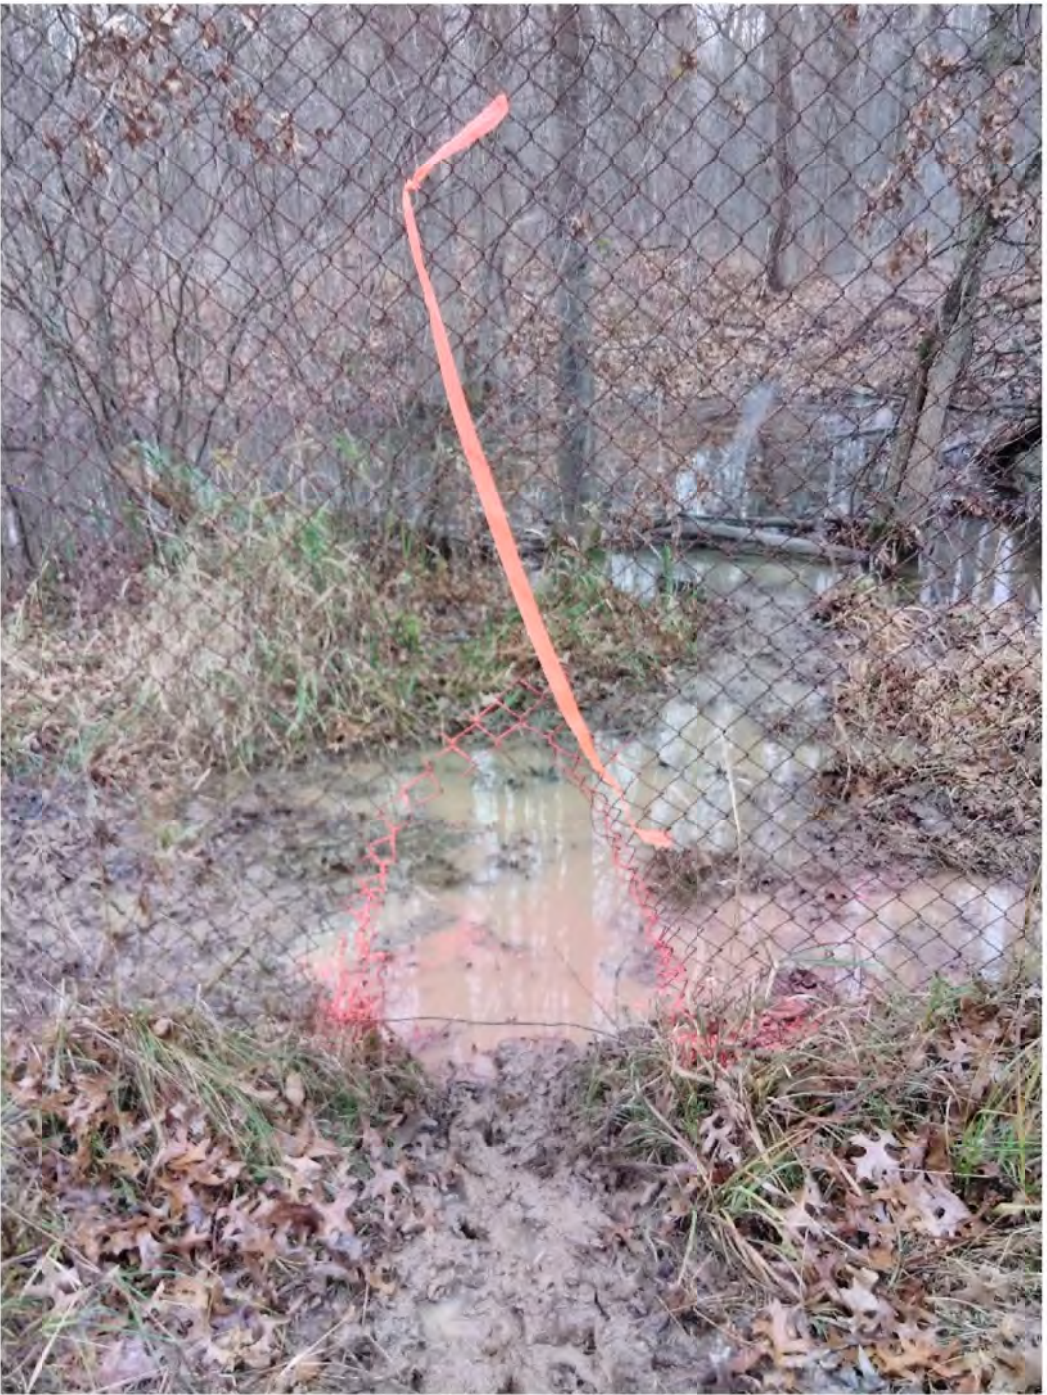
DETAIL SHEET FOR NE66

Tree on Fence at Mile 19.96

Discovered November 17, 2020

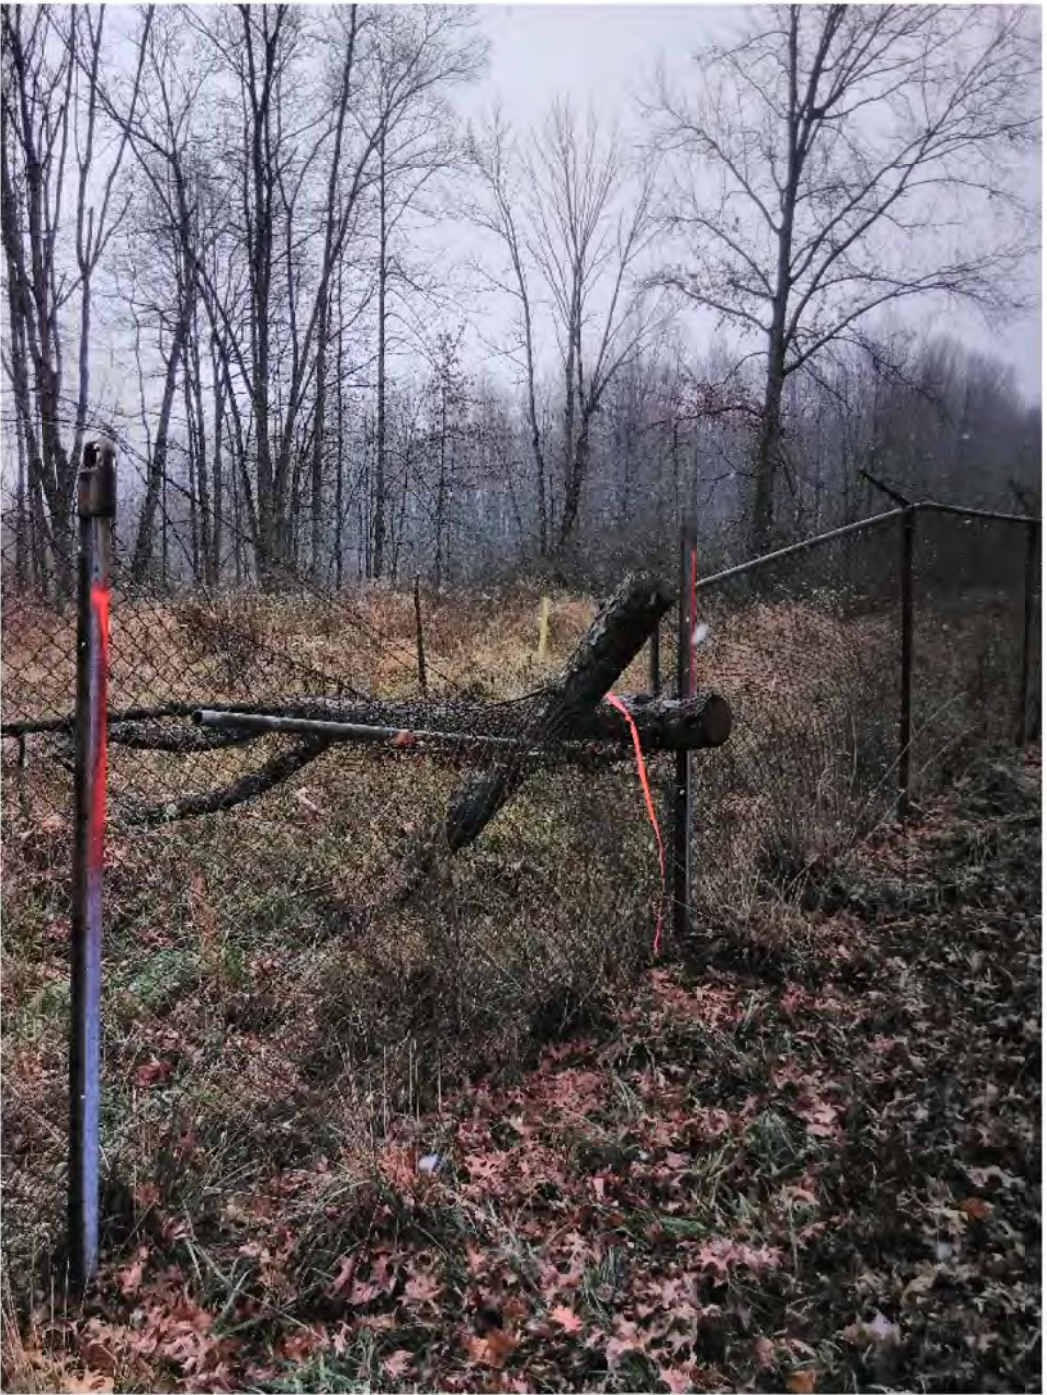
DETAIL SHEET FOR NE67

Tree on Fence at Mile 20.02

Discovered November 17, 2020

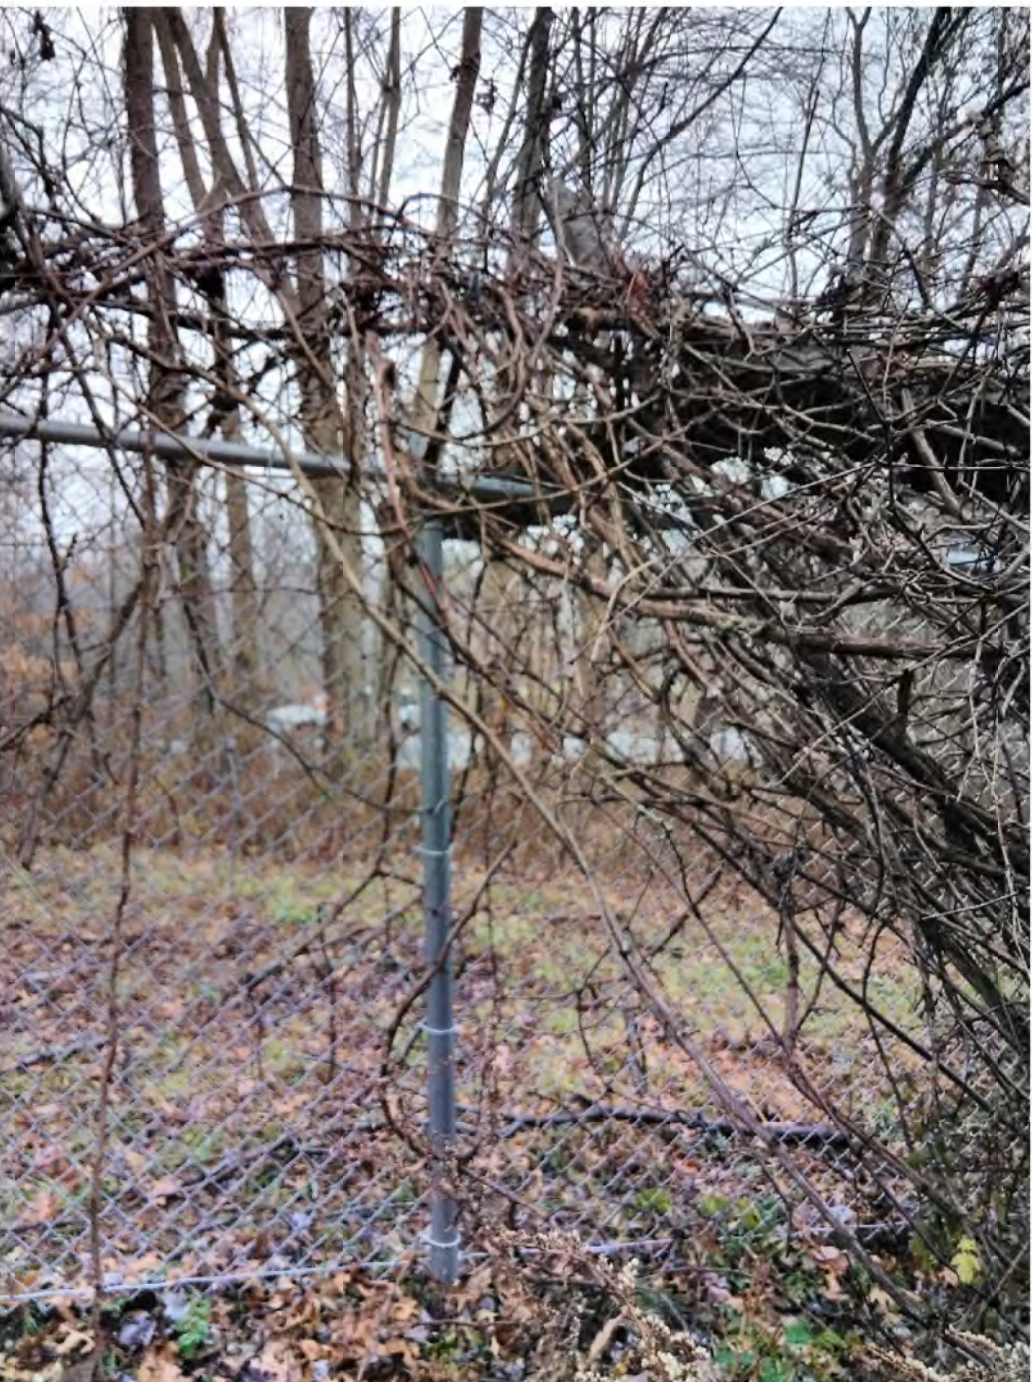
# DETAIL SHEET FOR NE68

Tree on Fence at Mile 21.50

Discovered November 17, 2020
