**Final**  
**2020 Annual Land Use Control Monitoring Report,**  
**RVAAP-01 Ramsdell Quarry Landfill,**  
**RVAAP-05 Winklepeck Burning Grounds,**  
**RVAAP-08 through RVAAP-11 (Load Lines 1 through 4),**  
**RVAAP-12 (Load Line 12) and RVAAP-51 (Dump Along Paris-Windham**  
**Road)**

**Camp James A. Garfield Joint Military Training Center**  
**Former Ravenna Army Ammunition Plant**  
**Portage and Trumbull Counties, Ohio**

**May 24, 2021**

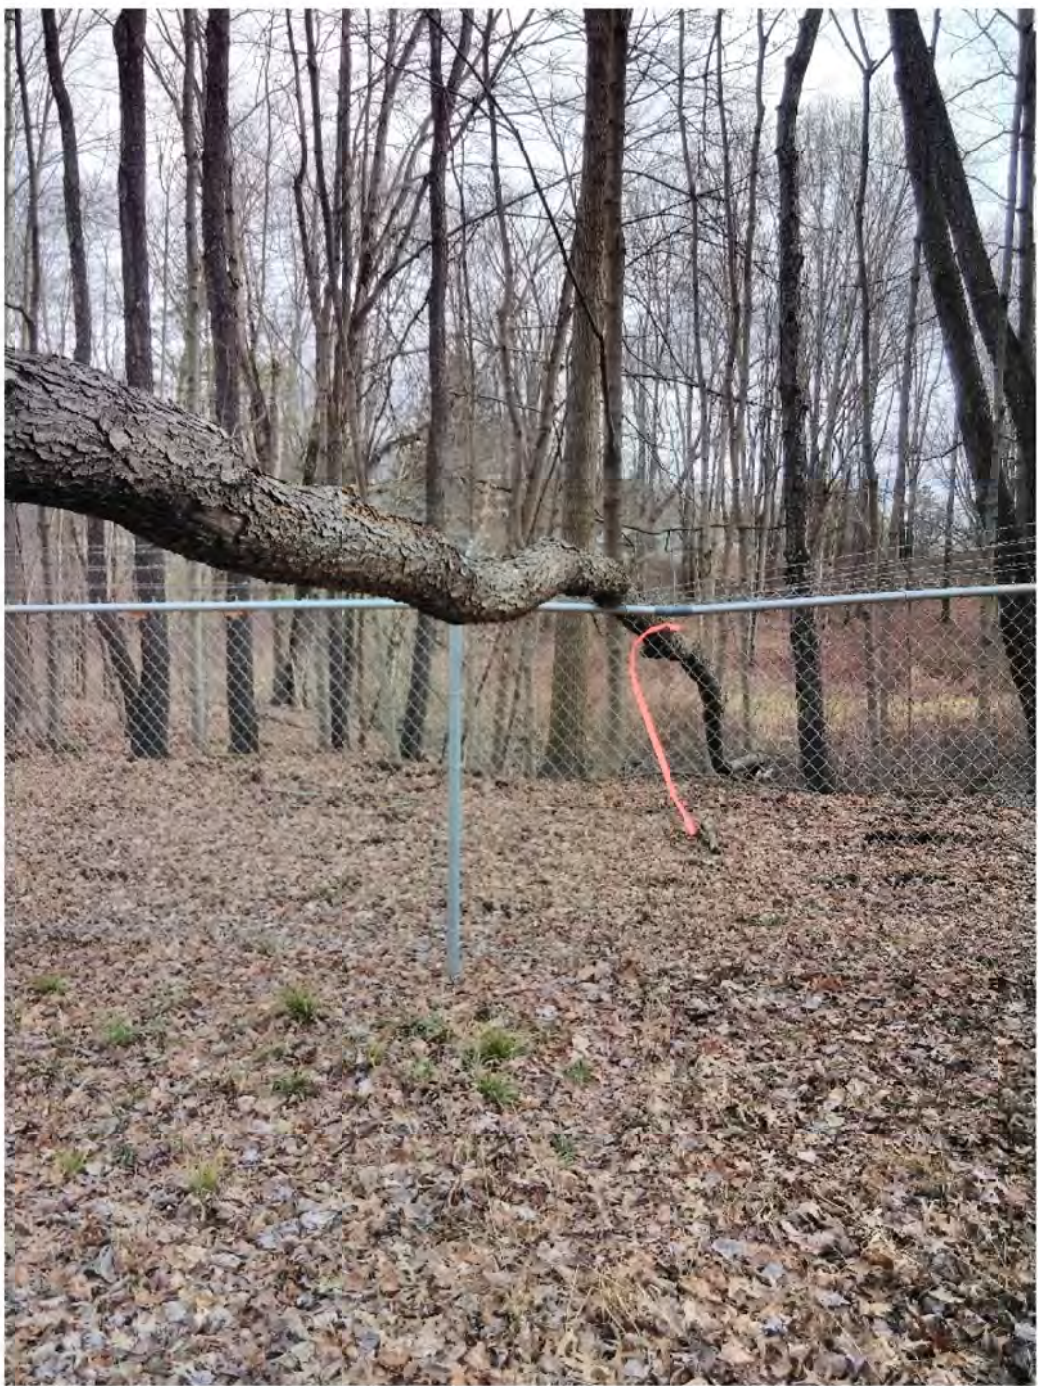
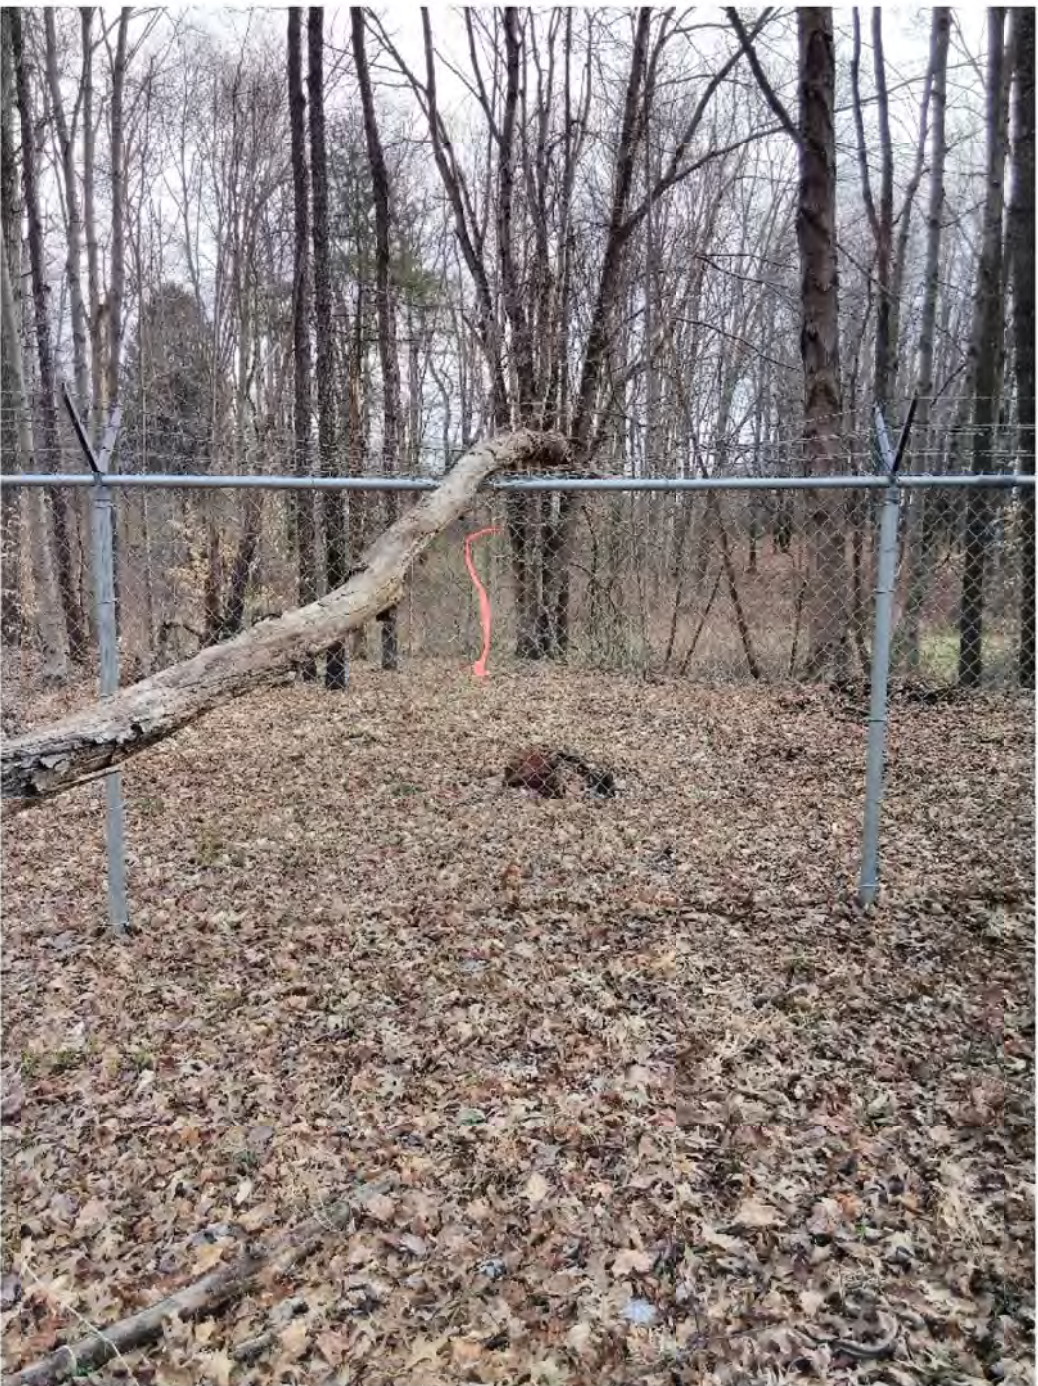
# DETAIL SHEET FOR NE69

Tree on Fence at Mile 21.82

Discovered December 15, 2020

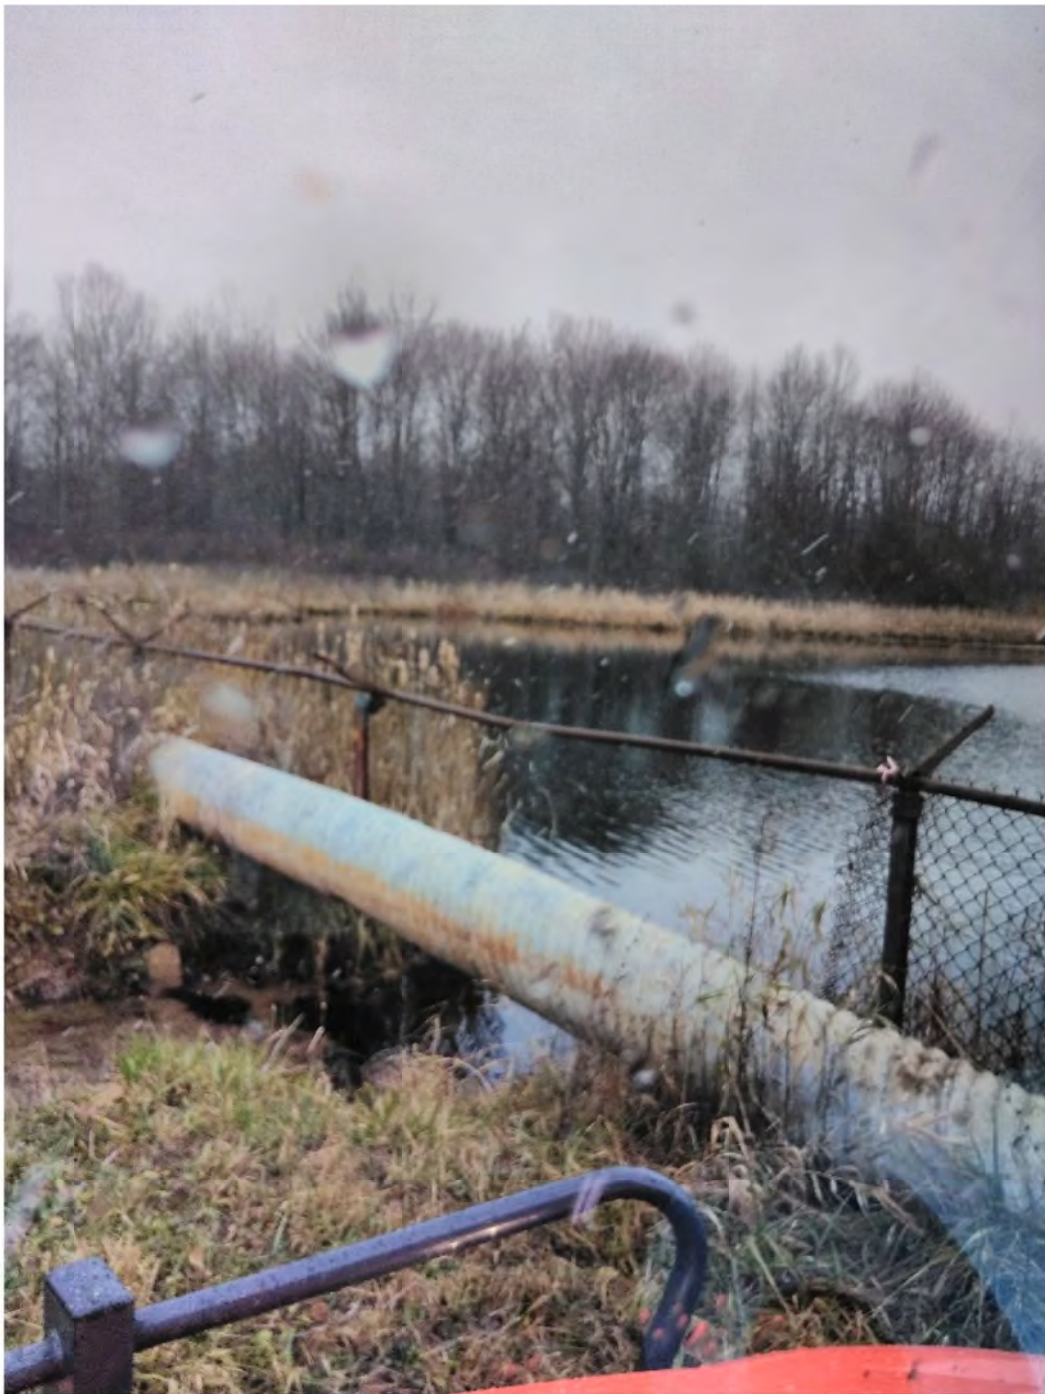
# DETAIL SHEET FOR NE70

Fence down / culvert breached at Mile 18.81

Discovered November 17, 2020

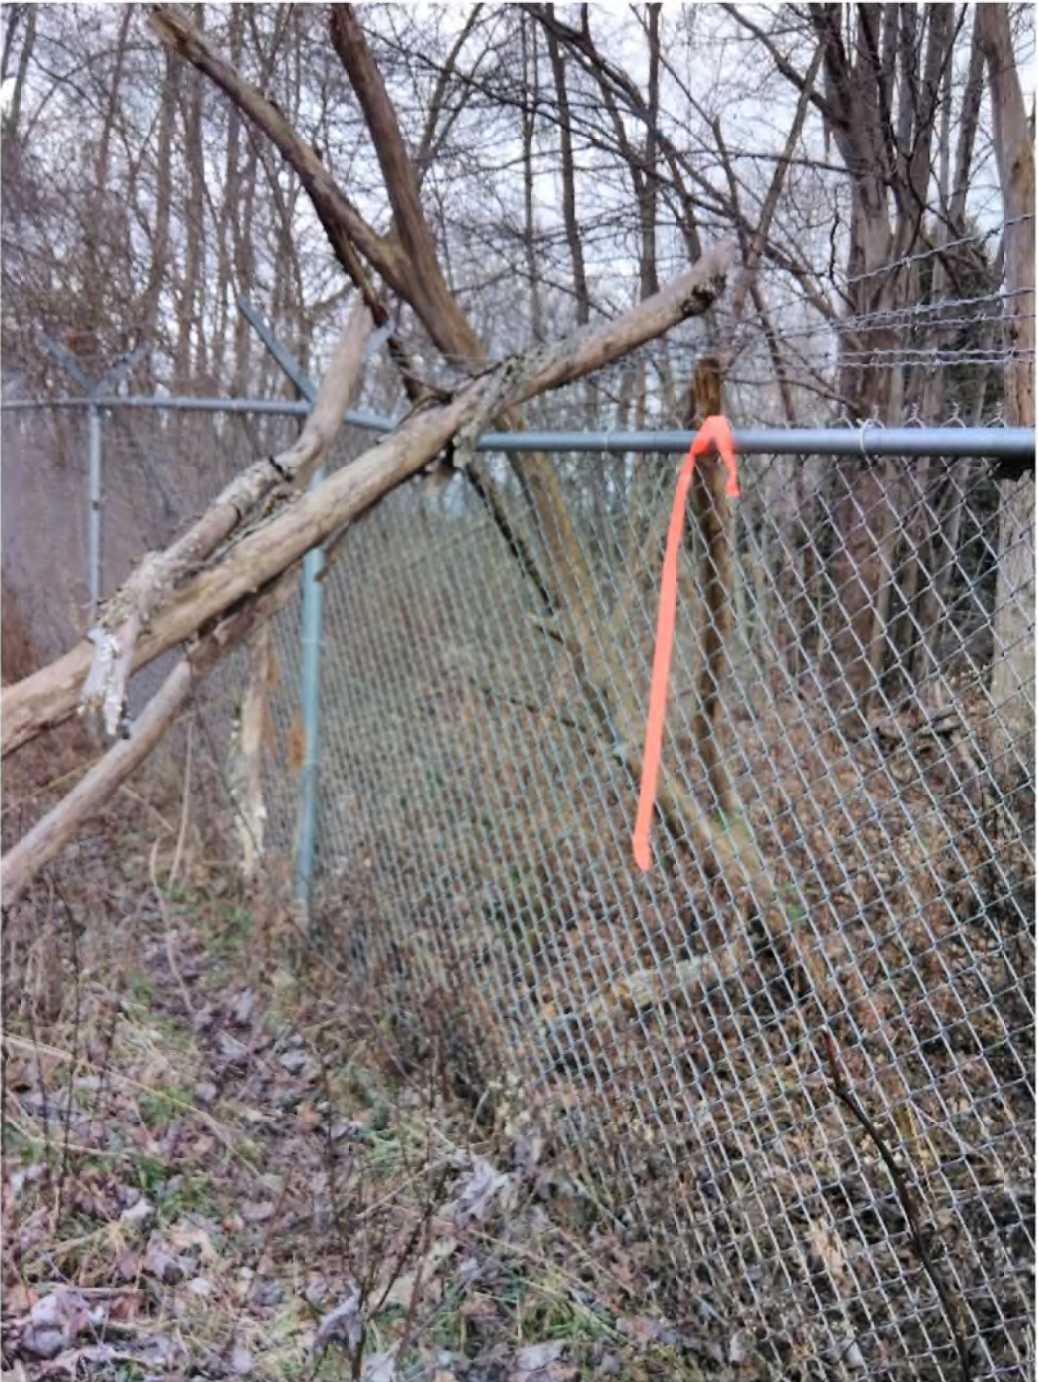
# DETAIL SHEET FOR NE73

Tree on Fence at Mile 21.69

Discovered December 15, 2020

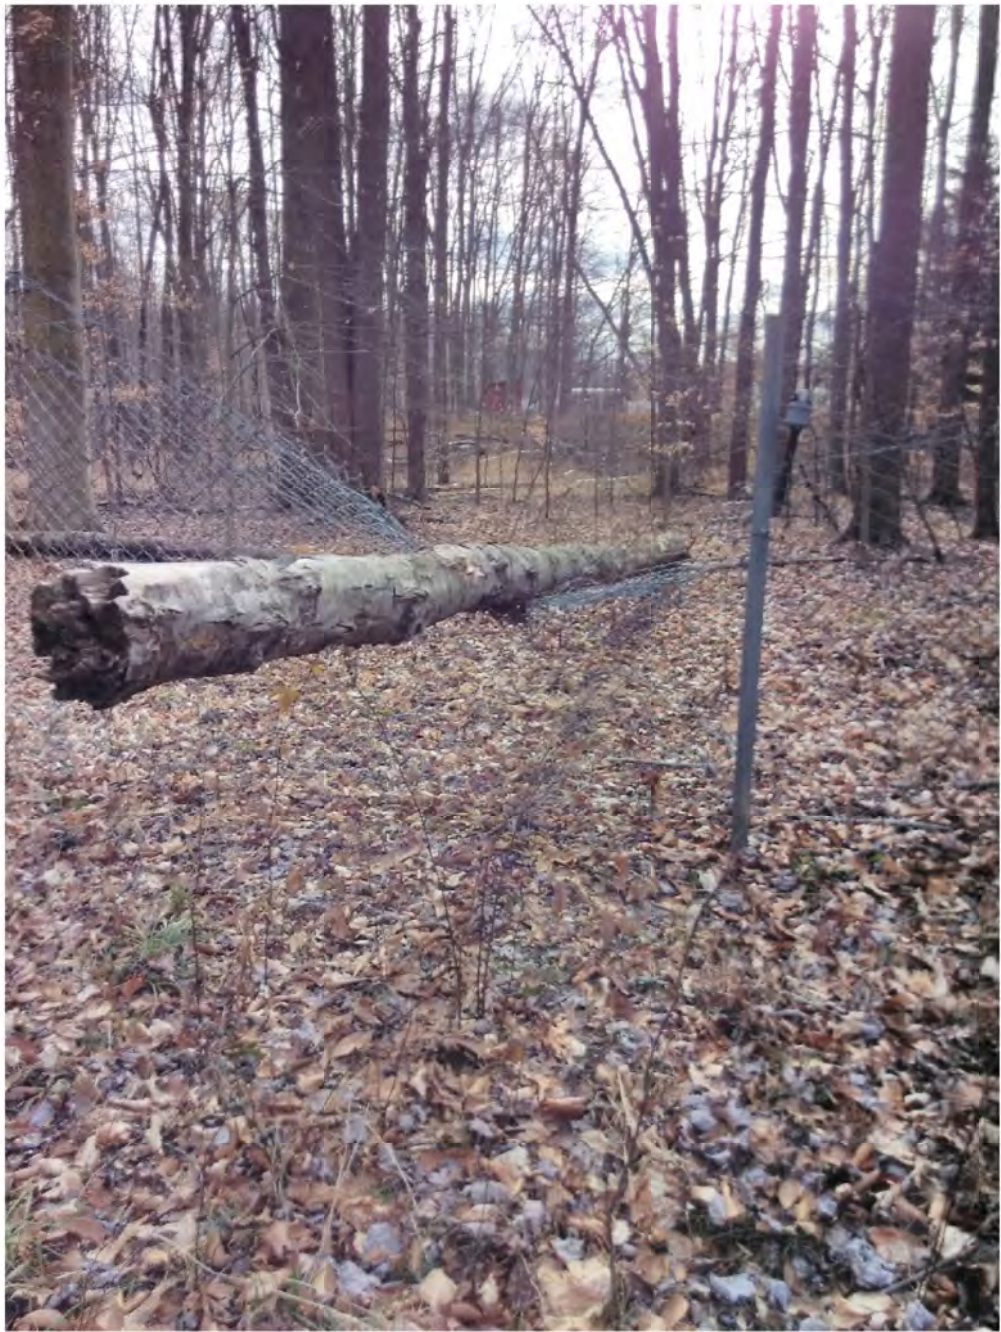
DETAIL SHEET FOR NE74/NE53

Tree on Fence at Mile 22.82

Discovered December 15, 2020

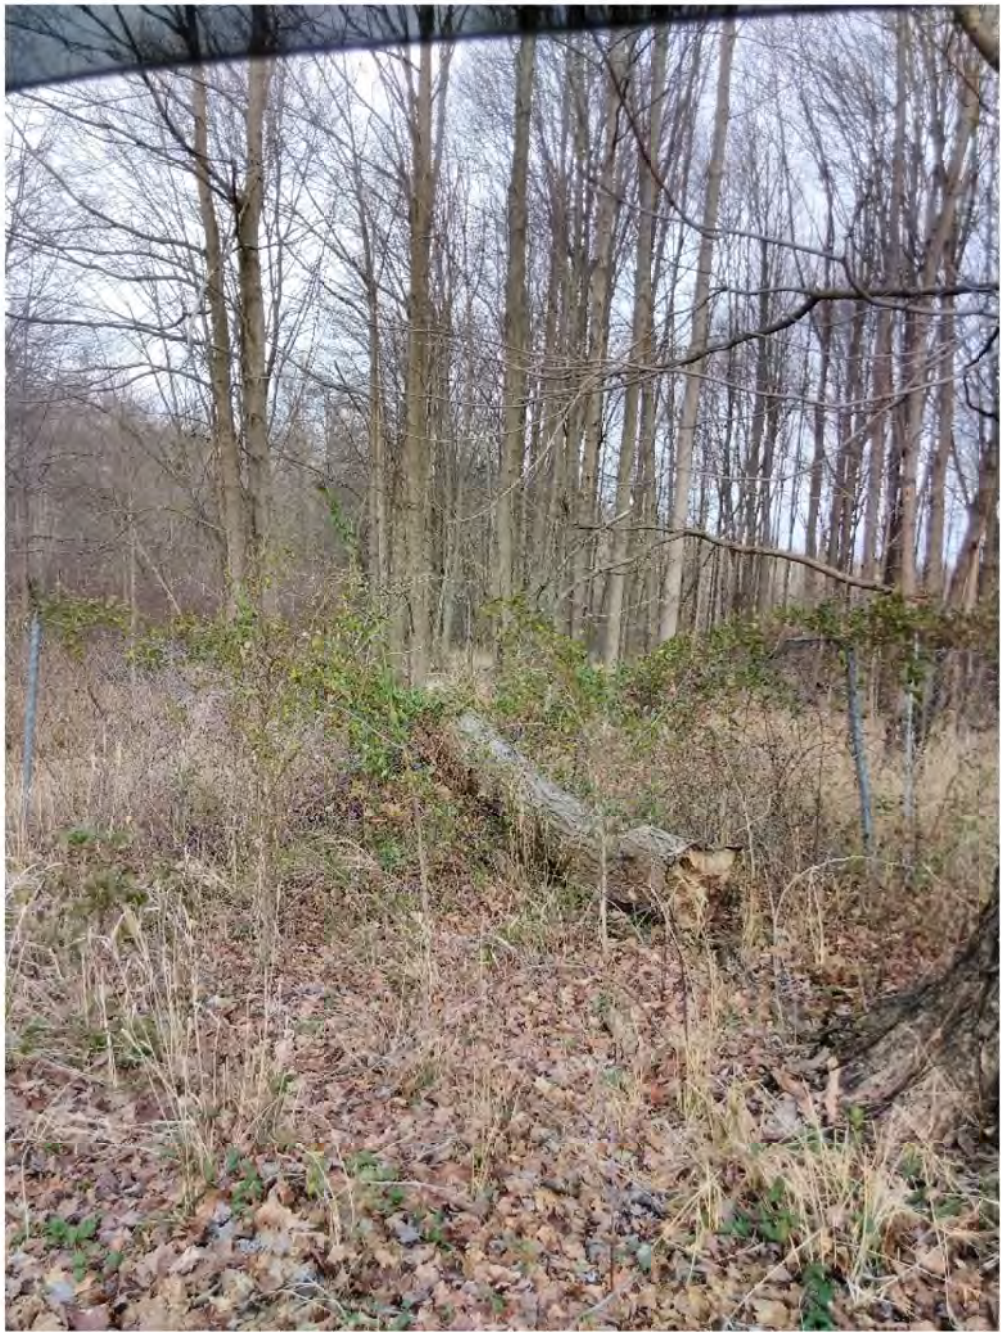
# DETAIL SHEET FOR NE76

Tree on Fence at Mile 23.57

Discovered December 15, 2020

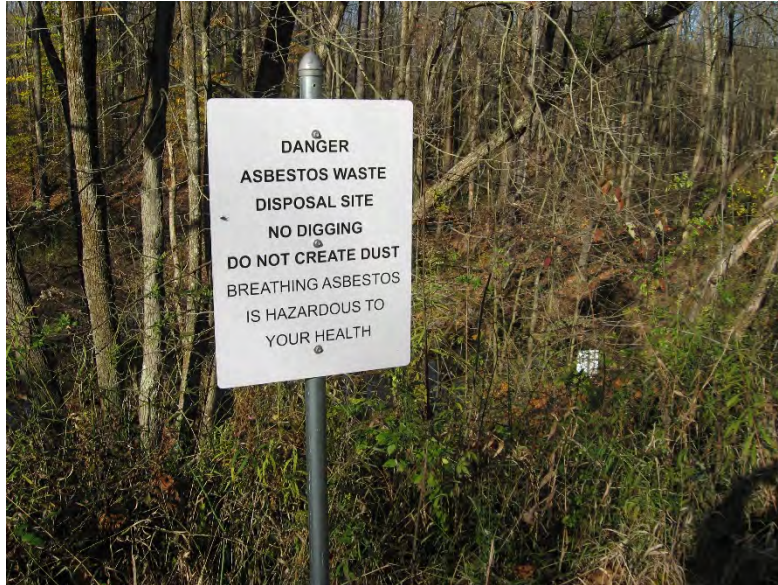
RVAAP-51, asbestos warning sign delineating Land Use Control area along Paris-Windham Road.

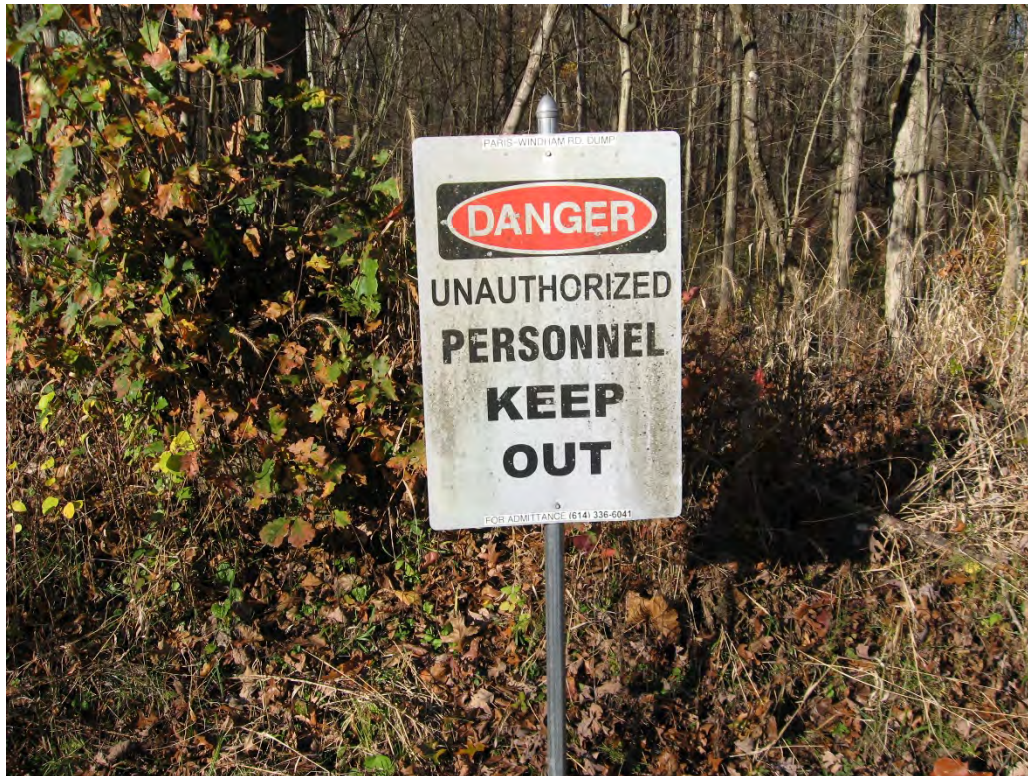
RVAAP-51, warning sign delineating Land Use Control area along Paris-Windham Road.

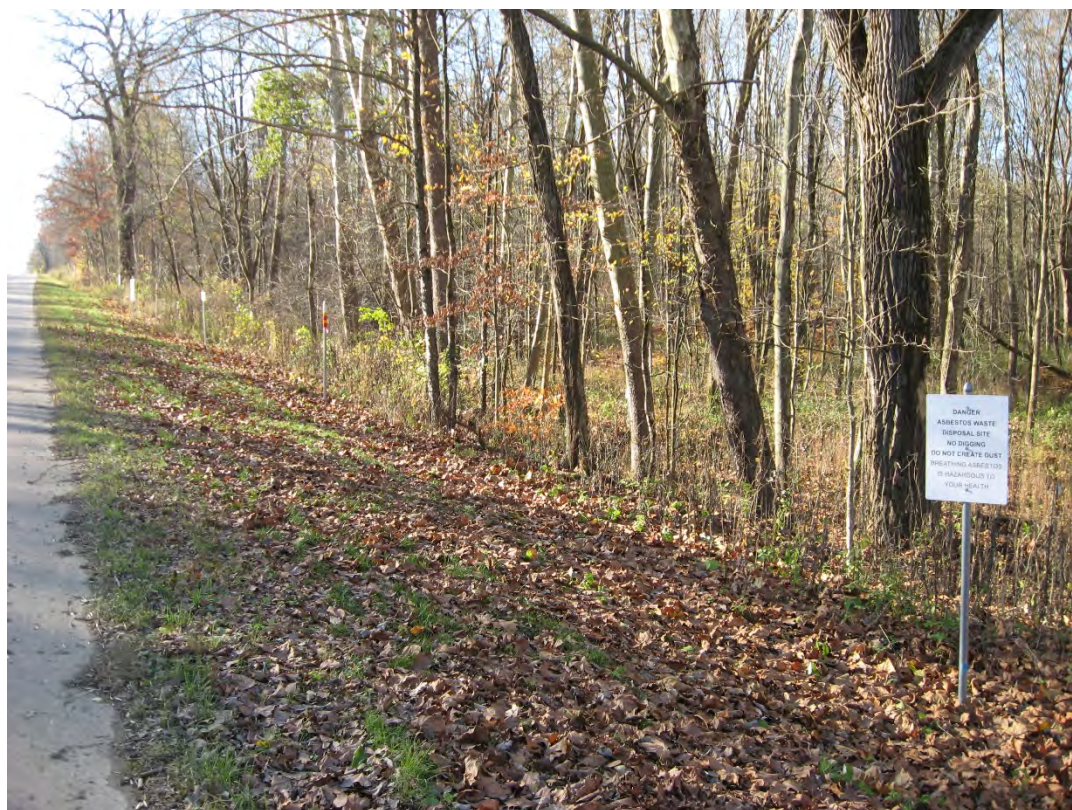
RVAAP-51, Land Use Control area delineated by signs along Paris-Windham Road, looking south.

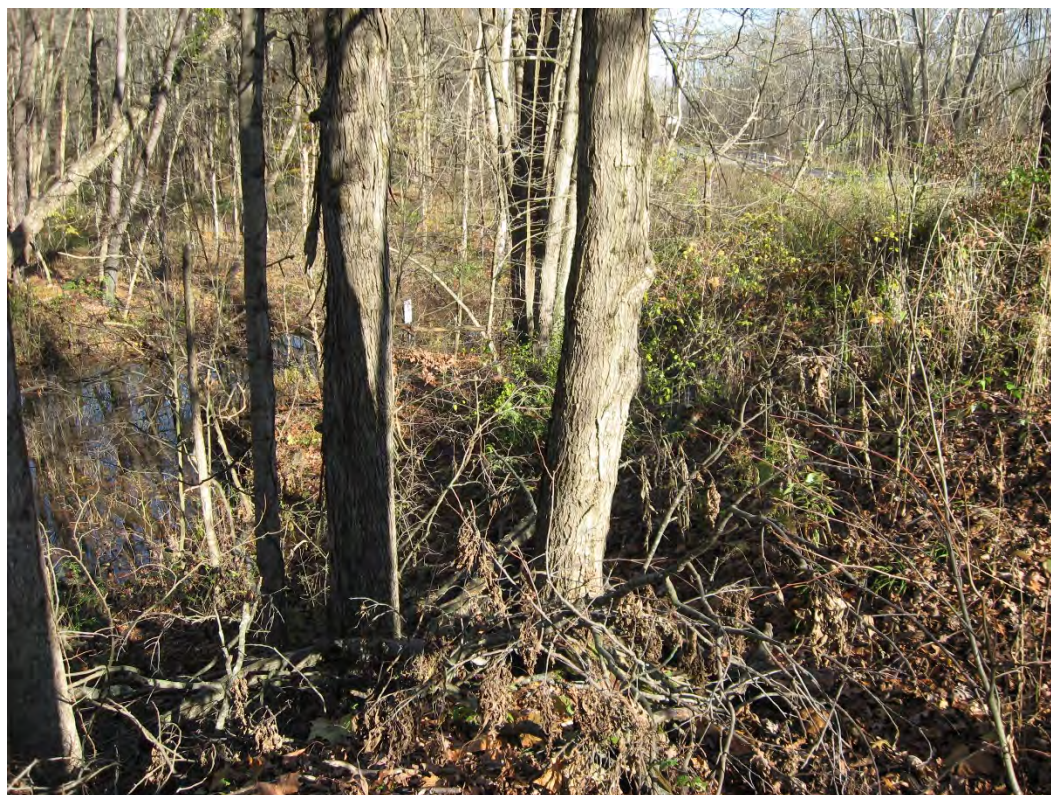
RVAAP-51, Land Use Control area delineated by signs along Paris-Windham Road, looking north from southern portion of the site.
